**Dagger Island Restoration
19-053-000-B087**

**Final Report
August 2021**

Prepared By:

Texas Parks and Wildlife
6300 Ocean Drive Suite 2501
Corpus Christi, TX 78412
361-825-2329

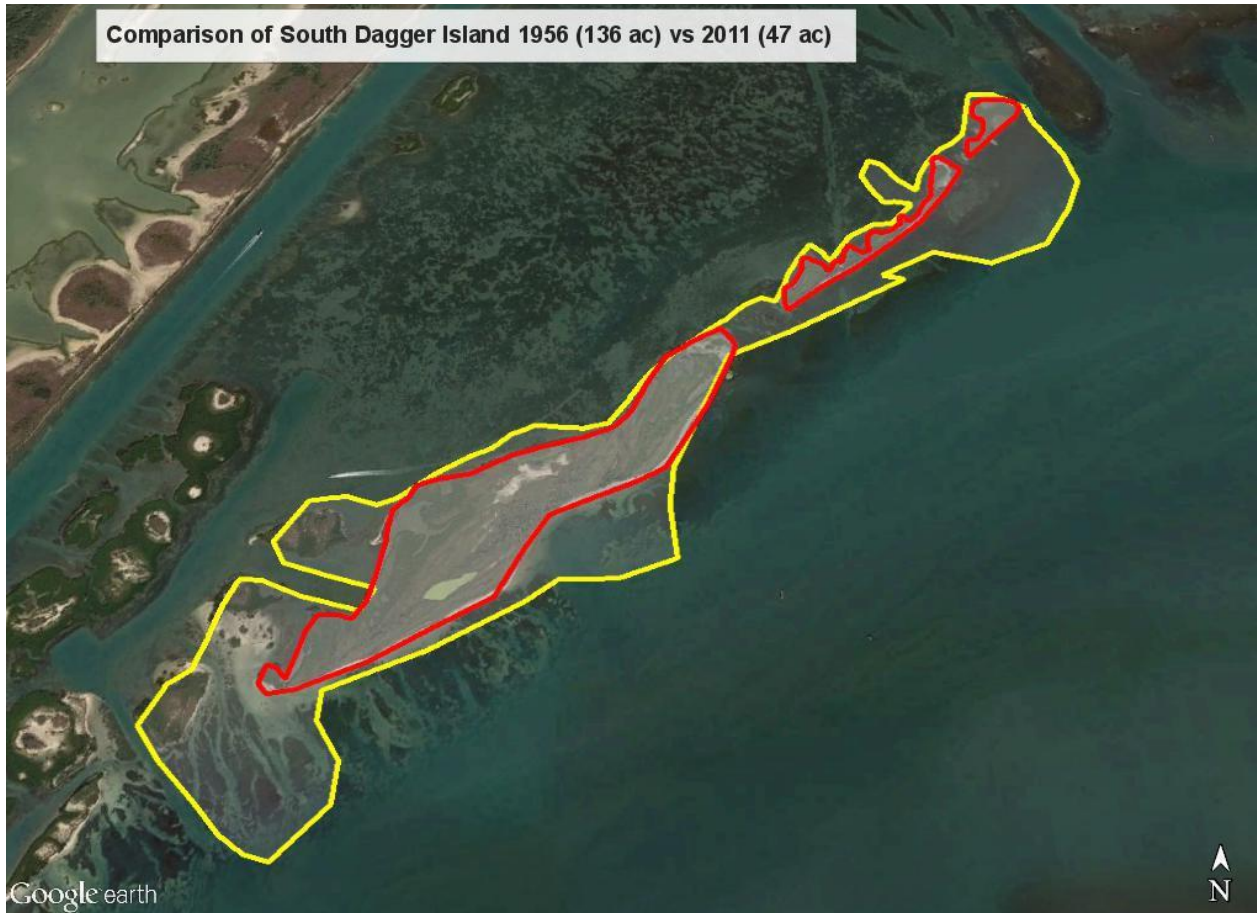
Figure 3. Comparison of the 1956 outline of Priority site 1 Southern Dagger Island (yellow) with the 2011 remnants of Dagger Island (red). In 1956 this section of Dagger Island was 136 acres in size, but now encompasses only 47 acres.

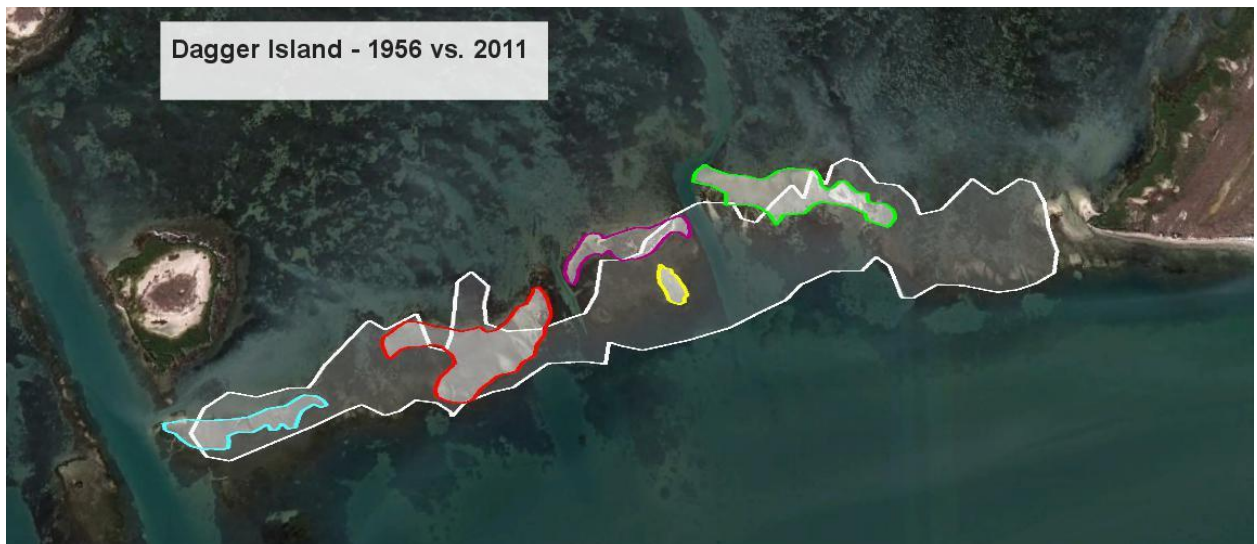
Figure 4. Comparison of the 1956 outline of Priority site 2 Northern Dagger Island (white) with the 2011 remnants of Dagger Island (colored). In 1956 this section of Dagger Island was 48.9 acres in size, but now encompasses only 13.22 acres.

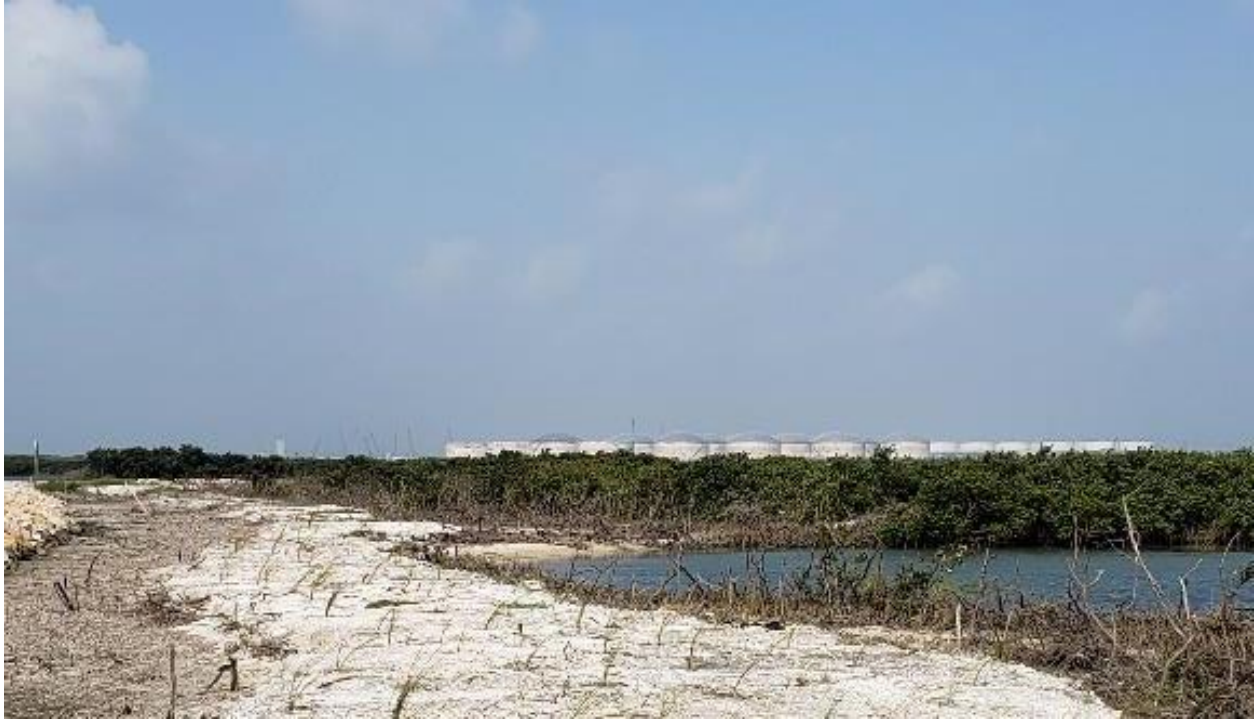
Figure 18. Site 1: saltmeadow cordgrass comparison, pre-Hurricane Hanna.

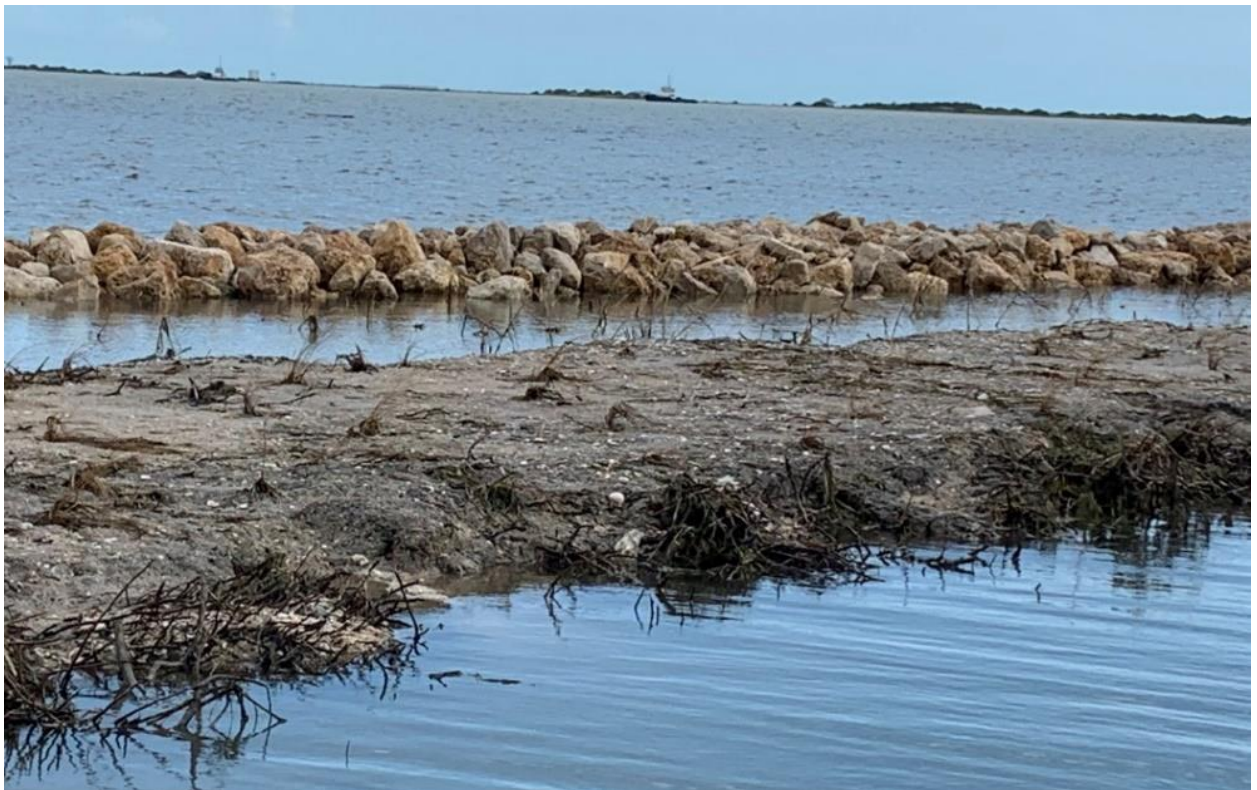
Dagger Island was impacted by Hurricane Hanna which made landfall just north of Port Mansfield as a category 1 hurricane on July 25, 2020. A site visit July 28, 2020 determined plantings of both *S. patens* and smooth cordgrass were damaged, buried, and washed away. Damage (Figures 18 - 23) included thick debris/wrack, scouring at levee crest, and shoreline erosion and undercutting in the northernmost section of the beneficial use levees. TPWD was able to obtain funding to hire Padgett Construction to repair the levee damage caused by the hurricane. Repairs were completed and a site visit conducted in August 2020 to confirm the site was restored to design plans and specifications.

Figure 19. Site 1: saltmeadow cordgrass comparison, post-Hurricane Hanna.

Site 1 experienced less damage and transplant survival was relatively high.

- Roughly 0.2-acres (6%) of planting area and 821 (6%) planting units were damaged.
- Saltmeadow cordgrass survival (66%), smooth cordgrass survival (69%) without adjustment from storm damage.

Since the survival rate did not meet success criteria due to unforeseen circumstances, a second planting event was required. TES proposed delayed transplant effort due to the prediction of more tropical storms accompanied by high tide events and the request was approved by TPWD and GLO. Texas experienced a winter freeze during the last two weeks of February resulting in a further reduction of plant survival. TES conducted a spring assessment survey on April 15, 2021 to determine which areas to replant that would provide the highest potential of plant survival. After reviewing the data, TPWD and TGLO agreed that the replanting efforts should be done at Site 1 due to a higher survival rate and the presence of birds at Site 2. TES submitted a planting contract amendment for a second planting that was approved in June 2021. TES replanted 3,847 three-stem units of smooth cordgrass, approximately one acre, at Site 1 on July 5-6, 2021 (Figure 24).

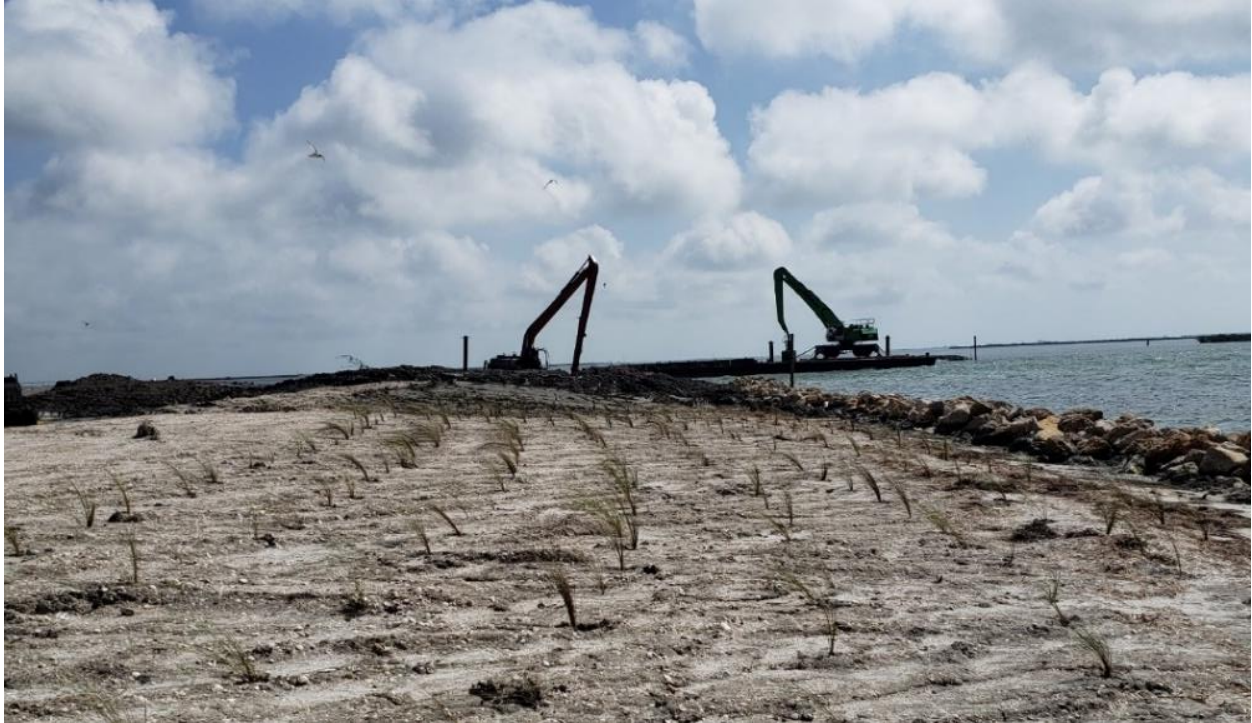
Figure 20. Site 2: levee face comparison, pre-Hurricane Hanna.

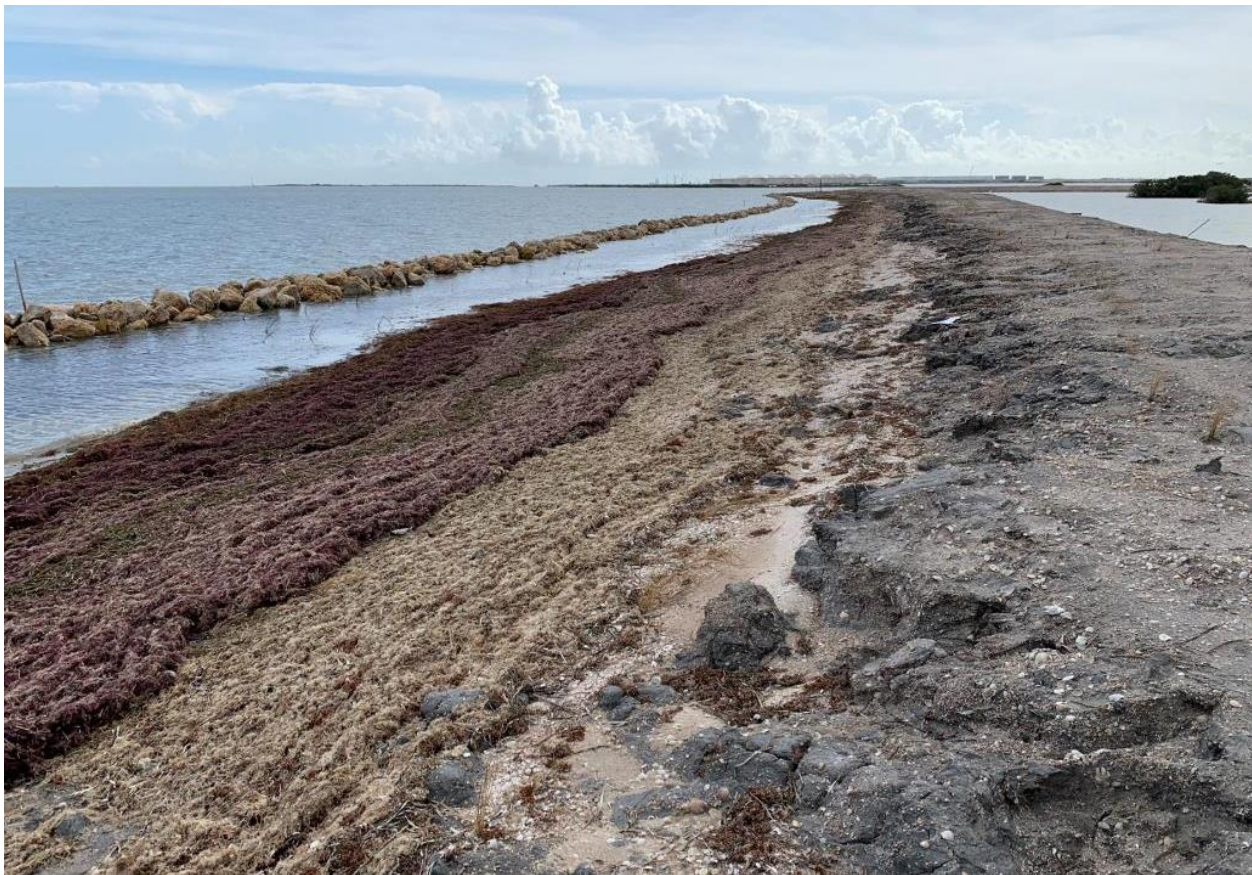
Figure 21. Site 2: levee face comparison, post-Hurricane Hanna.

Site 2 experienced significant damage to transplants from scouring, wrack/debris fill, and contractor levee repair following impacts from two hurricane events at the site.

- Roughly 2.1-acres (72%) of planting area and 8,623 (68%) planting units were damaged.
- Saltmeadow cordgrass survival (33%), smooth cordgrass survival (3%) without adjustment from storm damage.

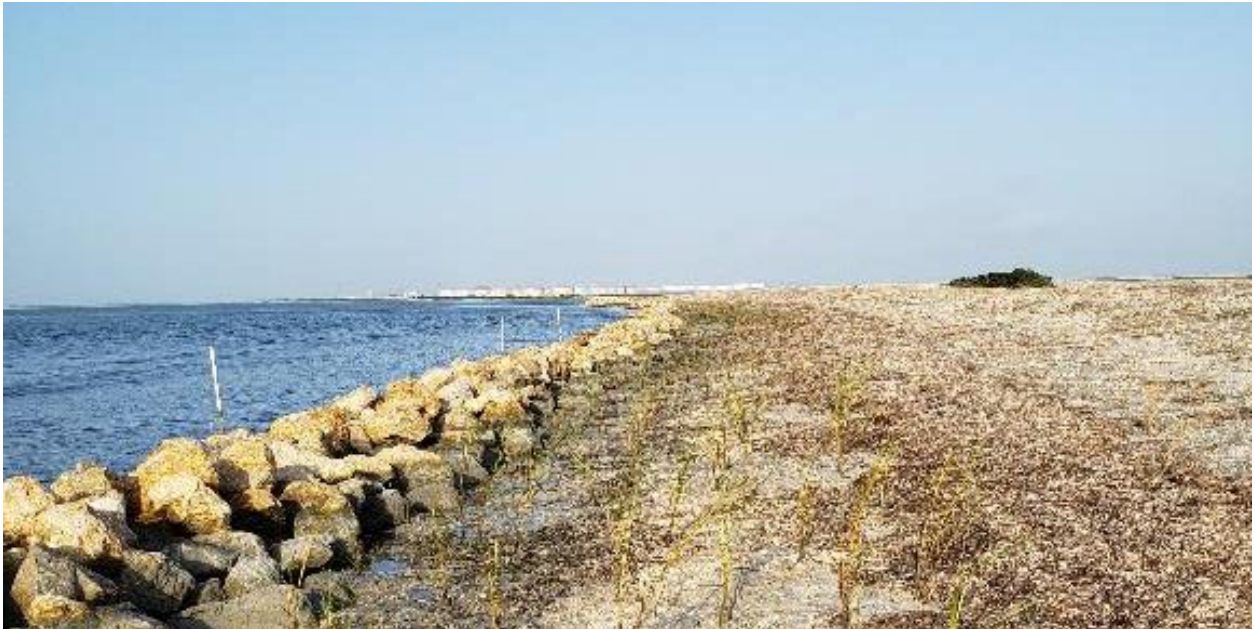
Figure 22. Site 2: smooth cordgrass comparison, pre-Hurricane Hanna.

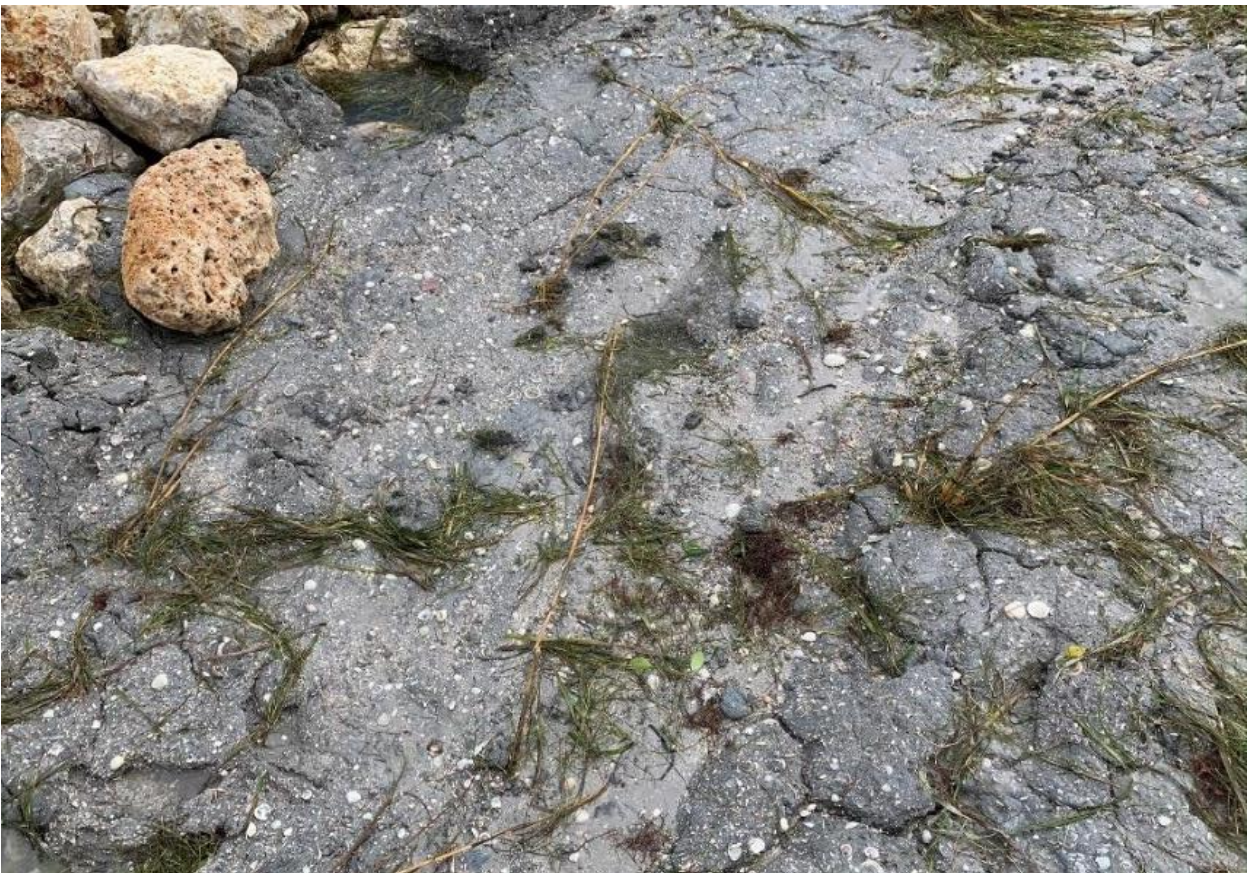
Figure 23. Site 2: smooth cordgrass comparison, post-Hurricane Hanna.

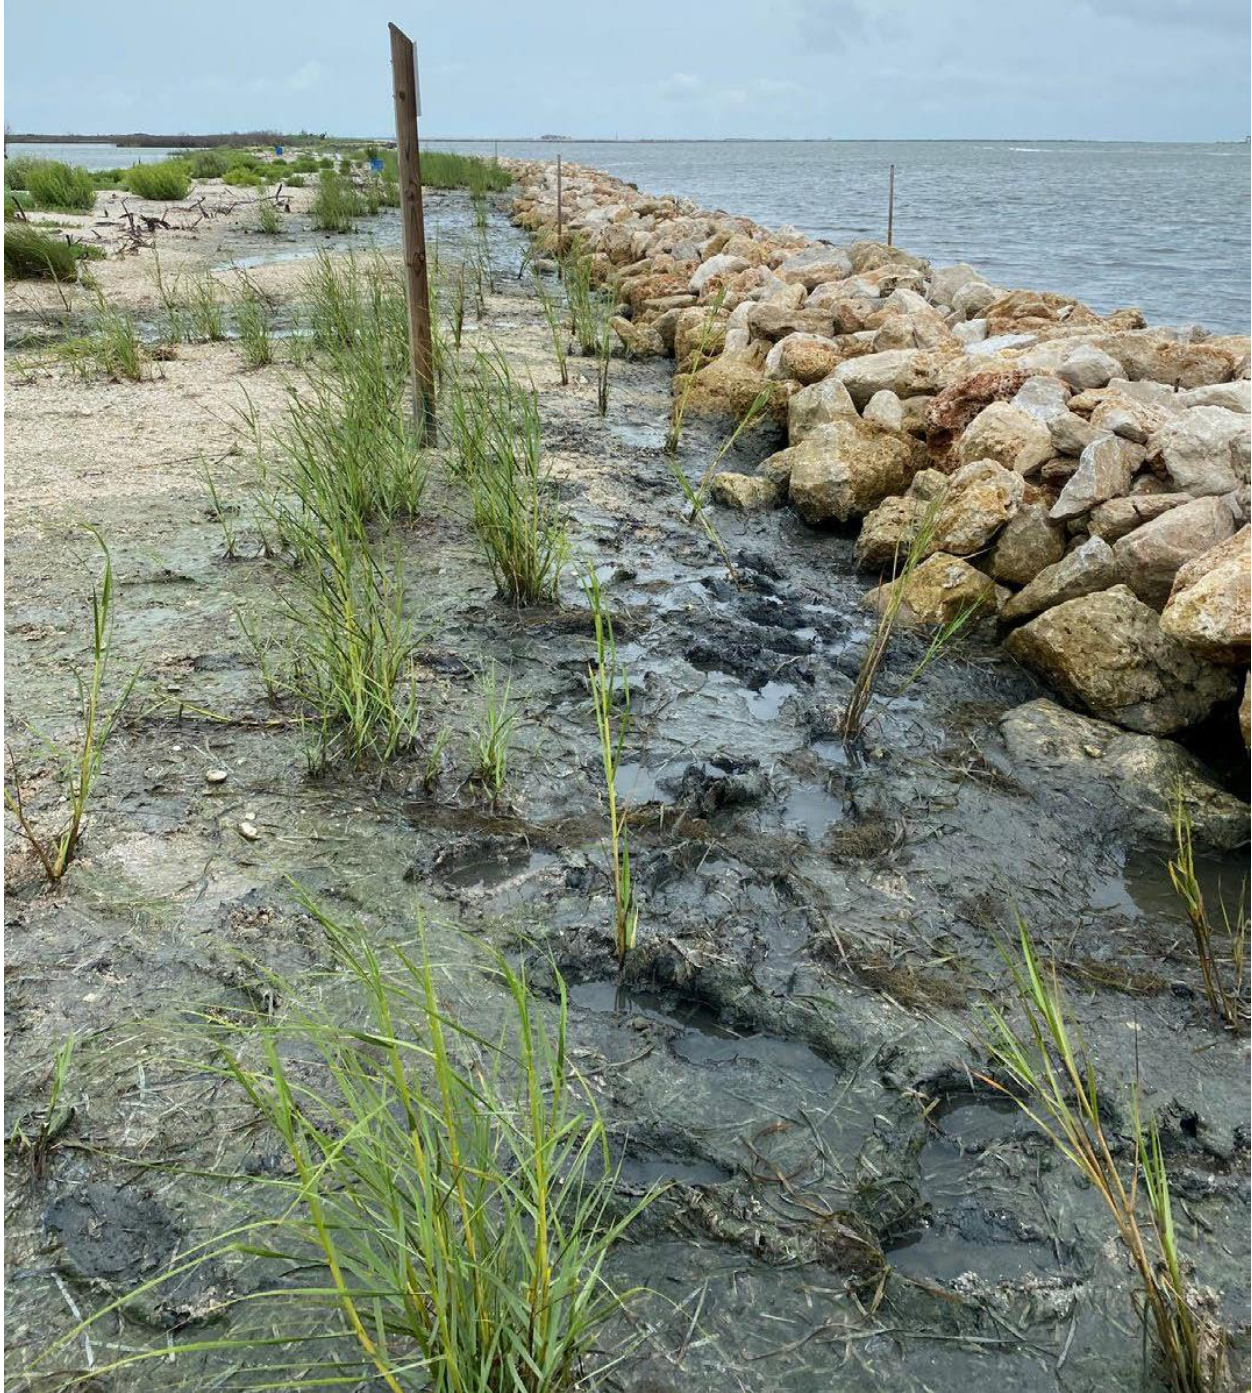
Figure 24. Smooth cordgrass replanting.
