Preconstruction and Post Construction Photographs

Erosion Protection for Pelican Island
GLO Contract No. 09-210-000-3719

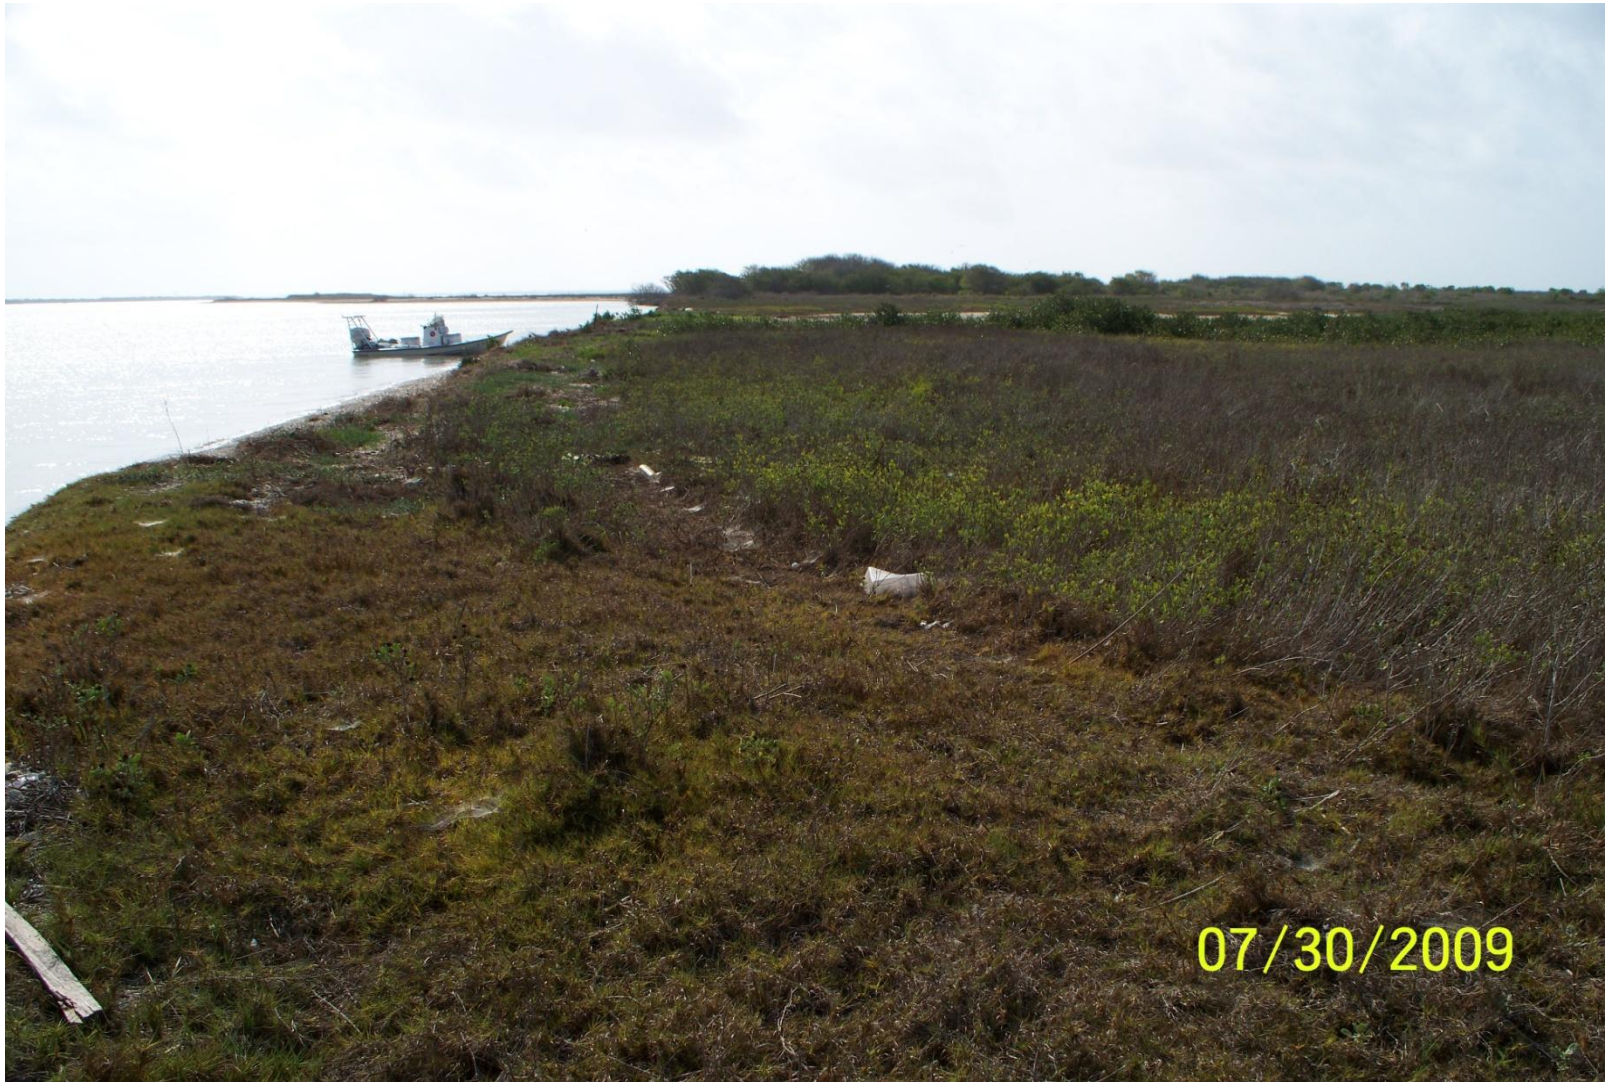
Photo Station 1 Pre-construction . View east view toward Photo Station 2

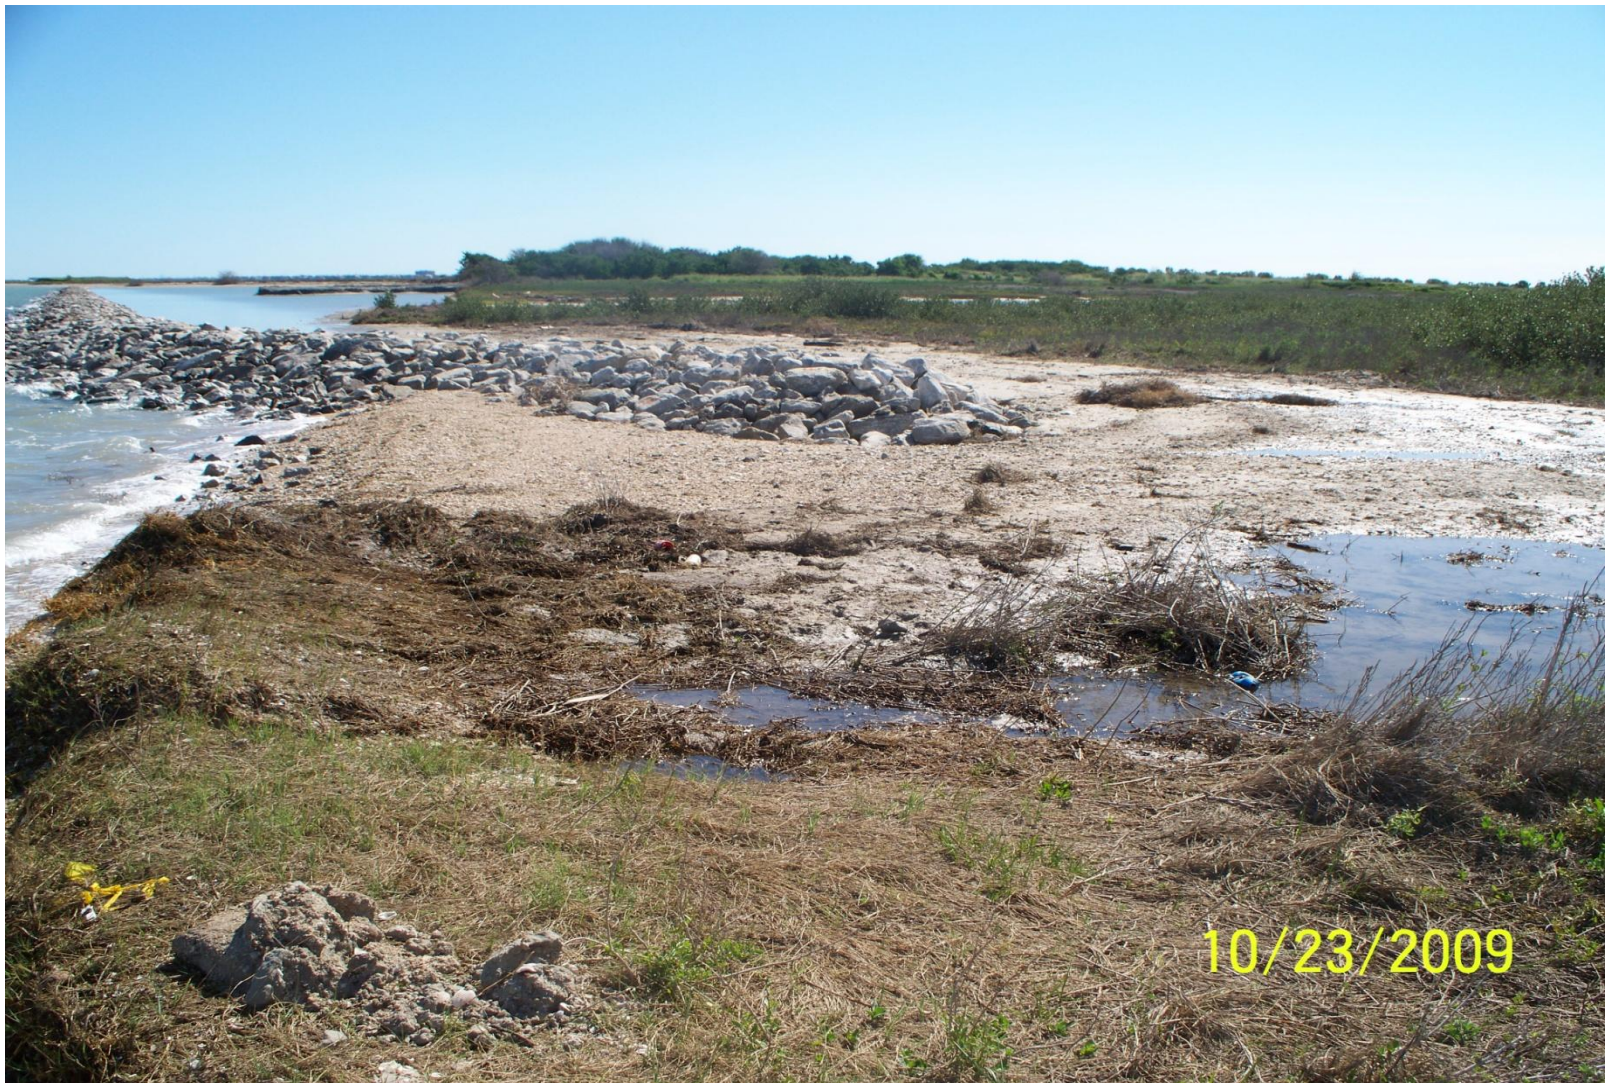
Photo Station 1 Post-construction . View east view toward Photo Station 2.
Project revetment section in foreground.

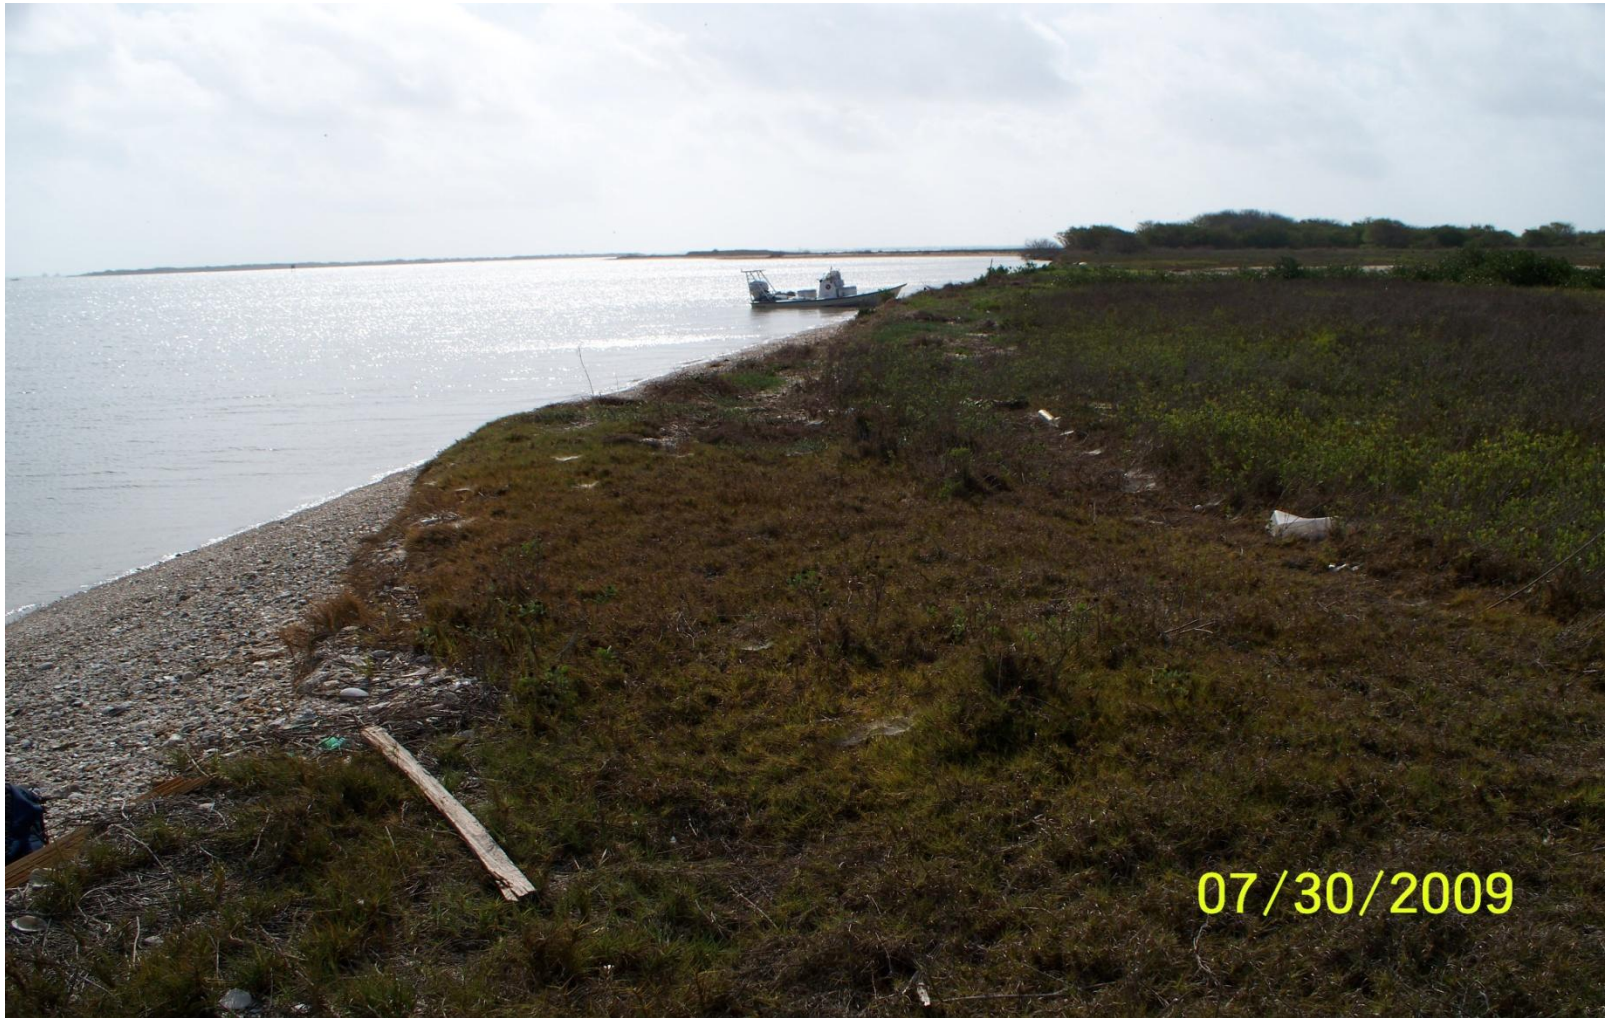
Photo Station 1. Pre-construction. East view . Point of Mustang in far distance with south edge of ship channel to NE.

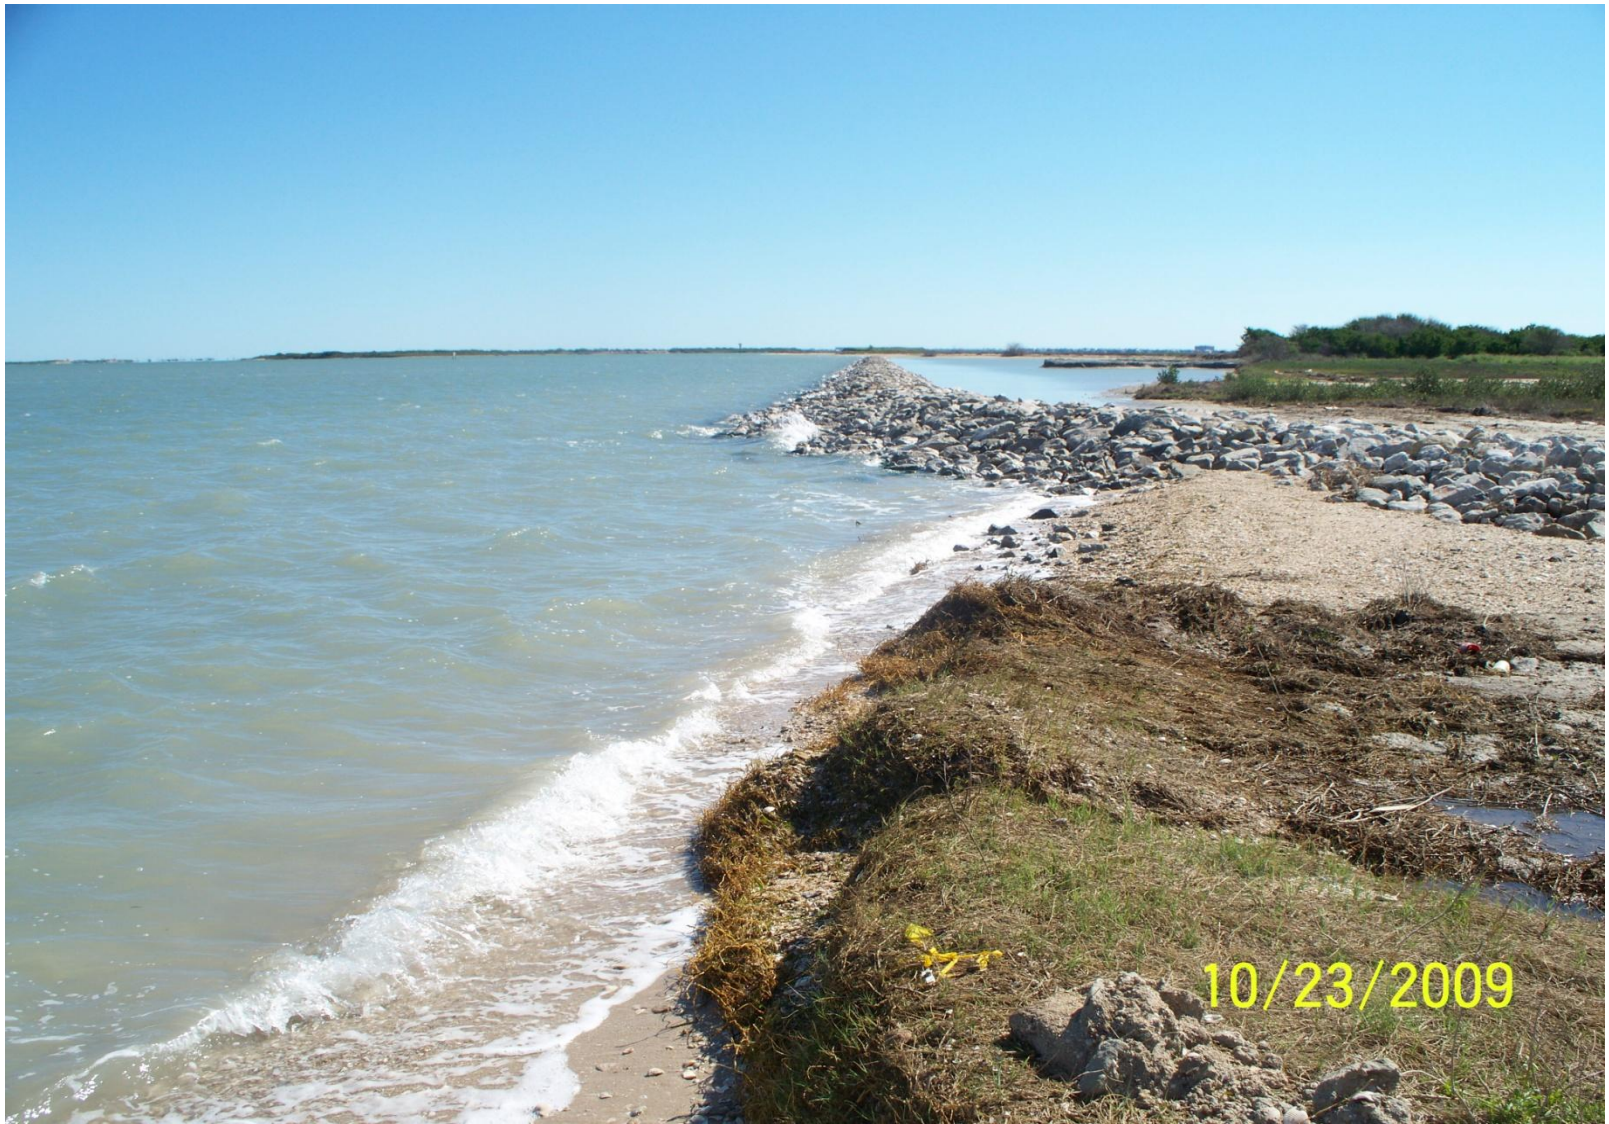
Photo Station 1. Post-construction . View east down alignment of completed breakwater. Note bank erosion compared to July 2009 photo.

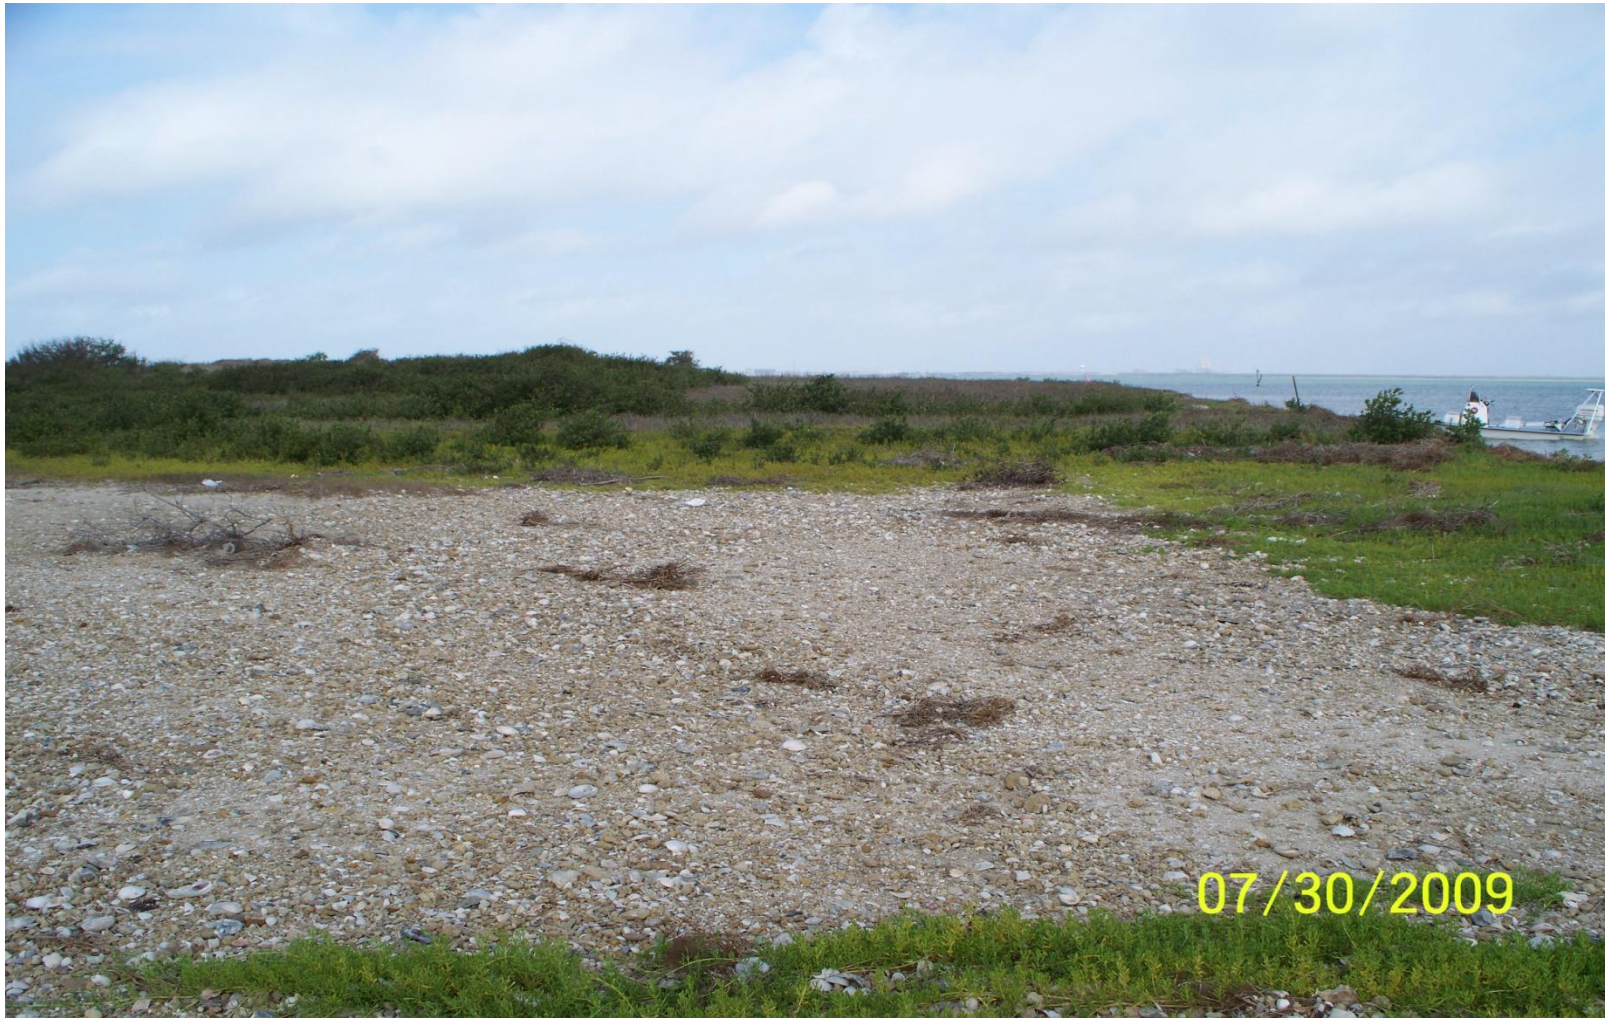
Photo Station 2. Preconstruction. View west toward Photo Station 1

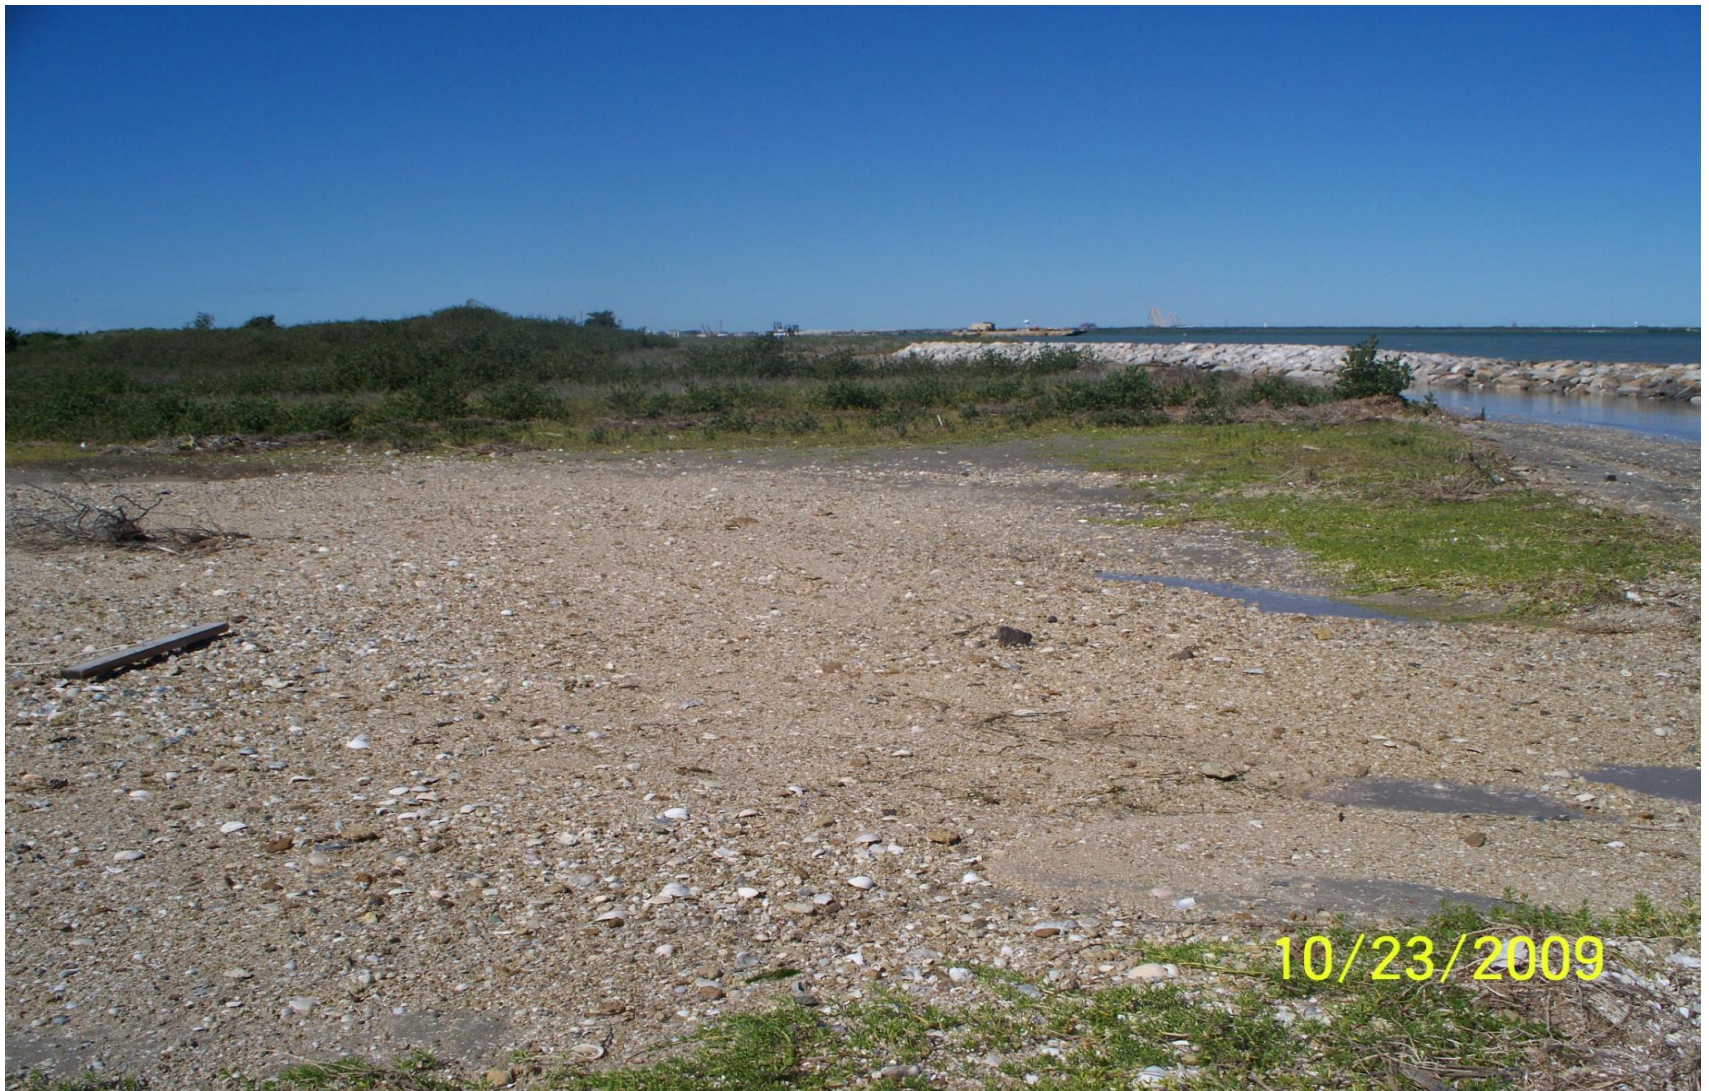
Photo Station 2. Post-construction . View west toward Photo Station 1 (behind revetment section)

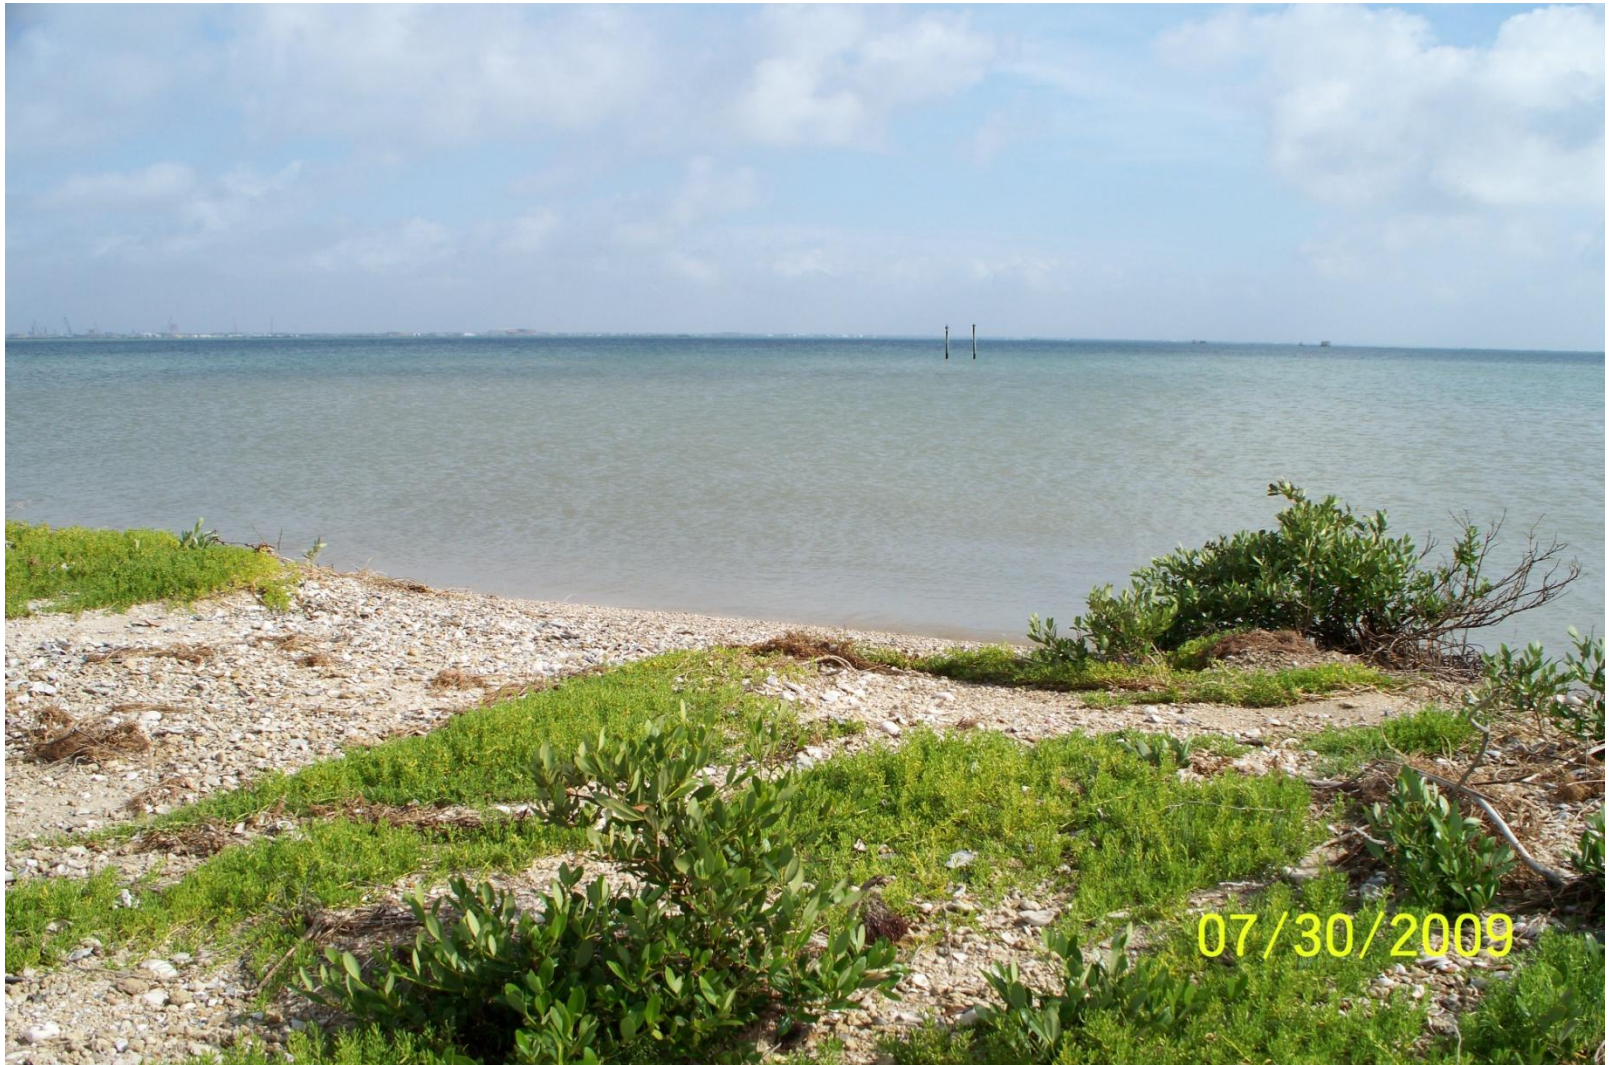
Photo Station 2. Preconstruction. View north west toward Corpus Christi Ship Channel . Note position of mangrove in immediate foreground.

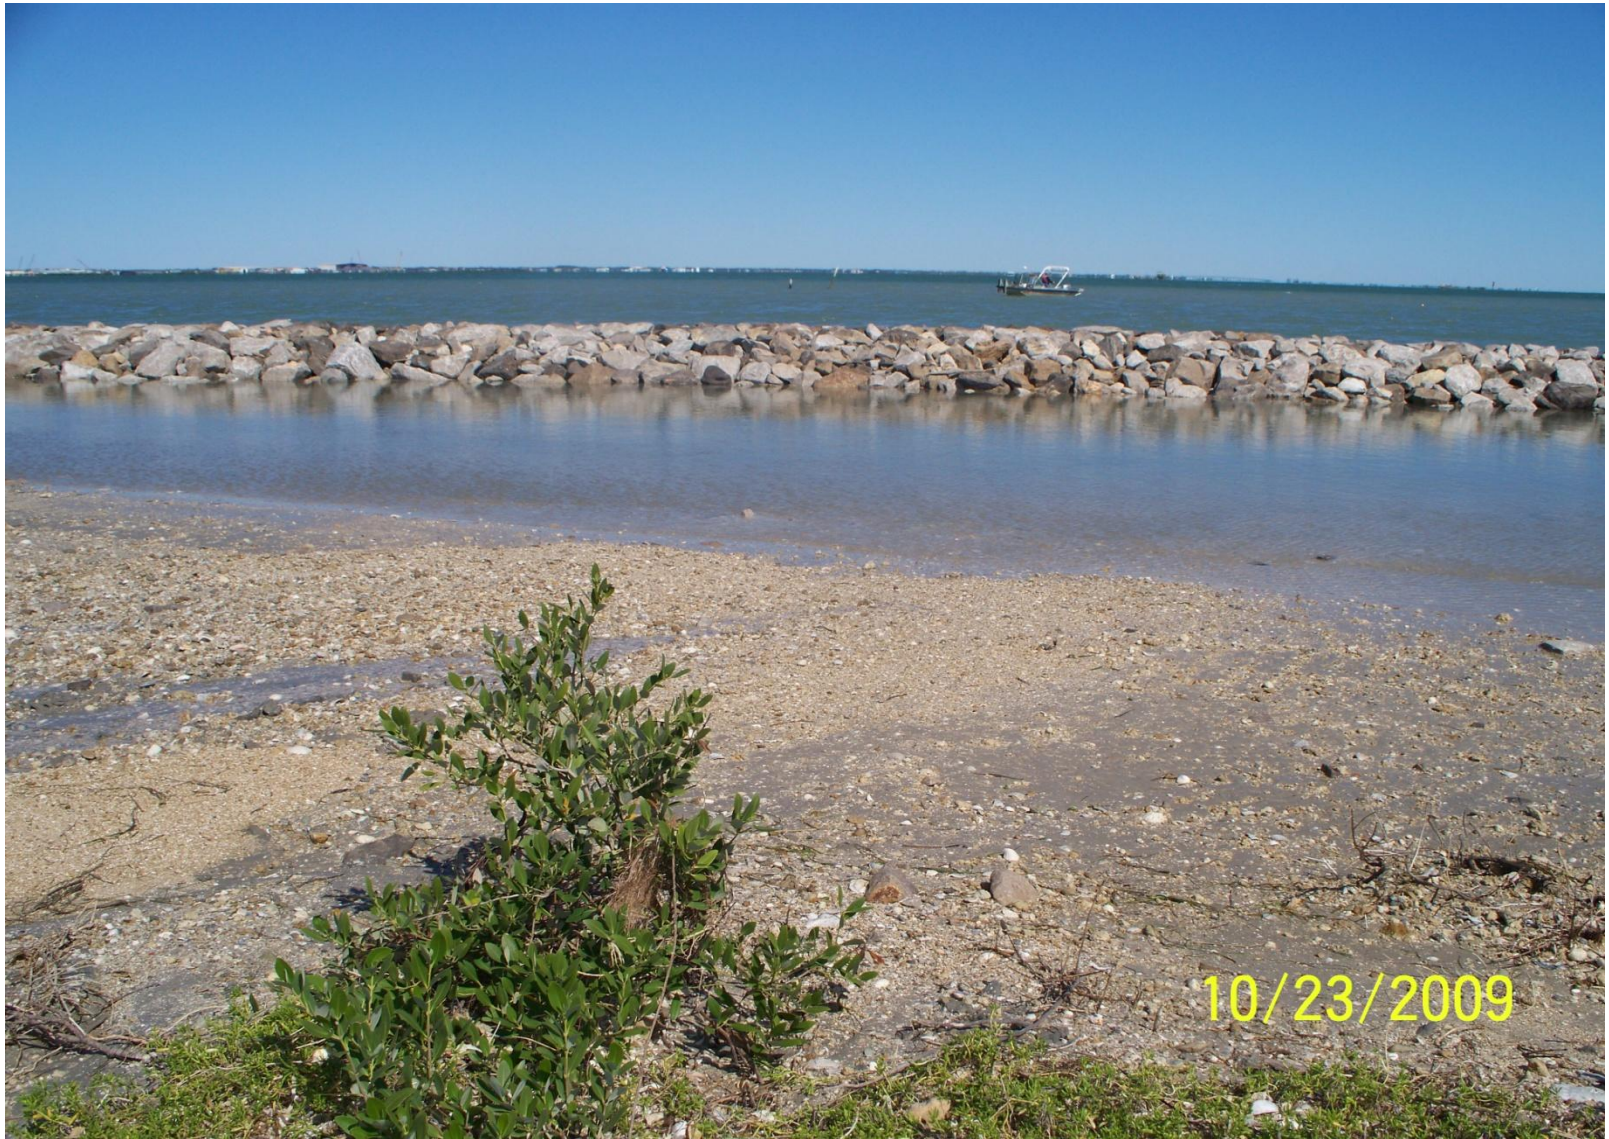
Photo Station 2. Post-construction . Note erosion up to mangrove between pre-construction photo and breakwater completion.

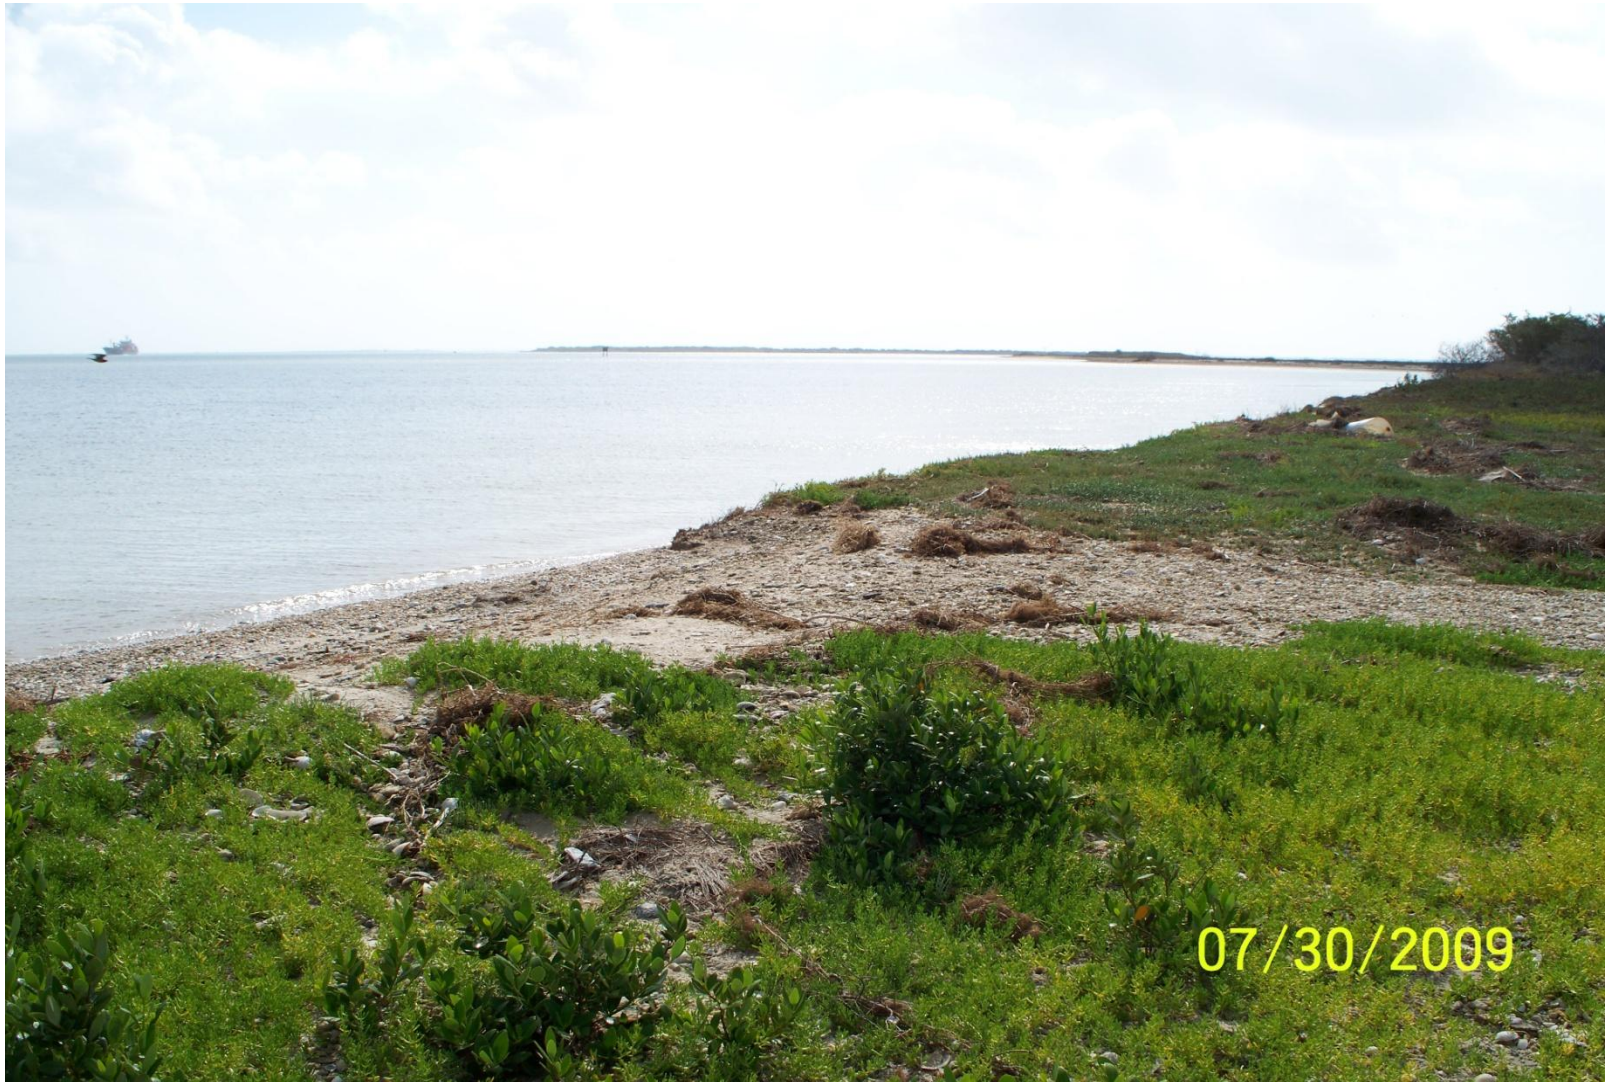
Photo Station 2. Preconstruction. View north east to ship in the Corpus Christi Ship Channel and Point of Mustang in far distance .

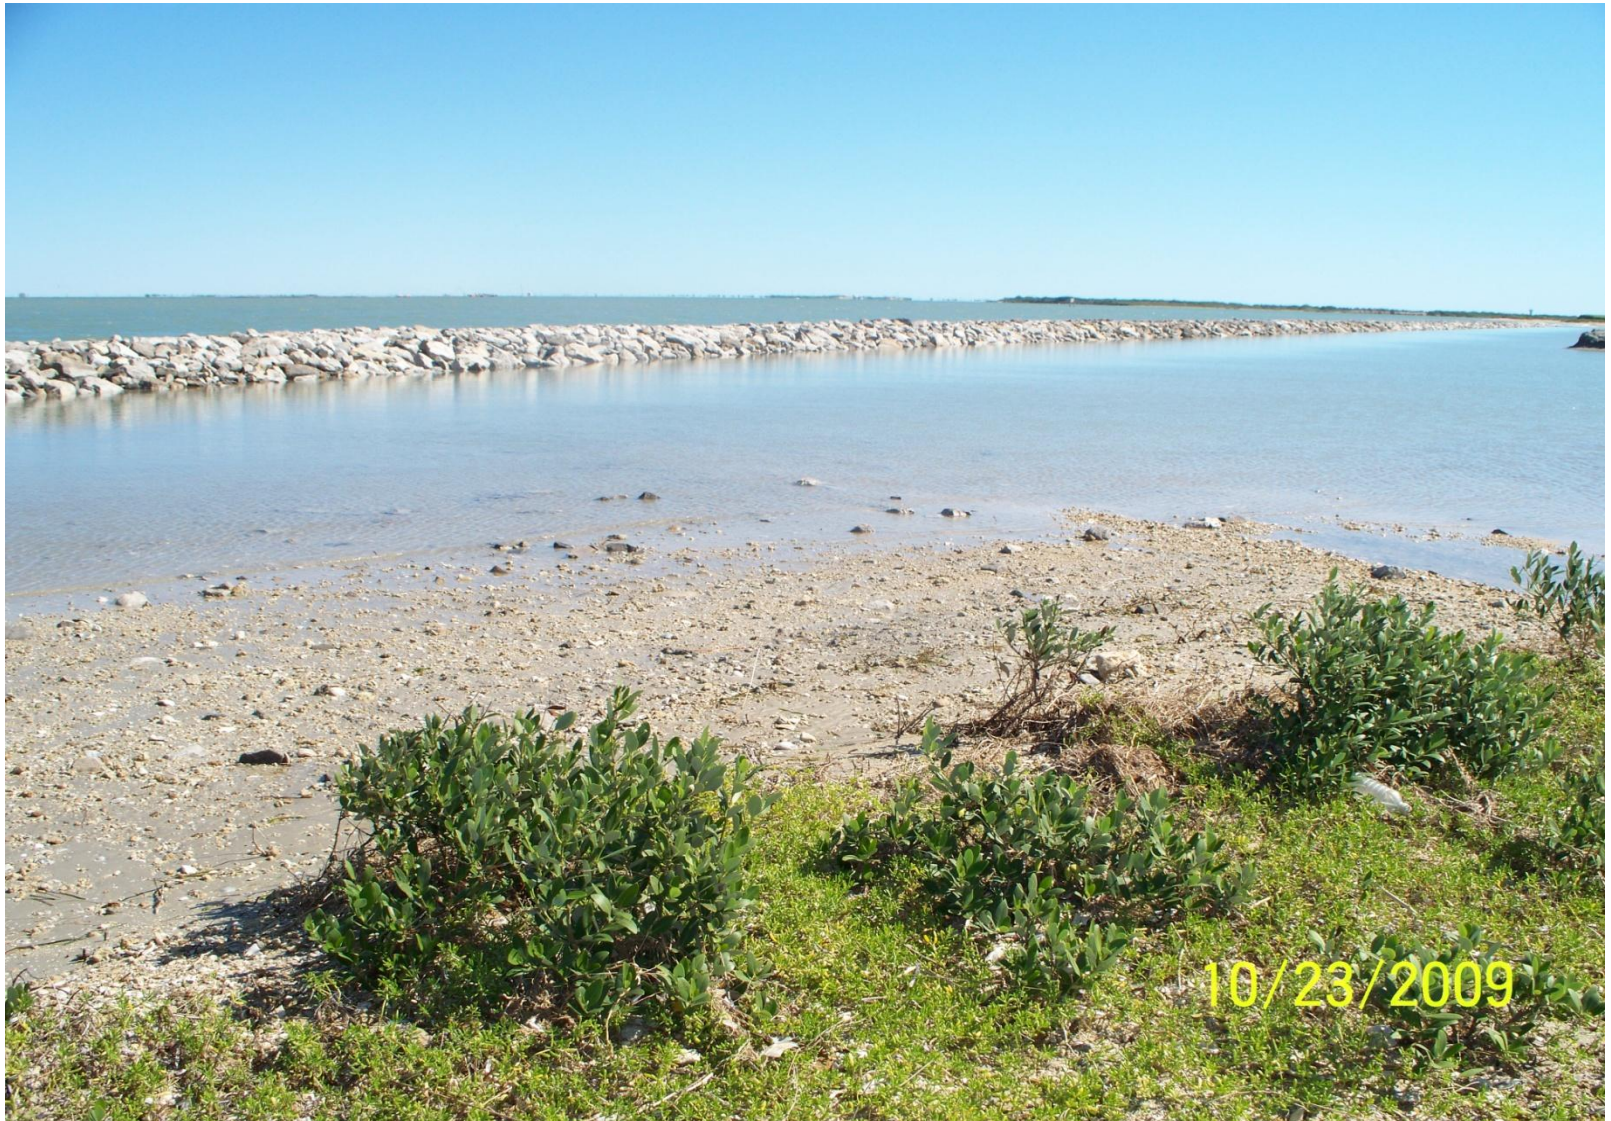
Photo Station 2. Post-construction . Note erosion between pre-construction photo and post construction.

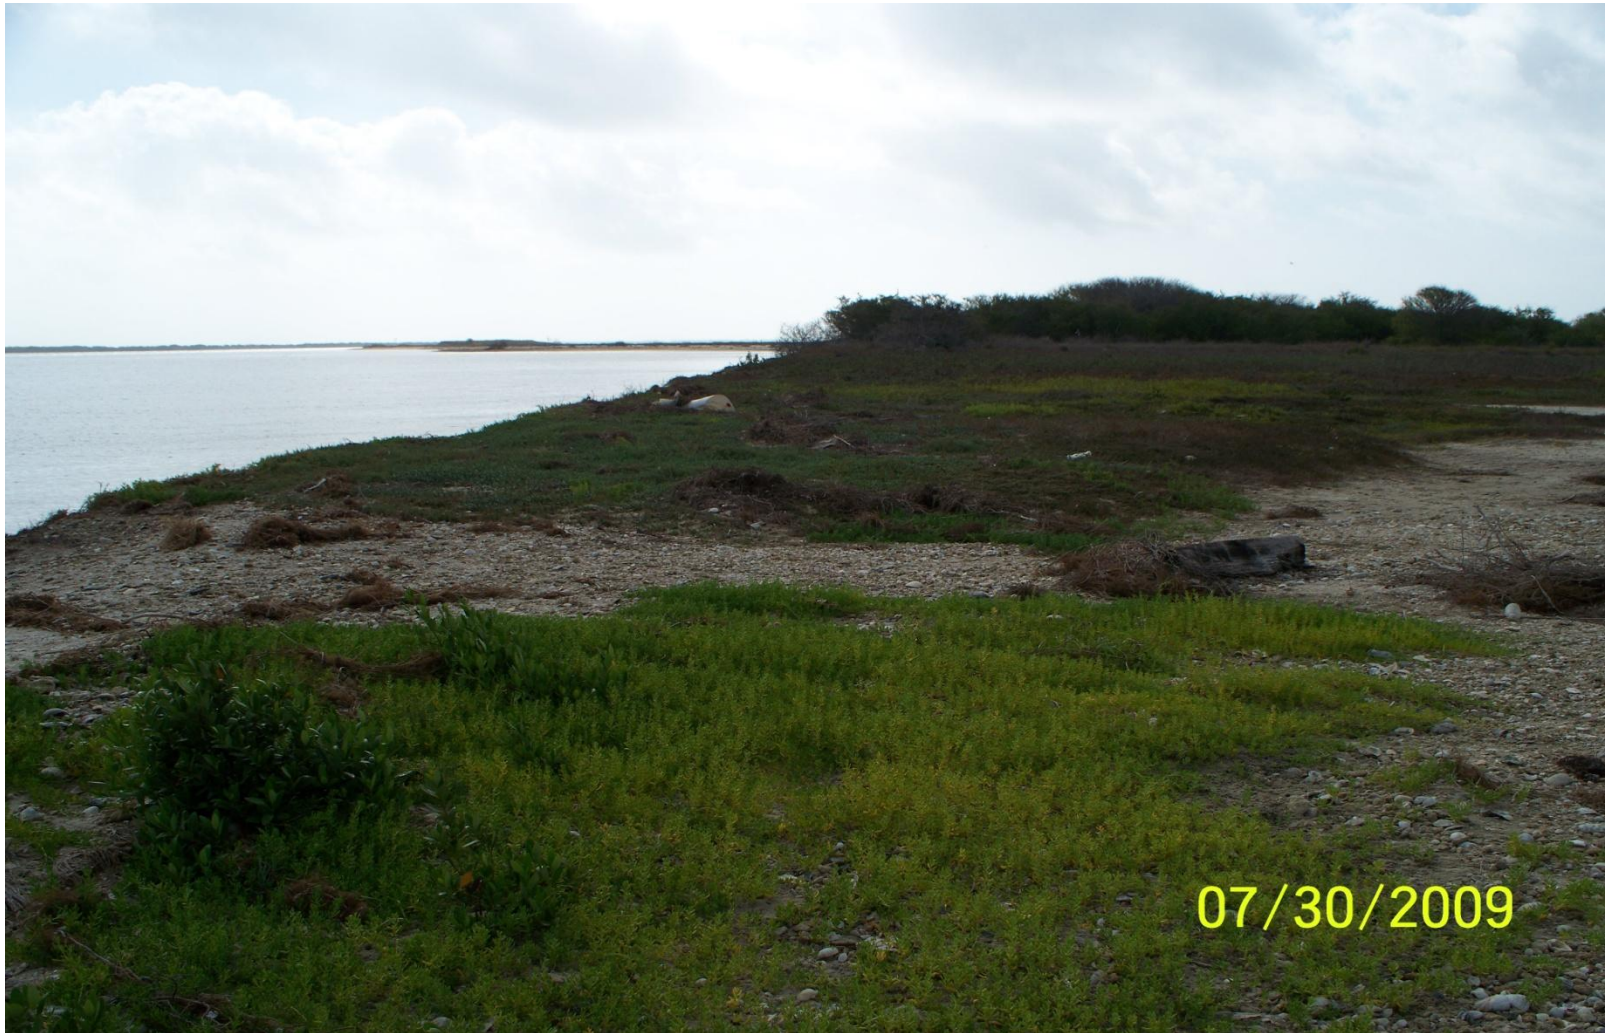
Photo Station 2. Preconstruction. East view toward Photo Station 3

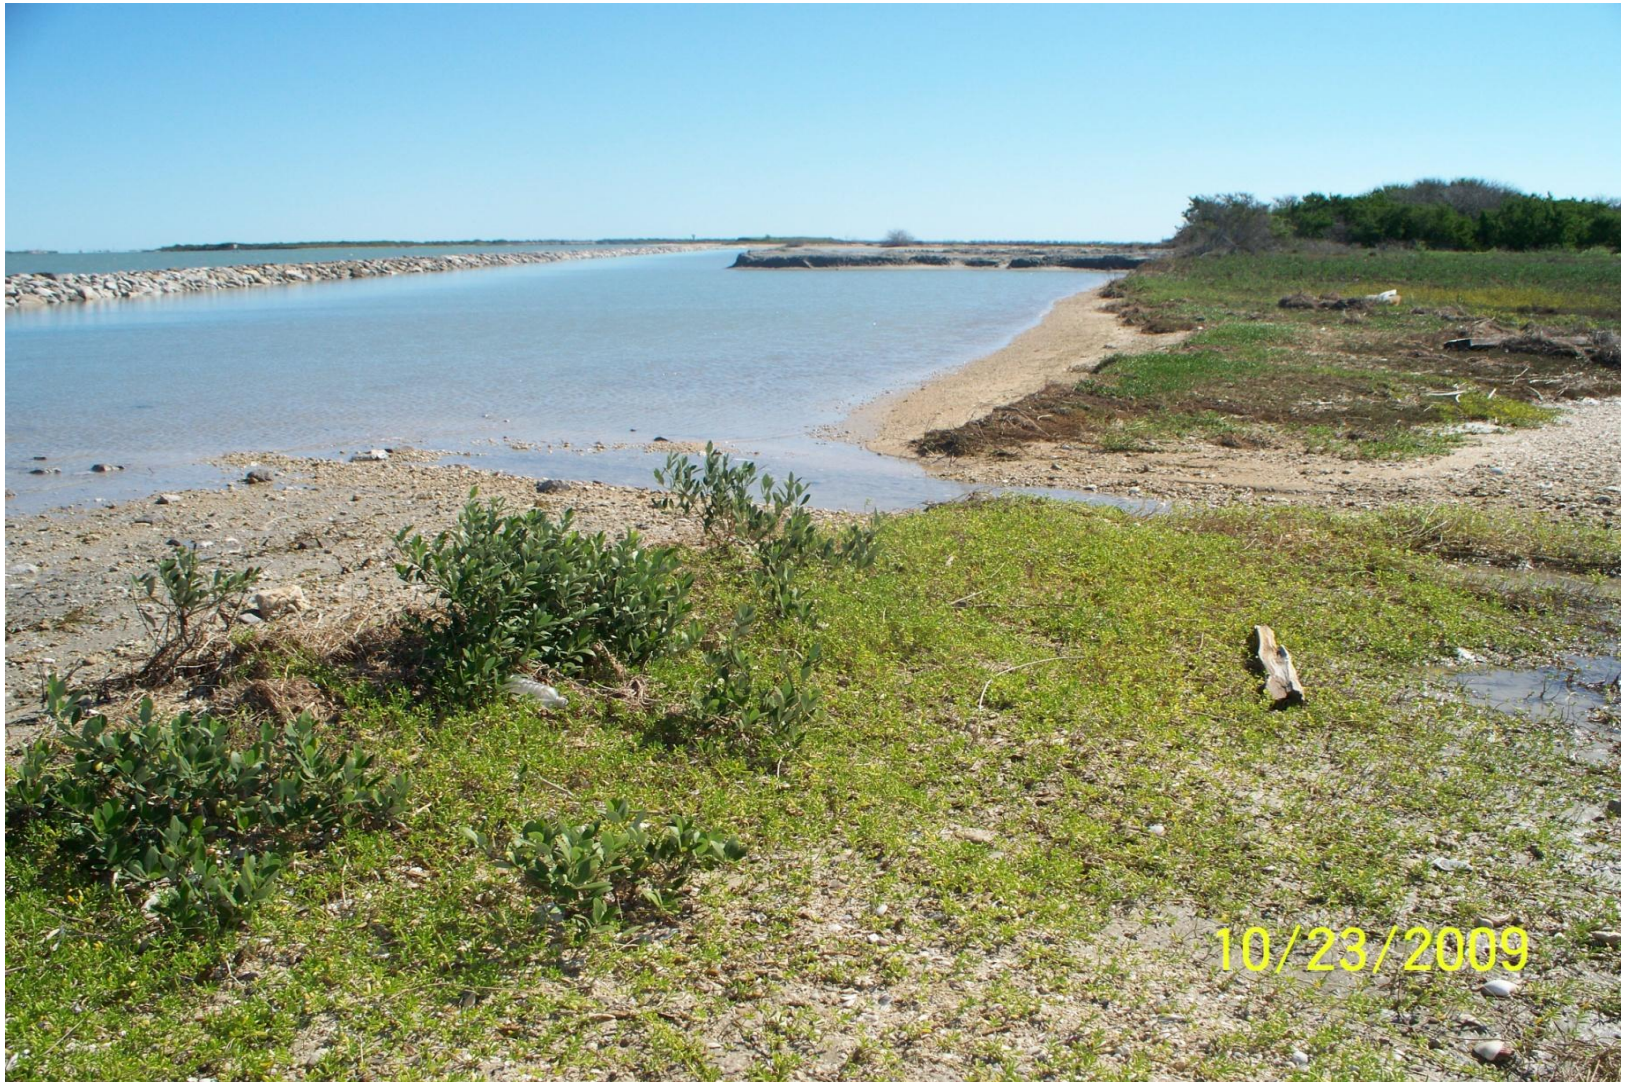
Photo Station 2. Post-construction . Note erosion between July 2009 photo and breakwater completion. Shoreline nourishment in mid distance .

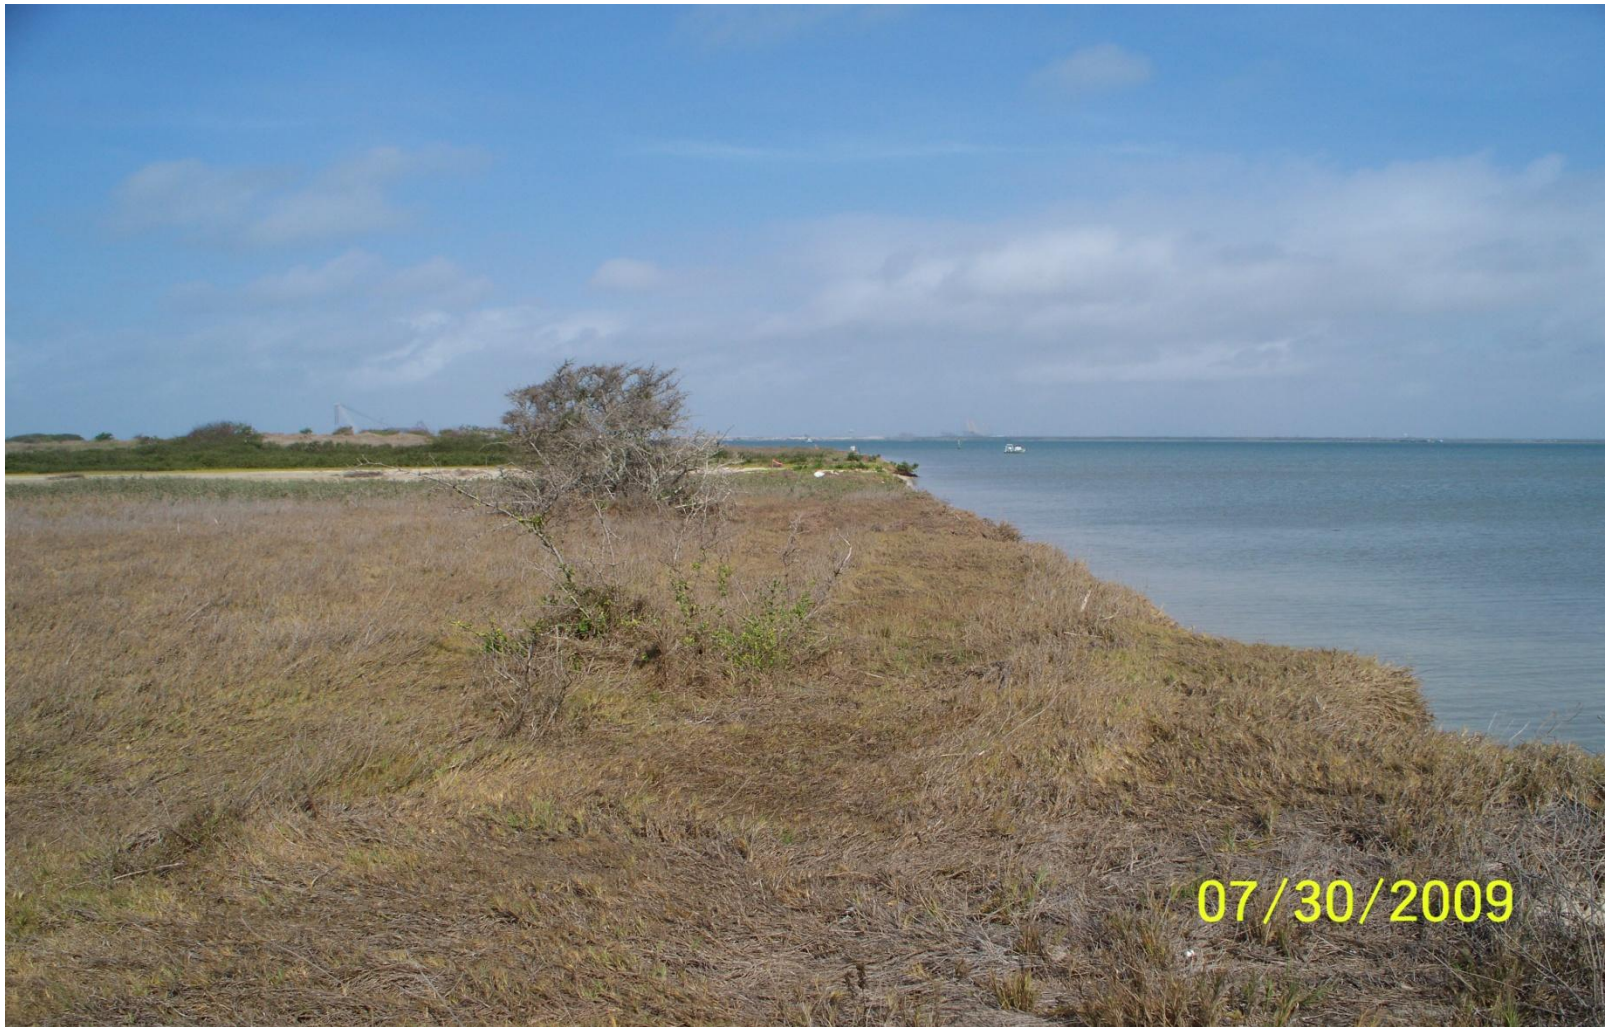
Photo Station 3. Preconstruction. West view toward Photo Station 2 .
