Preconstruction and Post Construction Photographs

Erosion Protection for Pelican Island
GLO Contract No. 09-210-000-3719

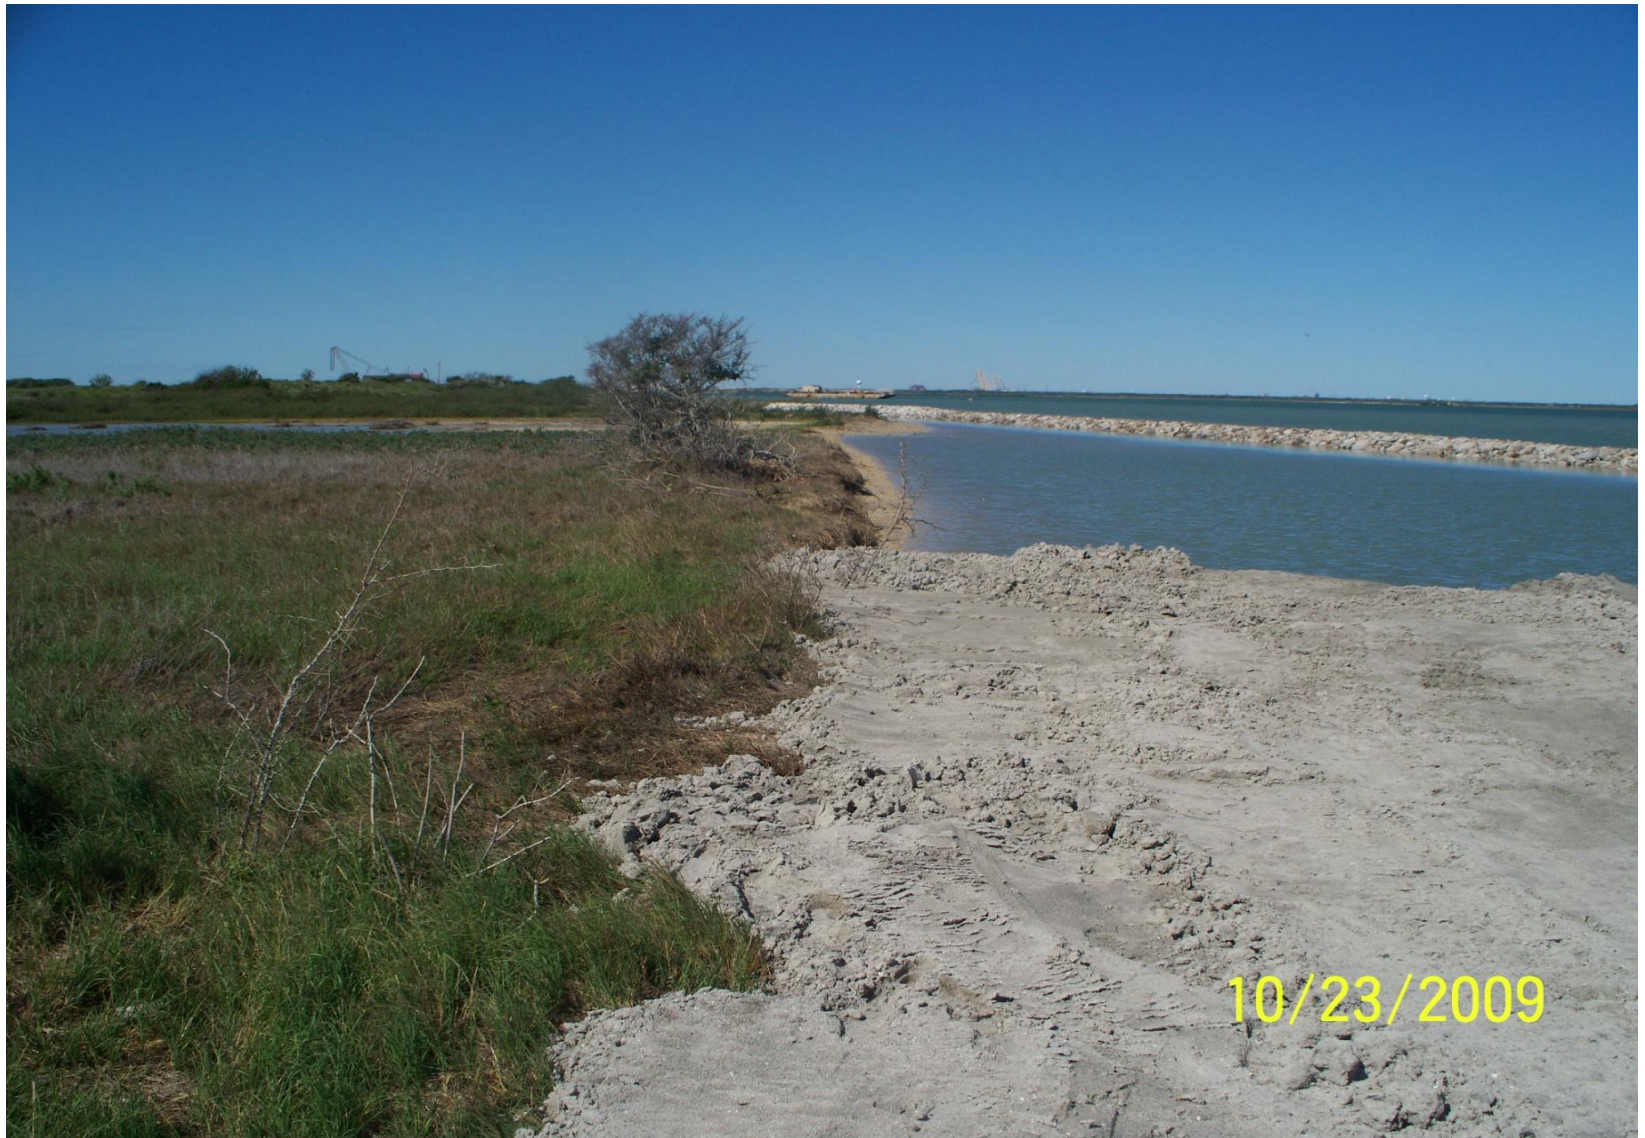
Photo Station 3. Post-construction . Note erosion between July 2009 and project completion. Shoreline nourishment in foreground.

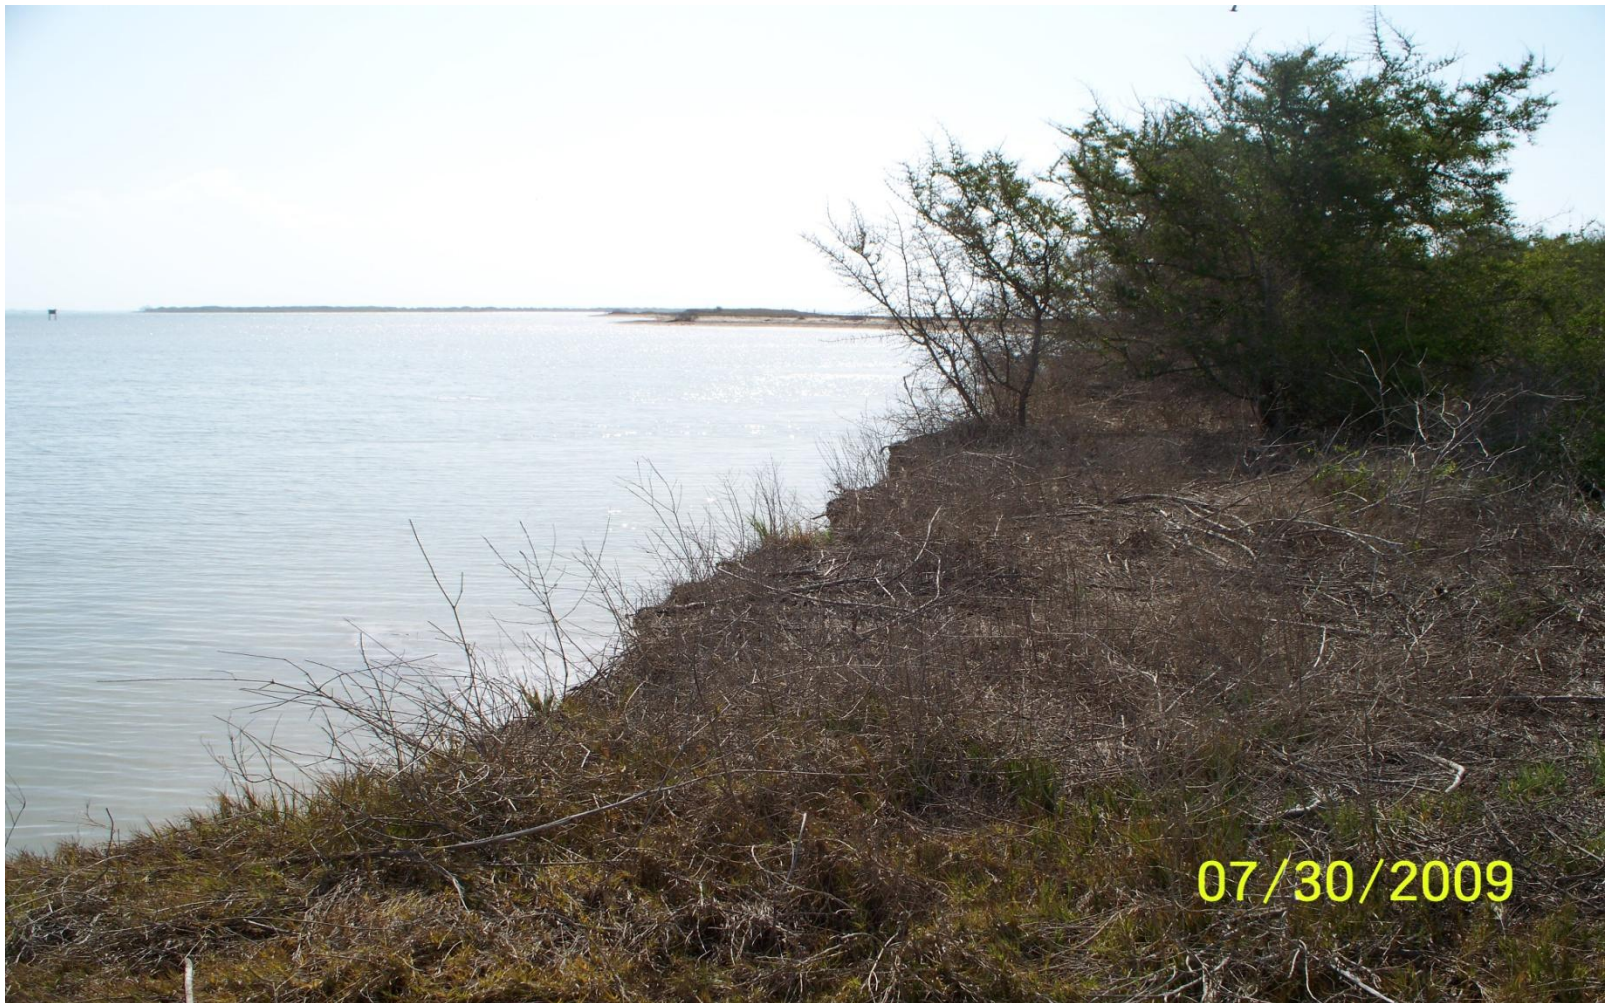
Photo Station 3. Preconstruction. East view. Point of Mustang in far left distance .

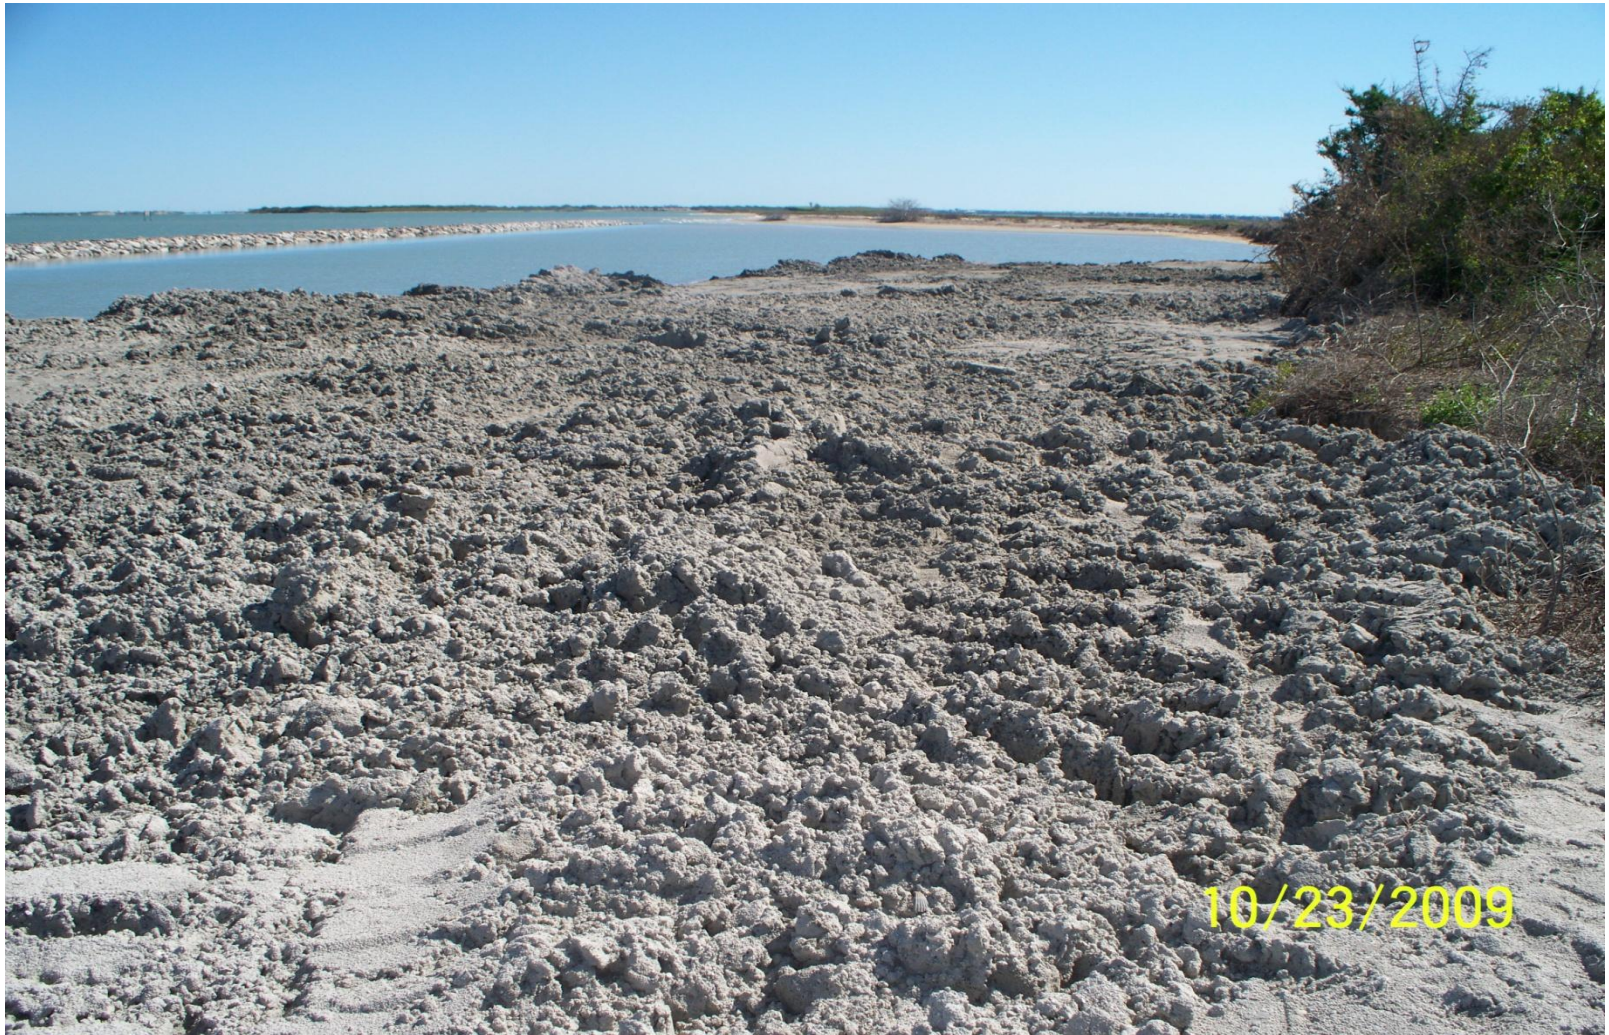
Photo Station 3. Post -construction. Shoreline nourishment and breakwater. Note erosion between pre-construction and completion of project.
