Nueces Bay Portland Causeway Marsh Restoration CMP Cycle 15 Final Report

August 29, 2012

COASTAL BEND BAYS & ESTUARIES PROGRAM**PORTLAND CAUSEWAY MARSH RESTORATION (DREDGING)****SITE VISIT / CONSTRUCTION STATUS REPORT**

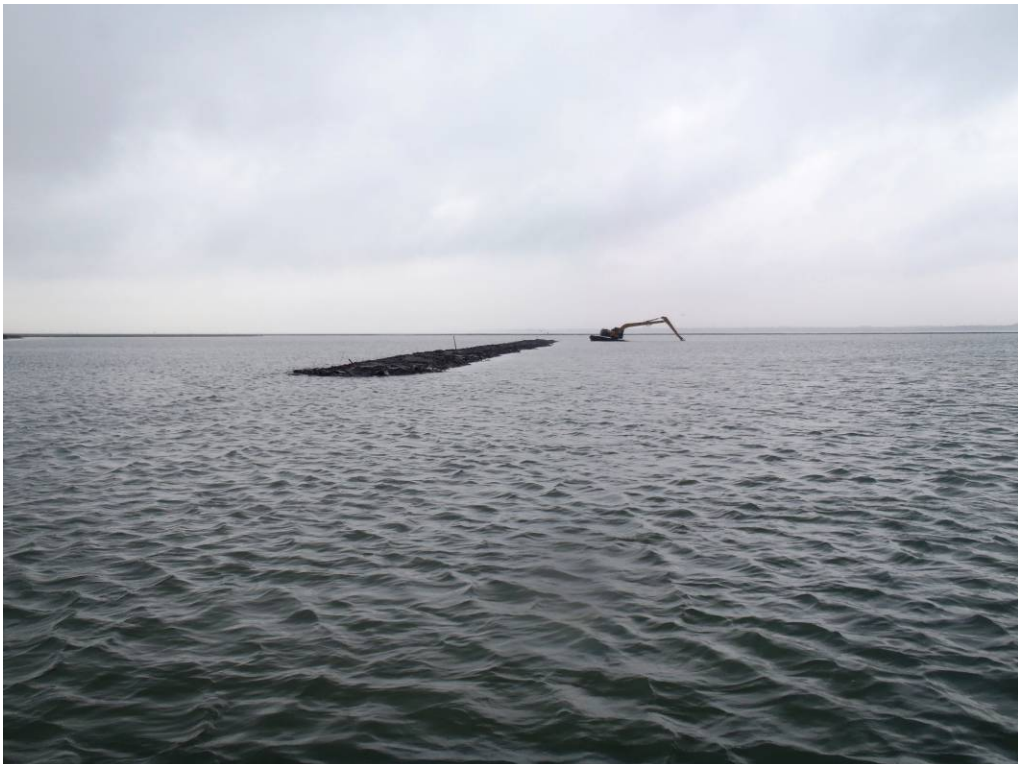
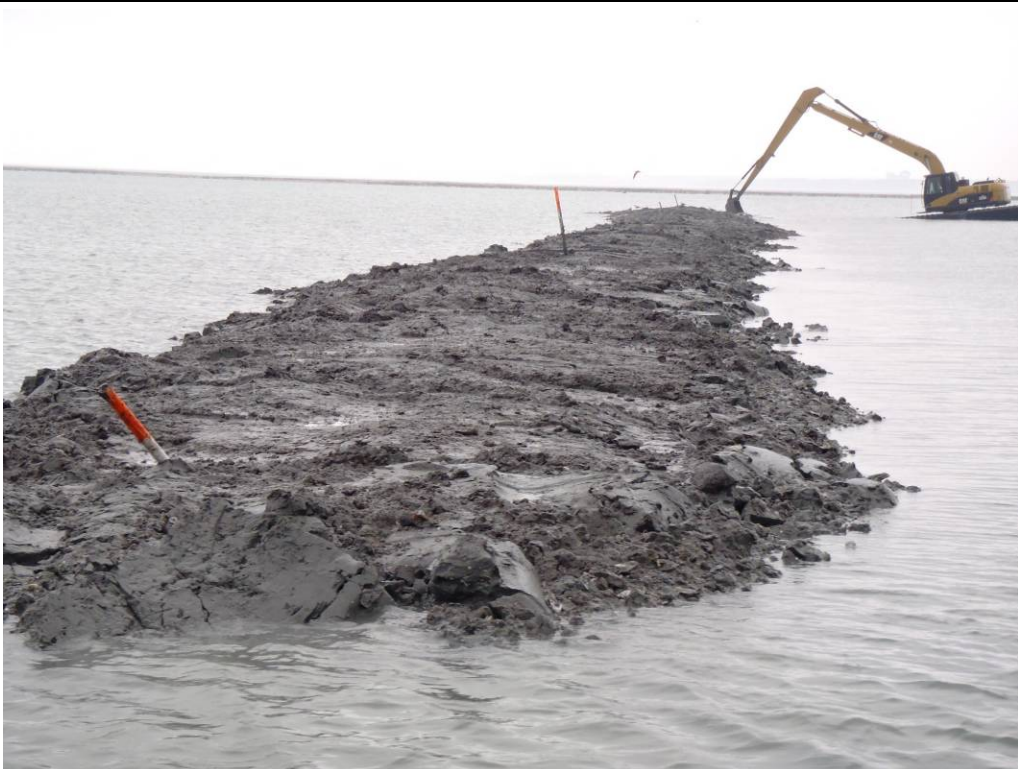
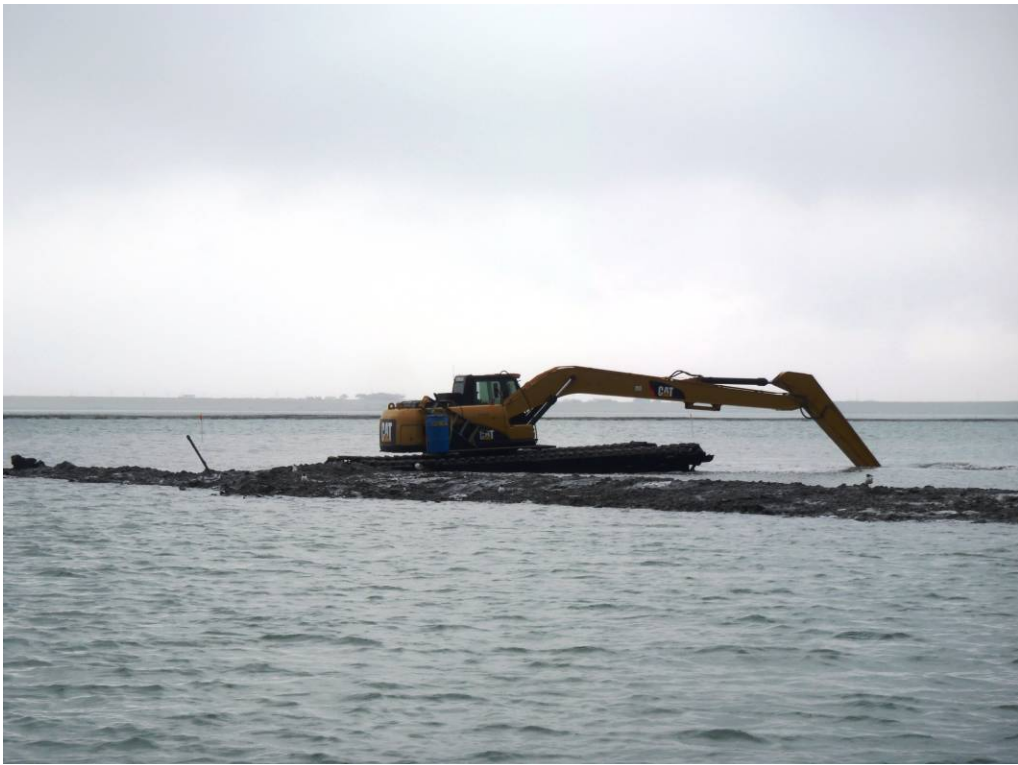
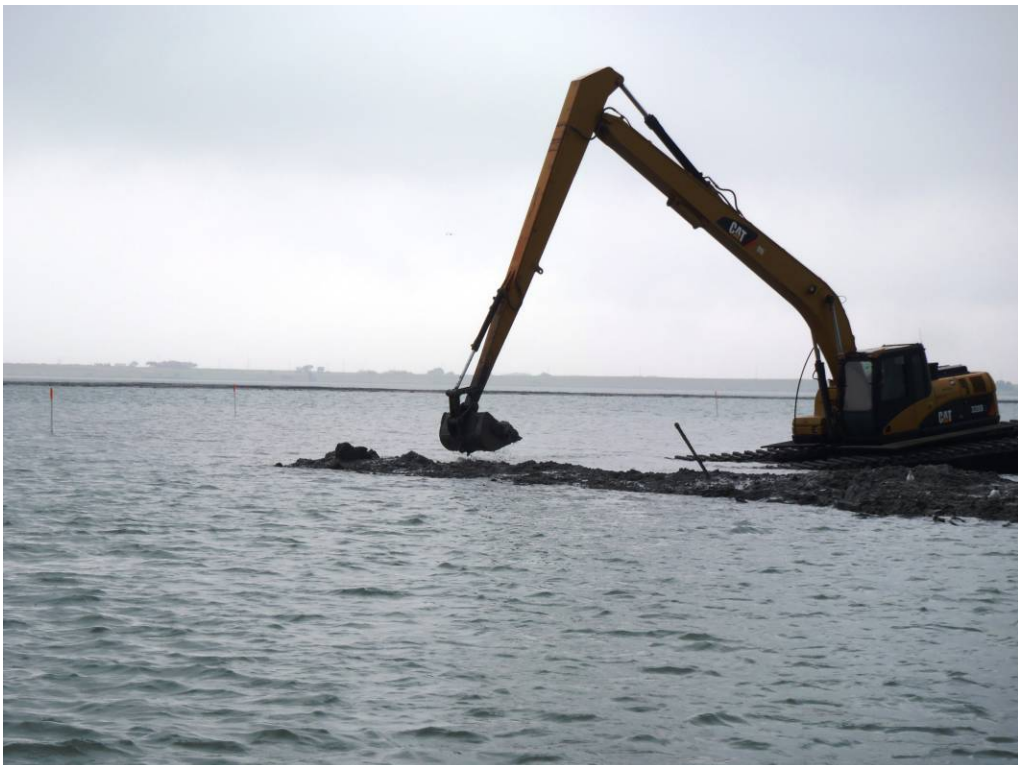
1. Contractor is having difficulty constructing toe berm because of high water levels. RFI No. 1 was submitted on 2/13/2012 requesting permission to excavate outside of cells for closing and repairing toe berm.

Construction of Cell 3 Toe Berm.

1. Refer to RFI No. 1 response dated 2/15/2011. Limited excavation outside of cells is acceptable. Final survey transects may need to be extended and/or added to cover additional excavation/borrow trenches.

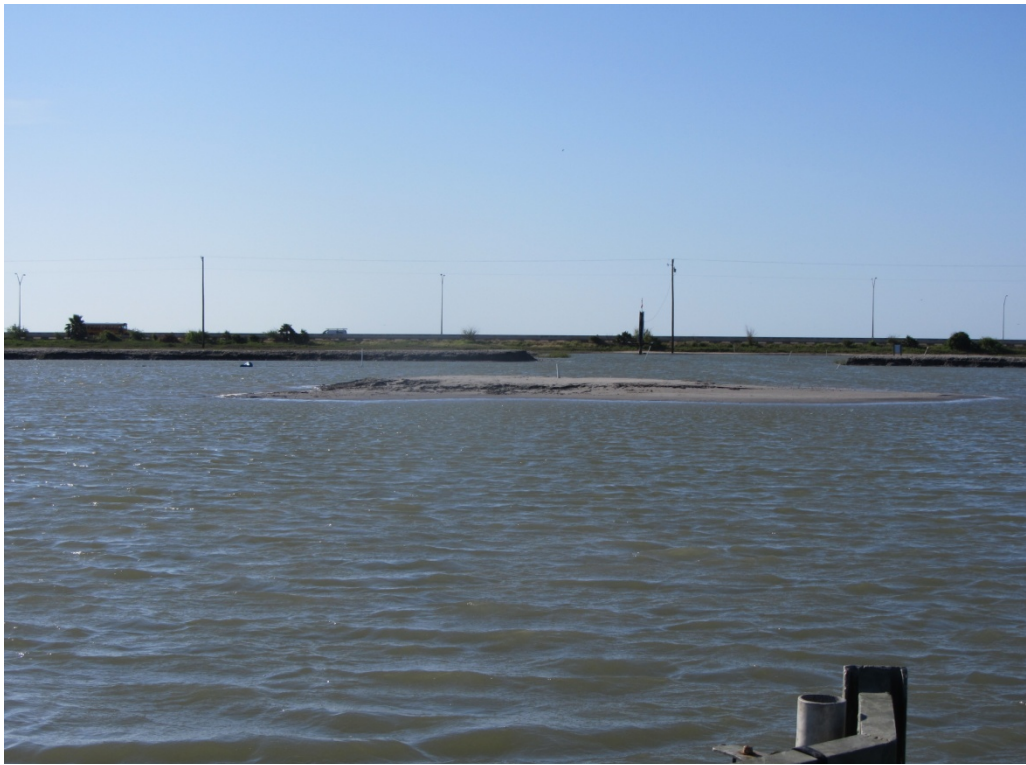
Marsh mound M11. Note equilibration of side slopes.

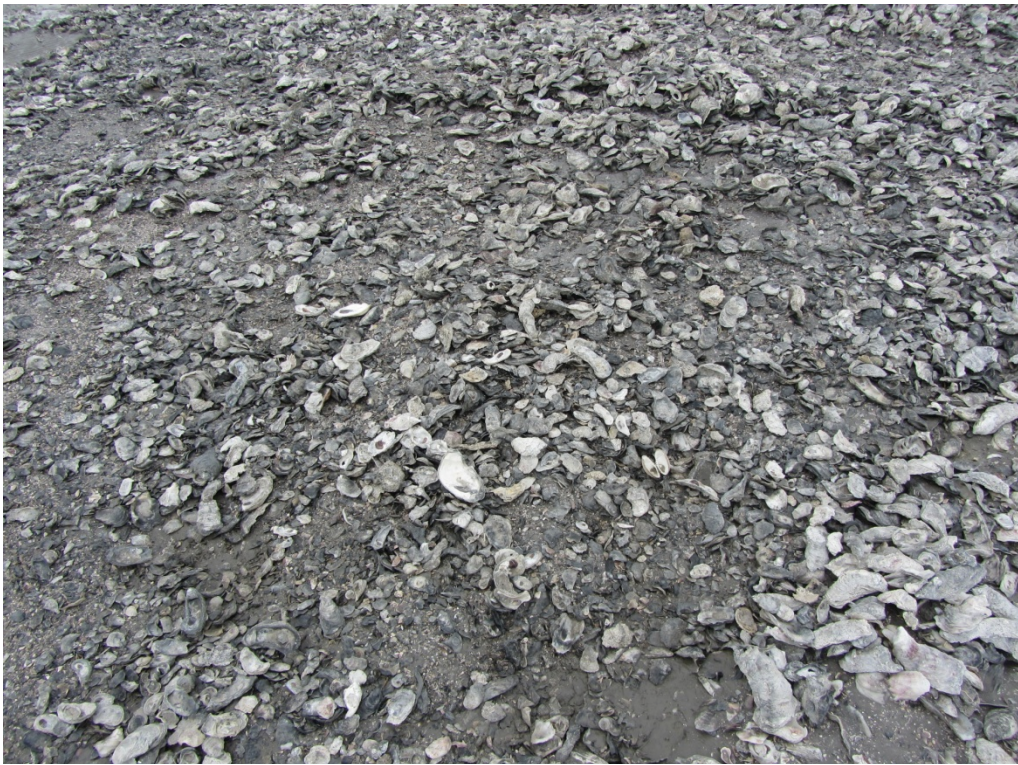
Relic oyster shells discharged onto marsh mound M2.

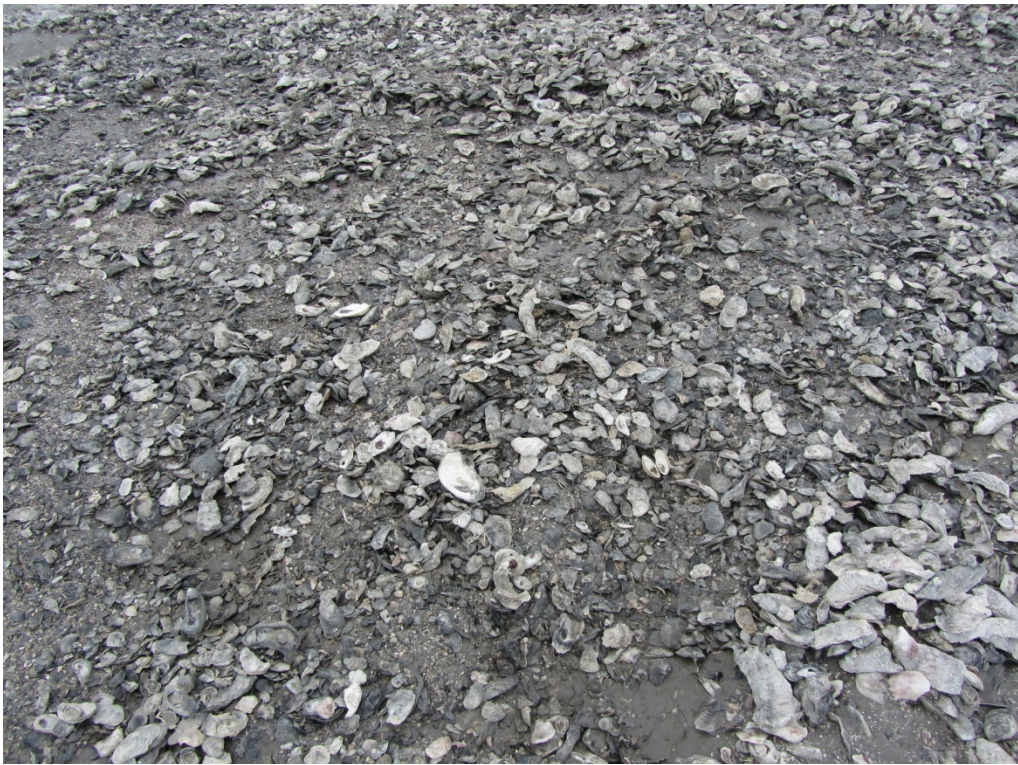
Relic oyster shells discharged onto marsh mound M2.

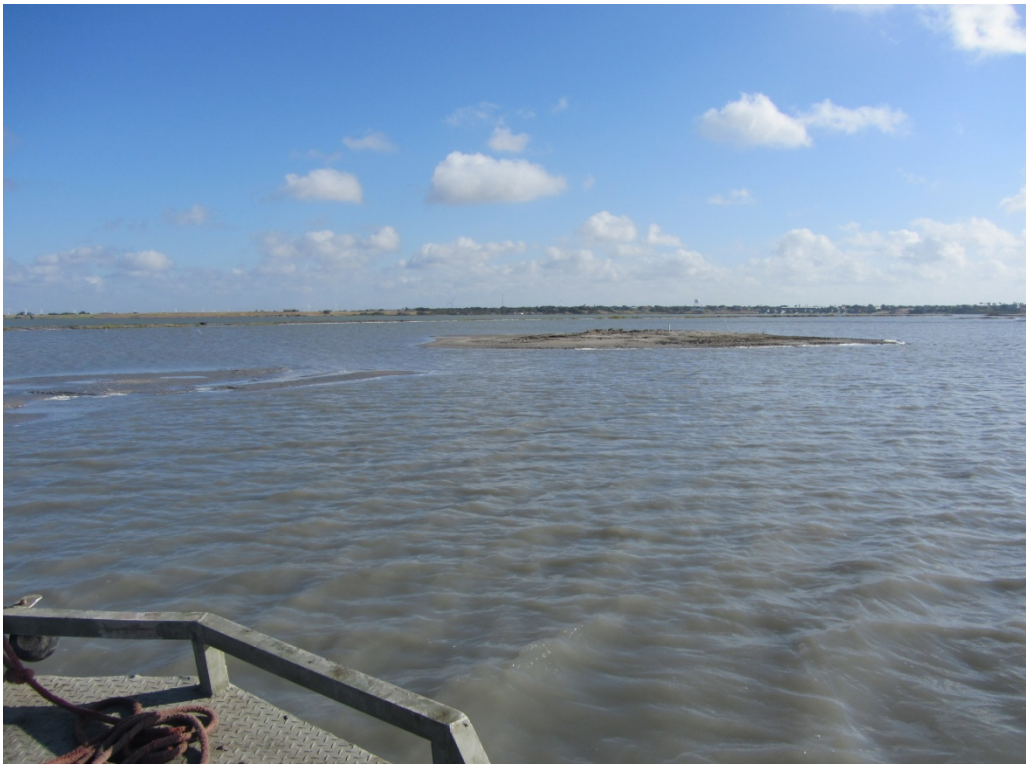
Material placed between M2 and M3. M3 shown and newly placed material on the left.

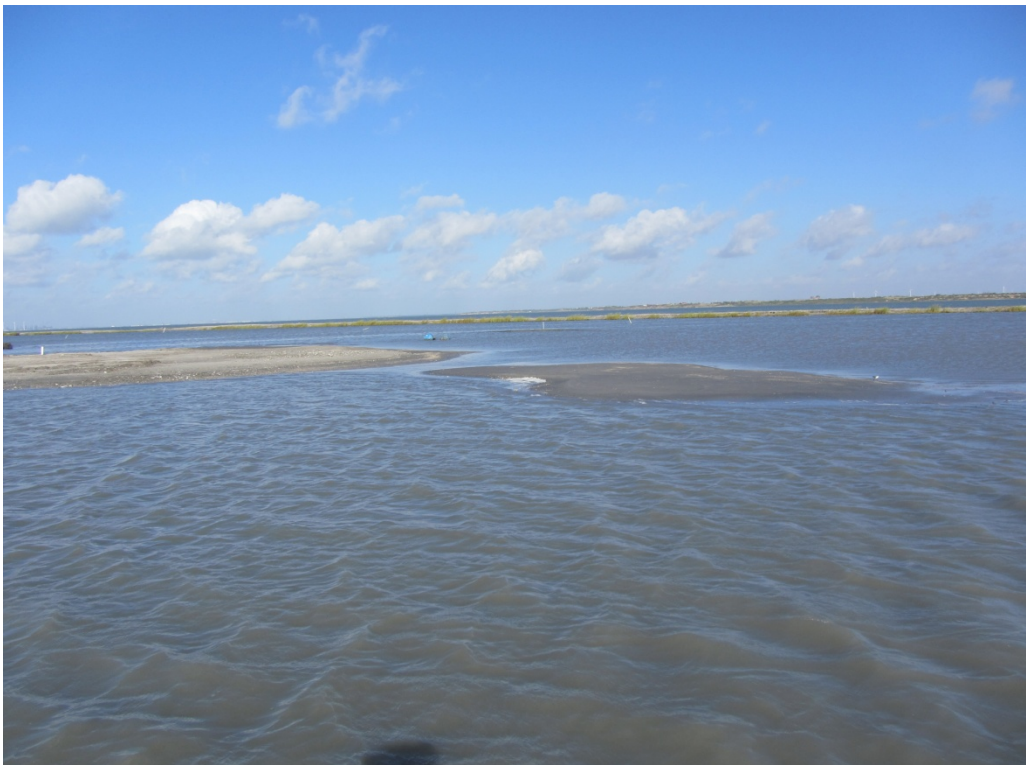
Material placed between M2 and M3. M2 shown and newly placed material on the right.

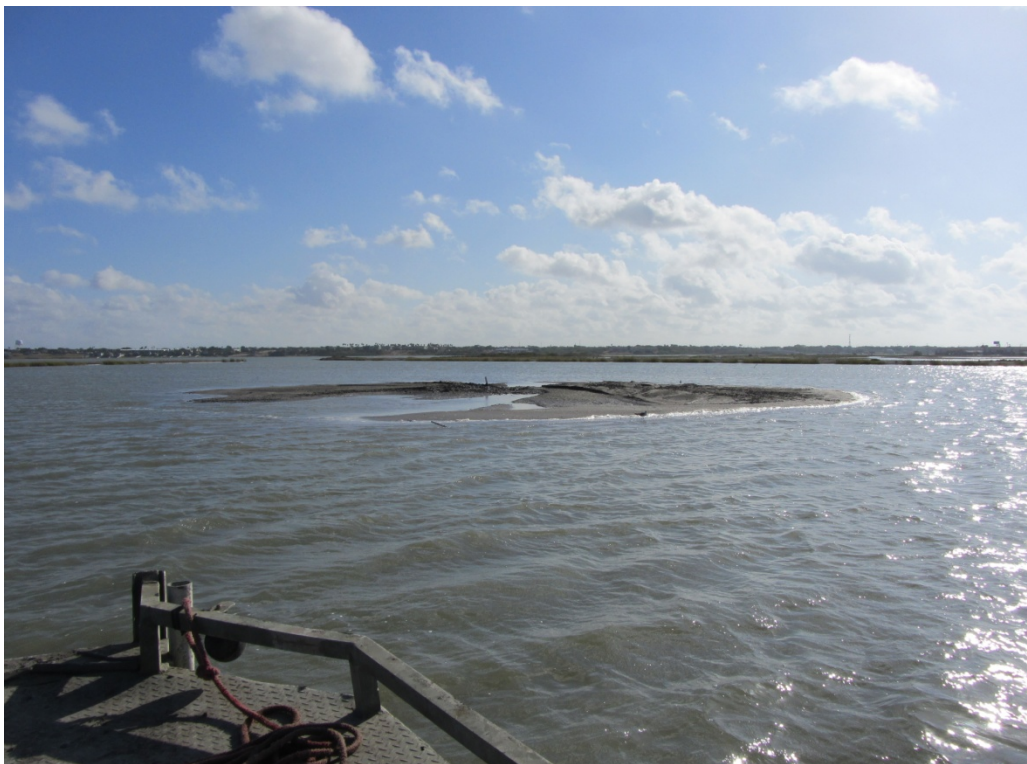
1. Crest on M8 needs to be raised and repaired.

Marsh mound M8. Crest needs to be rebuilt
