Analysis of Rollover Pass Impacts to Adjacent Beaches and the Littoral System

Galveston County, TX

**Analysis of Rollover Pass Impacts
to Adjacent Beaches and the Littoral System**

Texas General Land Office

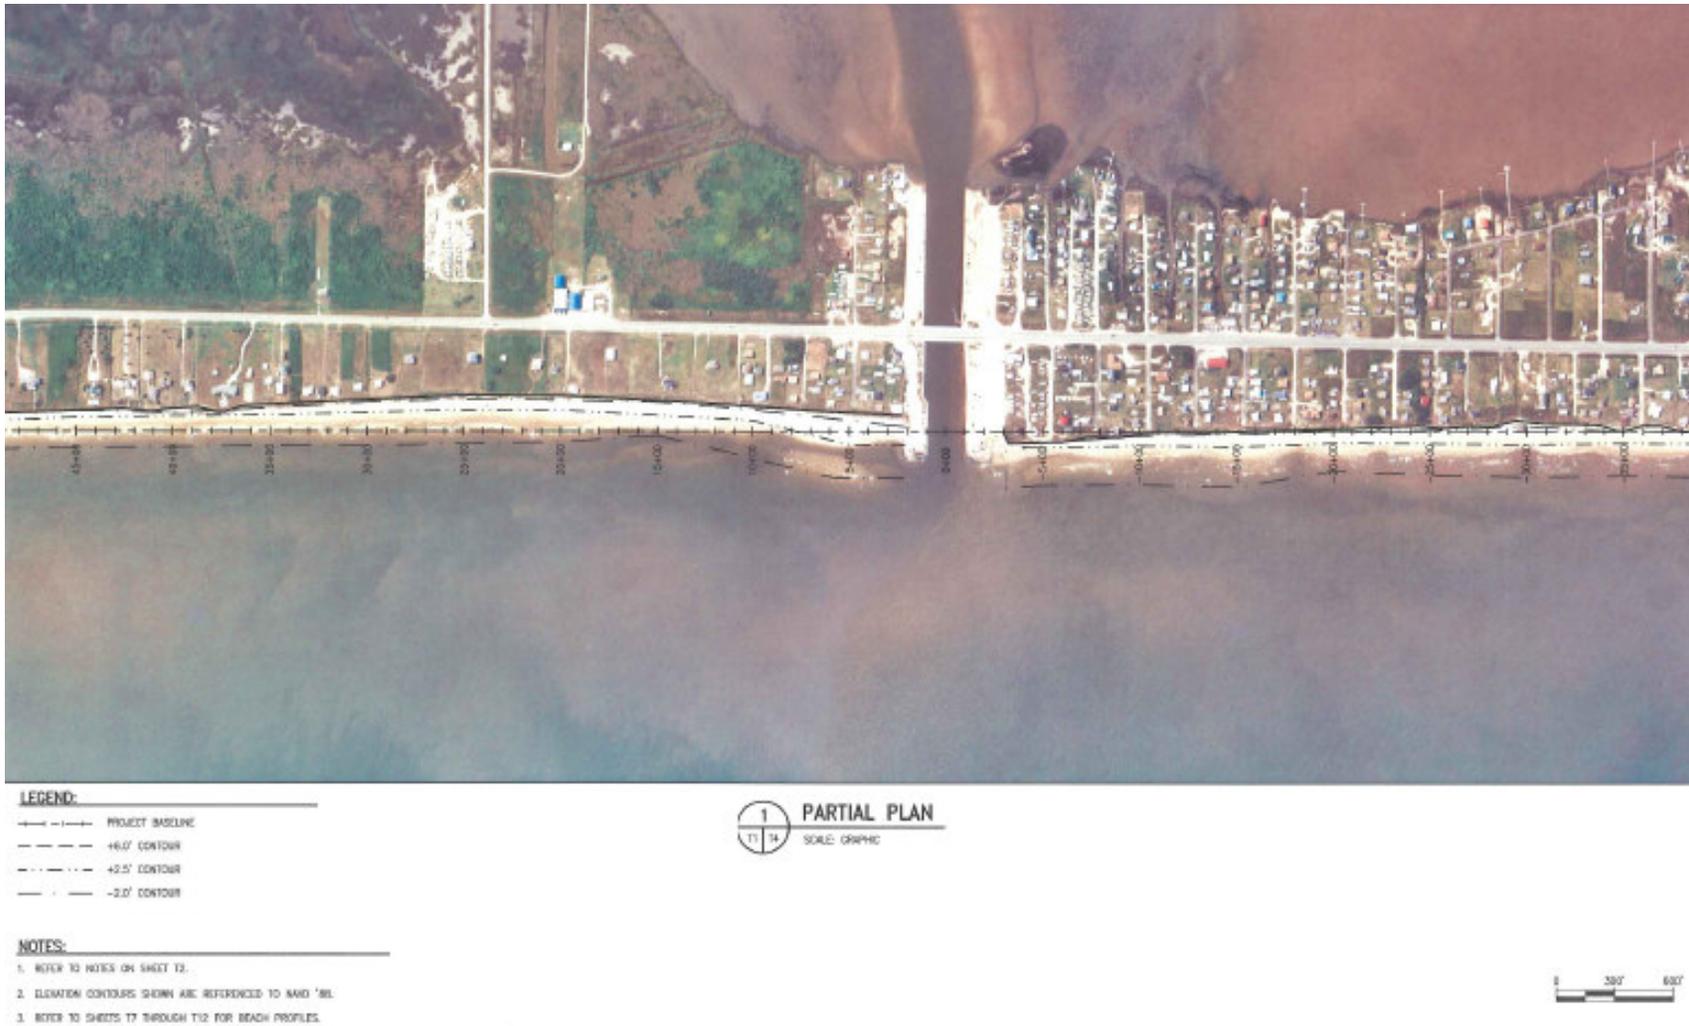
Figure 3 2008 Beach Contours near Rollover Pass (adapted from Galveston County, 2008)

USACE (1958), as cited in Lockwood et al. (1974), calculated an average shoreline recession rate of 5 ft/yr from 1850 – 1956 (i.e., the data period selected by the study authors to represent pre-construction conditions). Subsequently, the USACE (as cited in Lockwood et al, 1974) documented an increased shoreline recession rate of 8.5 ft/yr from 1956 – 1974 within the first mile (5,280 feet) southwest of the Pass compared to a recession rate of 3 – 4 ft/yr over the next 10 miles (mi). In separate studies, Morton (1975) and the USACE, as cited in Mason (1981), found that shoreline recession rates varied between 15 – 25 ft/yr and between 7 – 14 ft/yr, respectively. Through analysis of beach profile changes, Mason (1981) estimated that Rollover Pass causes an additional 26,080 cy/yr of beach volume loss (i.e., erosion) over a 14,000-ft-long shoreline segment southwest of the Pass. Through analysis of aerial photographs of the beach within 6,900 ft of each side of the Pass, Bales and Holley (1989) estimated the Pass causes an additional 9,000 cy/yr of erosion within their study area southwest of the Pass. The above estimates clearly indicate that Rollover Pass has increased the shoreline recession and beach volume loss rates of the nearby beaches. Figure 3 illustrates the effect of adjacent erosion, indicated by the landward retreat of the beach contours (6.0 ft, 2.5-ft, and -2-ft contours shown) southwest of the Pass relative to the contours northeast of the Pass.

Recent studies by the USACE (2006) and Galveston County (2008) document beach changes without specifying the level of erosion caused by the Pass versus that caused by background conditions. The USACE (2006) calculated erosion rates of 42,500 cy/yr over an area extending 6,300 meters (m) (20,670 ft) southwest of the Pass and 36,000 cy/yr over an area extending 4,300 m (14,108 ft) northeast of the Pass. Galveston County (2008) analyzed 1999 – 2008 beach profile data to monitor beach changes associated with geotextile tube shore protection projects. The data, covering a 7-mile stretch of shoreline centered at the Pass, indicates the shoreline southwest of Rollover Pass receded 22.6 ft (2.5 ft/yr) on average and the northeast shoreline receded 4.5 ft (0.5 ft/yr). Though the above shoreline and volume changes do not specifically quantify the erosion caused by the Pass, the data clearly shows the southwestern (i.e. downdrift) beach suffers significantly more erosion than the northeastern beach.
