Final Report

Restoration of the Slop Bowl Marsh, Brazoria National Wildlife Refuge: Phase I Planning

Dr. Rusty Feagin and Dr. Thomas Huff, Texas A&M University and Texas A&M AgriLife Research.

A report funded by a Texas Coastal Management Program Grant approved by the Texas Land Commissioner pursuant to National Oceanic and Atmospheric Administration Award No. NA17NOS4190139. Texas General Land Office Coastal Management Program Project # 18-091-000-A601.

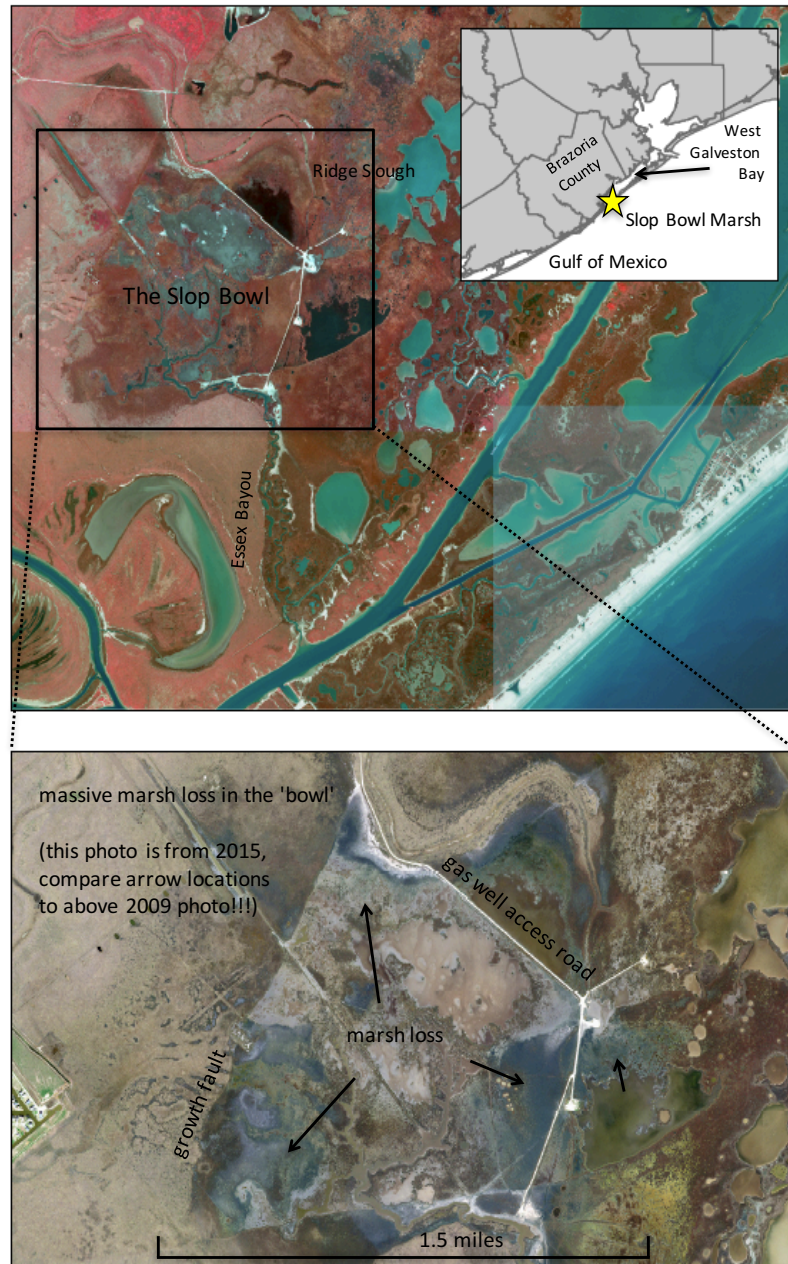
Fig. 1. The Slop Bowl, located on Brazoria NWR.

The Slop Bowl Marsh is located at the southern end of the Brazoria National Wildlife Refuge, in Brazoria County, Texas (Figure 1). Historically, this area has been known for the extraordinary use of its habitat by birds including waterfowl, shorebirds, wading birds, wood storks and 40 state-threatened Reddish Egrets.

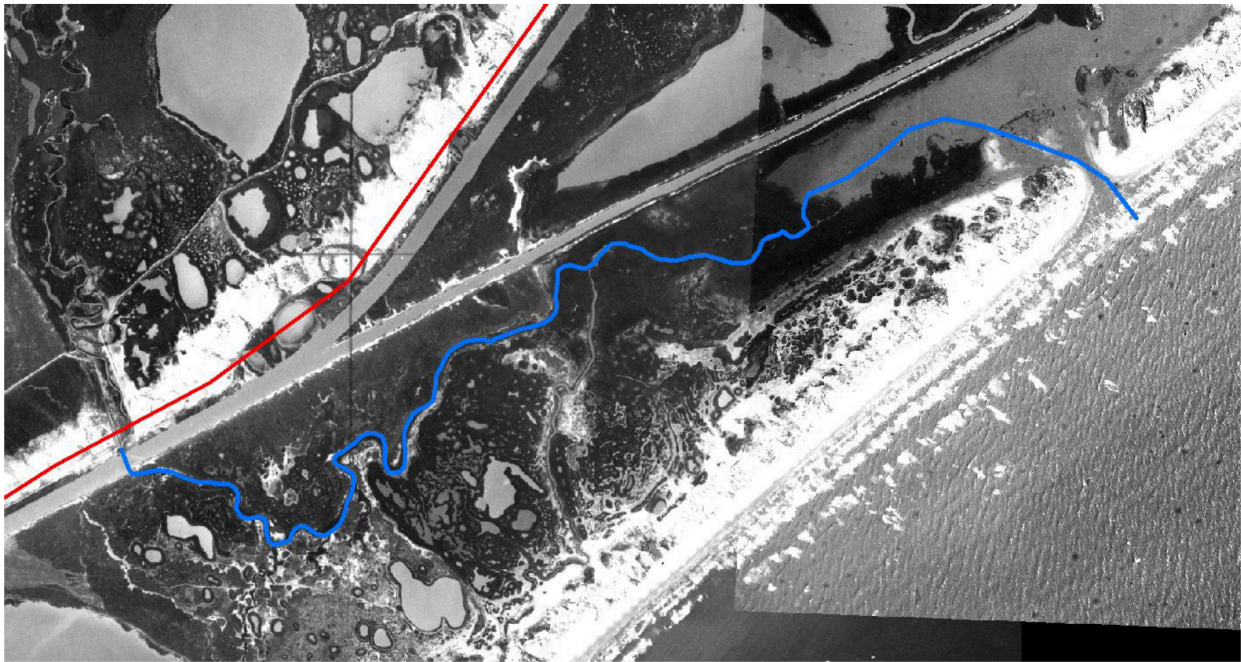
Fig. 4. Essex Bayou likely led all the way to the Gulf of Mexico prior to construction of the GIWW. Blue line denotes former channel path. Red line denotes the lower extent of the primary study area (refer to Fig. 2 for relative placement).

Assessment of one of the images (1944) showed that Essex Bayou likely continued further southward beyond the GIWW and eventually exited directly into the Gulf of Mexico, prior to the construction of the GIWW. This image also shows evidence that Essex Bayou was once much more riverine-like in its morphology, with meanders and small oxbow ponds. By the 2015 image, these features are less evident and remnant as the morphology of the channel has changed to appear more tidal. The channel width analysis and the morphological appearance both suggest that the creation of the GIWW likely instigated the initial transition of the Slop Bowl to a more saltwater dominated environment.

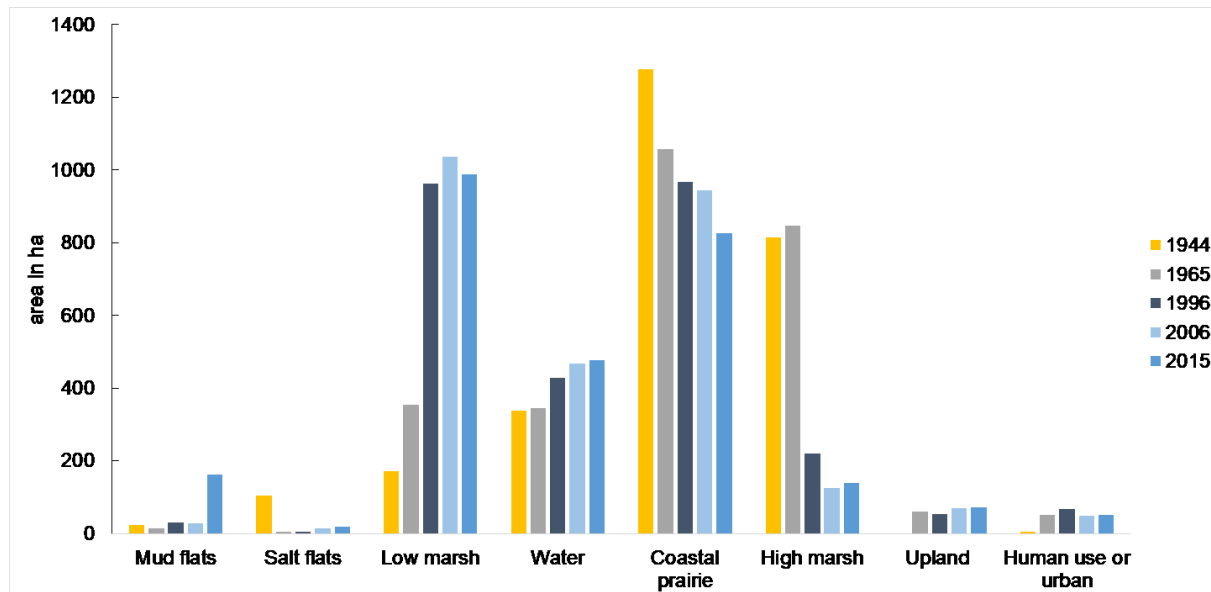
Fig. 6. Land cover change from 1944 to 2015.

Only 10.11% of the landscape did not change its cover type between 1944 and 2015 (Fig. 6). Open water was the most stable as 81.92% of its original area did not convert to another class. For low marsh, 72.86% of the original areas remained low marsh. Only 6% of the original 1944 high marsh areas remained. As high marsh and coastal prairie area decreased, low marsh and open water area increased; this was particularly evident between 1965 and 1996. This relatively rapid change could be due to increased faulting, or hydrologic restriction as the oil road was constructed during this time period.

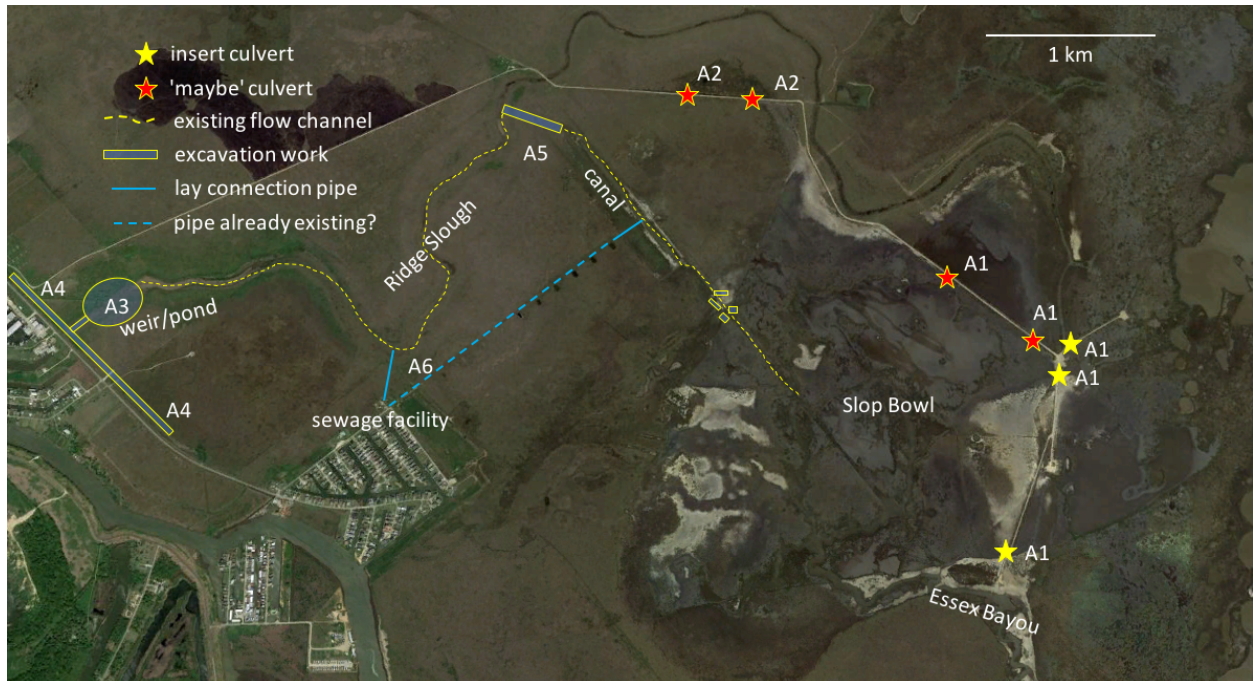
Map of Potential Actions to Restore the Slop Bowl (see text of Action Plan, numbers refer to potential actions)

(1) Place Culverts Under the Road Within the Bowl. The road is approximately 2-3 feet higher than the surrounding low marsh and composed of caliche, rock, and shell. It completely blocks E-W tidal flow, and limits the quantity of freshwater able to enter into the bowl from Ridge Slough.

Recommendation: Several culverts should be placed under the road, for example at locations depicted in the figure below. One of the culverts would substantially alter the small pond immediately adjacent to Ridge Slough by making it fresher – this may not be fully desired as there is some value in having at least one pond as hypersaline for bird habitat value (heterogeneity and variety of habitats is likely desirable). The culvert at this location would have to be further discussed with stakeholders to discern what is desirable.

Recommendation: Several culverts could be placed under the road, for example at locations depicted. However, while this could help the main bowl, it would likely hurt

Recommendation: Excavate 2-3 feet of depth in the plain for rainwater to accumulate in. Replace the weir and meter this water into Ridge Slough, and down towards the Slop Bowl. A potential issue with this action is that some of the land at the location is private, and work would rely upon whether this action was desirable for the landowner (it likely would be as it would provide a stock tank for their cattle operation).

Recommendation: The ditches should be re-excavated, and a trench dug to connect this flow over towards the plain and Ridge Slough. If possible, water could also be captured from a pond several hundred meters north, along Suggs Road. This would repair the original flow paths that were altered historically. This action would require coordination with the private landowner mentioned above.

Recommendation: Use Ridge Slough as a conduit, and connect it to a currently-existing flow path (a dredged canal used to help place an oil and gas pipeline), to capture much of its flow and direct it to the Bowl. A meter would then be placed at this connection to regulate the flow into the Bowl. The old canal is quite wide and deep, and no work would be needed on it. This should be done in collaboration with the private landowner downstream, but would be justified as it is entirely on federal property and is simply taking the same action as this landowner to use the water as needed.

Recommendation: Route an outflow pipe from the wastewater site, over to Ridge Slough, and eventually down the Ridge Slough conduit into the bowl. This should be done in collaboration with the Texas Commission on Environmental Quality (TCEQ). This recommendation may prove difficult to implement, but it is the best potential
