UHCL Habitat Restoration and Nature Trail

22-045-019-D116

Final Report

March 2024

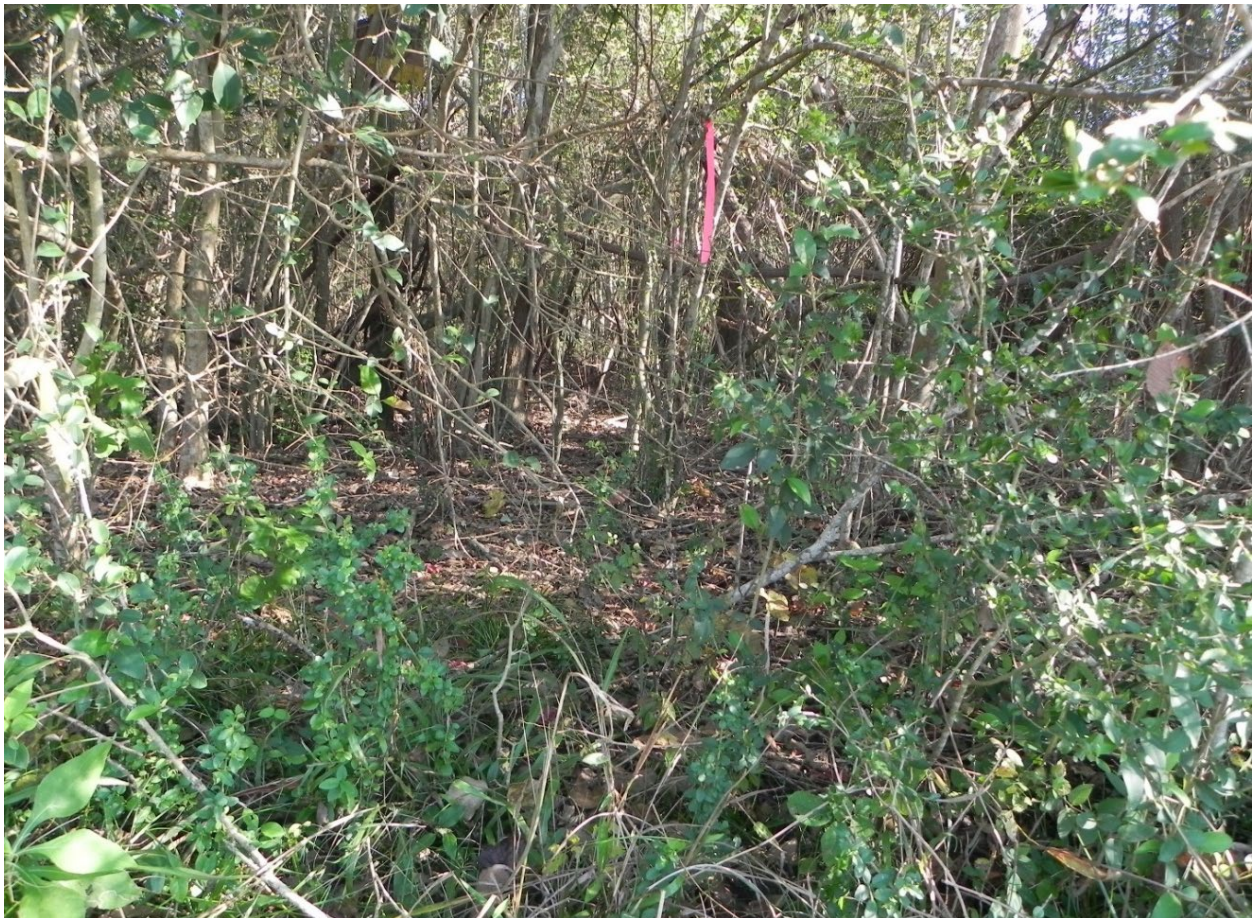
Figure 15. Site Before Mulching

All work was conducted within the two-acre site of former oak savanna on UHCL property. UHCL contracted with HLM, Inc. to remove woody plants from 1.5 acres of the site. Figure 15 shows the site prior to mulching. Selected trees and underbrush were removed and mulched by HLM, Inc., as seen in Figure 16. They also performed the initial removal of mulch on one acre of the property (Plots A and B) and left the mulch in place on Plot C. Additionally, volunteers and staff removed mulch because smaller pieces remained after the mechanical removal process (Figures 17 and 18). Herbicide was applied to the total 1.5 acres (Plots A, B, C) to treat woody plants and invasive non-native grass growth on an as needed basis (Figure 19).

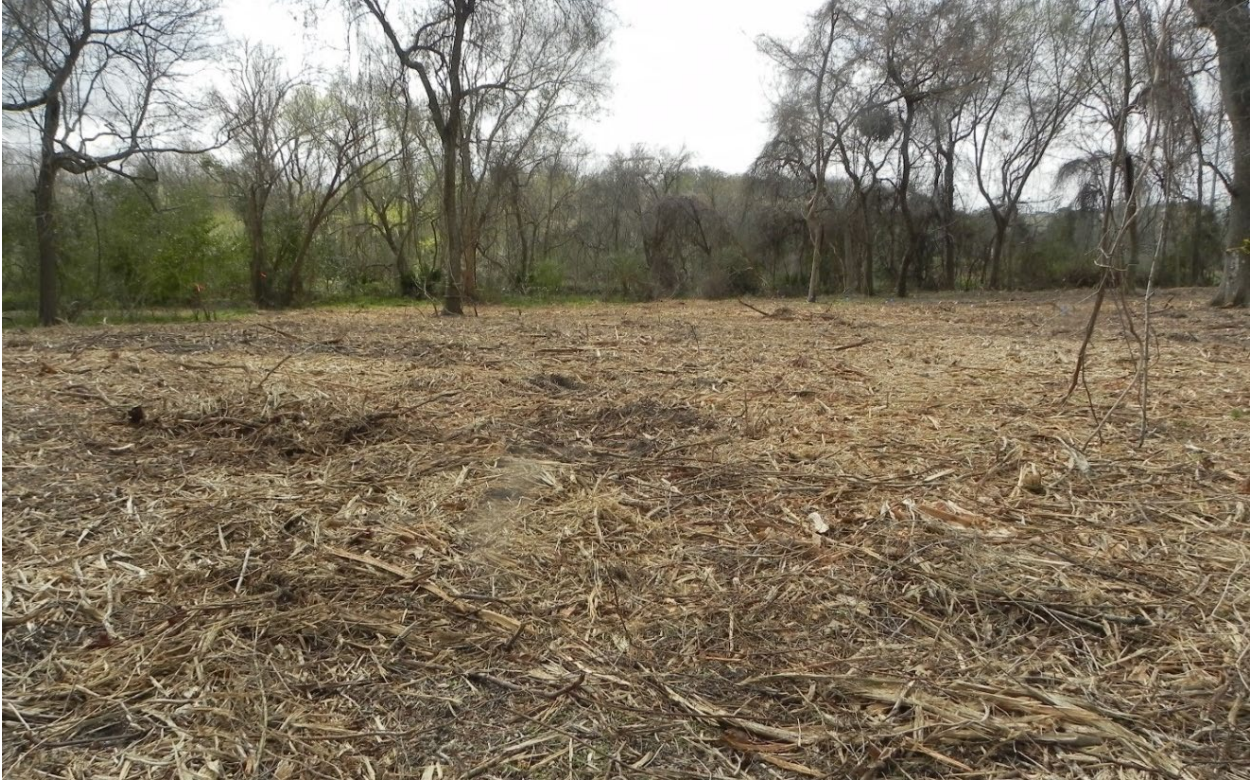
Figure 16. Site After Tree Removal and Mulching

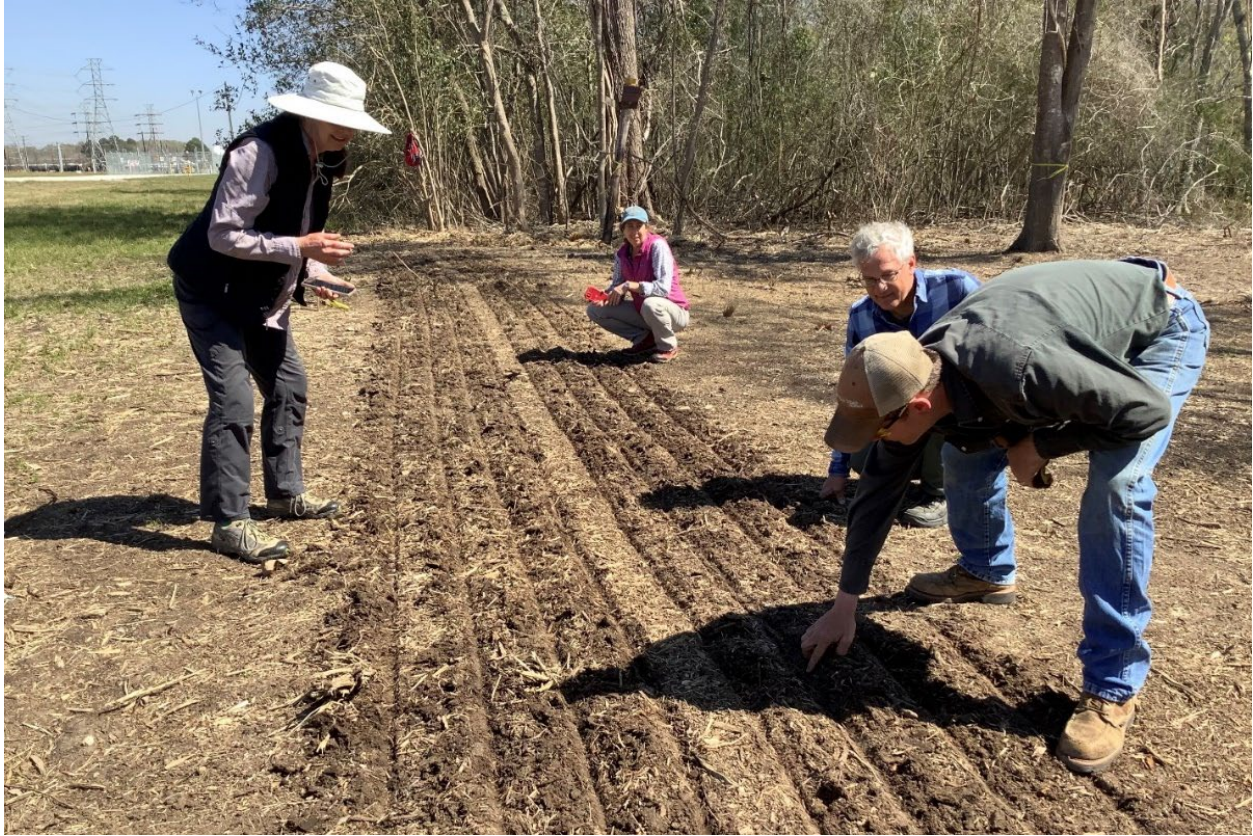
Figure 20. Inspecting the First Pass of the Seed Drill, Spring 2022

UHCL contracted with Native Texas Wildlife Service to use a seed drill to plant $\frac{1}{2}$ acre (Plot A) with native seed (Figure 20). A total of 16 native savanna tree seedlings were planted on the two-acre site (Figure 21). Figures 22 through 25 show plant growth after the seeding.

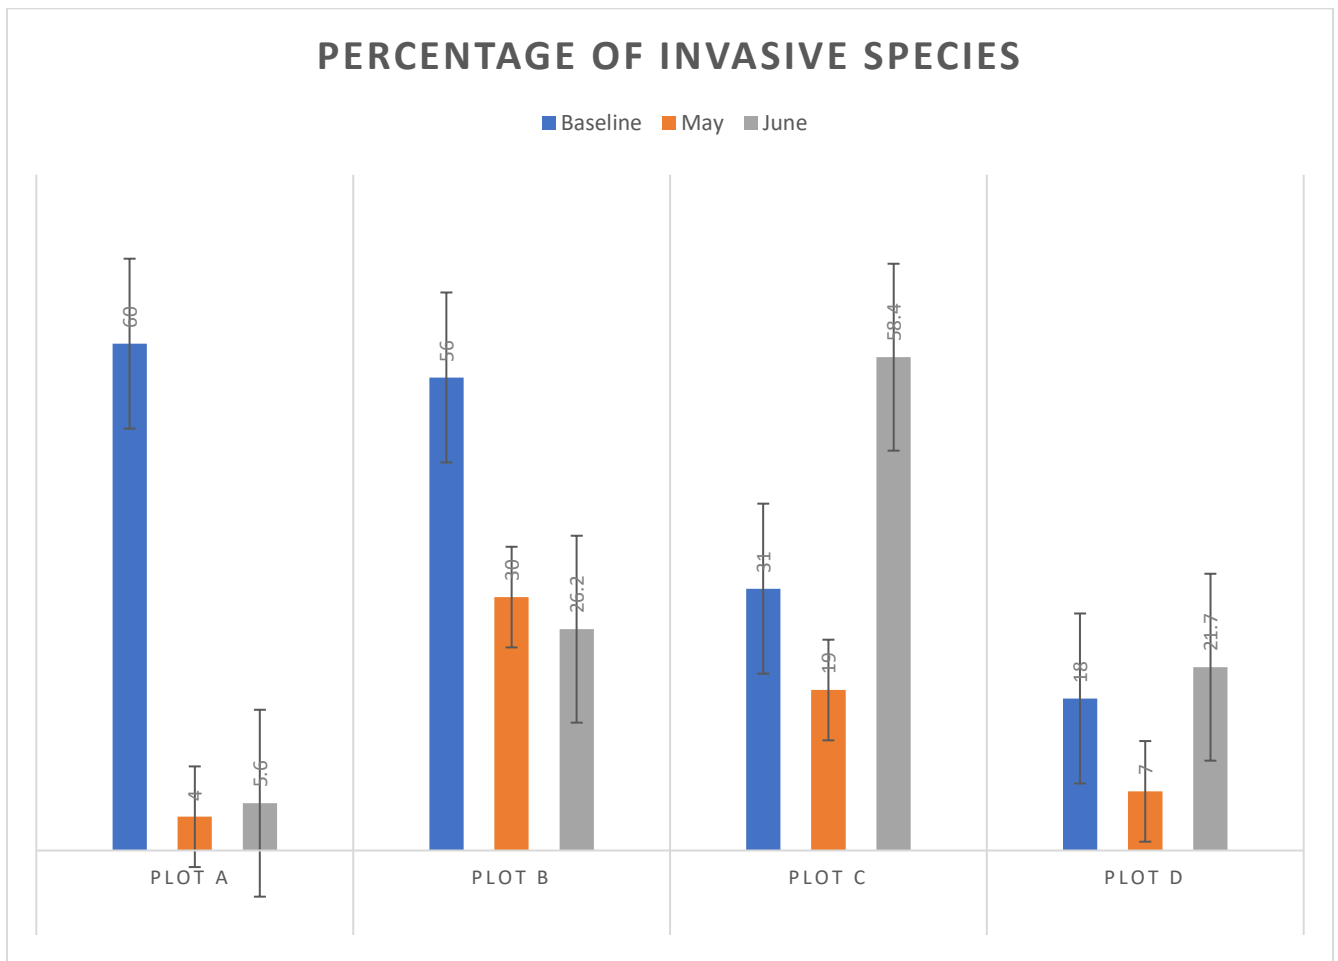
Graph 1. The percentage of plants counted that were non-native species. The differences were significant at the baseline survey (December 2021) at Plot A, at the May 2022 survey at plot B, and at the November 2022 survey at Plot C. There was no significant difference at Plot D (the untreated plot.)

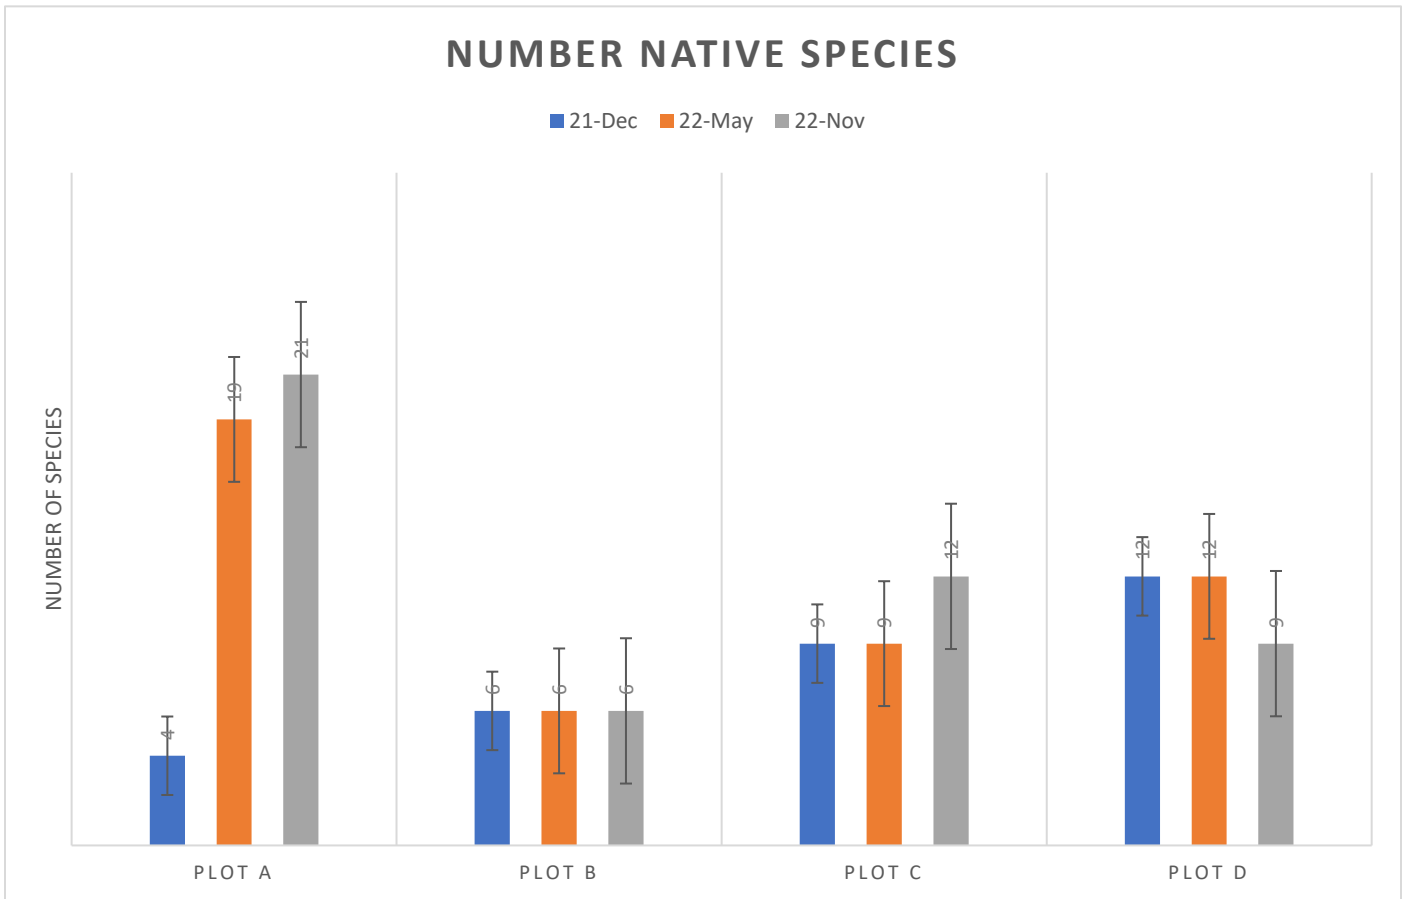
Graph 2: Number of native species identified. Significant increases were only found in Plot A which had been seeded with a native seed mixture.

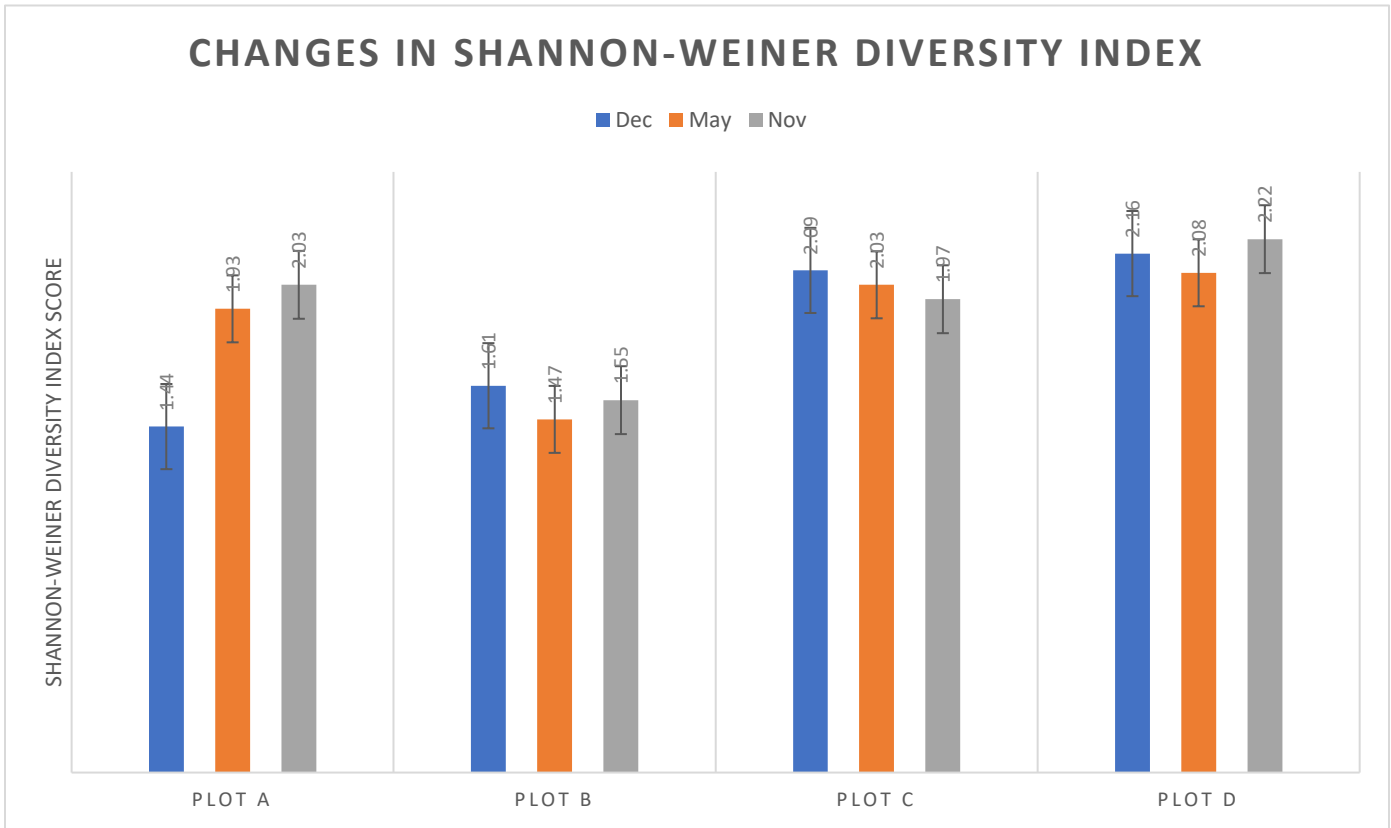
Graph 3. Only Plot A, planted with native seeds, shows a score on the Shannon-Weiner Diversity Index significantly different to the score of the baseline survey.

Plot A showed significant changes as measured by the Shannon-Weiner Diversity Index. (See Graph 3.) A total of sixteen grass species and thirty-five forb species were in the planting mix in varying amounts. A total of four grass species and seventeen forbs species were counted during the November 2022 survey. Only species found in the quadrat plot were recorded so it is possible that not all species were counted.
