TEXAS COASTWIDE EROSION RESPONSE PLAN

2020 Update

**Final Report to the Texas General Land Office
K. K. McKenna, P.G.
GLO Contract No. 20-110-000-C061**

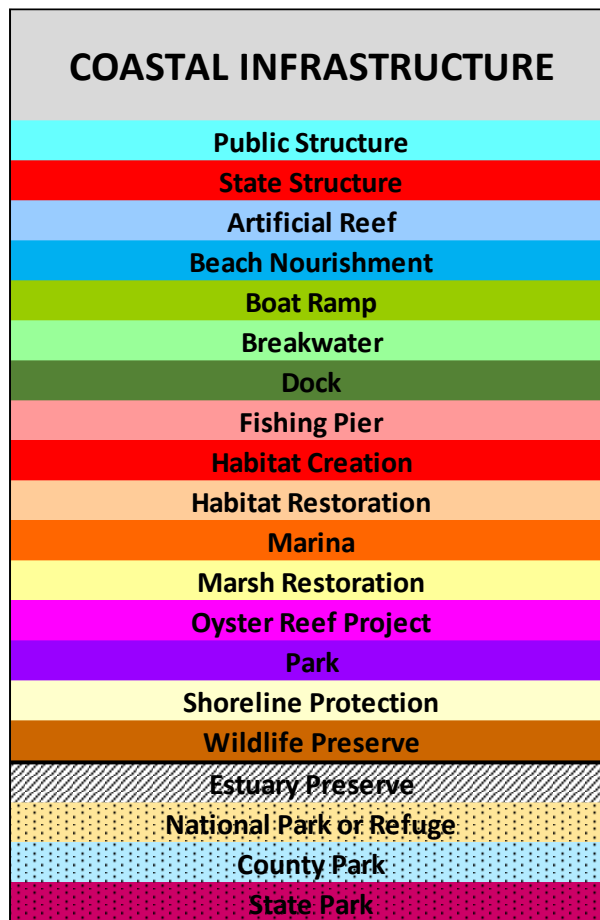
Coastal infrastructure includes public government and public non-government structures, and sites of artificial reefs, beach nourishment and shoreline protection (Figure 6). This data layer also includes the Gulf Intracoastal Waterway (GIWW). Coastal infrastructure becomes critical infrastructure in areas where coastal erosion is greater than 2 ft/yr. Coastal infrastructure data were downloaded from the GLO’s coastal leases (points and polygons) vector website (<https://www.glo.texas.gov/land/land-management/gis/>). These data are also available on the Coastal Resources Mapping Viewer if GIS capabilities are not available (<https://cgis.glo.texas.gov/rmc/index.html>)

Figure 6. Coastal infrastructure data layers available from the GLO.

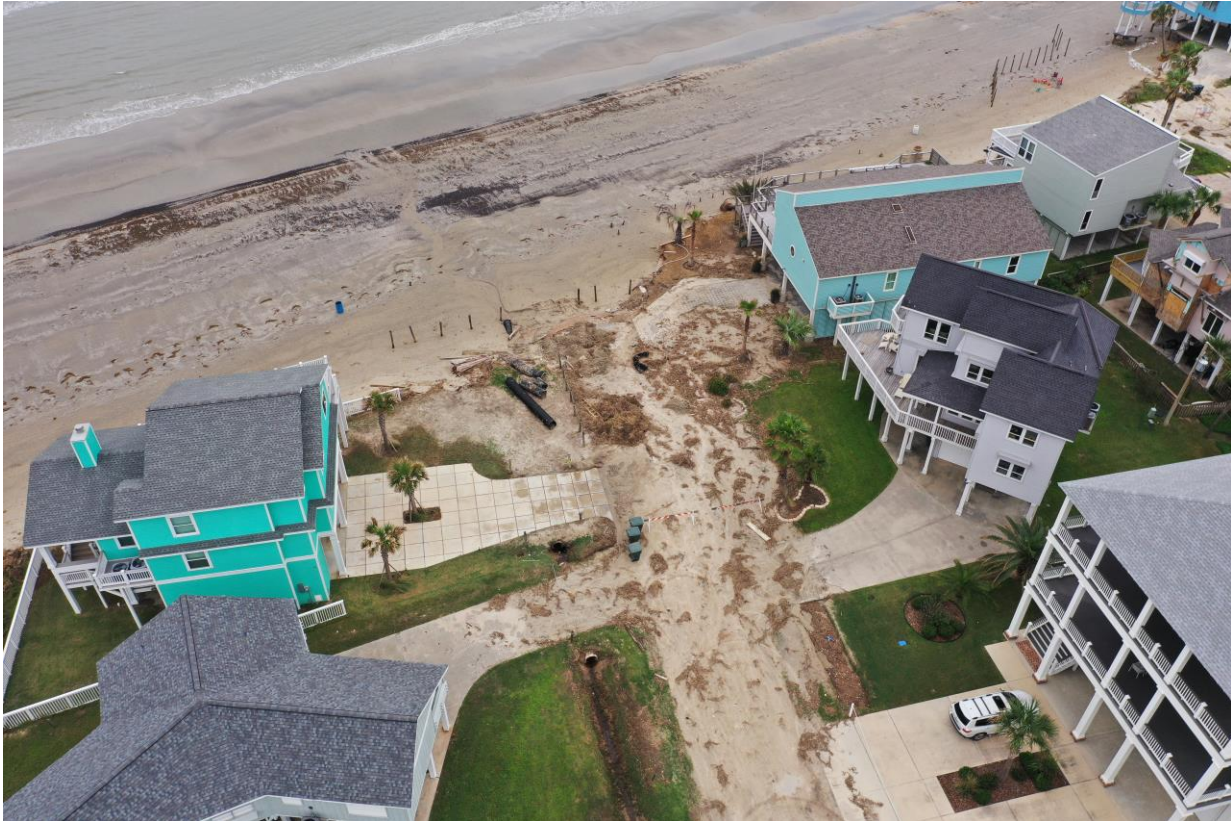
Figure 22. Drone view of the beach and access following Tropical Storm Beta (September 2020) and legacy drainage infrastructure that is collocated and affecting public beach access. (Photo courtesy: D. Henry)

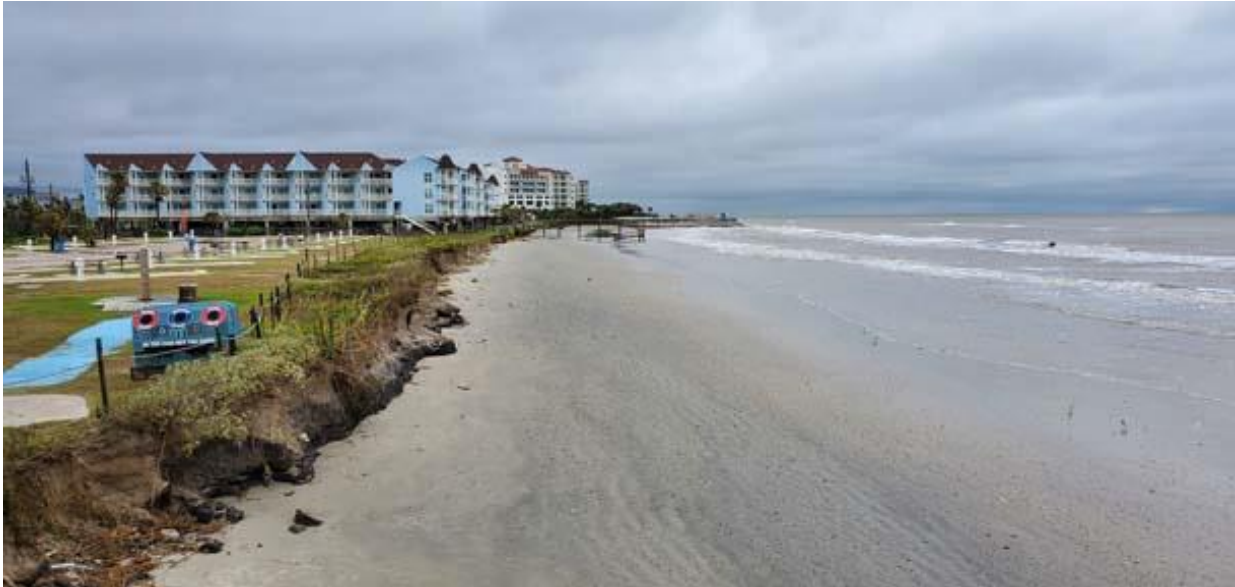
Figure 24. The beach at Dellanera following Tropical Storm Beta (photo taken 2020-09-23 courtesy S. Rozier)

Highlighted Project: CEPRA 1615 (Cycle 9) will begin to repair Harvey damages at Dellanera RV Park and include additional funding from FEMA funding following H. Laura.

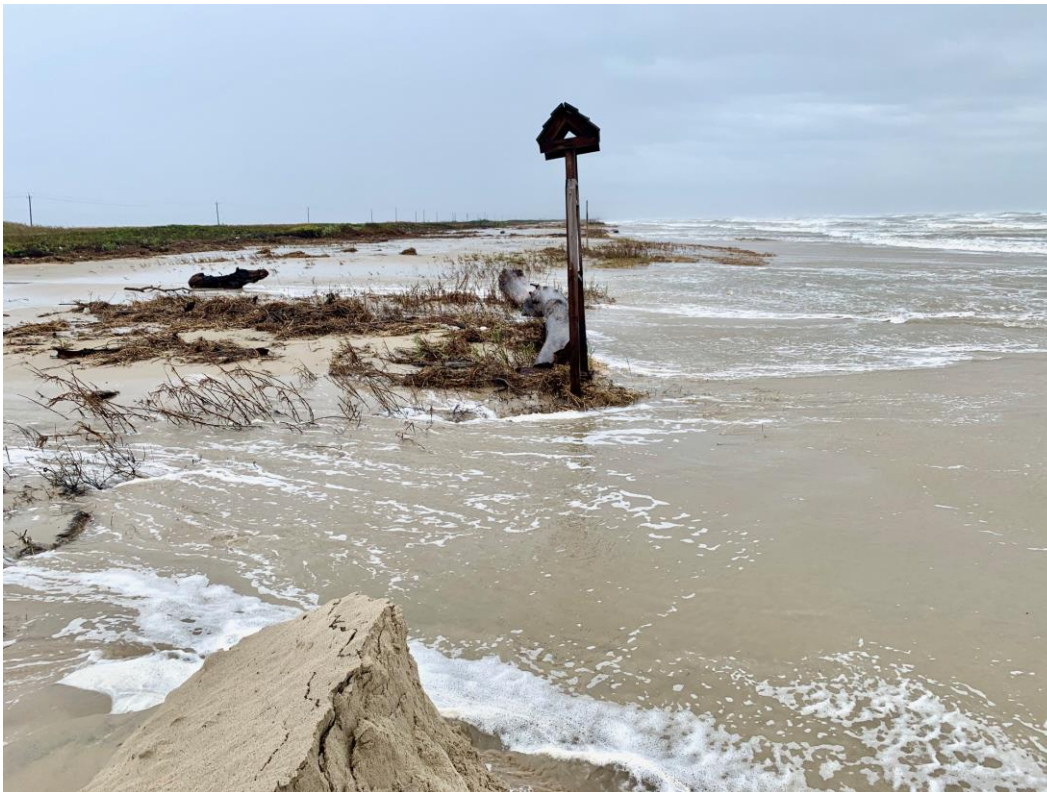
Figure 25. High water from TS Beta hinders public beach access at Beach Access Road 5 on Follets Island (photo courtesy B. Frazier).

Highlighted Project: There is an urgency in keeping beach access open. Beach Access Road 5 will be lost if nothing is done and sand is needed for dune and beach restoration (Figure 25). Other areas of concern are eastern end of Follets Island and western end of Quintana.

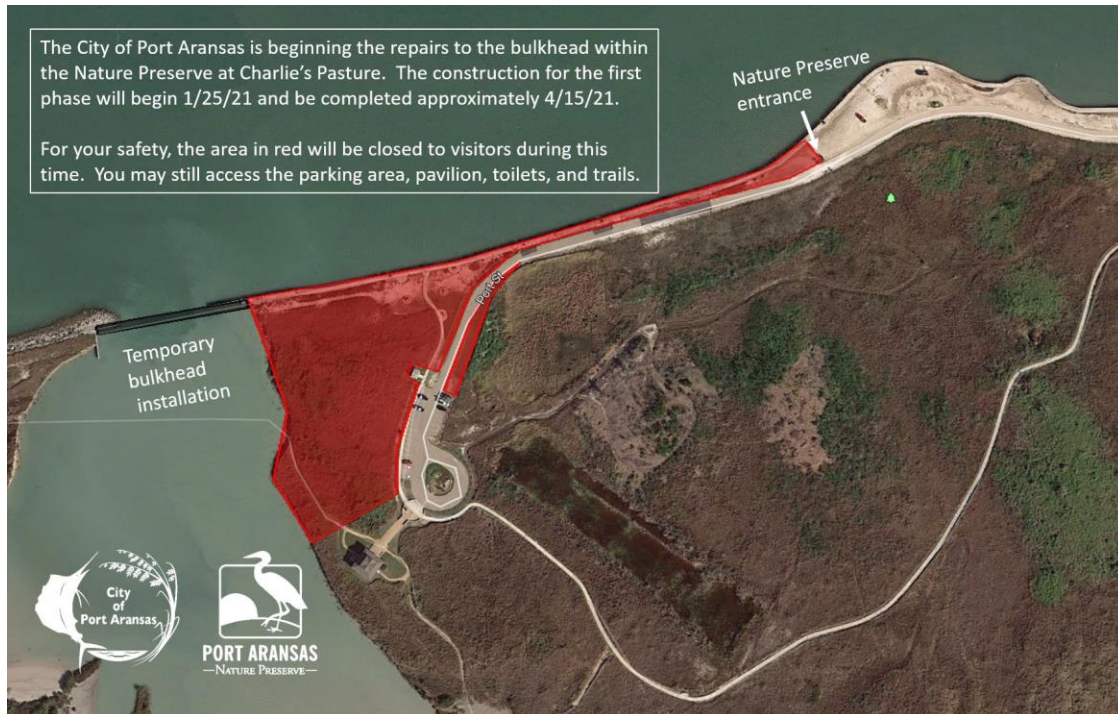
Figure 27. Map showing location of bulkhead at the Nature Preserve at Charlie's Pasture, City of Port Aransas (courtesy C. Simpson).

bulkhead. The temporary bulkhead is under construction. After the permanent structure is complete, habitat restoration of the mud flat area will commence.

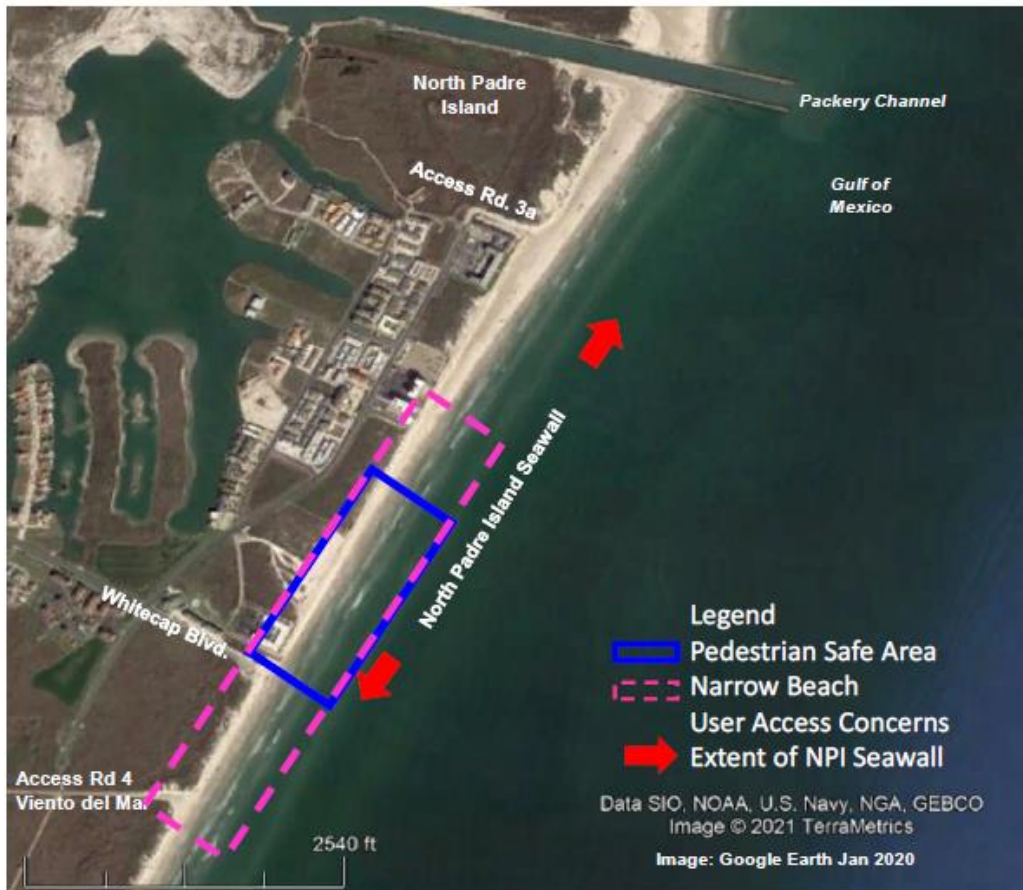
Figure 29. Aerial view of the North Padre Island Seawall and Packery Channel. Erosion at the south end of the Seawall has created difficulties in managing public access.

- The deficit in beach nourishment material to maintain the beach fronting the NPI Seawall and south to Access Rd 4 at design width or at a minimum between 150 and 200 ft.
- Plan for managing erosion of bayshore pocket parks that provide beach access points.

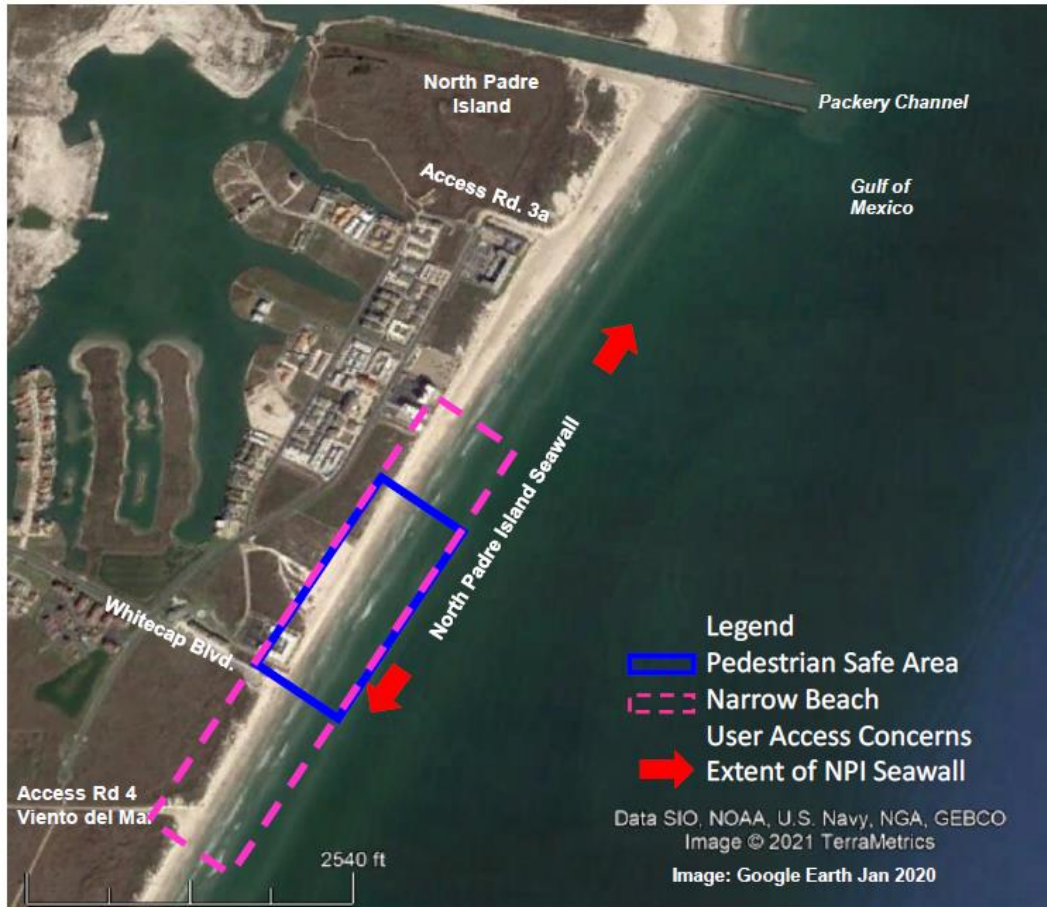
Figure 3. Key features in the vicinity of the NPI Seawall and Packery Channel 3.

A site map is provided in Figure 1 showing the location of beaches discussed in the responses below. Key features related to discussion of erosion in the vicinity of the North Padre Island (NPI) Seawall are shown in Figure 3.
