Tule Marsh East Master Plan

September 10, 2009

**Prepared by
Earl Matthew, M.D.
President, Aransas First Land Trust
and
Greg Harlan, The Grant Connection**

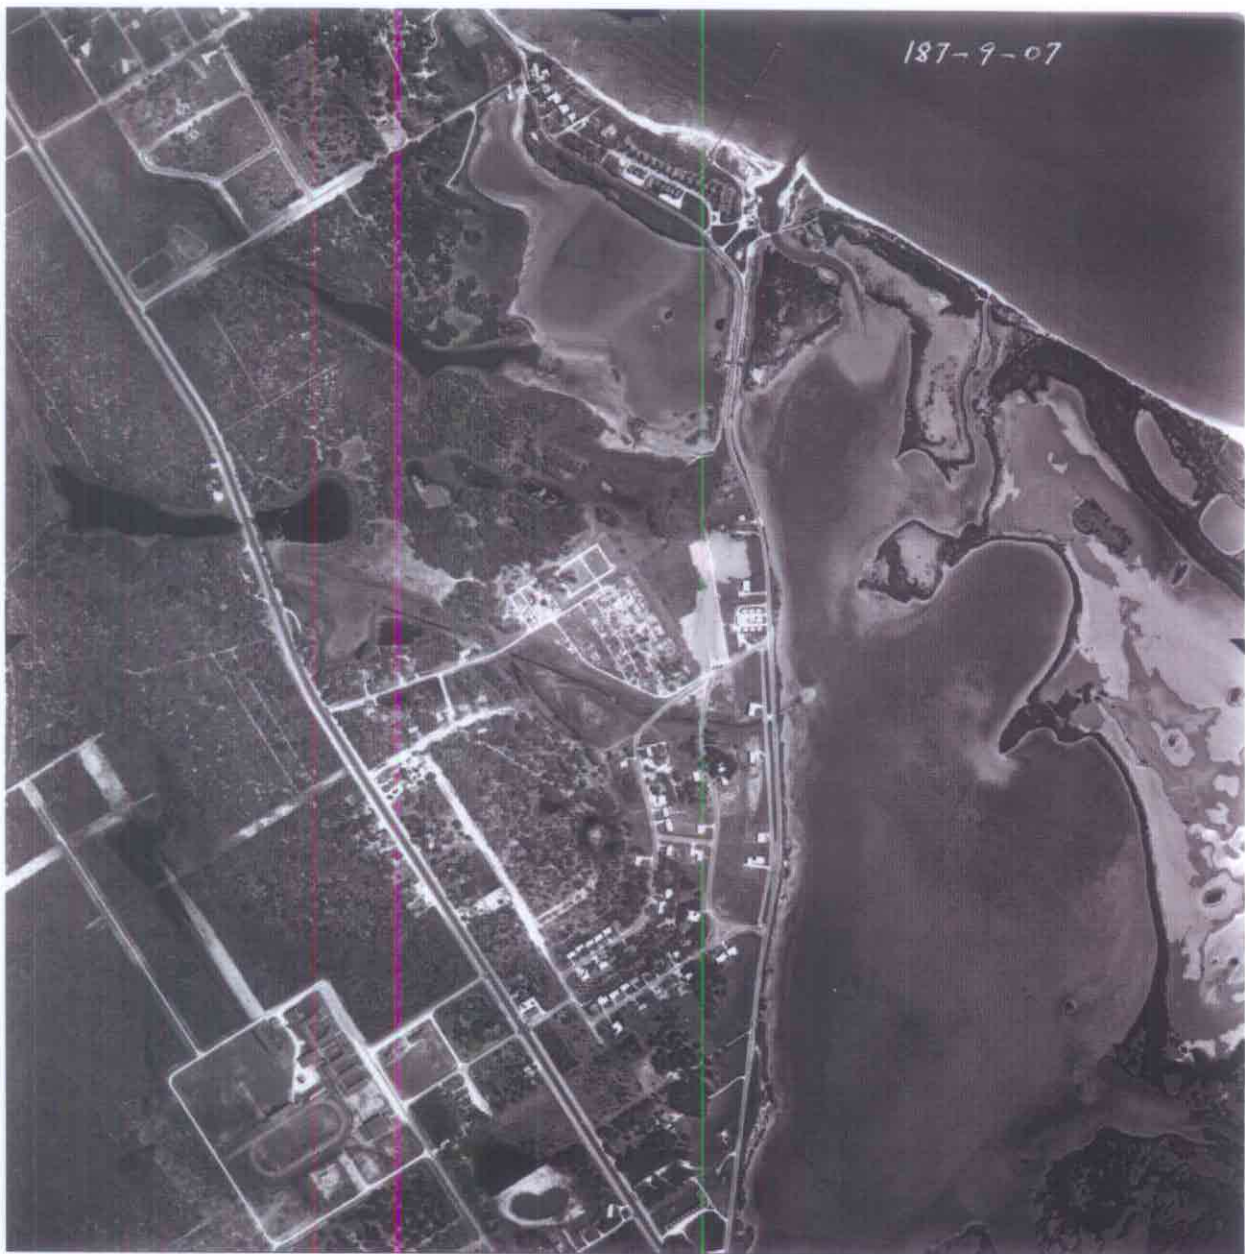
Photo 1. Tule Wetlands, 1959-Lake to East and West of Tx 35 with the Marsh below East end of lake, Little Bay to right

Tule East Marsh was originally part of extensive wetlands to the east and downstream from Tule Lake, with Tule Creek draining into it (Photo 1). The wetlands acted as a floodwater retention area for Tule Creek drainage from the north and west, along with Long Reach Canal and Canoe Lake farther to the east. The original Tule Lake extended from the north end of this site, went under State Highway 35, and backed north to past Henderson Street.(Photo 1) It covered about 12 acres and was up to 6 ft deep in the year 1939 (Photo 5).

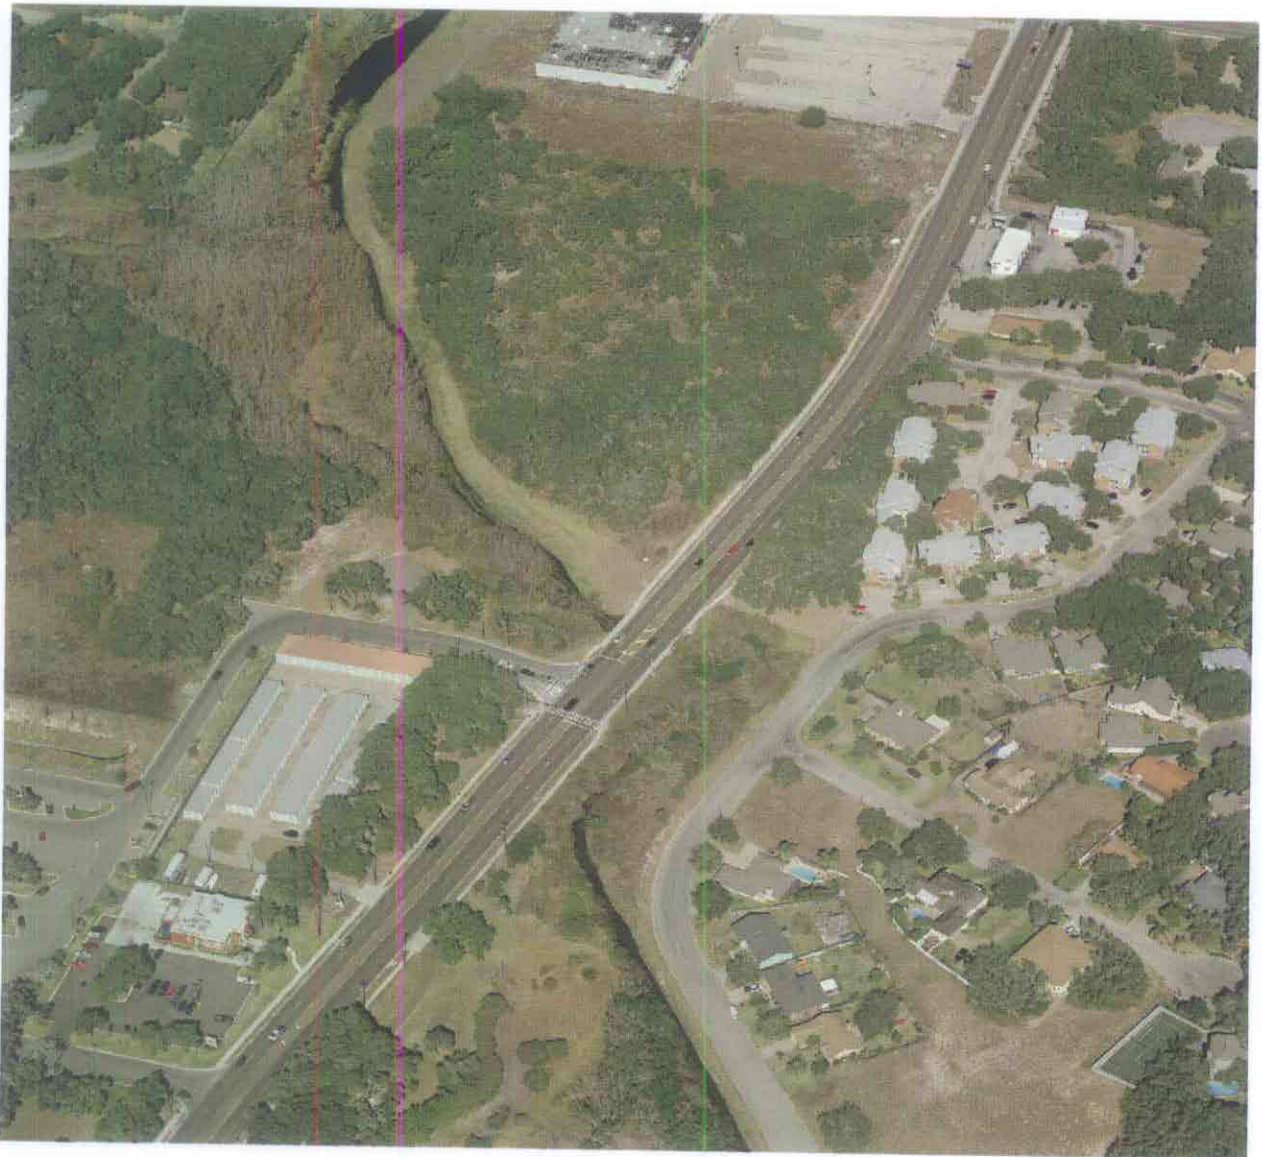
Photo 4-Overgrown old Tule Lake West Lakebed with North portion of Tule East Marsh below-2009

The portion east of Highway 35 was filled in during development of Harbor Oaks Subdivision and the excavation of Canoe Lake. The old lake and most of the wetlands west of Highway 35 have drained and are now fully silted in and (Photos 4,5,6) have to be dredged periodically to keep the creek bed open.

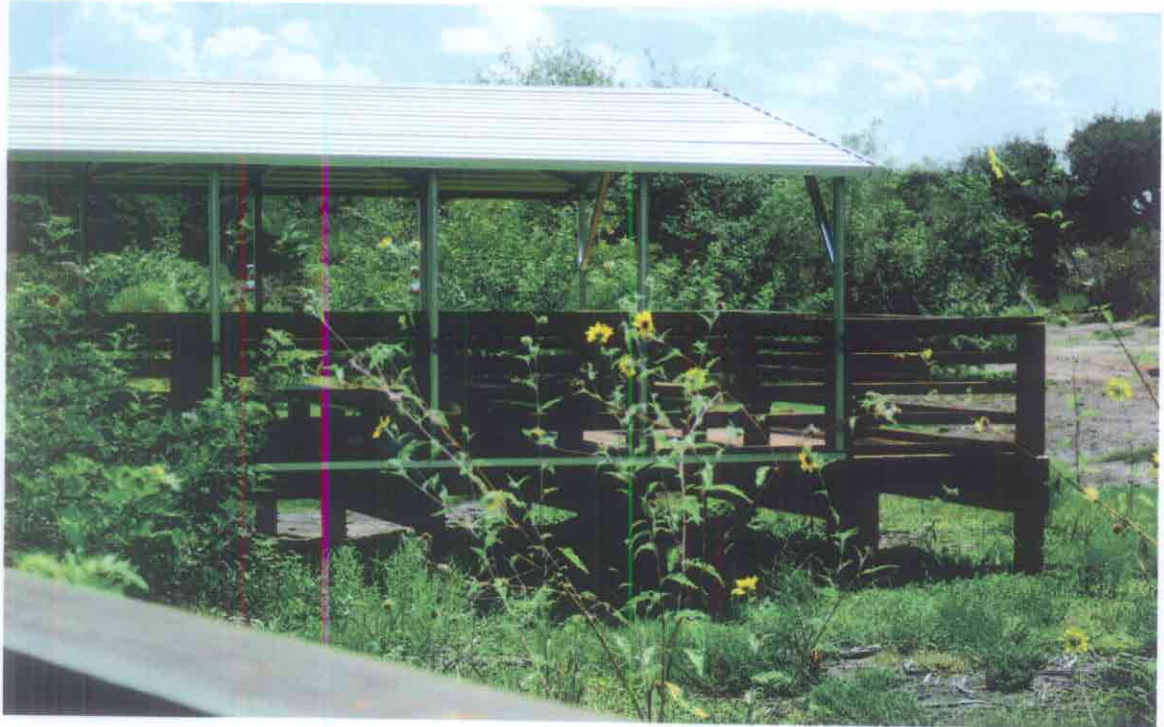
Photo 11. Covered pavilion built in 2009.

With a Coastal Management Program (CMP) grant from the Texas General Land Office (Photo 10), and with financial assistance from Aransas County, Aransas First constructed a 20 x 30-foot covered pavilion (Photos 11 and 12); built a 700-foot granite-based walking trail with viewing stations on the Live Oak Ridge (Photos 13 and 14); and rebuilt the ridgeline seep ponds (Photos 16-19).

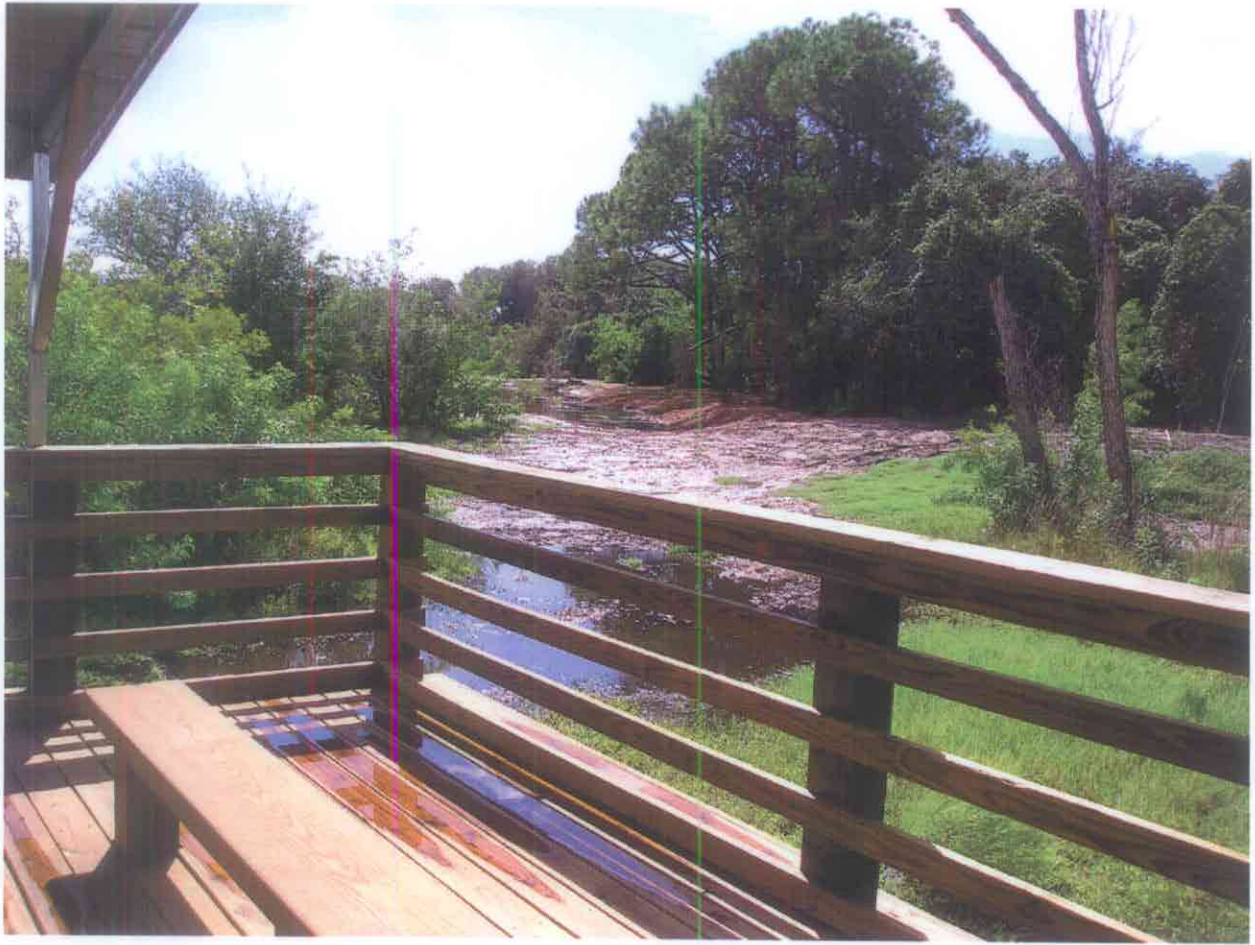
Photo 24. Downstream Ponds to East which direct flow and empty to Tule Ditch in floods. Remain with water from underground seepage from sandy ridge to right in drier periods.

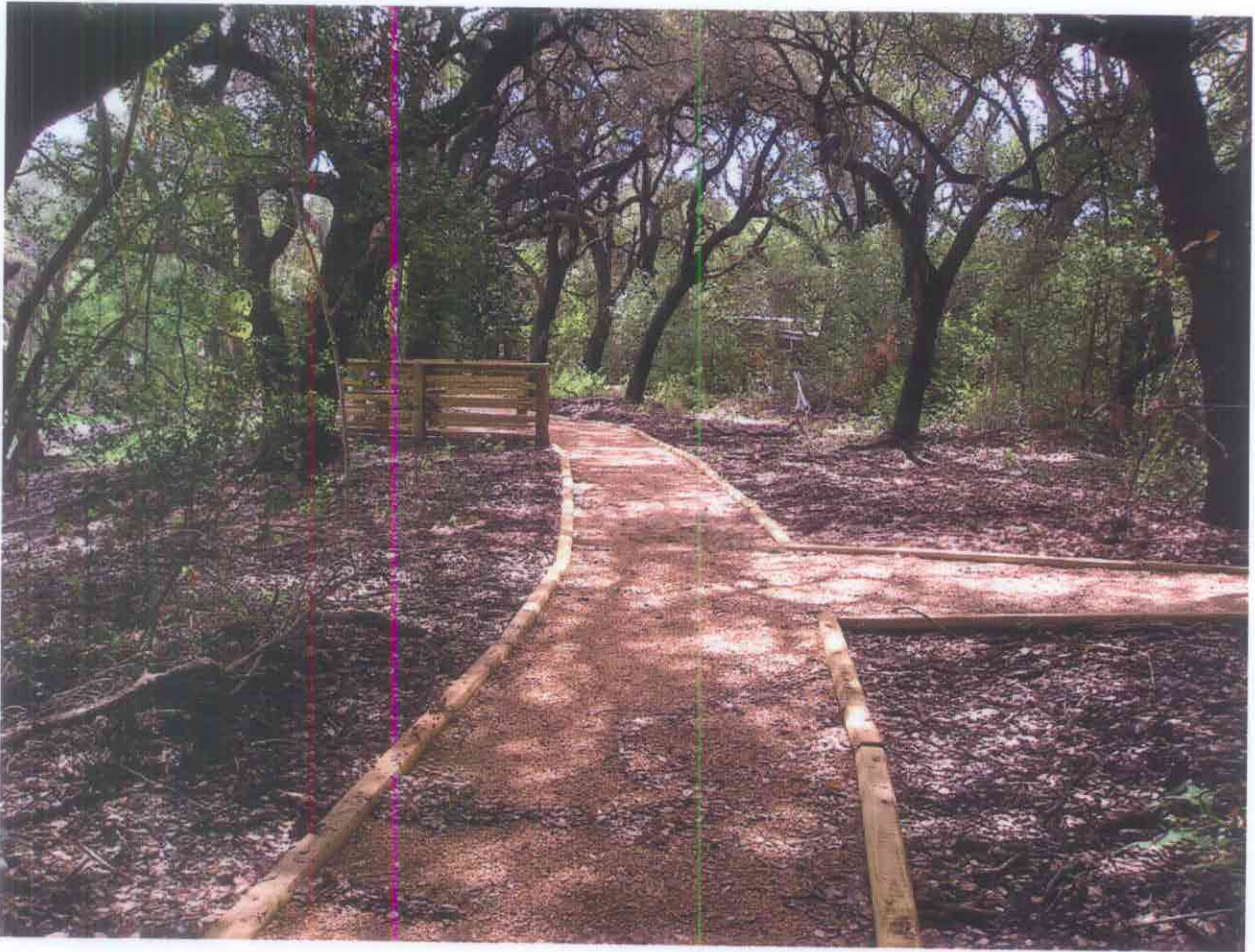
Photo 25. Granite based trail to first viewing station
