Tapley Tributary

Buffalo Bayou Partnership
CMP Grant # 09-042
Tapley Tributary, Final Report

BRINGING THE BAYOU TO THE BAYOU CITY

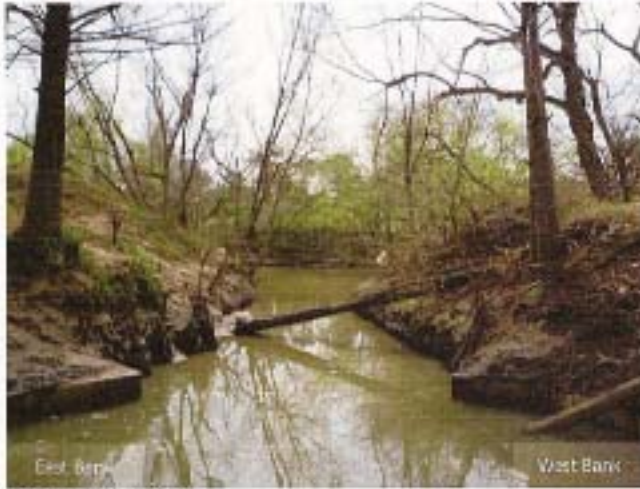
East Bank
West Bank
Canoe Launch Outlet
Looking South

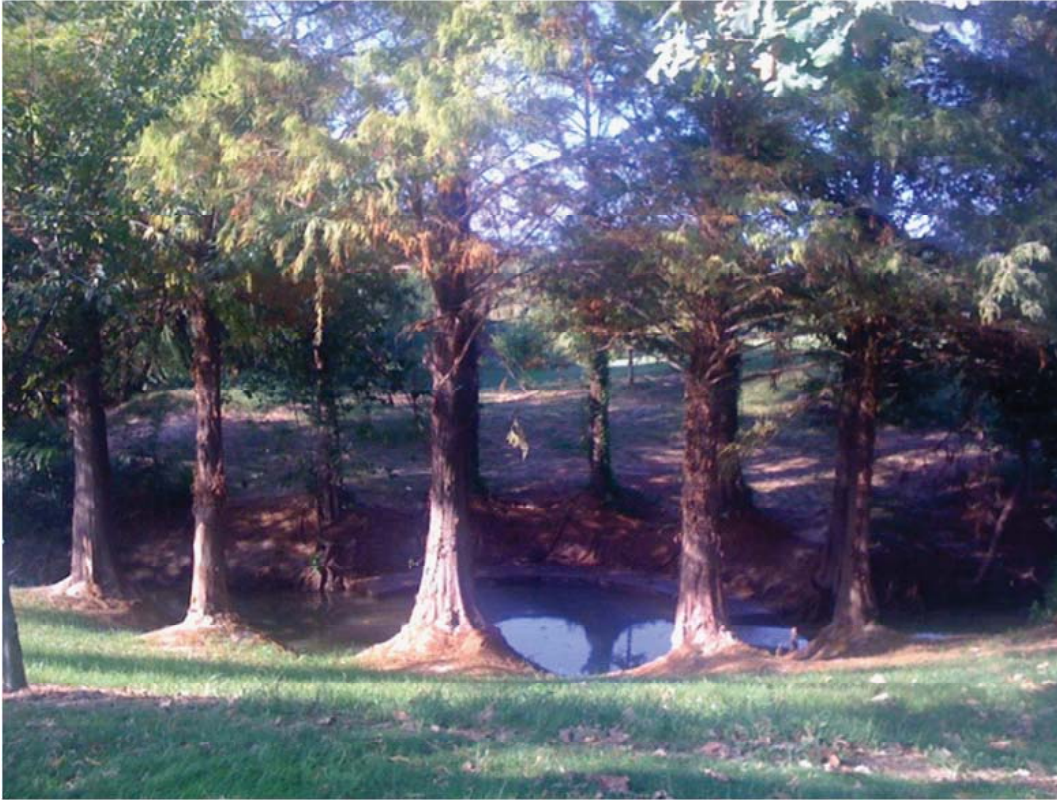
Once covered in over three feet of sediment, the majestic bald cypress are revealed and the Indian Ring is restored. The Indian Ring marks a pool near where Tapley Tributary feeds into Buffalo Bayou.

The granite weir at the Indian Ring is uncovered allowing both water and people to flow through the site and restoring the pool-run feature. The riffle-pool-run hydrologic model is important for healthy stream ecology providing habitat and nutrients.

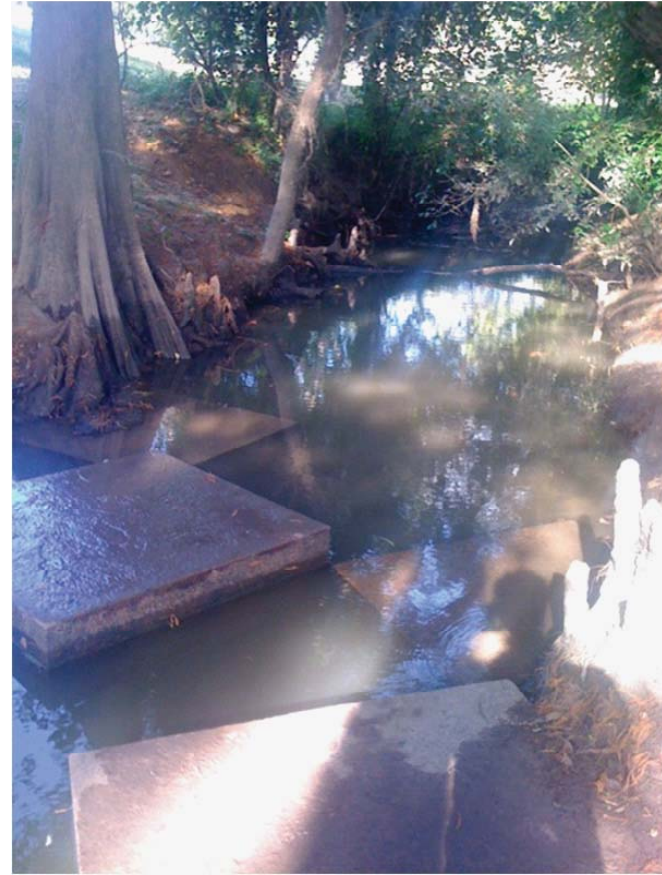
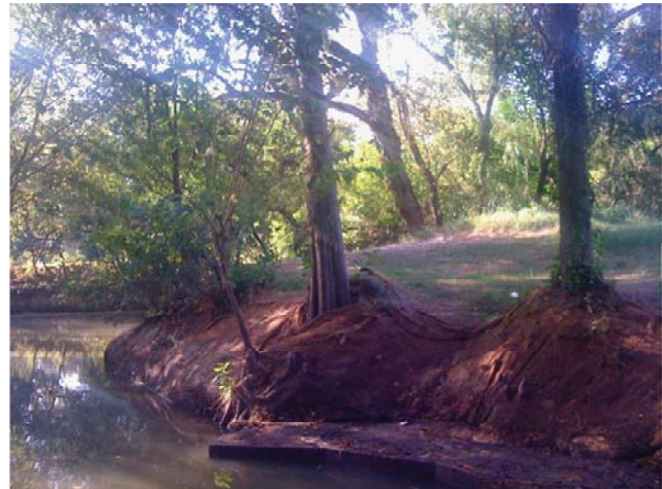
Fiber mat utilized in other locations along Buffalo Bayou is wrapped around the base of the bald cypress. Grass seed was sprayed.

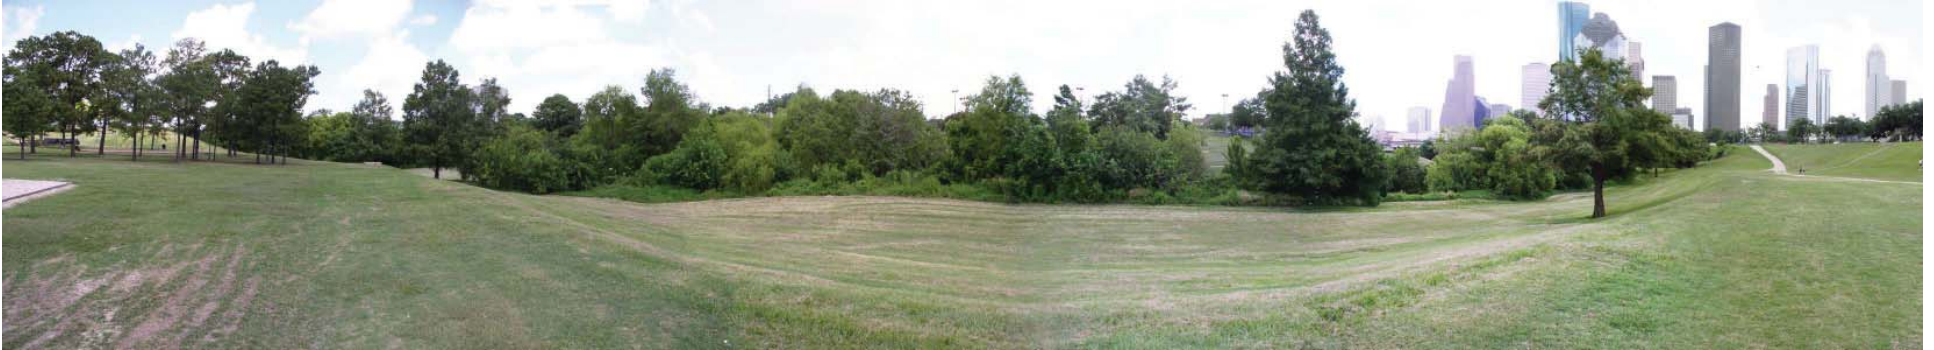
Matching funds were provided by a project being completed in conjunction with Harris County Flood Control District to the main channel of Buffalo Bayou, near the mouth of the Tapley Tributary. This image showcases the bayou greenway before invasive species and sediment removal. Limited to no access to the water. Invasive species and vines trap sediment and cause issues with flooding.

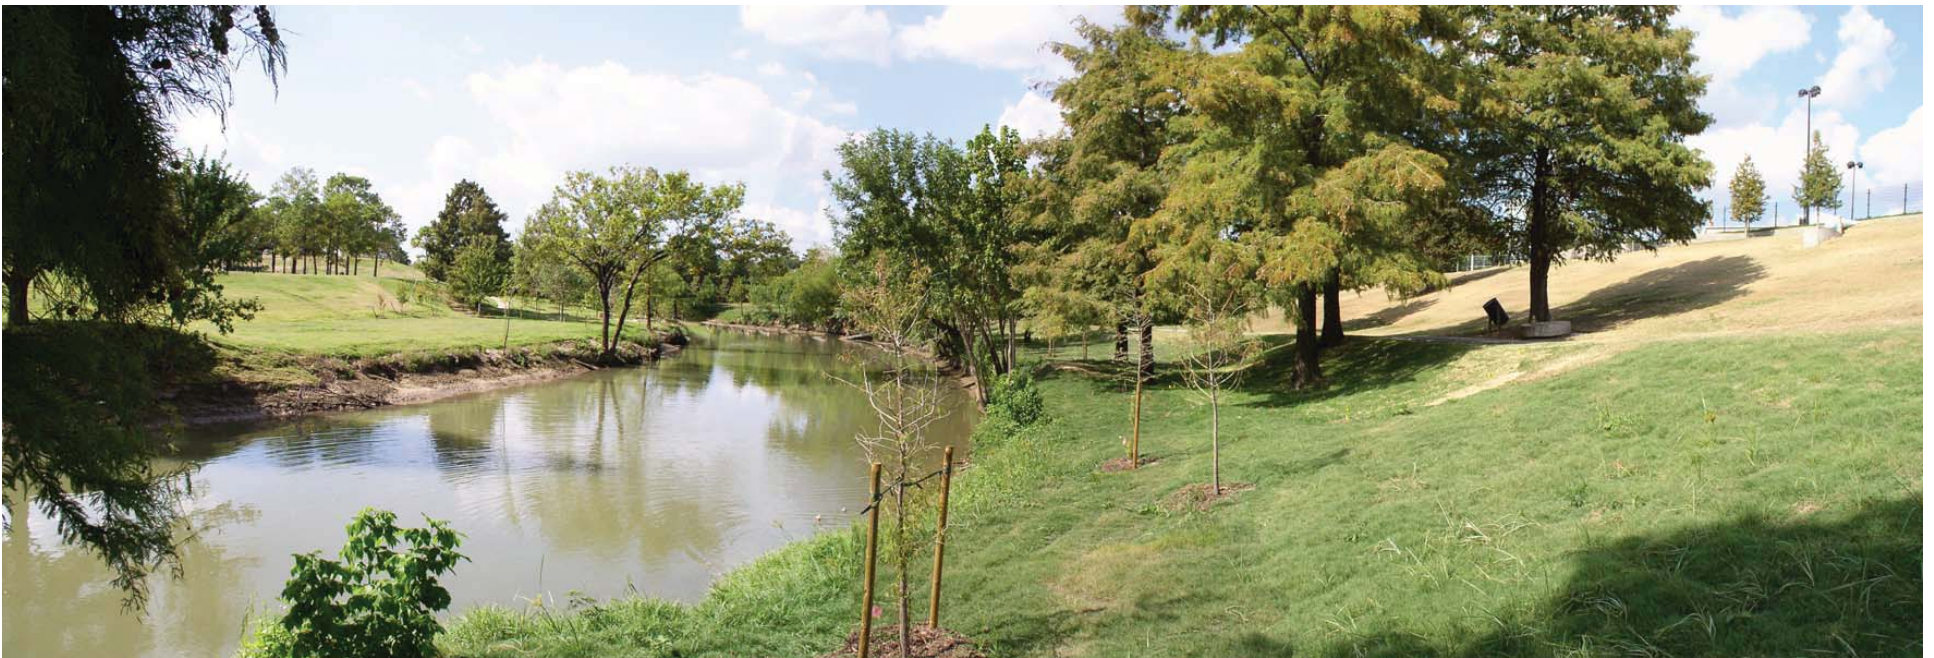
Buffalo Bayou after invasive species and sediment removal. Incredible native trees revealed. New native tree plantings included. Access to the water allows people to view the water and sediment to move through the channel in times of heavy flooding.

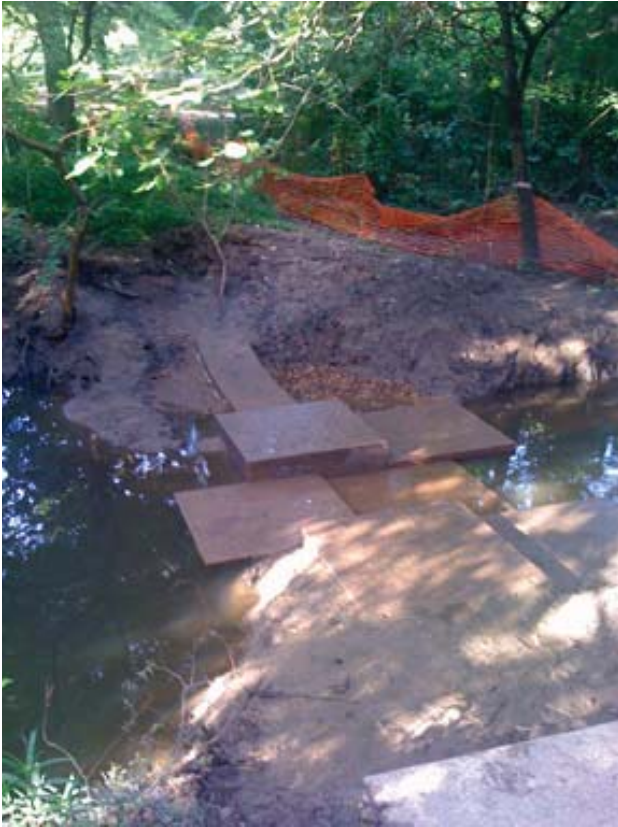
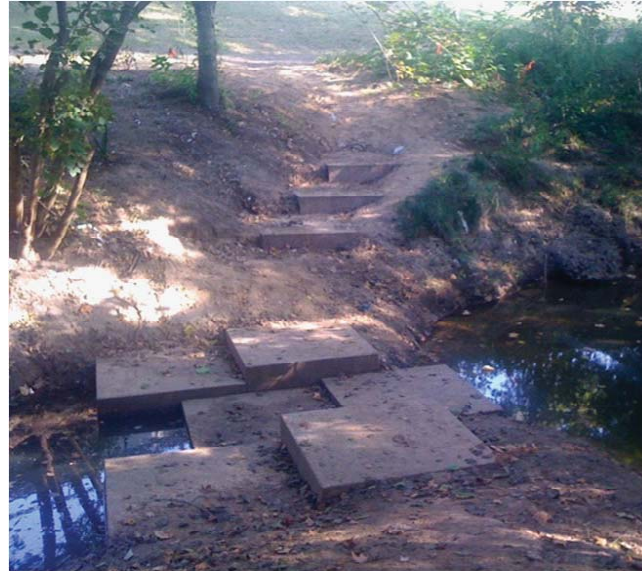
Spillway repairs at Turtle Pond . Installation of gravel fill and rubber backing.

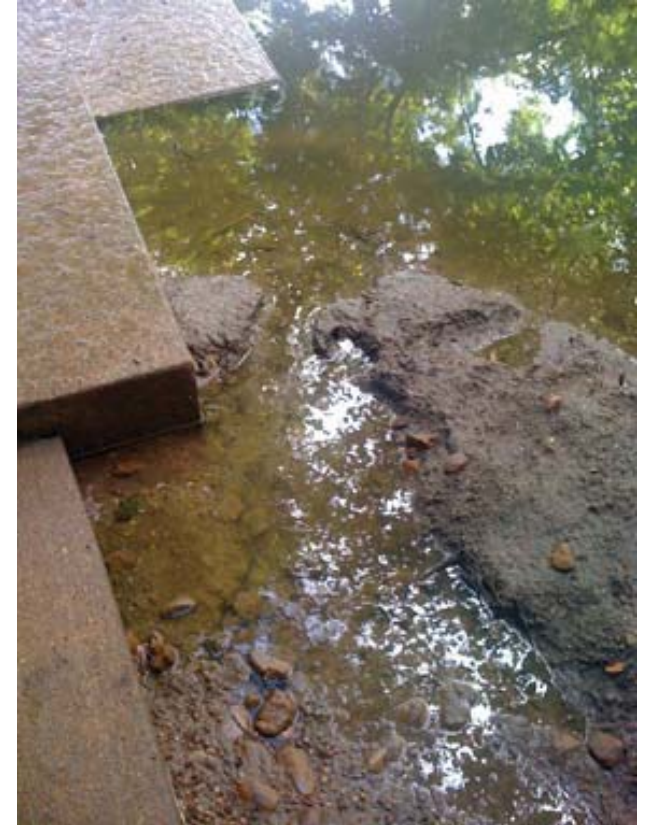
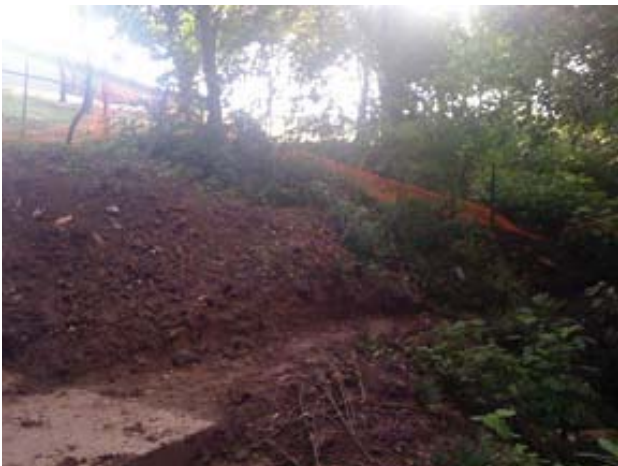
Granite step excavated and a new trail path has been configured in lieu of a stair because of steep slope.

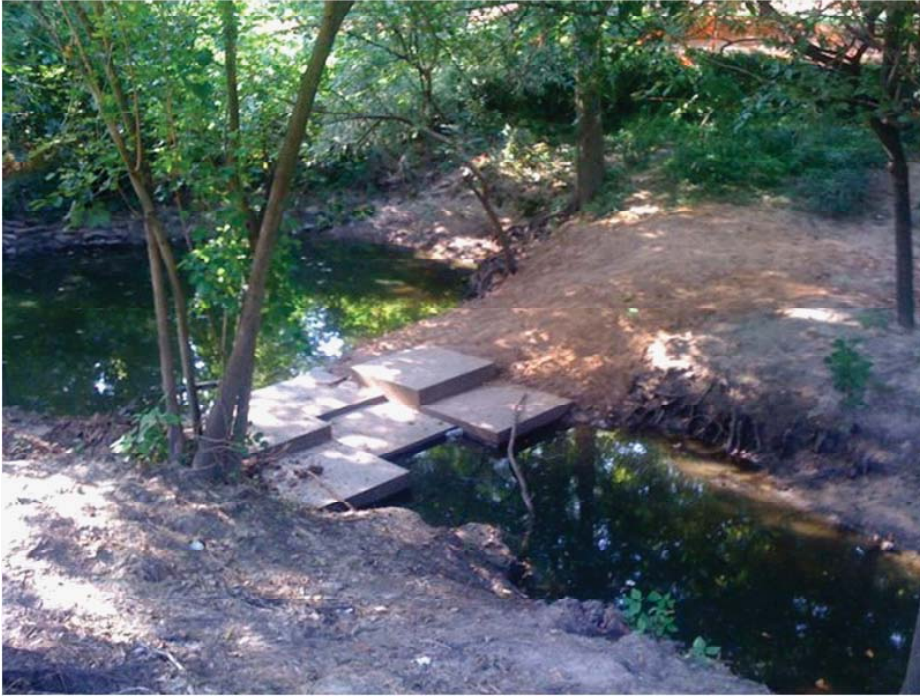
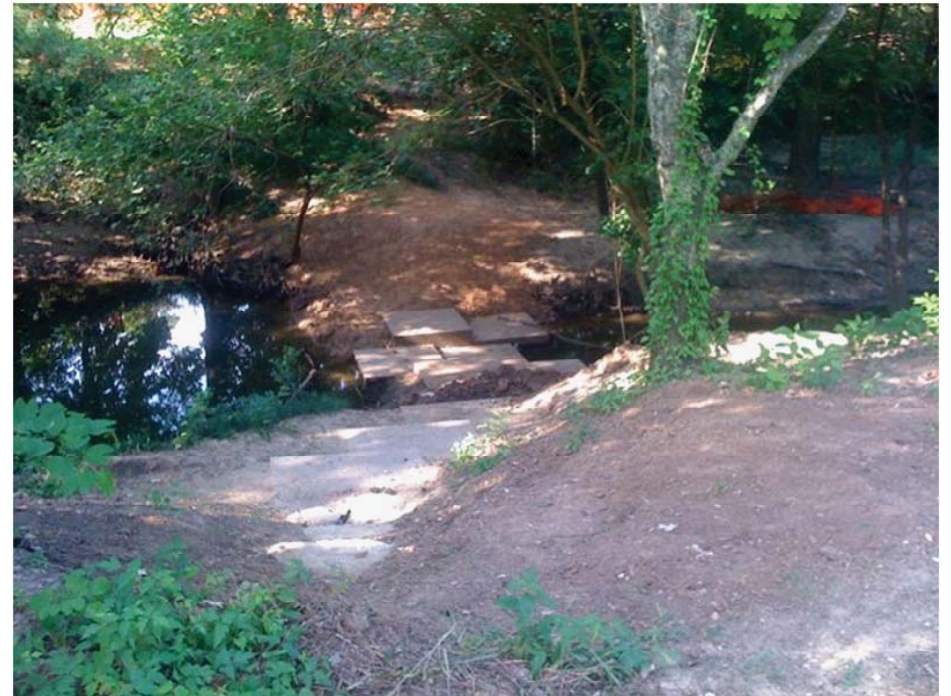
Water is now forced to flow over the top of the weir rather than cutting and eroding along the edge of the granite weir. The weir doubles as a pathway for people, allowing them to access the Turtle Pond. A new stair was built into the side of the hill.

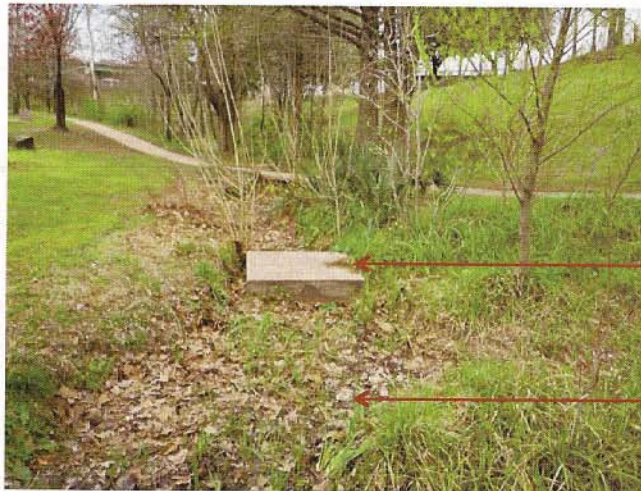
Headwater and Weir

Original Weir Stone

Sand Lens Spring Marsh Weir to maintain 1' water elevation

Task three installed a new weir system in hopes of retaining a constant water level in the wetland pond. Originally, we hoped to cut a channel in the granite slab, but it was determined it would be better to reinforce the bank edges. This was included in a no-additional cost change order.

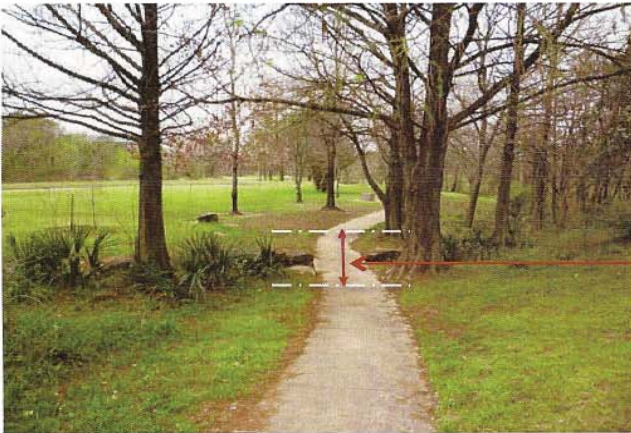
Remove approximately 25' of Trail and Bridge (Realign trail and bridge as necessary to minimize impact on two trees north of trail.)

Task Four removed a spillway being used inappropriately as a trail segment, installation of a pedestrian bridge and French drain. On the secondary hike and bike trail that divides the pre-existing tributary from the more recent headwater extension, the narrow concrete path creates several dangerous conditions for trail users. As the trail approaches the tributary it dips down often becoming covered with stormwater after normal rain events. Over 25-feet of existing trail was removed and a Con-tech bridge was installed. French drain installed to improve safety on trail after rain events.

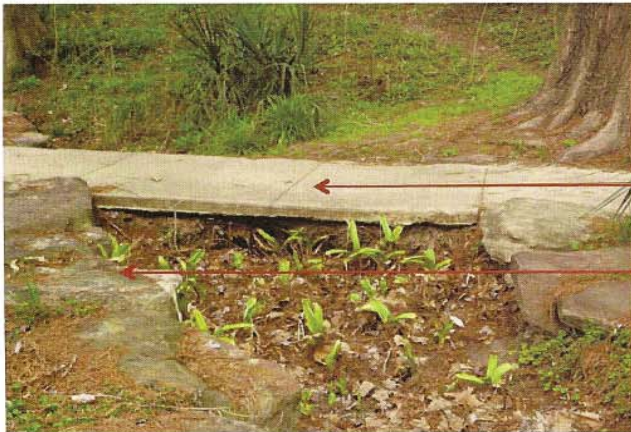
Remove existing sidewalk bridge

Install new edge stones under new bridge to maintain consistent tributary edge condition. Stones to match existing edge stones.

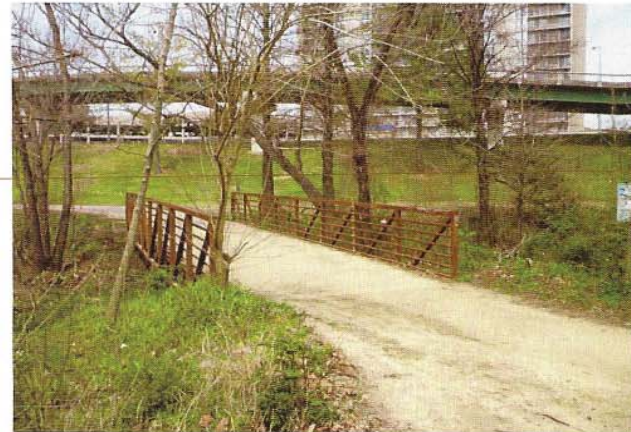
12 'Specimen Bridge at Tapley Tributary (just west of new bridge location)

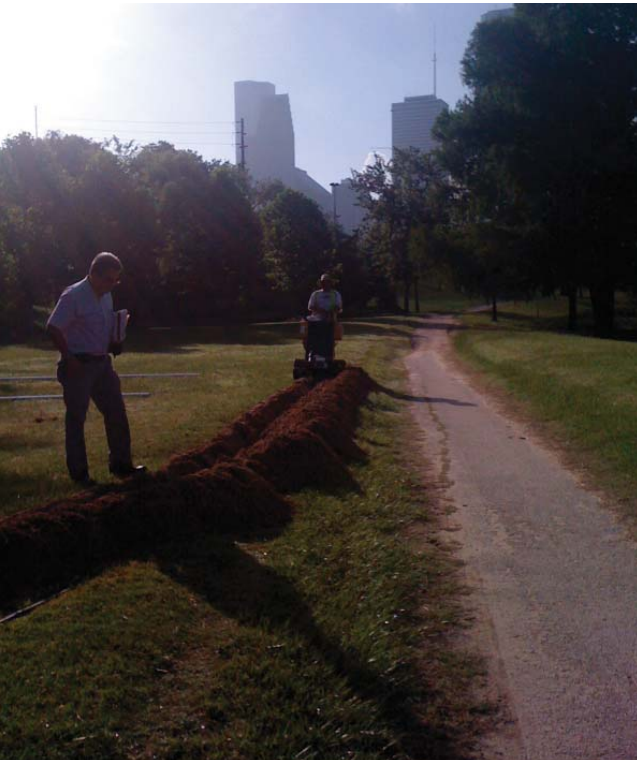
Pedestrian bridge and new pathway being installed. A small section of the existing trail was removed and realigned to safely connect the new bridge and existing pathway. New Con-tech bridge matches another bridge located nearby. The elevated pathway will allow pedestrians to move safely across the site and water to flow from the wetland headwaters to the tributary and exceeds expectations.

New drainage being installed.

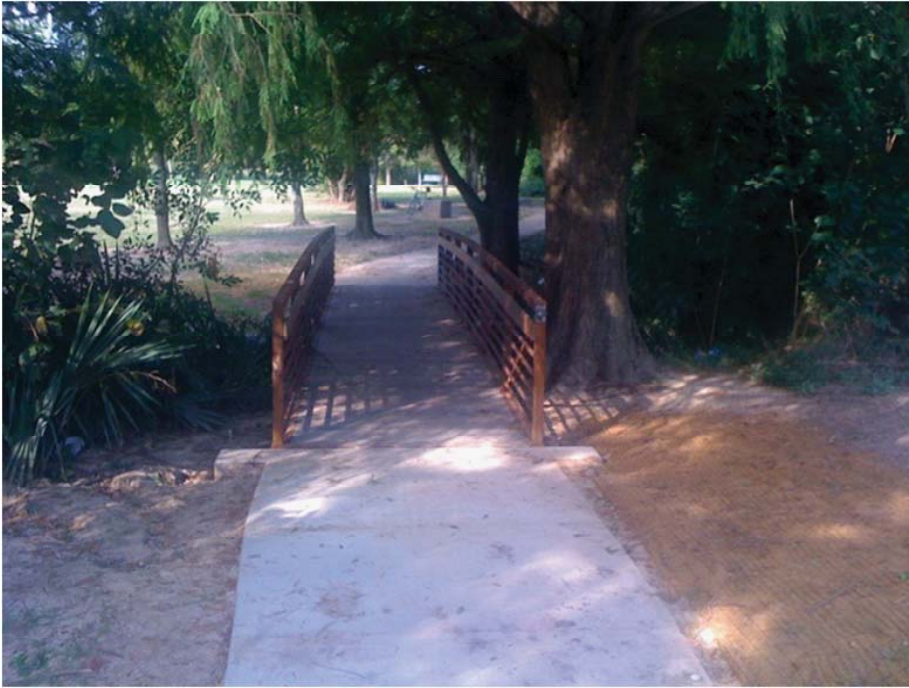
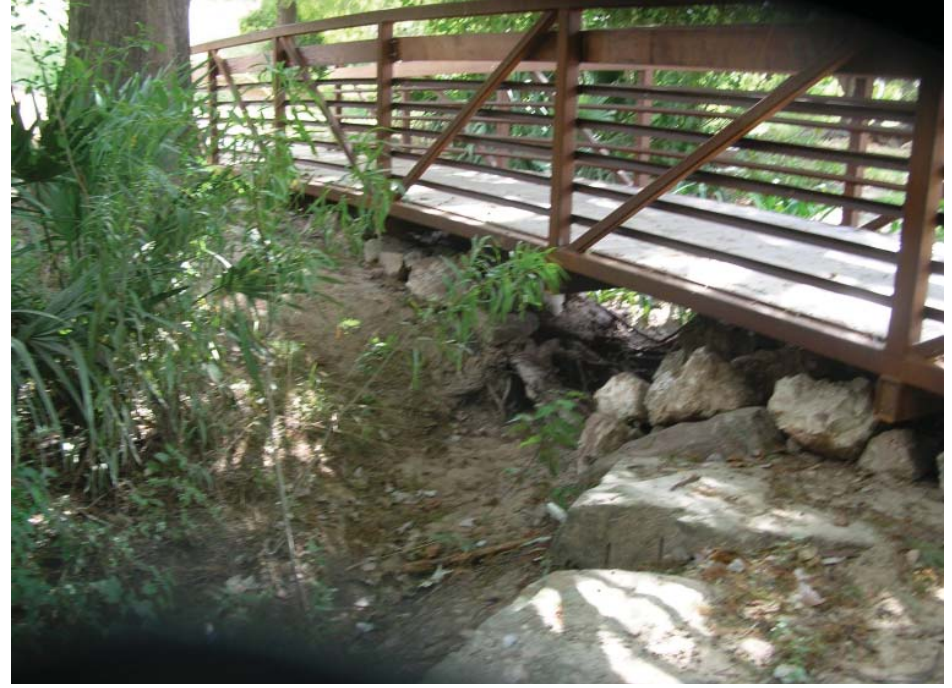
New bridge after installation. New bridge exceeds expectations

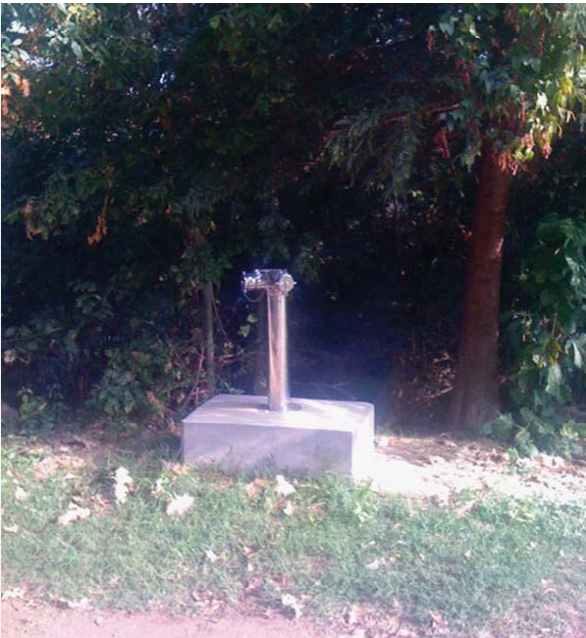
New standpipe

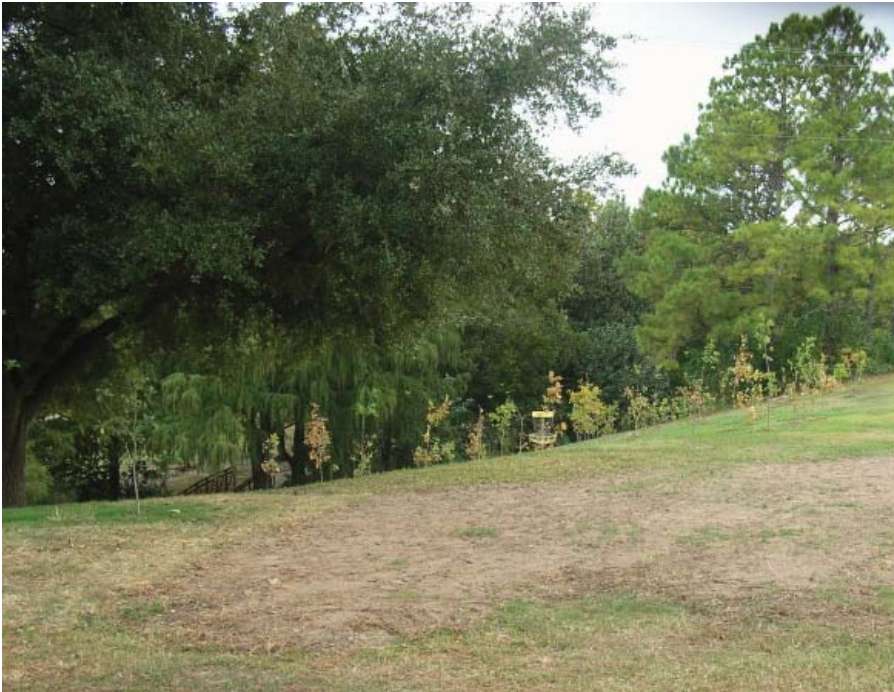
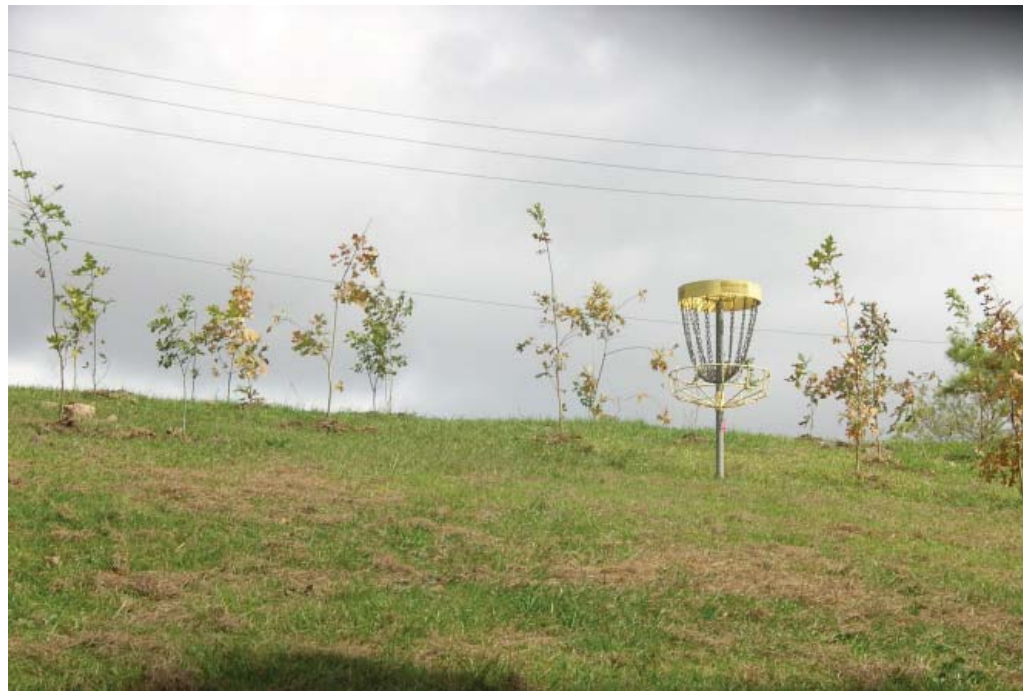
Task 5 Description: Installation of Tree Canopy and Niche Habitat Features

Two projects influenced the location of the tree planting: Future Texas Department of Transportation funded trail realignment and the Sabine to Shepherd Master Plan. Both of these projects will be let for construction in 2011. The trail project specifically impacted the area planned for tree canopy reforestation because much of this area would be impacted by construction. Consulting with the Master Plan design team, a planting plan was designed that incorporated the new trail realignment and also considered the Shepherd to Sabine Greenway Project proposed design for this area. In addition, the design team consulted with the Disc Golf organization and the Houston Parks and Recreation Department, which maintains the area. The Memorial Disc Golf Course runs through Tapley Tributary. Specifically, three tees were impacted by the proposed planting. Two of the tees were slightly adjusted to accommodate proposed Master Plan recommendations. These modifications were amendable by all parties.

On October 16th, over seventy five volunteers helped plant nearly 1000 trees and understory plants.

Buffalo Bayou Partnership, in cooperation with Trees for Houston, will be watering the trees.
