Enhancing Water Quality and Dredged Material for the Port of Harlingen (Phase I)

**By
T. Allen Berthold
Texas Water Resources Institute**

**Texas Water Resources Institute Technical Report No. 417
Texas A&M University System
College Station, Texas 77843-2118**

Conceptual Design Report

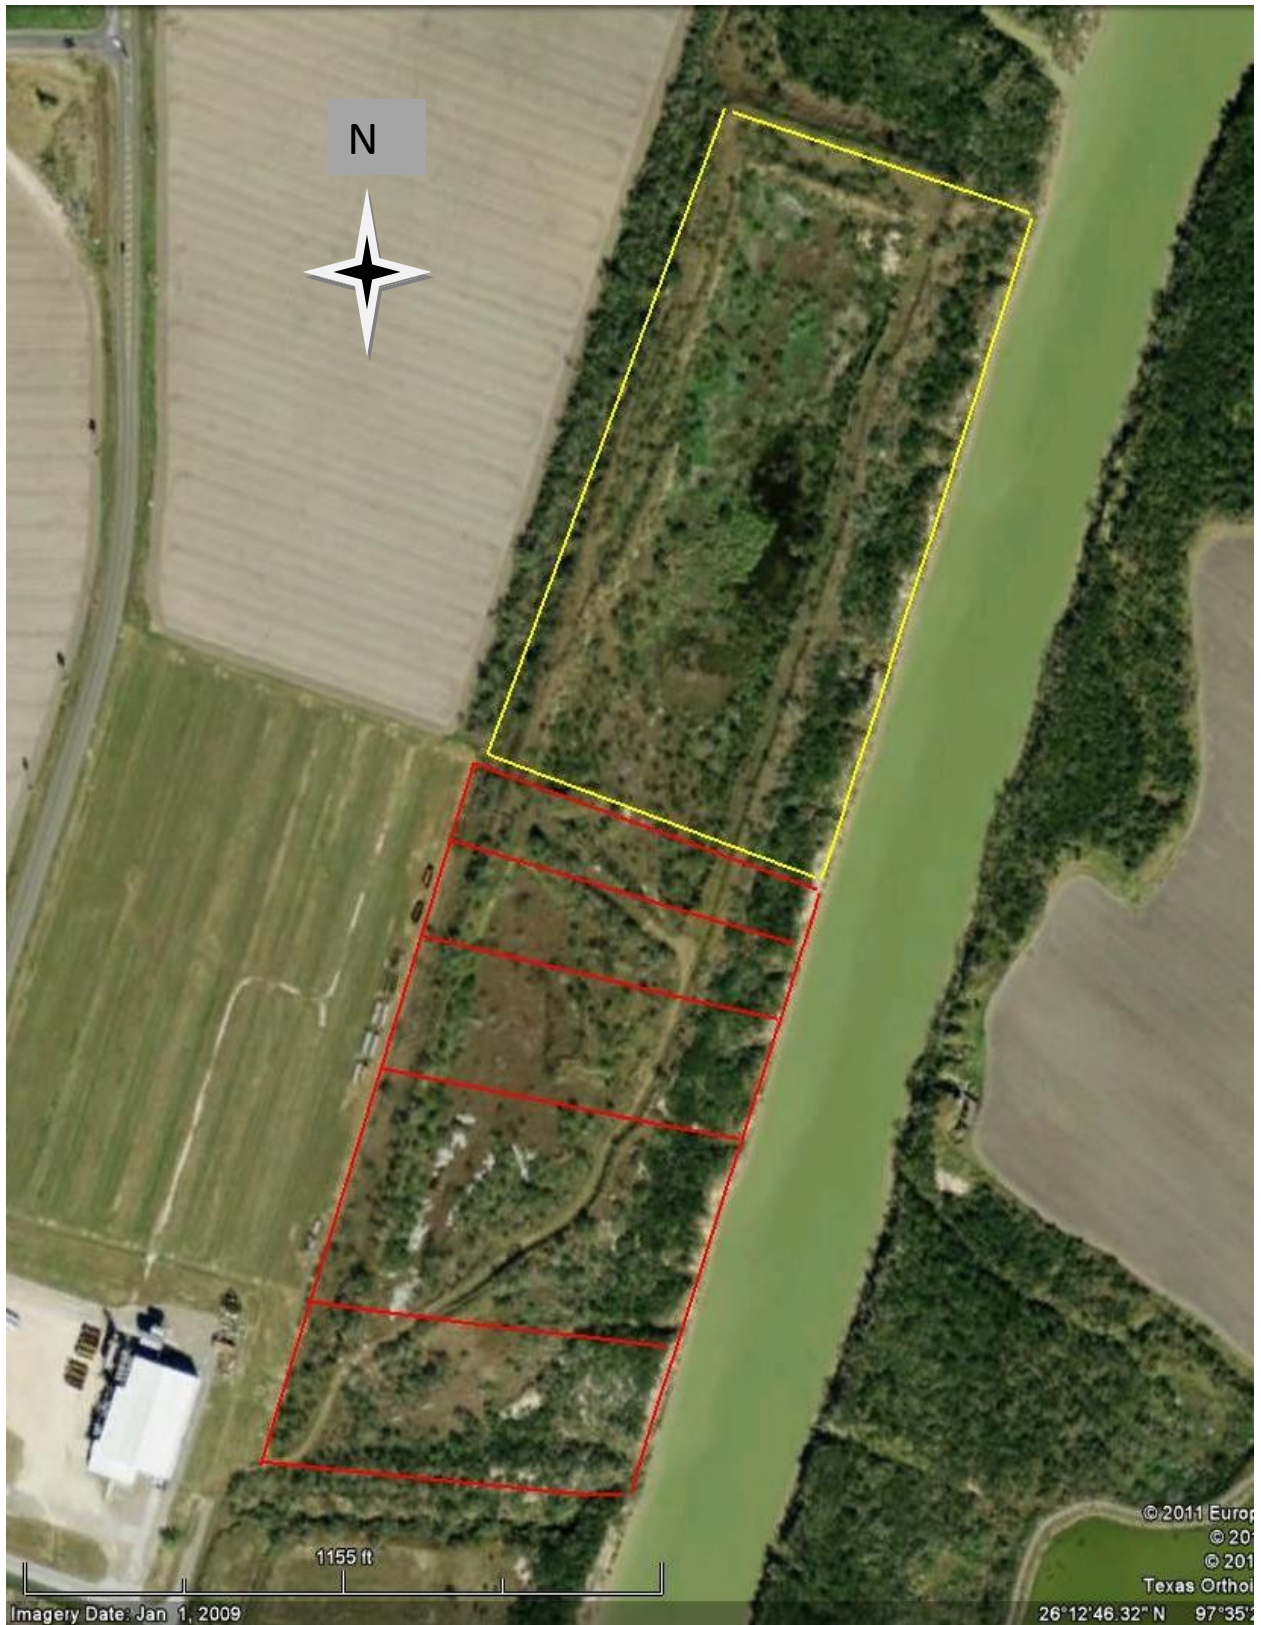
Figure 2. The piece of land being surveyed for species identification located at the Port of Harlingen divided into Area 1 (red) sub-divided into plots 1-5 and Area 2 (yellow).

The area of land surveyed for this project is located at the Port of Harlingen in Harlingen, Texas. The rectangular piece of land runs parallel to the Arroyo Colorado and is found on the western bank. The dimensions for the land surveyed are approximately 815 yards by 190 yards (Fig.2). For the purpose of this project, the area of land being surveyed was divided into two parts which are highlighted in Figure 2; Area 1 is outlined in red and Area 2 is outlined yellow.

Due to the size of the area of land being surveyed, Area 1 was further divided into five plots, with plot 1 starting at the south end of the area heading north to plot 5. The edges of these plots were logged into a GPS and marked using a piece of orange rope for visibility (Fig. 3). Once marked, the area in between was surveyed by walking west to east down to the rivers' edge. Using field guides and binoculars, all identifiable plant species within the plotted area were recorded. When fauna were

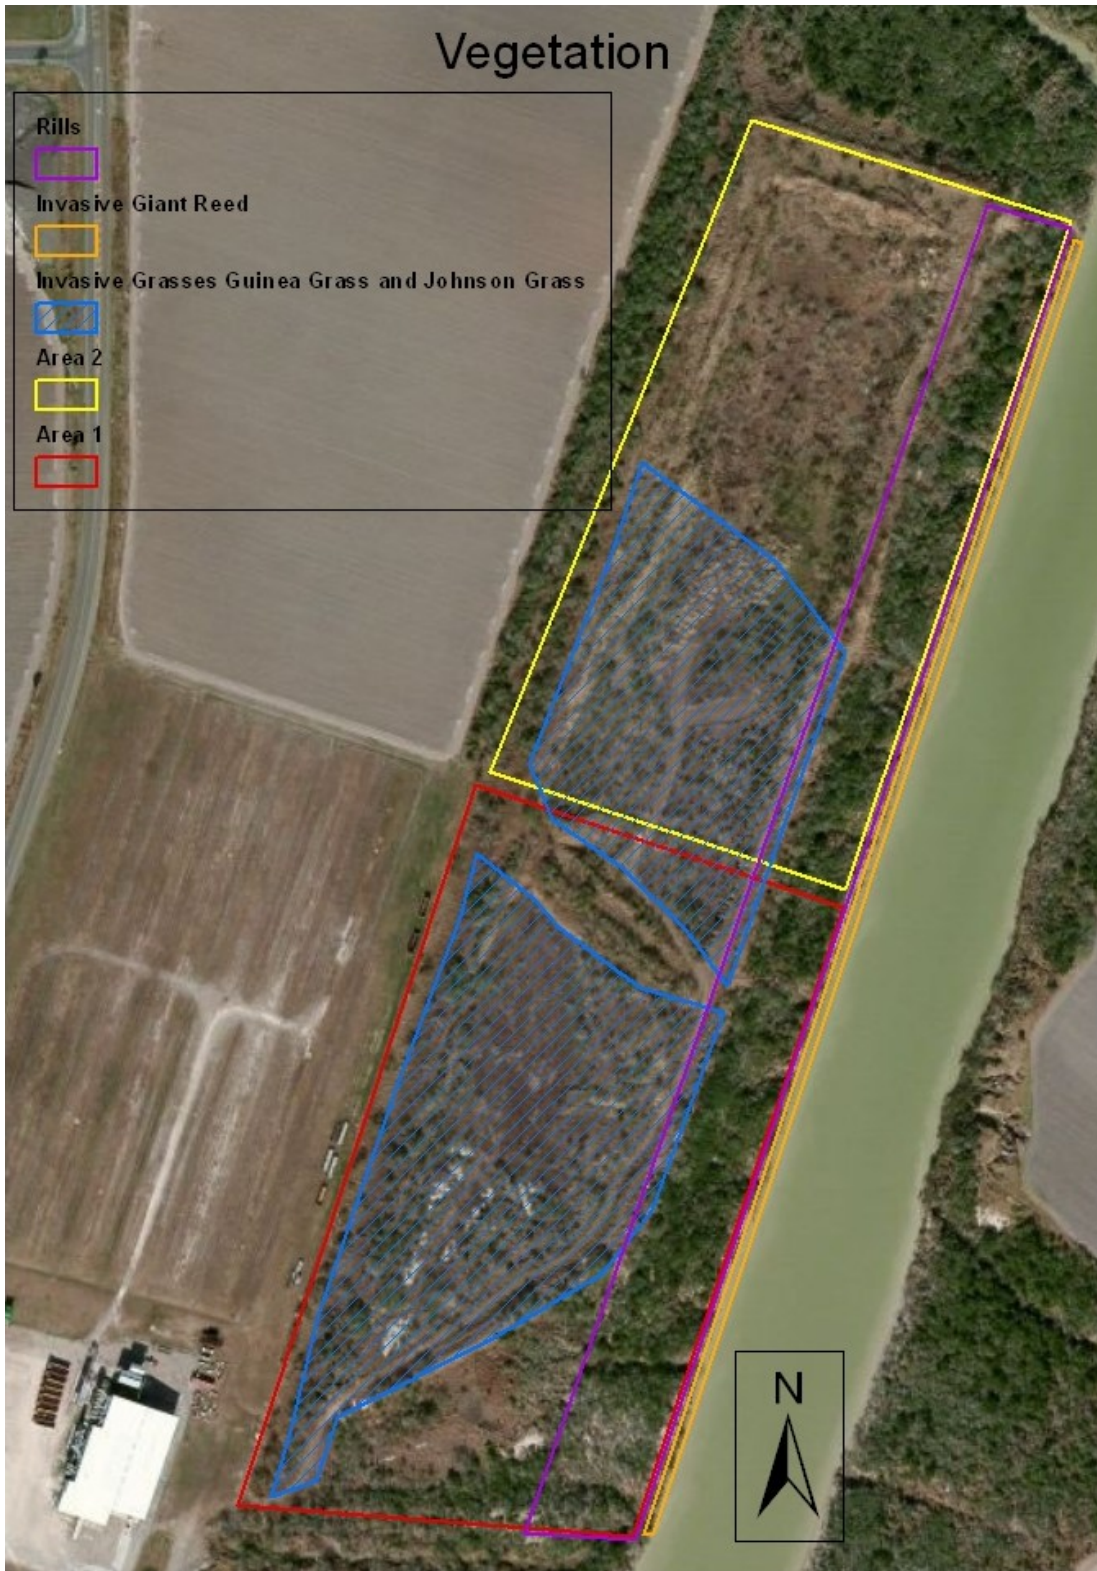
APPENDIX 2. NATIVE AND INVASIVE VEGETATION

The soils in the mapped areas are clay dominated loam. The areas dominated by invasive grasses (shown as blue on the last figure) have disturbed clay-rich soils. The areas where erosion is an issue are directly adjacent to the Arroyo Colorado. The erosion noted are rills and uprooted vegetation due to runoff from rainfall events (purple box on the last figure). This type of erosion is typical along stream banks. There are no wetlands or wetland type-soils on the property.

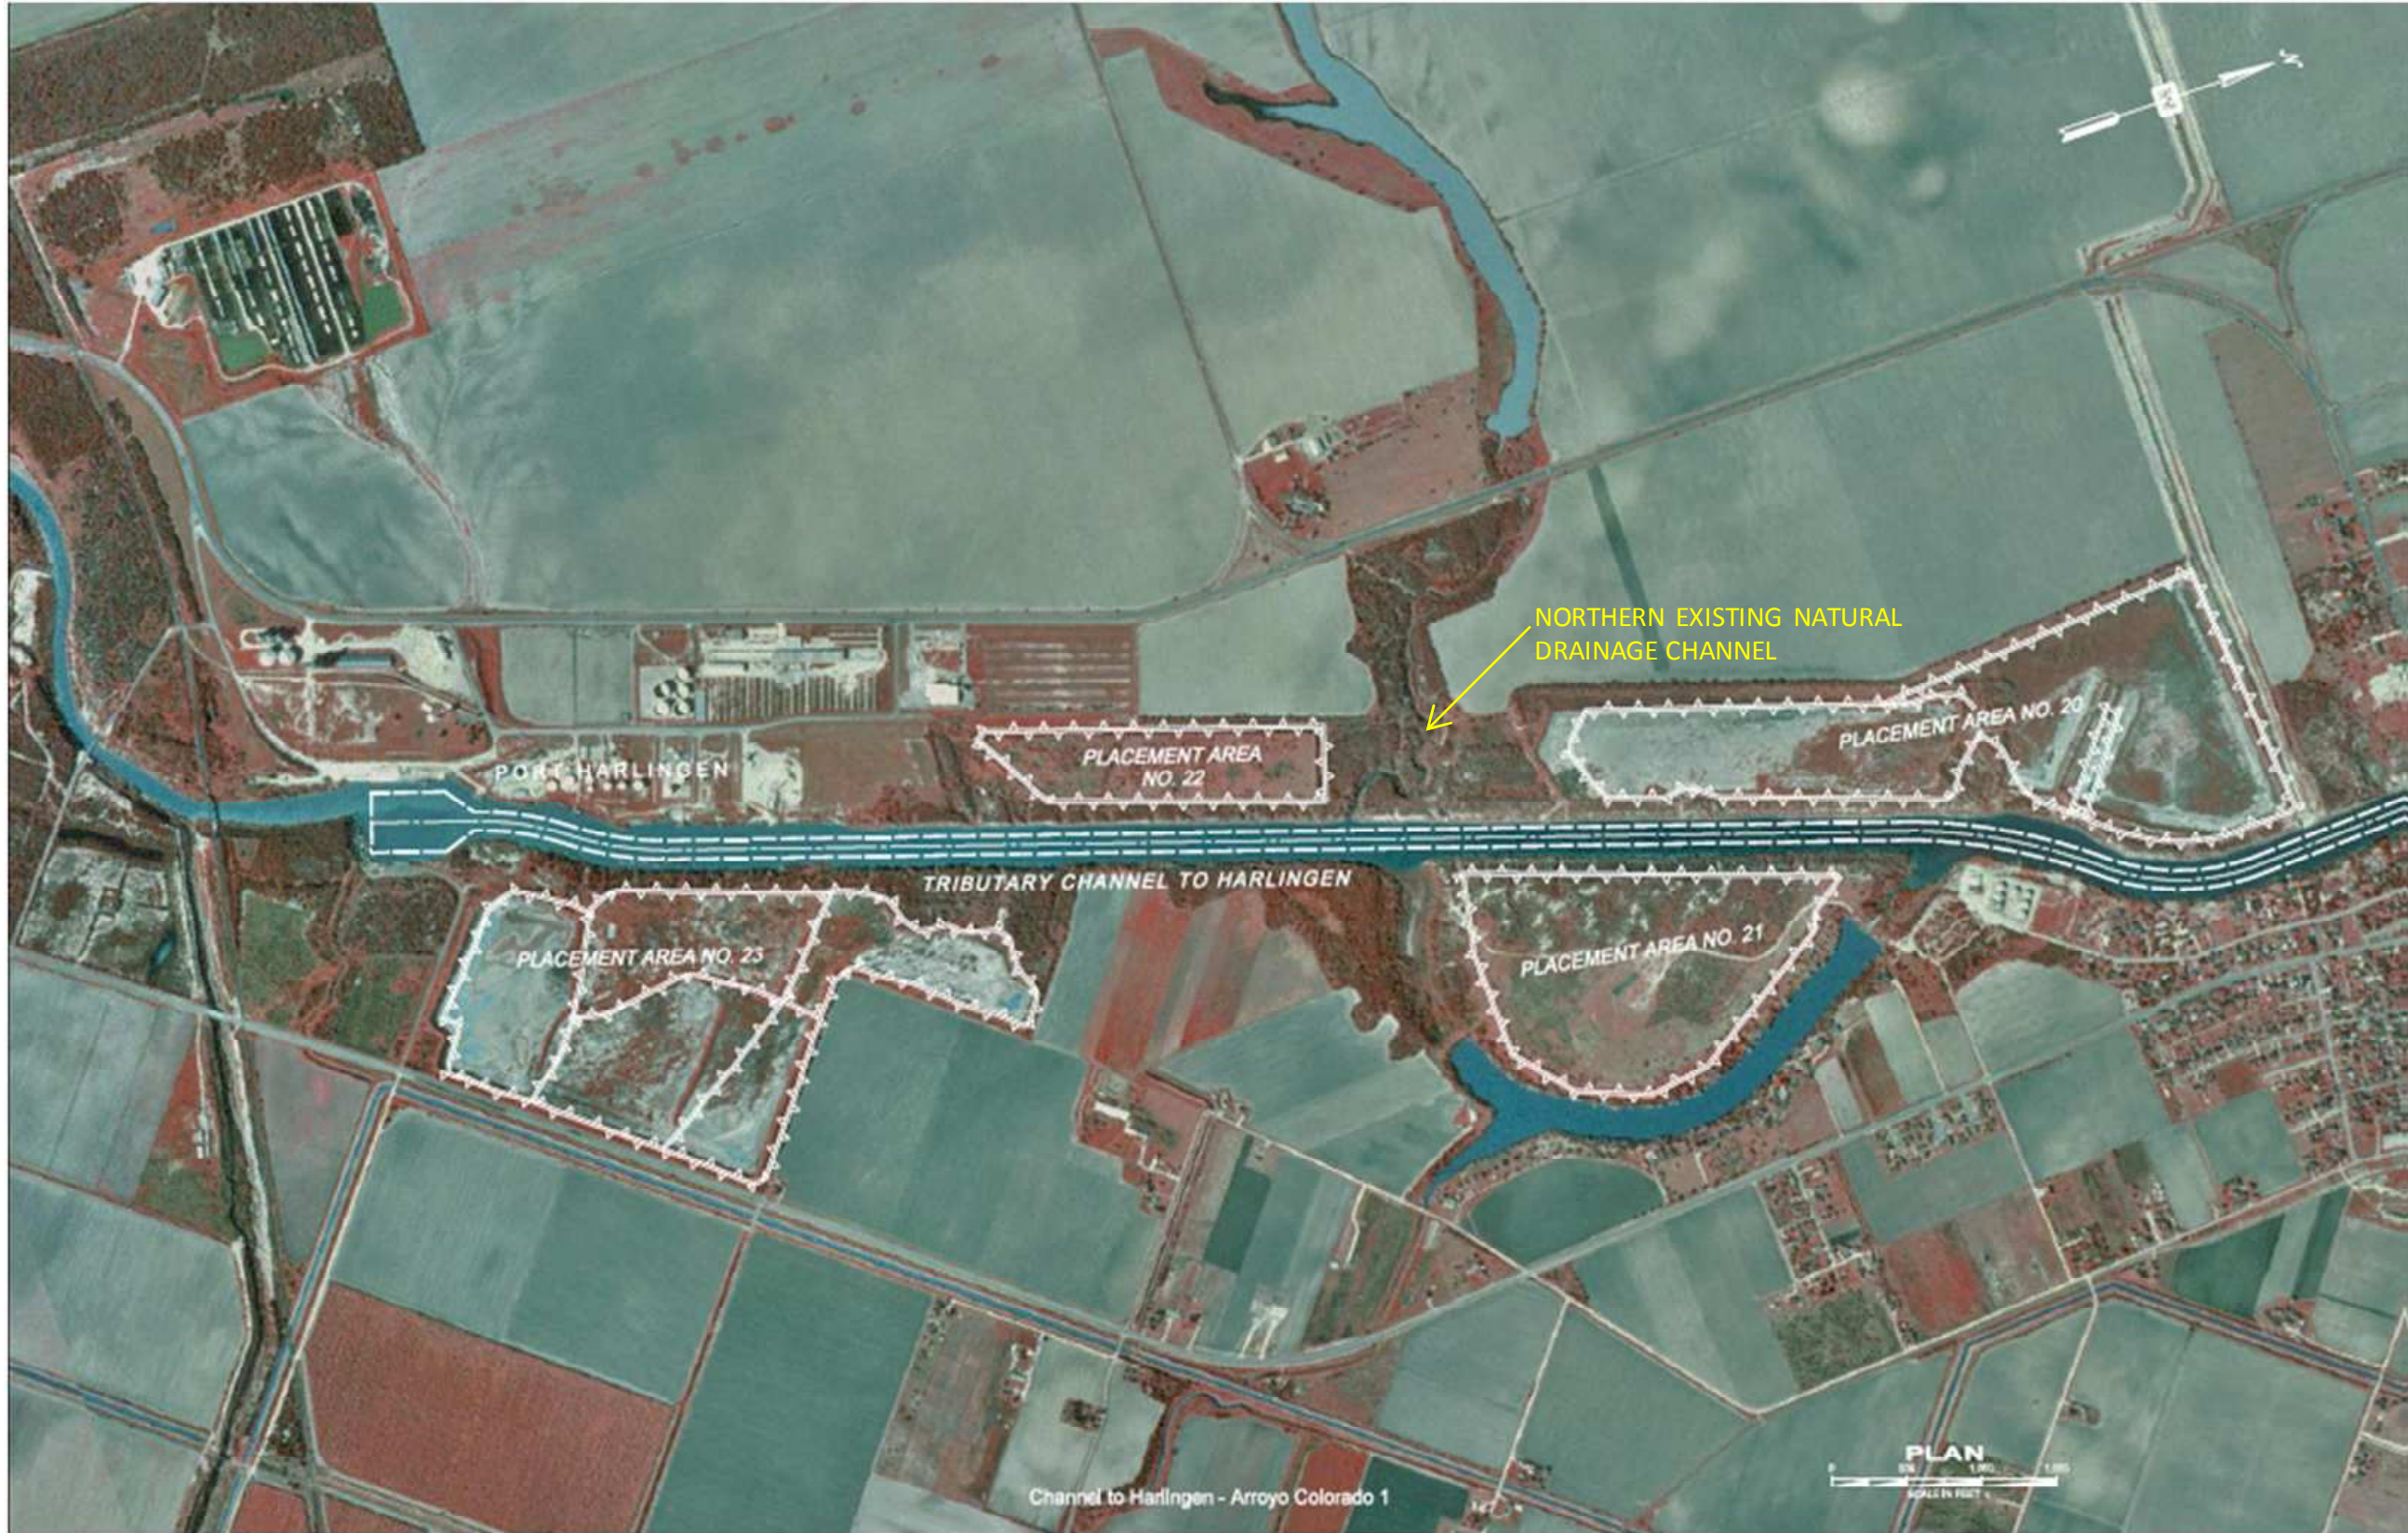
Figure 2.1 Port of Harlingen Turning Basin and Channel

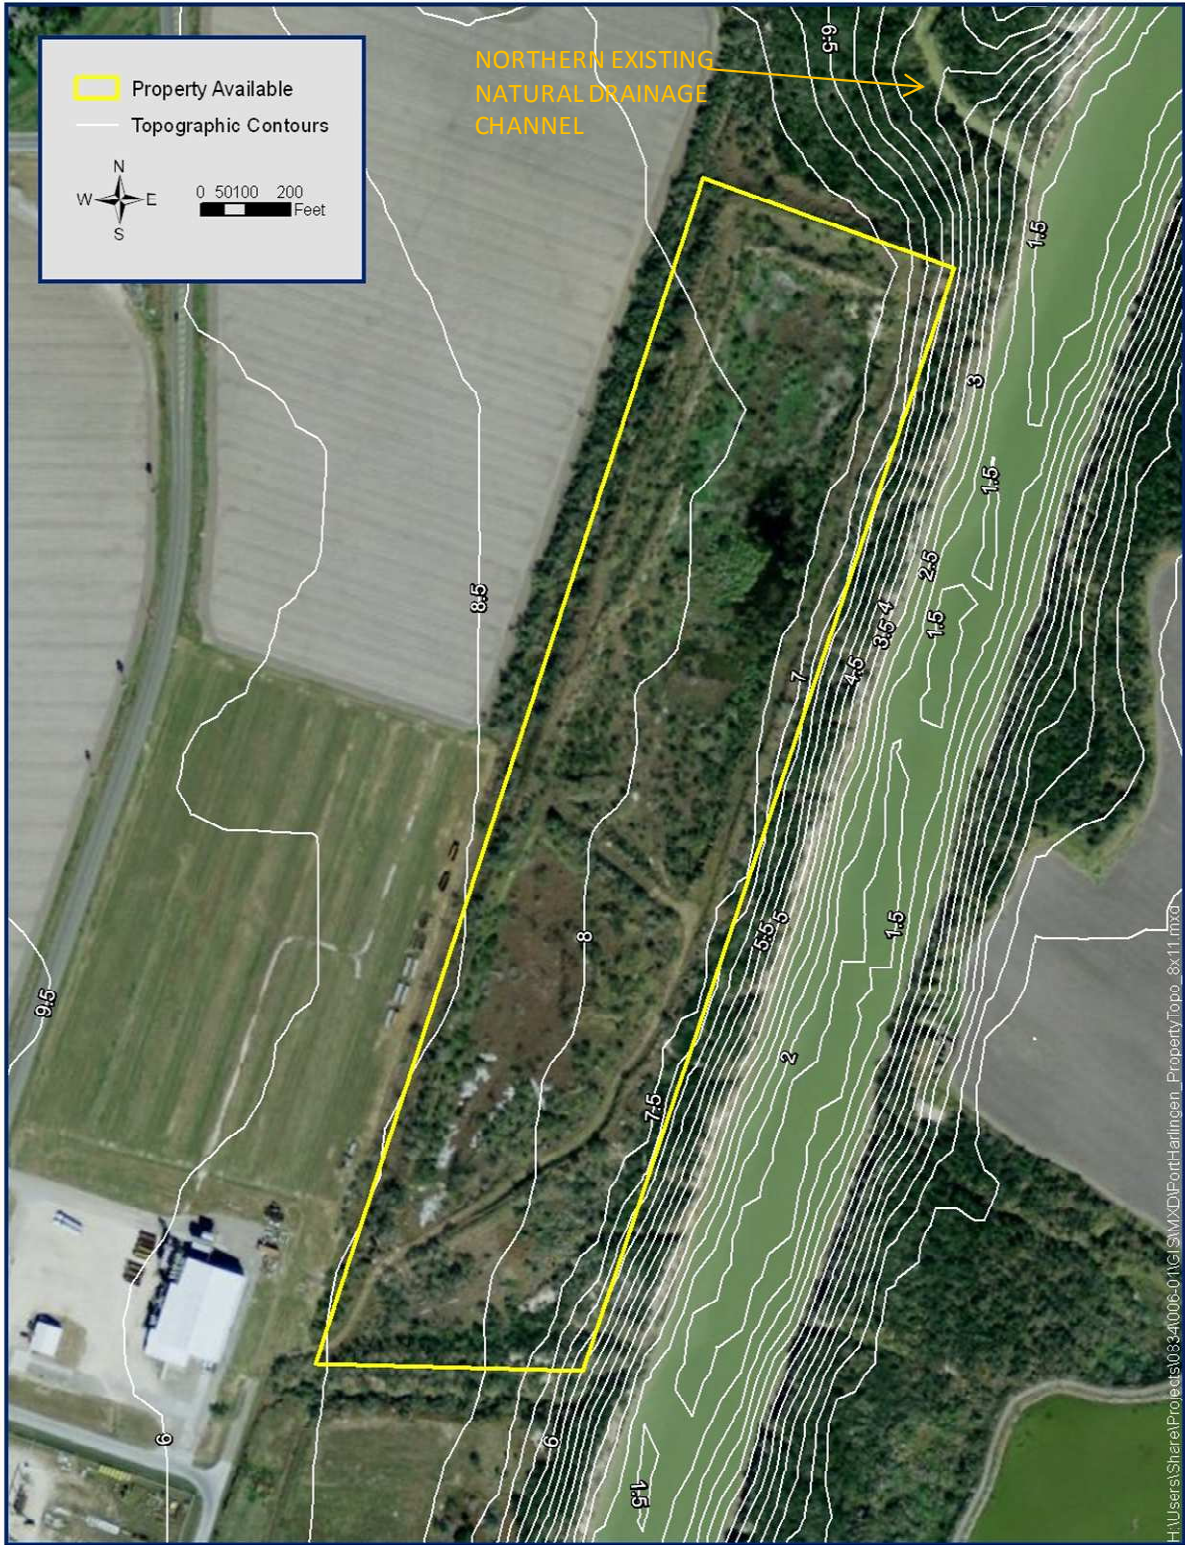
Figure 2.2 Site Topography Map

No recent survey data was found to be available for the site. Topographic contours generated for the site from a Digital Elevation Model (DEM) using spatial analyst are shown in Figure 2.2. According to the available information, the site has little variation in elevation across its length as the eight foot contour extends through the middle of the site almost from one end to the other. A slight downward slope occurs at the northeast corner of the site. A gradual downward slope also occurs along the edge adjacent to the Arroyo Colorado. However, the more steeply sloping bank was not considered for development of wetland area to avoid destabilizing the slope. As such, the bank area along with its cover of vegetation would be left undisturbed.

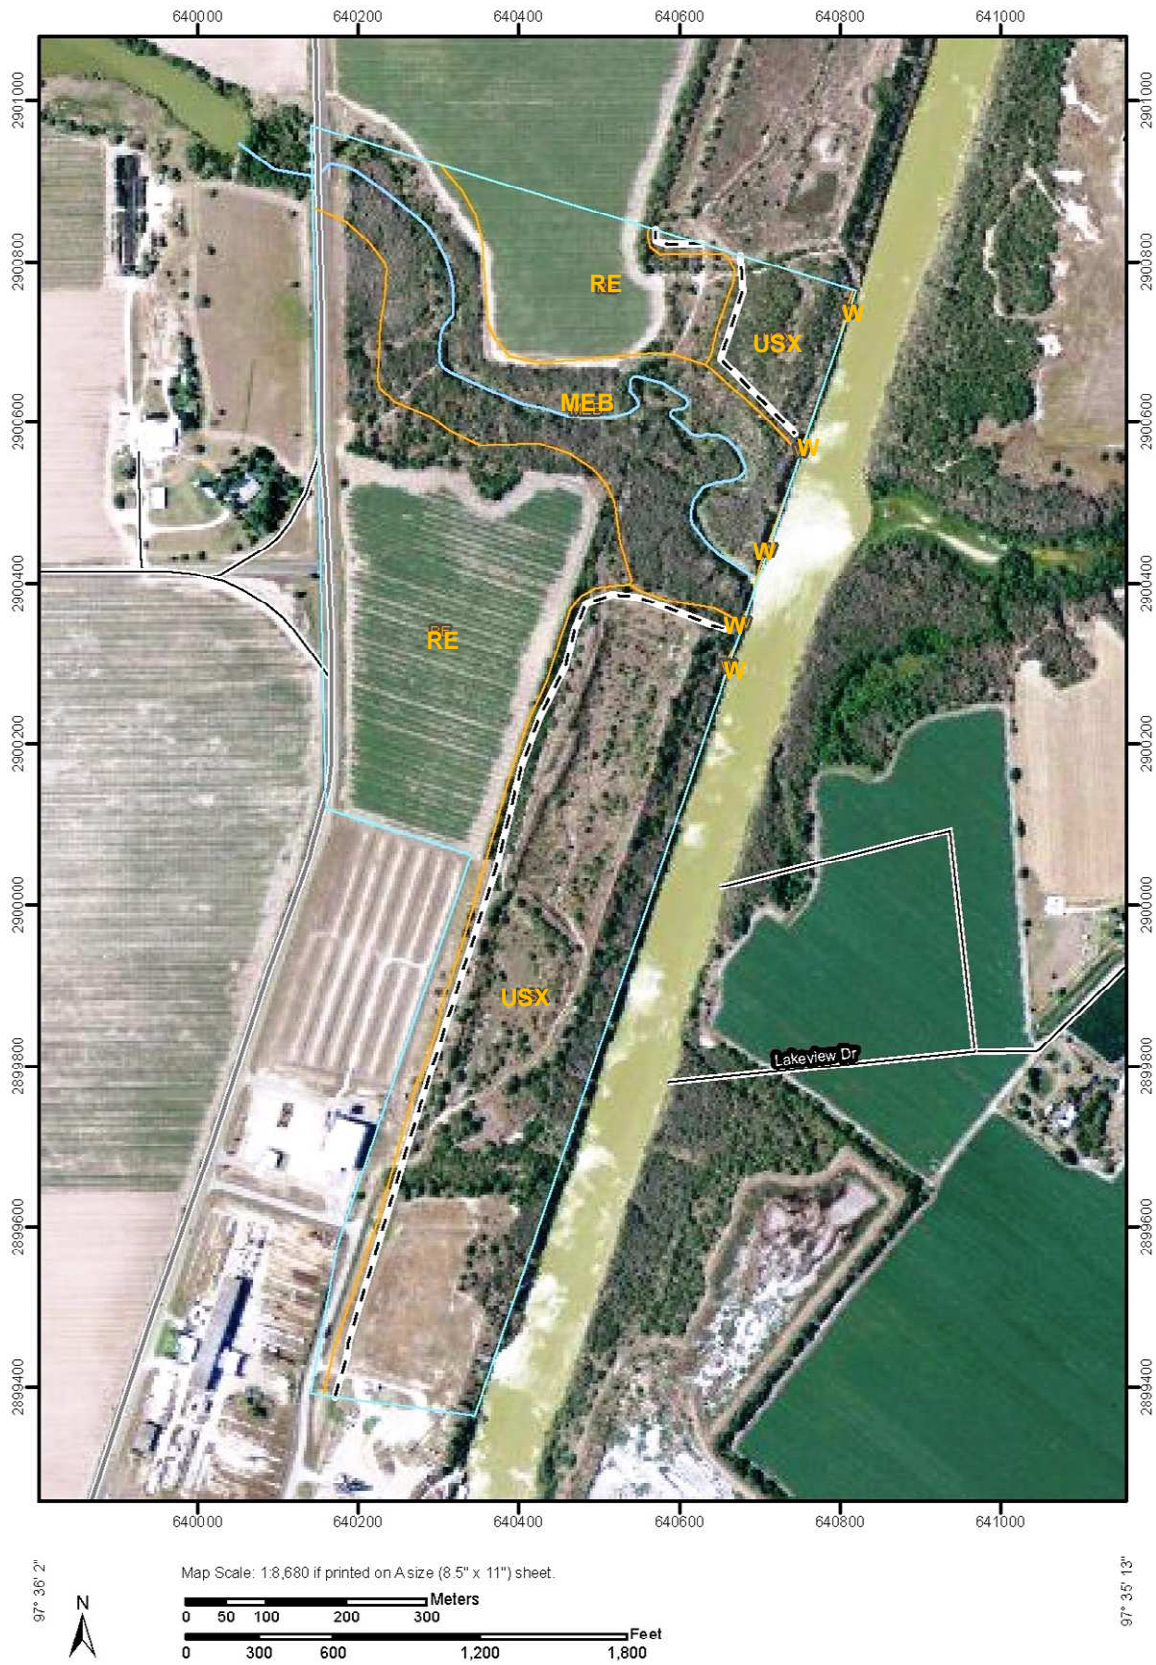
Figure 2.4 Soil Survey Map

Soils information was acquired from the Natural Resources Conservation Service (NRCS) Web Soil Survey. As shown in the soil survey map included as Figure 2.4, the entire proposed wetland site is identified with soil type Ustifluvents, clayey (USX). Other soils in the vicinity include Raymondville, clay loam (RE) to the west of the proposed wetland site and Mercedes, clay (MEB) in the drainage channel to the north of the site. Soil type USX is described by the NRCS as consisting of moisture limited alluvial flood plain deposits with significant clayey properties. These soils are somewhat poorly drained, are rarely flooded, and not subject to ponding. Type RE soils are moderately well drained and have a fourteen inch surface layer of clay loam with clay layers below. MEB soils occur in areas with slopes of 1 to 3 percent and are moderately well drained with a clay dominated profile. Table 2.1 provides a brief summary of the soil types found. The complete descriptions for these soils are provided in Appendix A.
