Final Report

Science Based Monitoring of Created Wetlands and Restored Habitat within the Galveston Bay System

Prepared for the Coastal Management Program of the Texas General Land Office
and the National Oceanic and Atmospheric Administration

Cynthia L. Howard, PhD, Principal Investigator (UHCL)
James A. Dobberstine, MS, MS, Co-Principal Investigator (Lee College)
Tia Hall, MS, Co-Principal Investigator (Lee College)

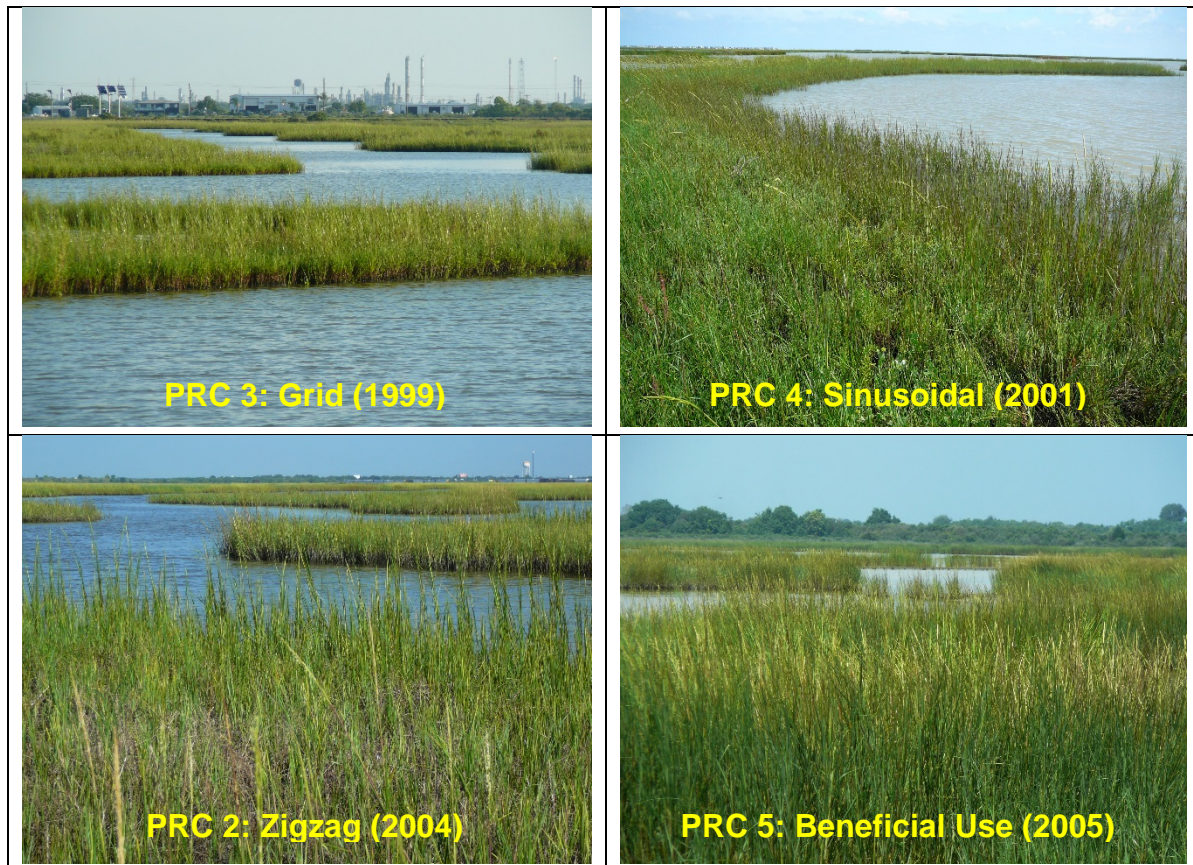
Figure 3. Photographs of the four designs used to restore marsh habitat in the Pierce Marsh complex, with dates the sites were constructed and planted with *S. alterniflora*.

Five areas of the marsh have been the focus of low marsh restoration efforts since 1999 (Fig. 2 and Fig. 3):

1. Grid terraces (PRC3 or GRD): constructed in 1999; 153 terraces in a 63-acre area
2. Sinusoidal terraces (PRC4 or SIN): constructed in 2001; 41 terraces within a 49-acre area, and including oyster shell on the crown of each terrace for colonial bird nesting use
3. Zigzag terraces:
 - a. PRC2 or ZIG2: constructed in 2004; 49 terraces within a 25-acre area
 - b. PRC6 or ZIG6: constructed in 2011; 48 terraces within a 25-acre area [new to the present study, in the 2008 project, open-water bay bottom samples were collected in this location]
4. Beneficial uses marsh (PRC5 or BUM): constructed in 2005; approximately 200 acres total within the levees

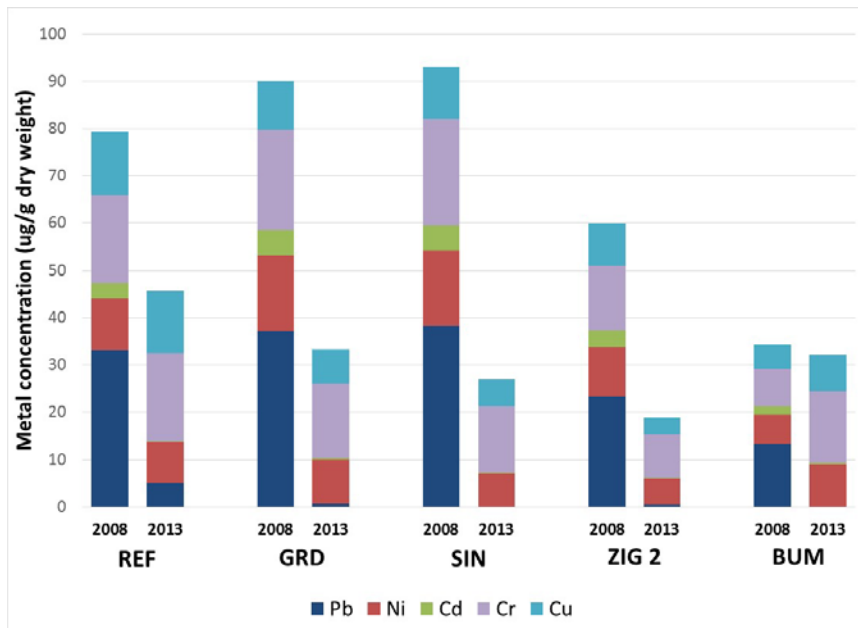
Figure 4. Comparison of selected sediment heavy metals among reference and restoration designs in the Pierce Marsh complex, 2008 and 2013 (REF = reference, GRD = grid terrace, SIN = sinusoidal terrace, ZIG = zigzag terrace, BUM = beneficial use material).

As in 2008, sediment samples from each station were acid digested and heavy metals were determined by ICP (inductively coupled spectrophotometry). Comparing 2008 to 2013 raises a number of questions that require further inquiry (Fig. 4). A possible explanation could relate to sediment deposition in the months following Hurricane Ike. Factors related to the ICP analysis could also have contributed to the observed differences.

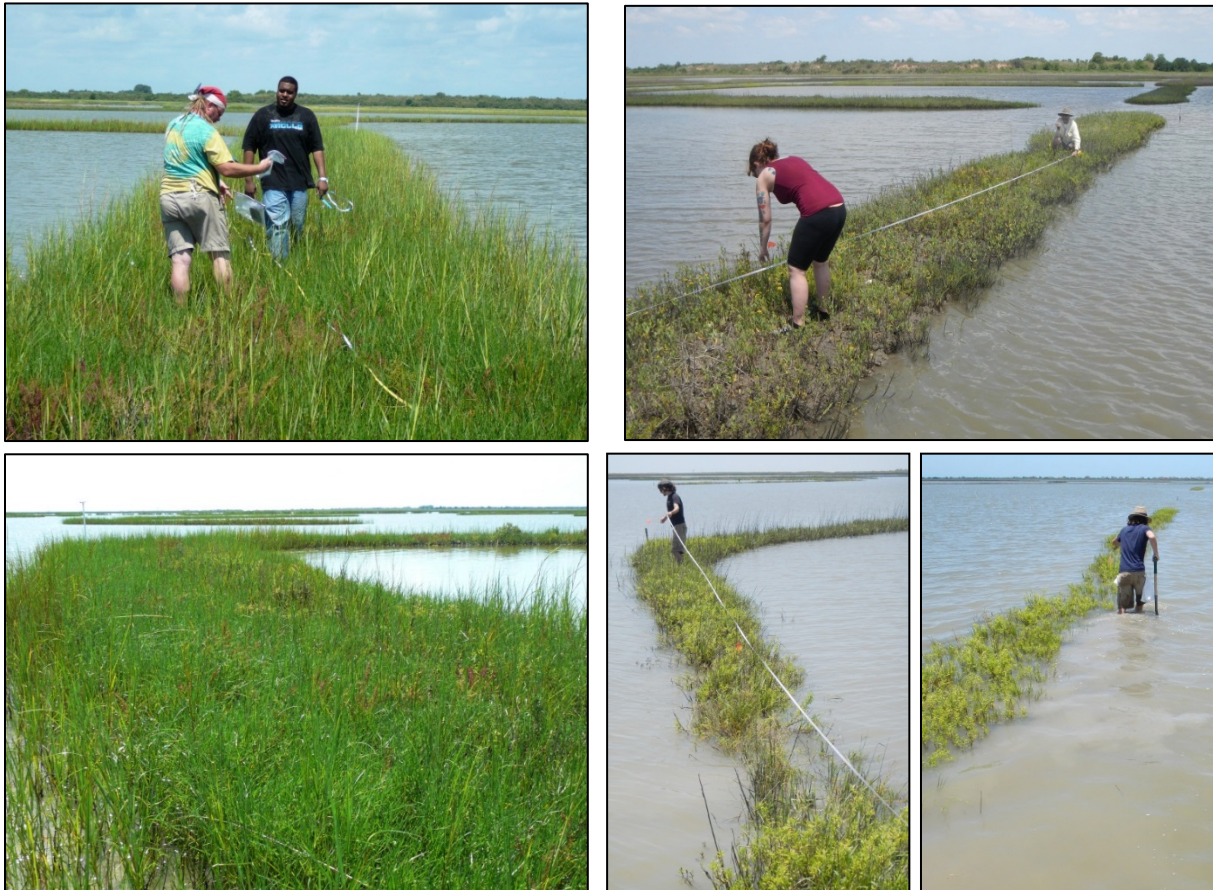
Figure 5. Visual negative changes in morphology in GRD terraces from 2007/2008 (top left) to 2013 (top right) and in SIN terraces from 2007/2008 (bottom left) to 2013 (bottom right).

Marked erosion was evident at three of the four previously sampled sites, particularly GRD and SIN (Fig. 5). GRD and SIN terrace berms that were solid and

2-3 m wide in 2008 had been reduced to unstable, undercut sediment <0.5 m wide in some cases. Category 2 hurricane Ike swept through the area one month after the 2008 sampling event and may have started this erosional process. However, during the same time interval, the BUM site accreted sediment and greatly expanded in size (Fig. 6).

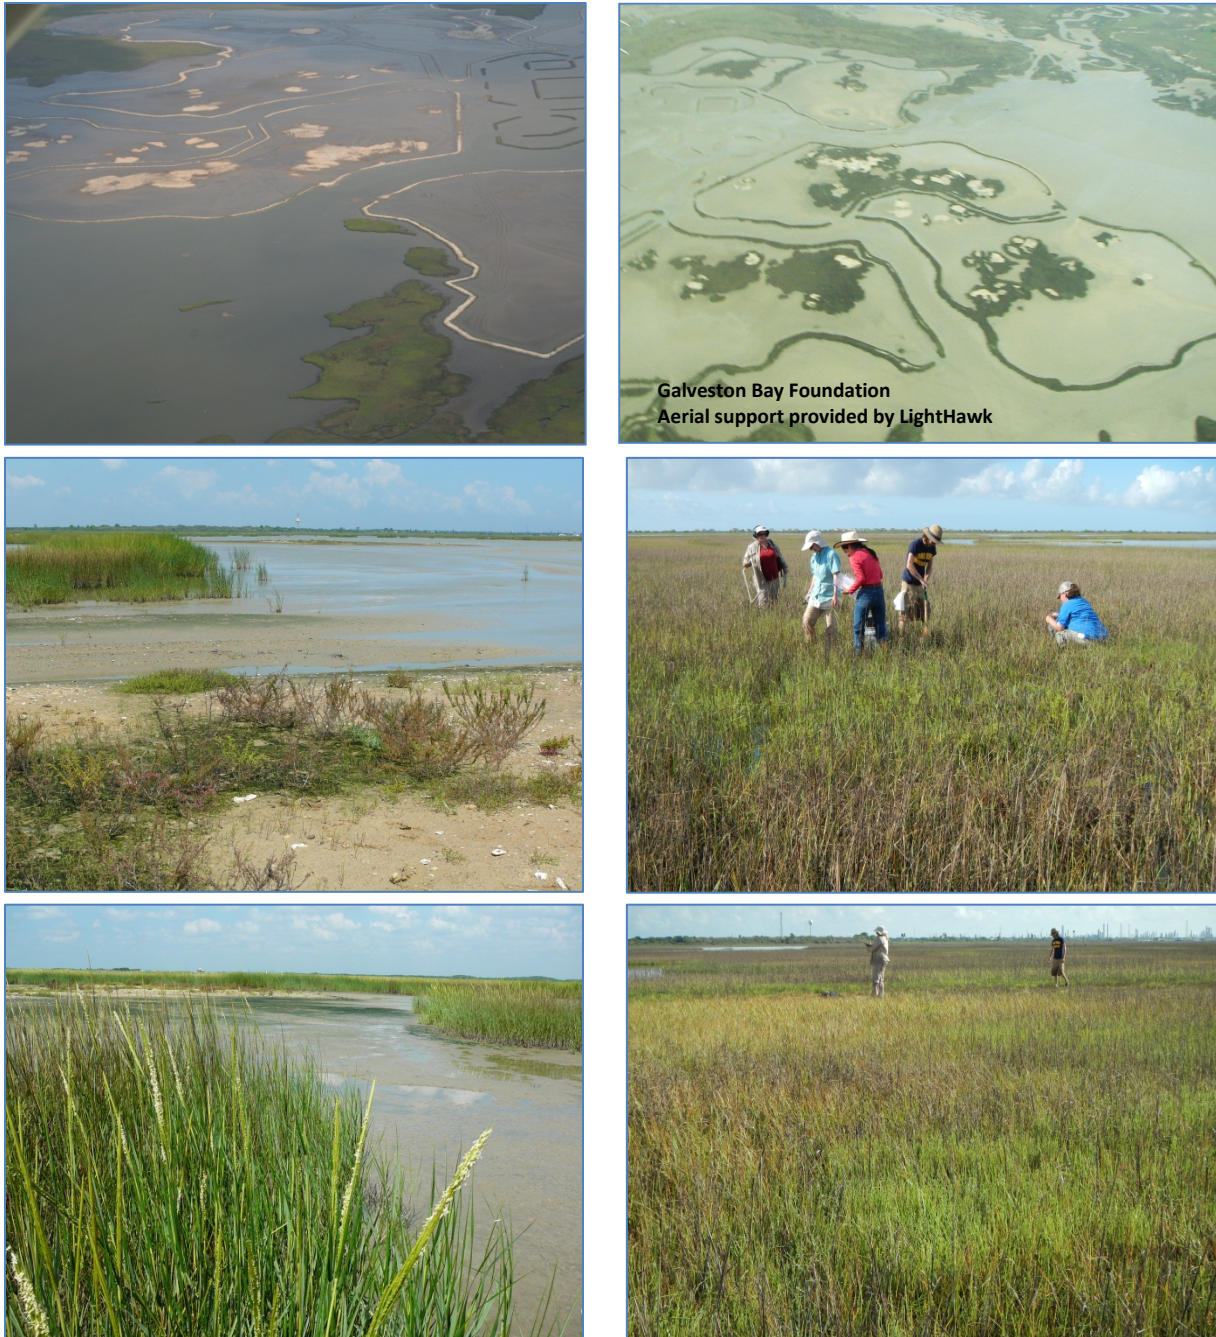
Fig. 6. Visual positive changes in morphology at the BUM site transects from 2008 (photos on left side) to 2013 (photos on right side).

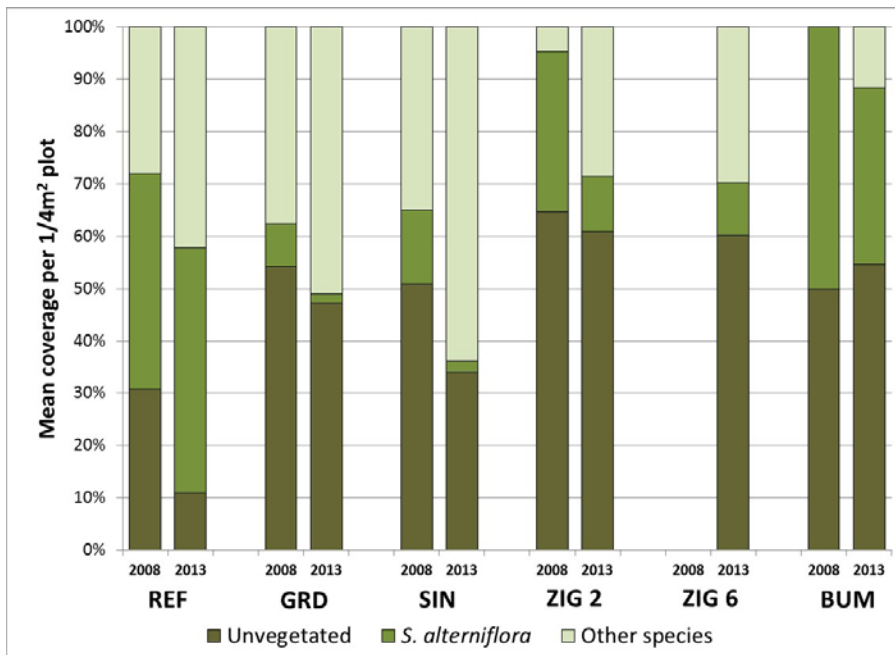
Figure 7. Comparison of total plant cover and *S. alterniflora* cover among reference and restoration designs in the Pierce Marsh complex, 2008 and 2013 (REF = reference, GRD = grid terrace, SIN = sinusoidal terrace, ZIG = zigzag terrace, BUM = beneficial use material).

As in 2008, the total plant coverage was significantly higher ($p \leq 0.05$) in the REF marsh (90%) than in the restored sites (35-65%), with coverage in the two ZIG sites less than half of that found in the REF site (Fig. 7). Total coverage at both ZIG

sites was negatively affected by the absence of *S. alterniflora* at the berm midpoints (Station 2). Coverage by *S. alterniflora* increased from 40% (2008) to 50% (2013) at the REF site, but decreased significantly at all of the restoration sites over the same time period. The decrease in *S. alterniflora* percent cover at the BUM site was balanced by the successional increase in species richness, as *S. alterniflora* had been the only species present in 2008. Similarly at ZIG2, *S. alterniflora* cover decreased as cover by other species (in particular, *Batis maritima*) increased.

Of greatest concern is the nearly complete loss of *S. alterniflora* cover at GRD and SIN (<2% at each site). The decrease in terrace berm integrity at both sites has resulted in a loss of suitable substrate and tidal regime for *S. alterniflora*; these sites were instead dominated by *B. maritima* and *Borrchia frutescens* in 2013.

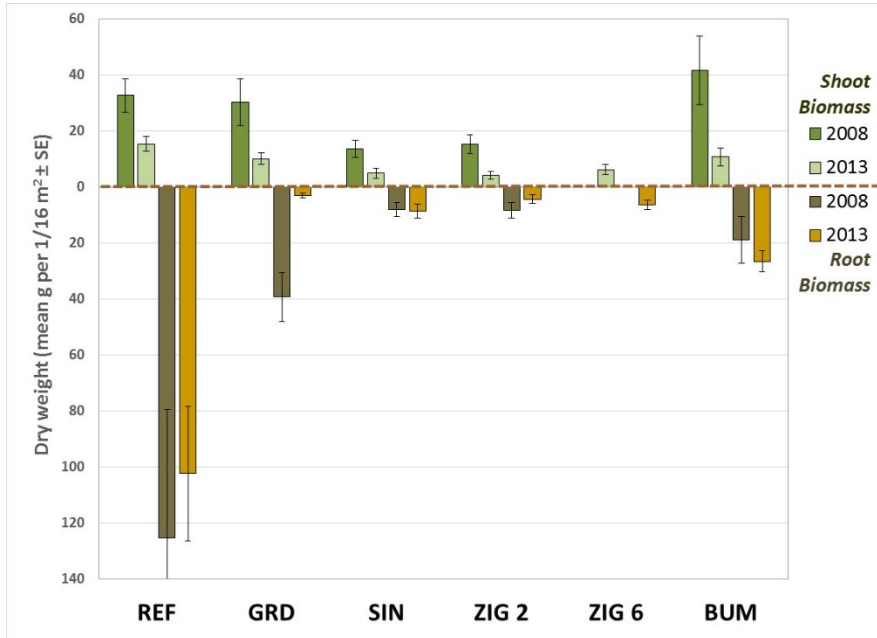
Figure 8. Comparison of shoot and root biomass of *S. alterniflora* among reference and restoration designs in the Pierce Marsh complex, 2008 and 2013 (REF = reference, GRD = grid terrace, SIN = sinusoidal terrace, ZIG = zigzag terrace, BUM = beneficial use material).

As in 2008, the biomass of *S. alterniflora* shoots was significantly higher ($p \leq 0.05$) in the REF and BUM marshes than in the other restored sites, with lowest shoot biomass occurring in ZIG (Fig. 8). In addition, the mean shoot length of *S.*

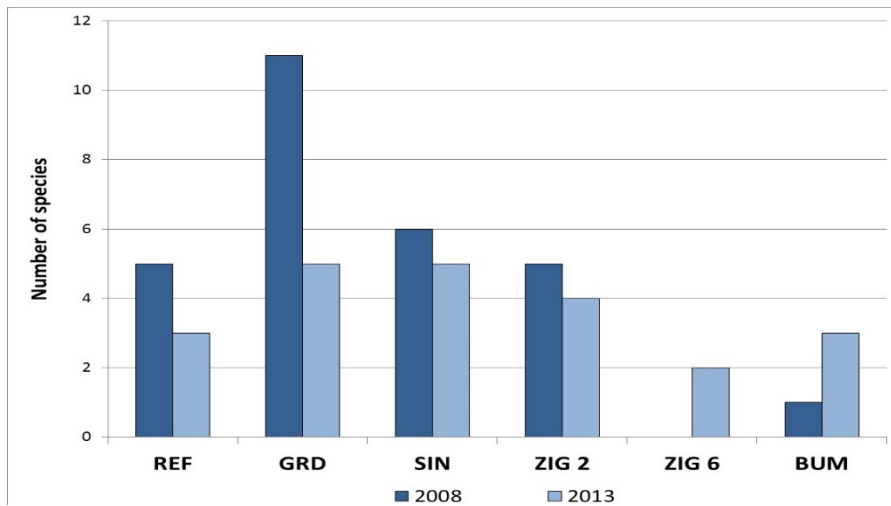
Figure 11. Comparison of total plant species richness among reference and restoration designs in the Pierce Marsh complex, 2008 and 2013 (REF = reference, GRD = grid terrace, SIN = sinusoidal terrace, ZIG = zigzag terrace, BUM = beneficial use material).

Mean species richness at REF, GRD and SIN did not change significantly from 2008 to 2013, although the total richness at each of these sites declined (Figs. 10 and 11). Total and mean species richness both increased significantly at the BUM restoration site, indicating the occurrence of some successional maturation.

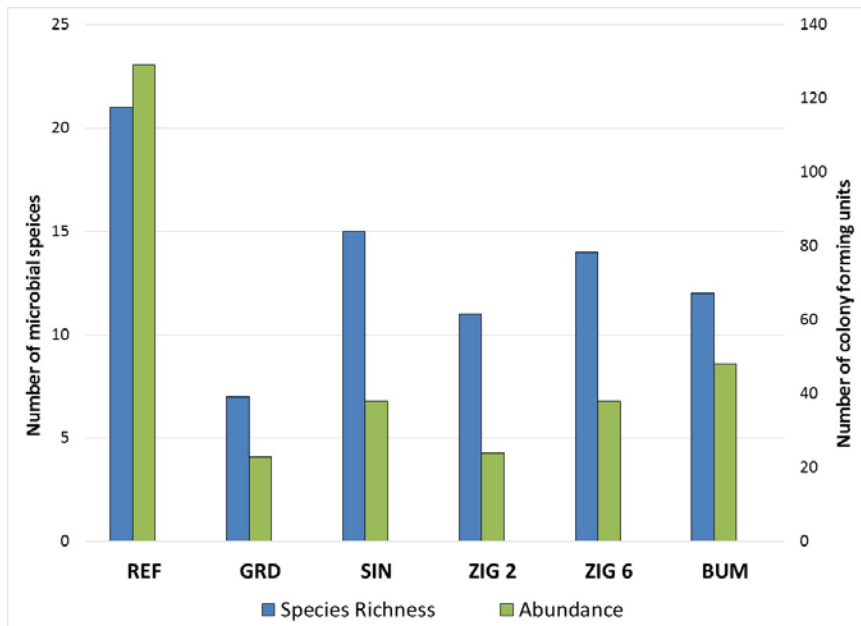
Figure 14. Comparison of benthic macroinvertebrate community taxa and abundance among reference and restoration designs in the Pierce Marsh complex, 2008 and 2013 (REF =

reference, GRD = grid terrace, SIN = sinusoidal terrace, ZIG = zigzag terrace, BUM = beneficial use material).

Maximum benthic microbial species richness and number of colony forming units occurred at the REF site (Fig. 14). Both indicators were significantly higher at REF than richness and abundance at all of the restored sites; the restored sites did not

vary significantly among each other. This is more evidence that the restored sites, due to age and/or design, are not functioning at the level of the REF site.
