Beach and Shoreline Changes Along the Upper Texas Coast: Recovery from Hurricane Ike

HDR Engineering, Inc.
Texas Registration No. 754
555 N. Carancahua, Suite 1600
Corpus Christi, TX | 78401
HDR Project No. 166742

March 17, 2014

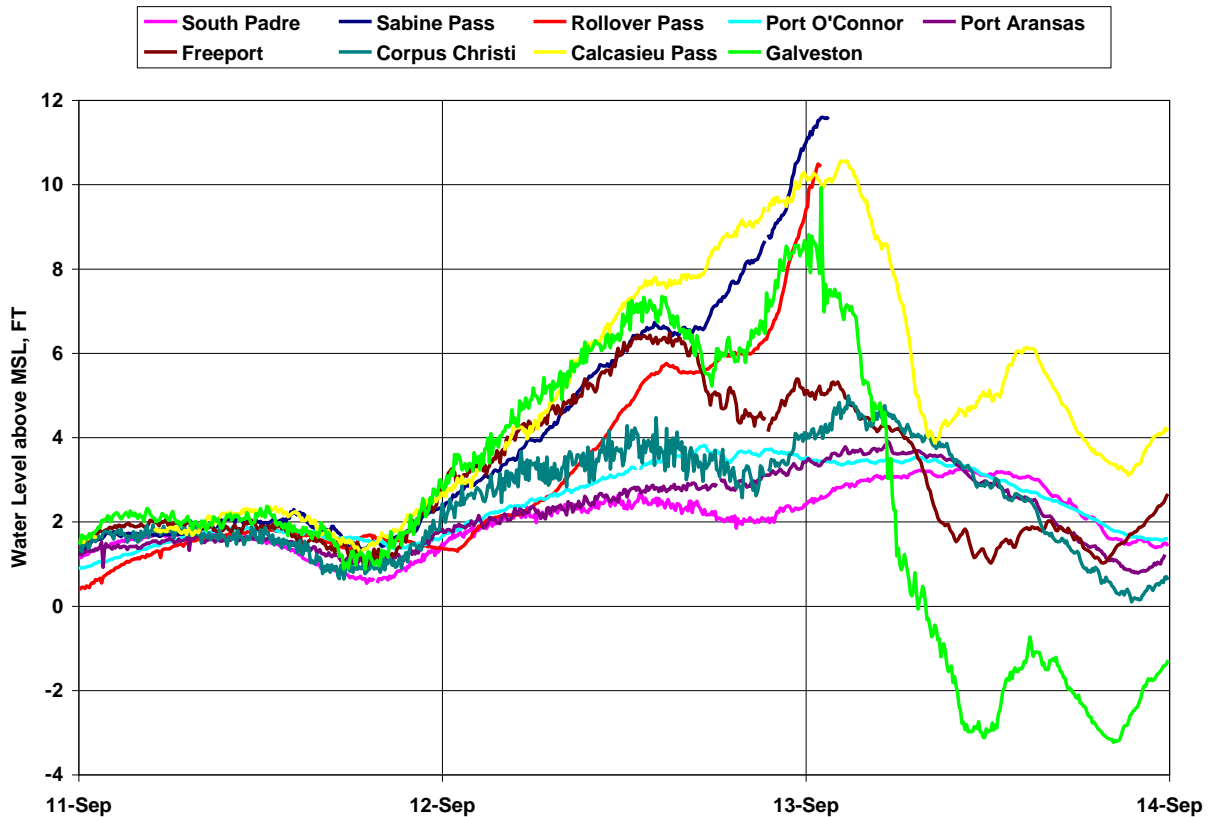
Figure 2.3 Water level measured at NOAA tide gauges during Ike.

storm surge was estimated to be between 15 and 20 ft NAVD² along the worst impacted areas (Berg 2009). The highest still water level measured by FEMA during the storm was 17.5 ft located 10 miles inland in Chambers County (Berg 2009). Including wave height and runup, the absolute peak high water mark observed during Ike was over 19 ft on Bolivar Peninsula (East *et al.* 2008).

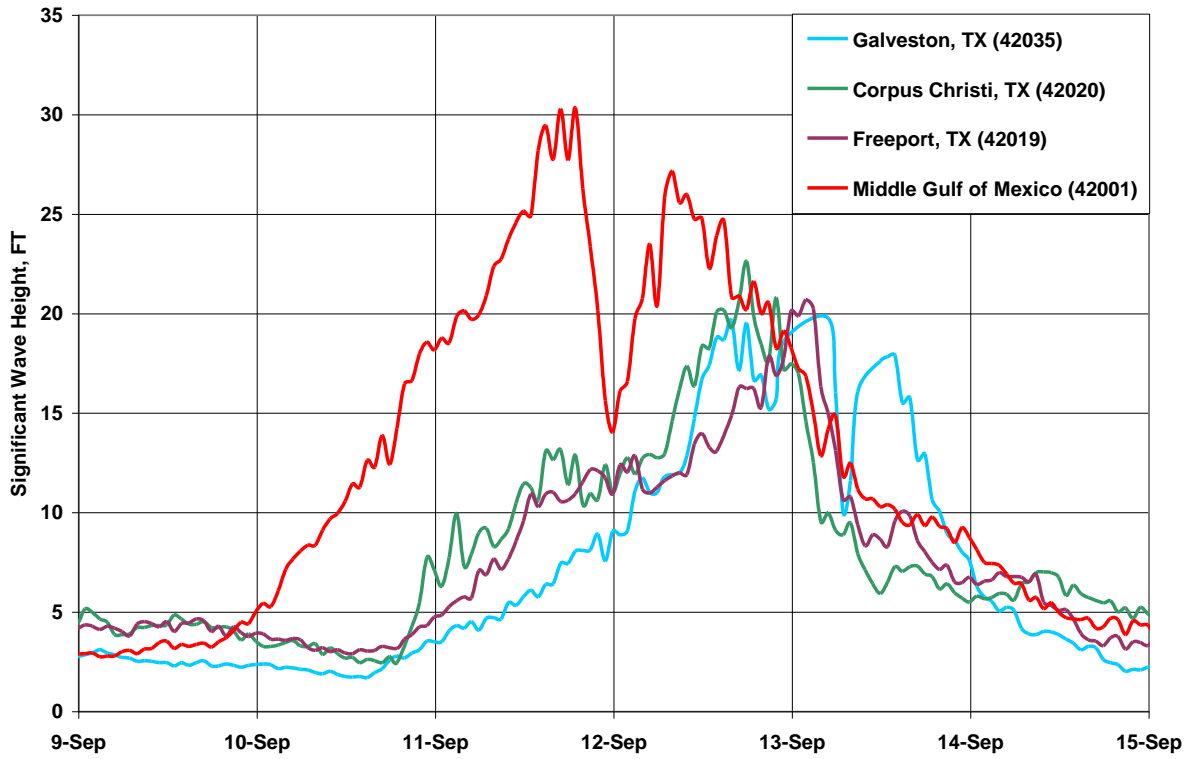
Figure 2.4 Wave height at buoys near the Texas coast during Ike.

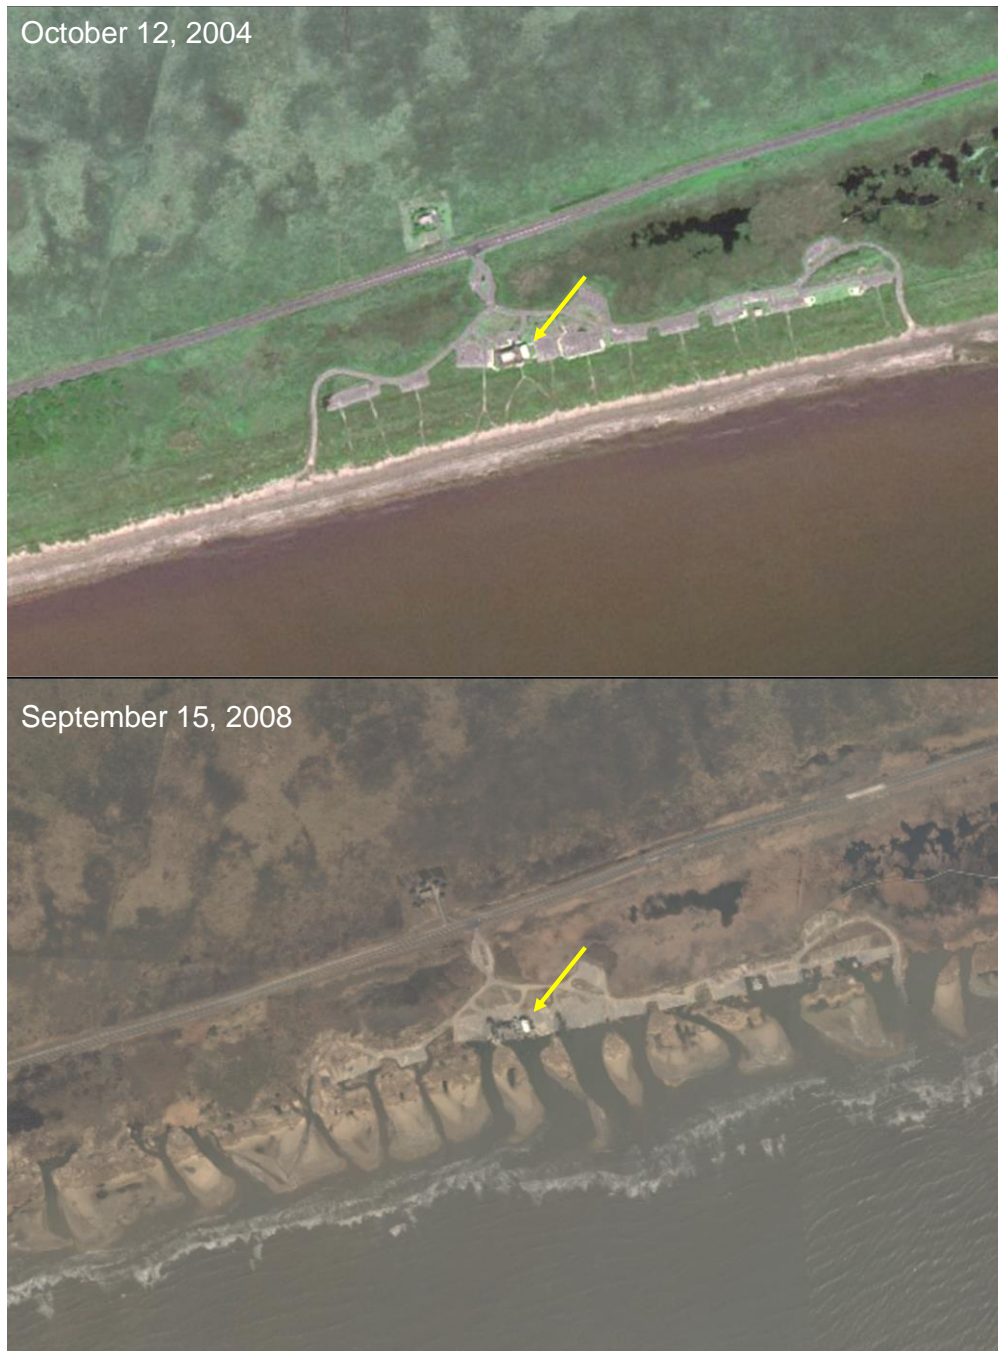
Figure 3.1 Pre and post storm photo comparison at Sea Rim State Park.

Dr. Don Stauble⁴ provided a comparison of shorelines traced from USGS Orthoimagery collected days after Ike and 2006 aerial photography. The comparison was used to estimate shoreline erosion during Ike from Sabine Pass to High Island. Average shoreline erosion from Sabine Pass to High Island was 180 ft with peak erosion over 300 ft. Figure 3.1 shows the shoreline at Sea Rim State Park with shoreline erosion of 200 to 300 ft evident in the photos.

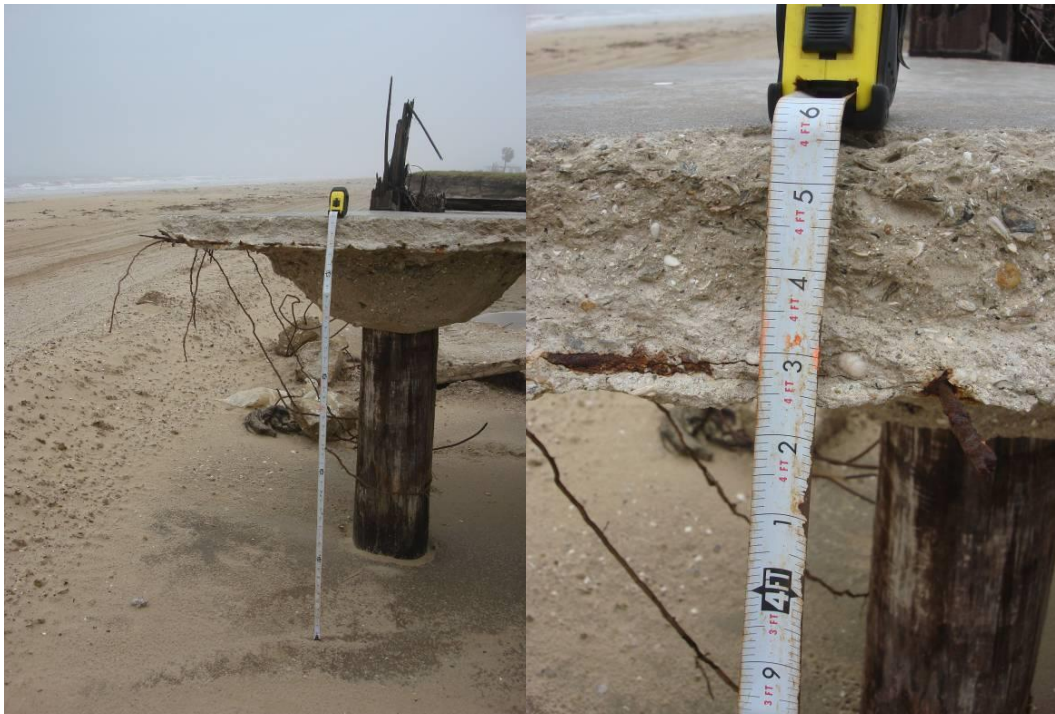
Figure 3.3 Erosion under a house foundation south of Rollover Pass.

all dune cover, extensive damage to the geotextile tubes and over 4 ft of vertical erosion landward of the geotextile tubes. Figure 3.3 shows erosion under a house foundation landward of the previously existing geotextile tubes. Figure 3.4 is an aerial photo taken of damage along a section of beach on Bolivar, showing extreme damage to the geotextile tubes along this section of Bolivar Peninsula. Damage at Rollover Pass is shown in Figure 3.5.

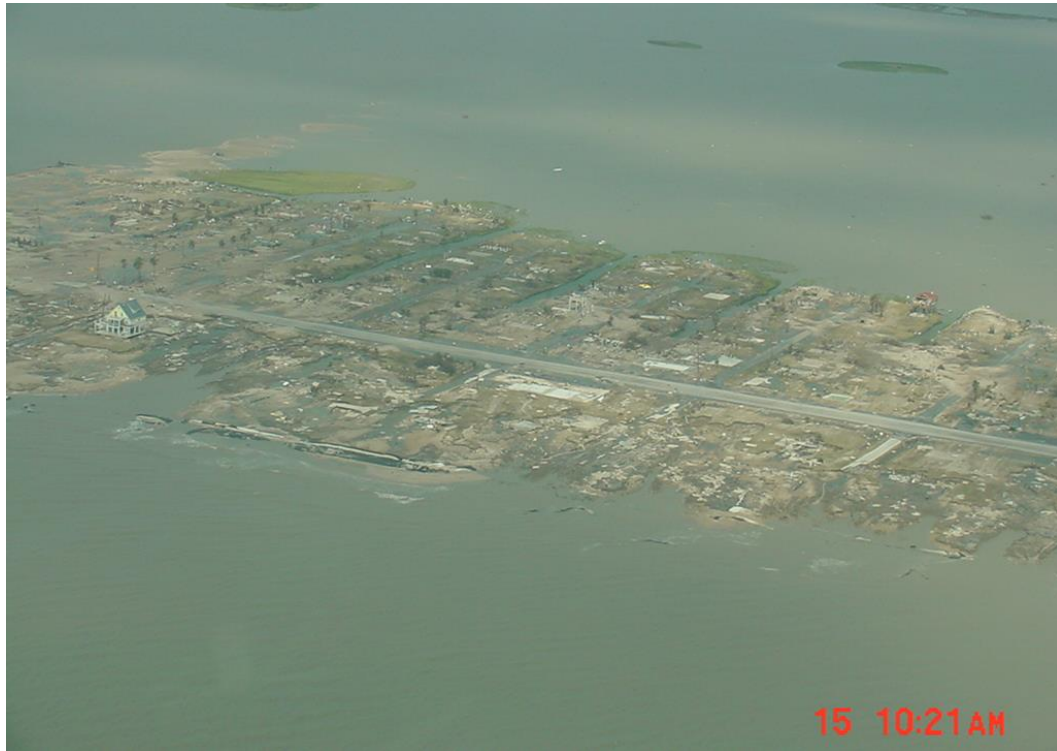
Figure 3.4 Aerial photo of Bolivar Peninsula showing damage to geotextile tubes.

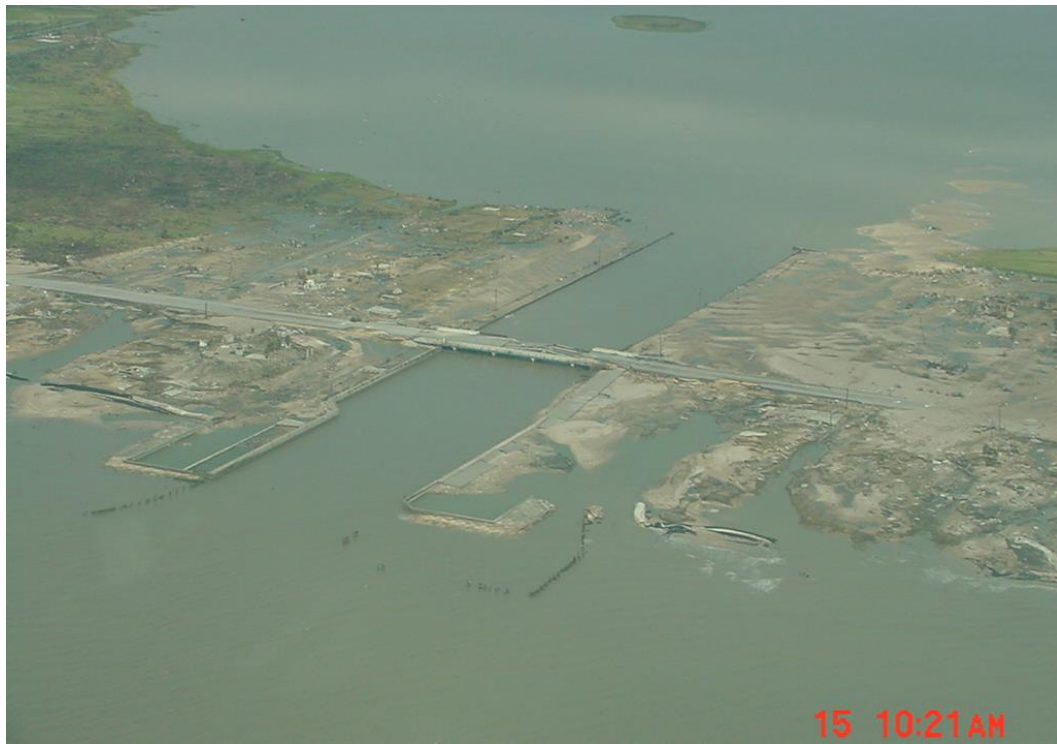
Figure 3.5 Aerial Photograph of damage at Rollover Pass.

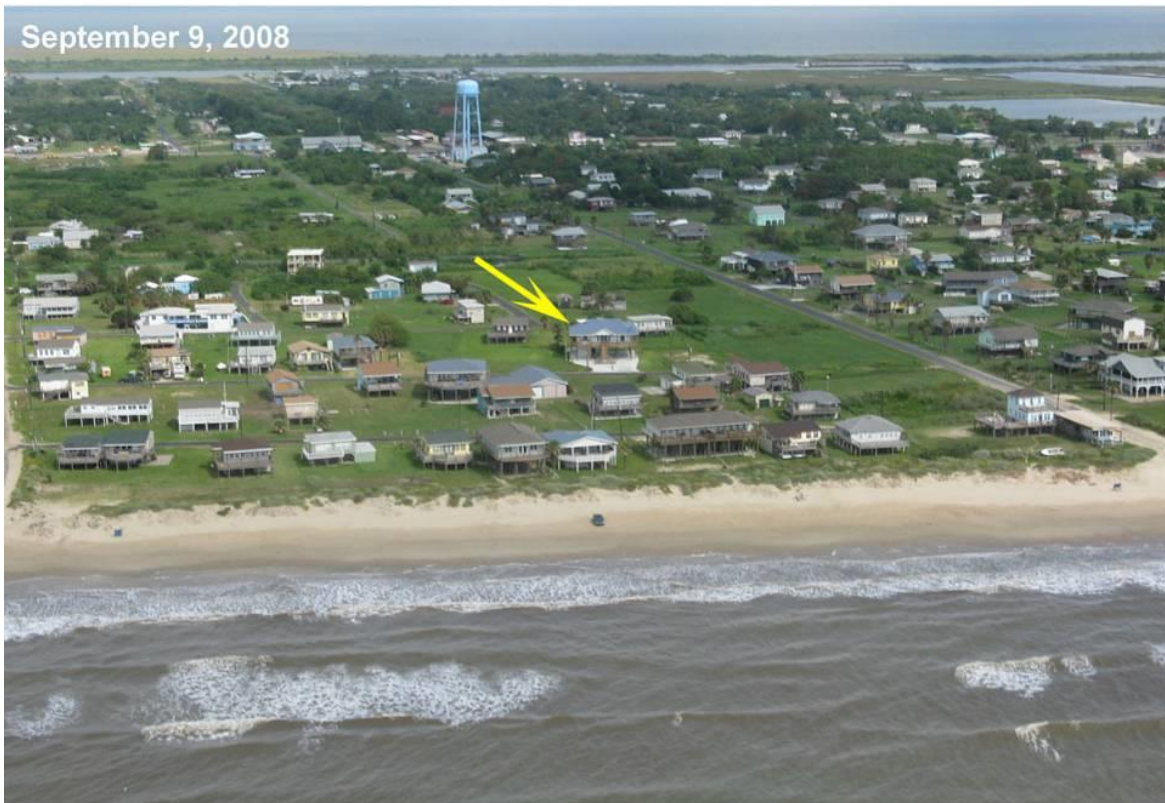
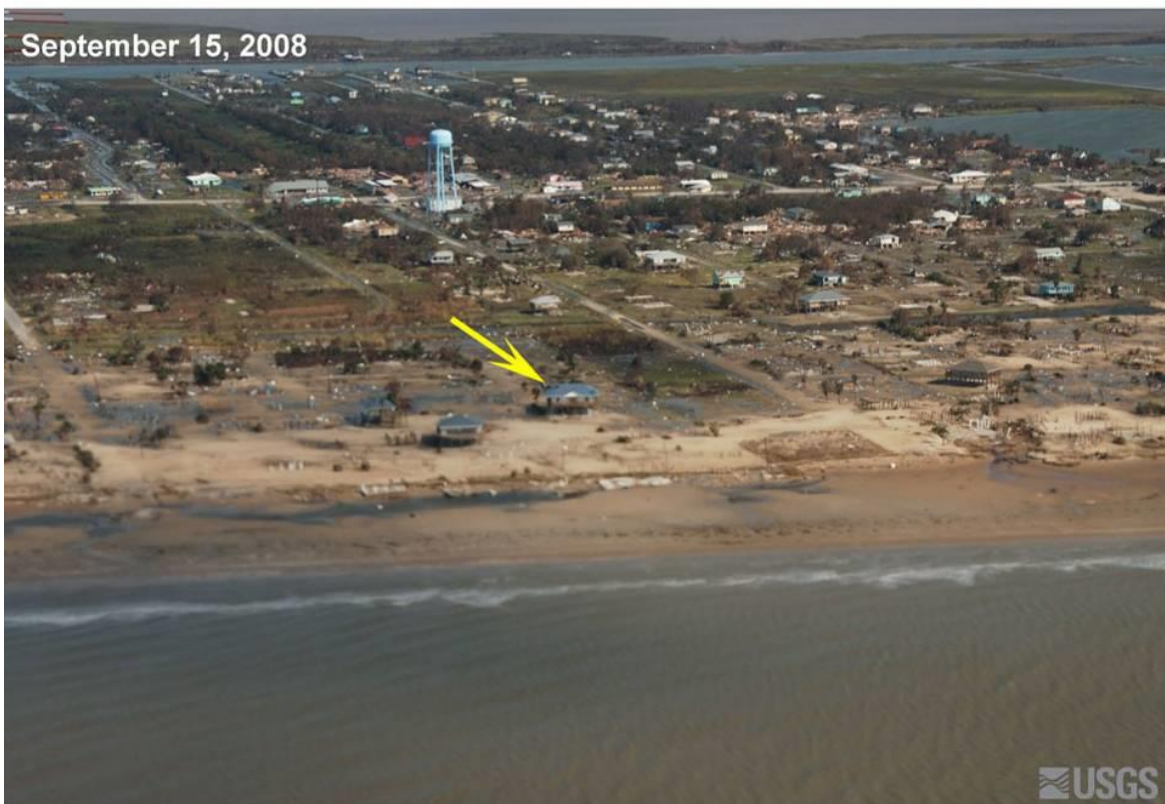
Figure 3.6 Pre and post storm photo comparison at Crystal Beach (USGS 2008).

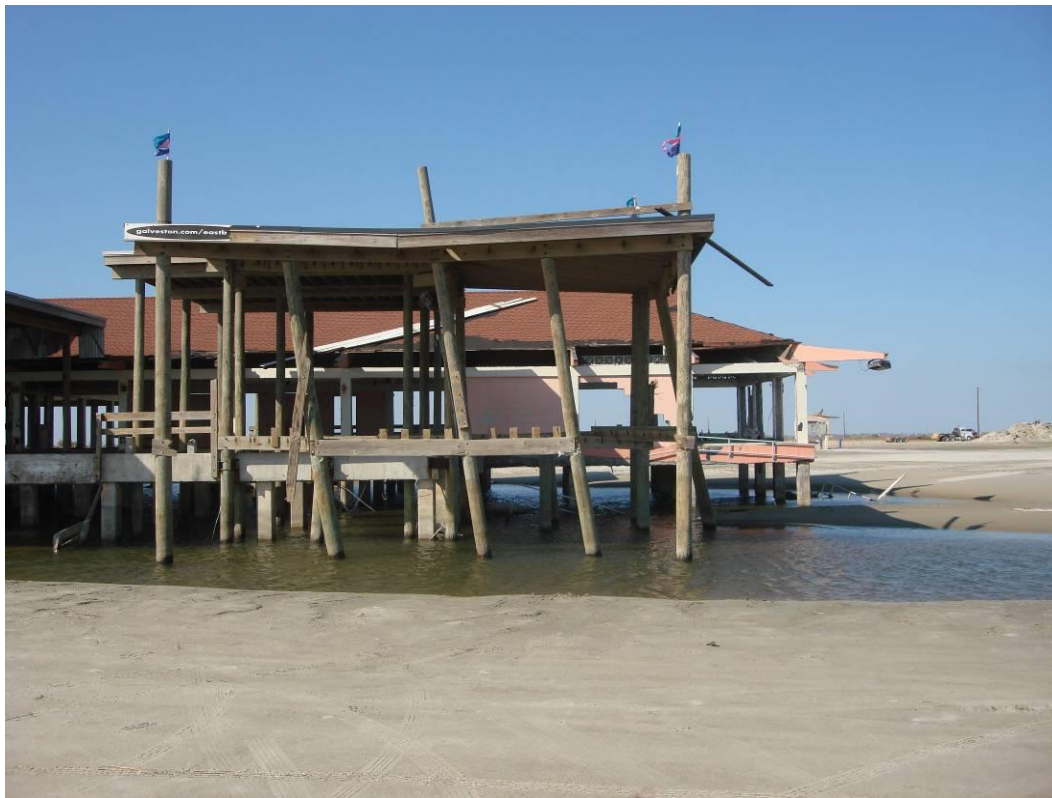
Figure 3.7 Pavilion on East Beach damaged during Ike.

HRI (2009) analysis of aerial photography shows that the average shoreline erosion during Ike at East Beach on Galveston Island was 315 ft with peak erosion over 700 ft immediately adjacent the south jetty. However, it is common for extreme shoreline change to occur adjacent to jetties during a storm because waves, currents and surge all tend to be amplified as they interact with the structure. Much of the sand from East Beach was likely transported over the jetty towards Big Reef and the Galveston Entrance Channel. Damage to the East Beach Pavilion (Figure 3.7) is indicative of the high surge and large waves during Ike. Figure 3.8 shows a comparison of the pre and post-Ike beach near high rise condominiums on the east end of Galveston Island.

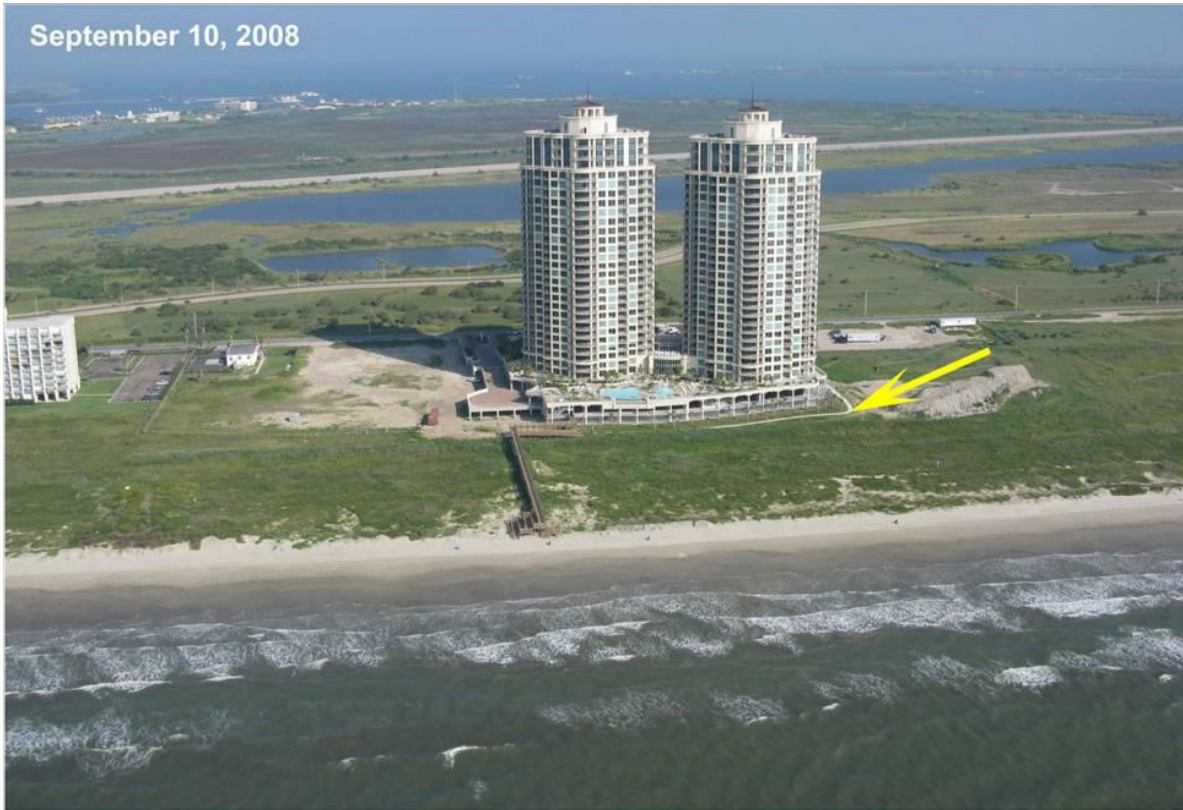
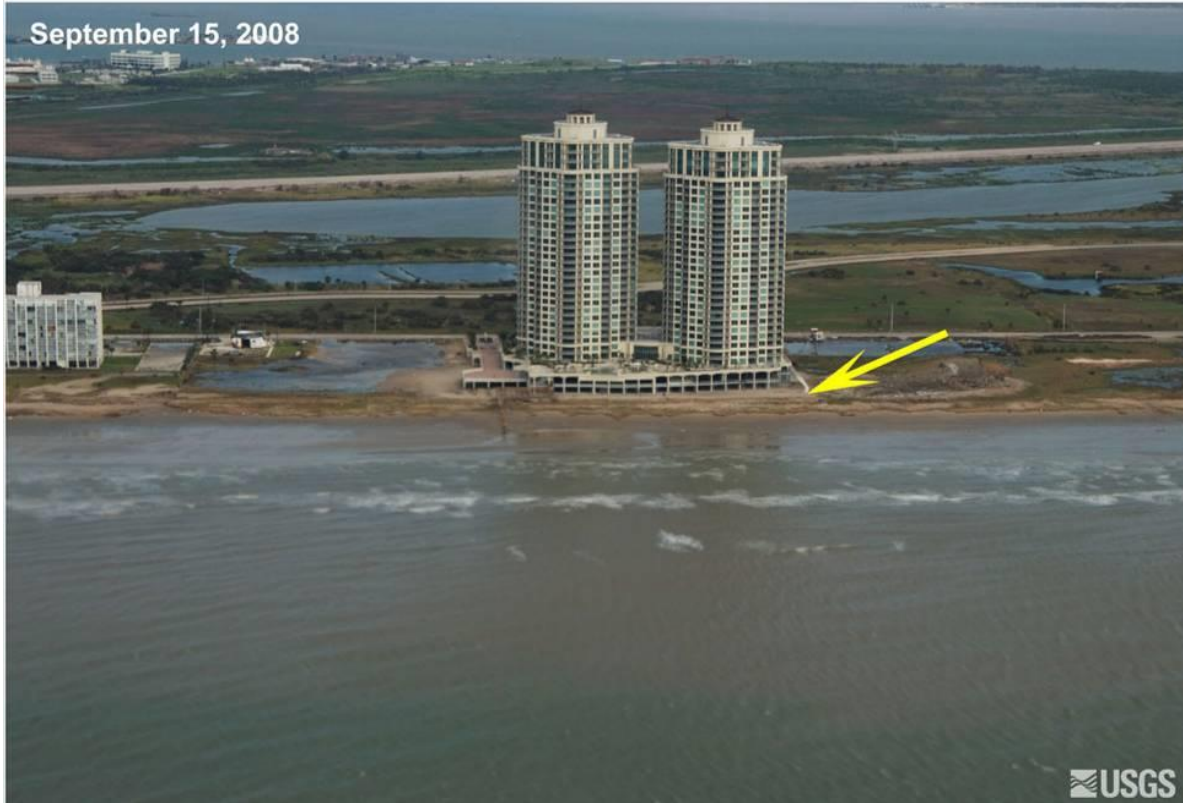
Figure 3.8 Pre and post storm photo comparison on Galveston East Beach (USGS 2008).

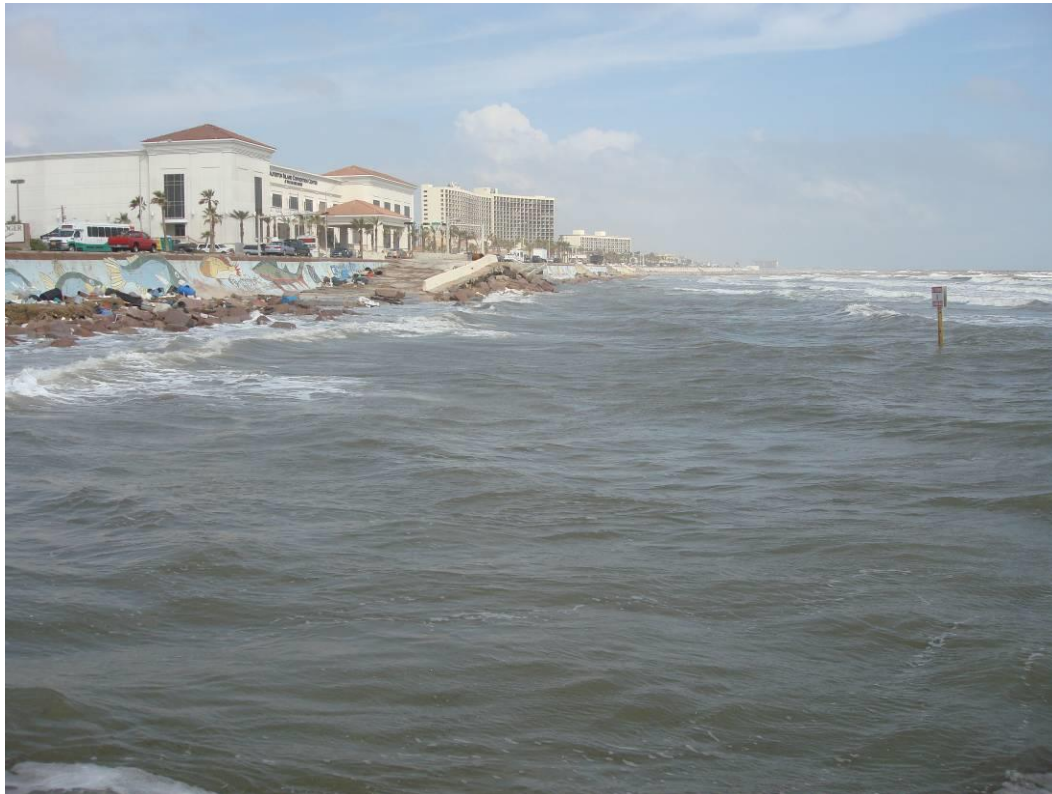
Figure 3.9 Beach near the Galveston Island Convention Center.

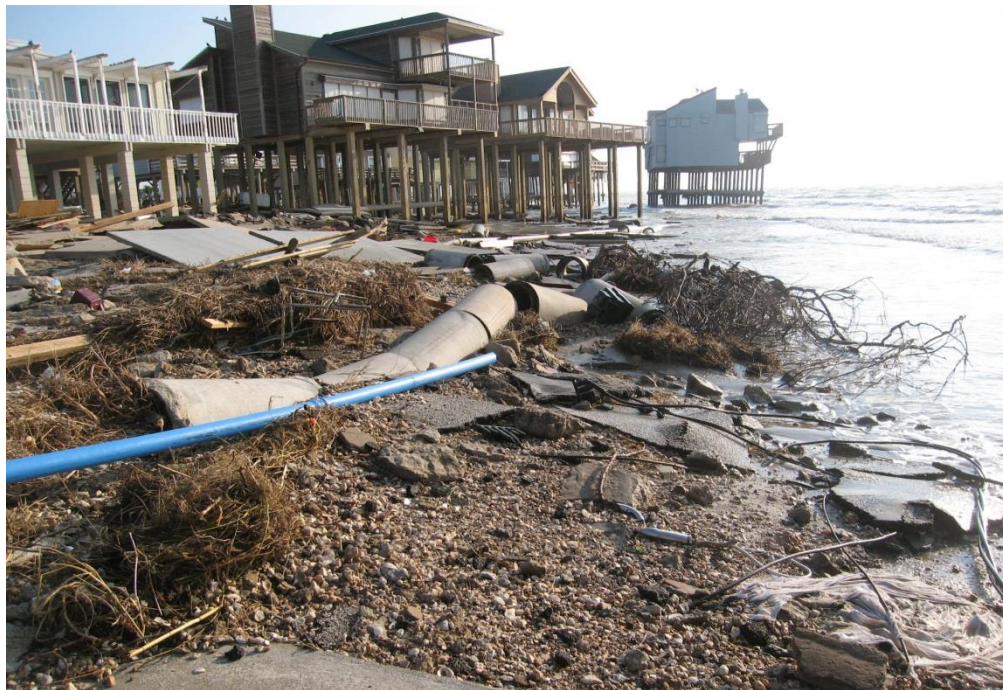
Figure 3.11 Damage in Spanish Grant on West Galveston Island.

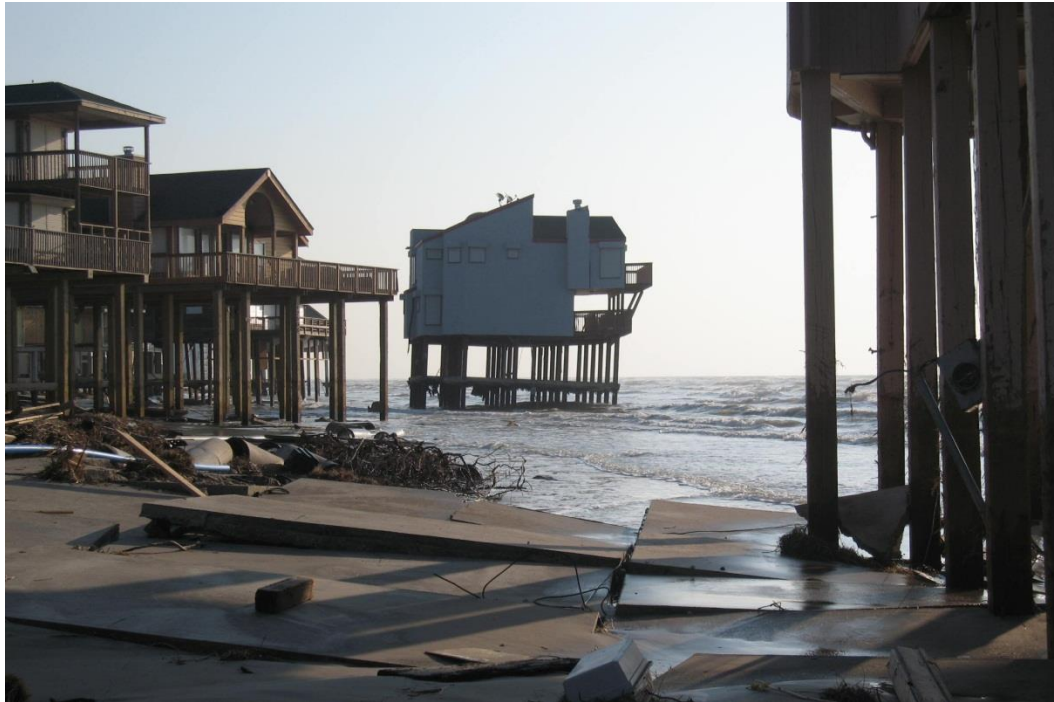
Figure 3.12 Damage in Spanish Grant on West Galveston Island.

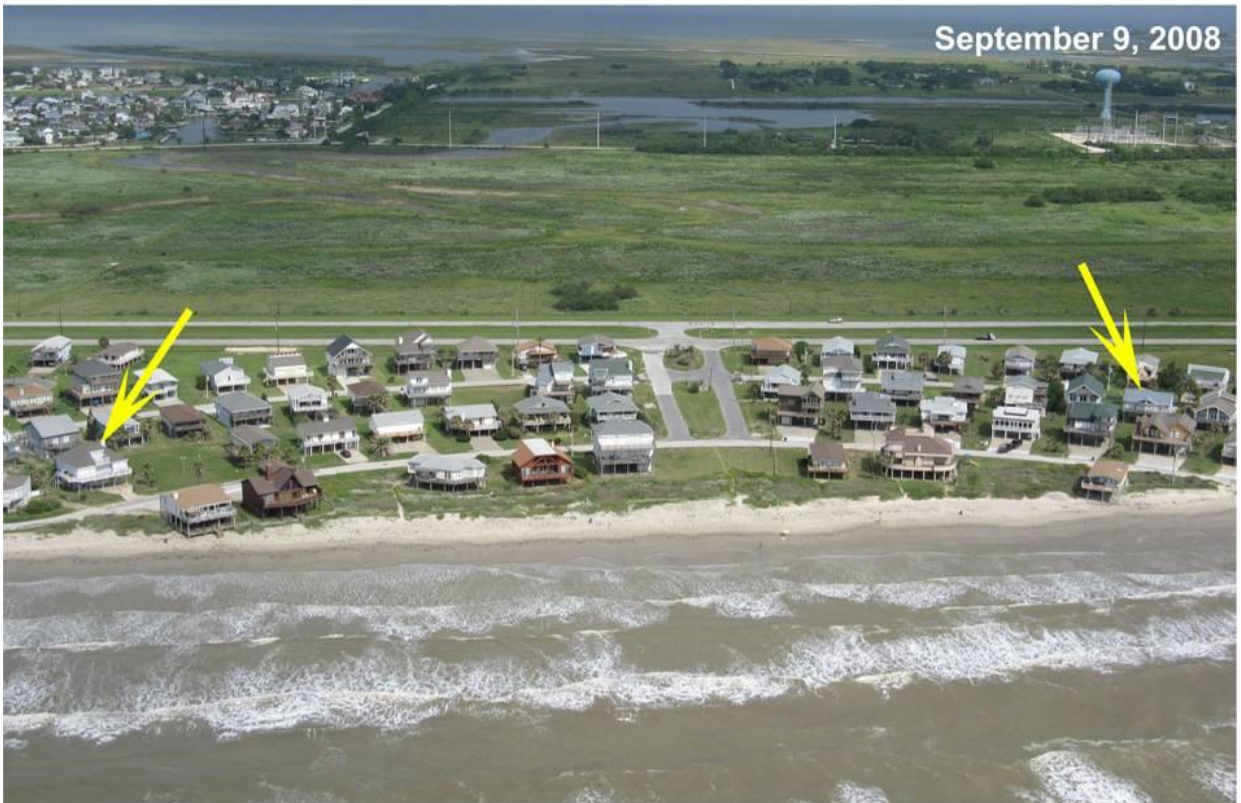
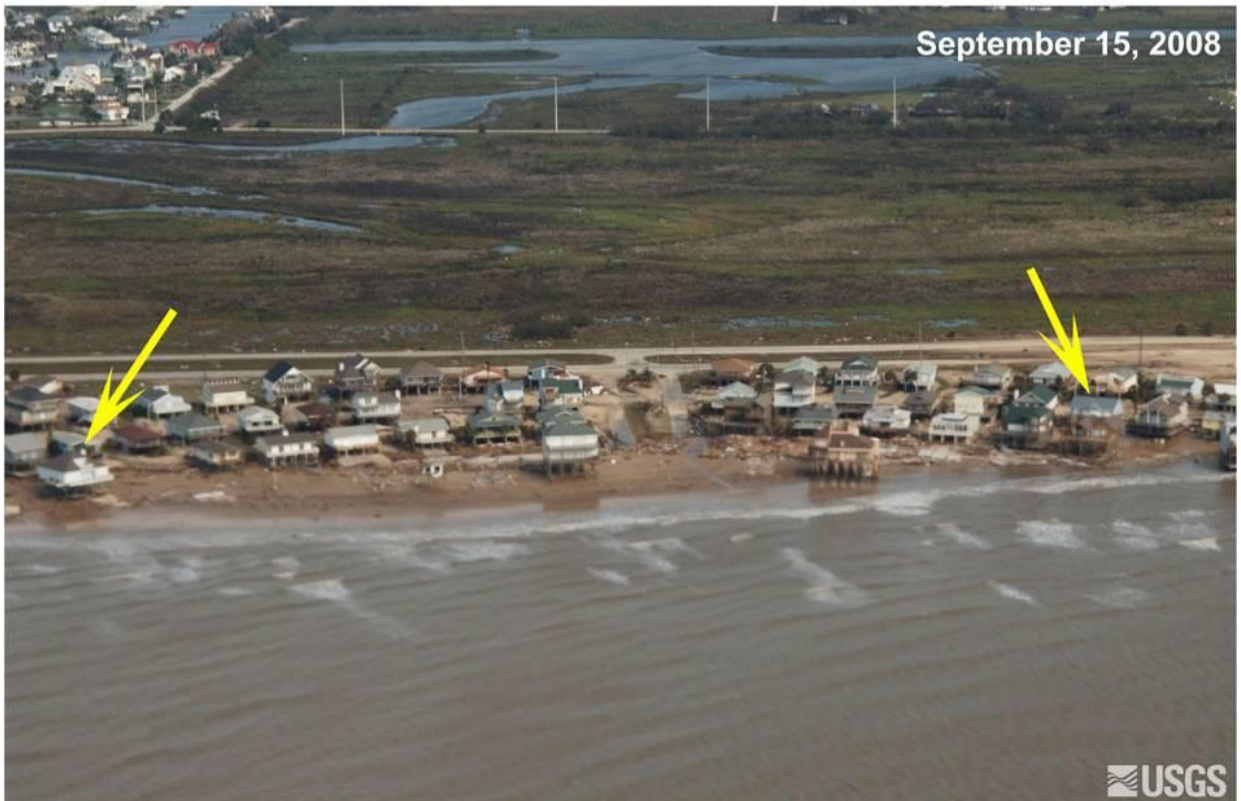
Figure 3.13 Pre and post storm photo comparison on West Galveston Island (USGS 2008).

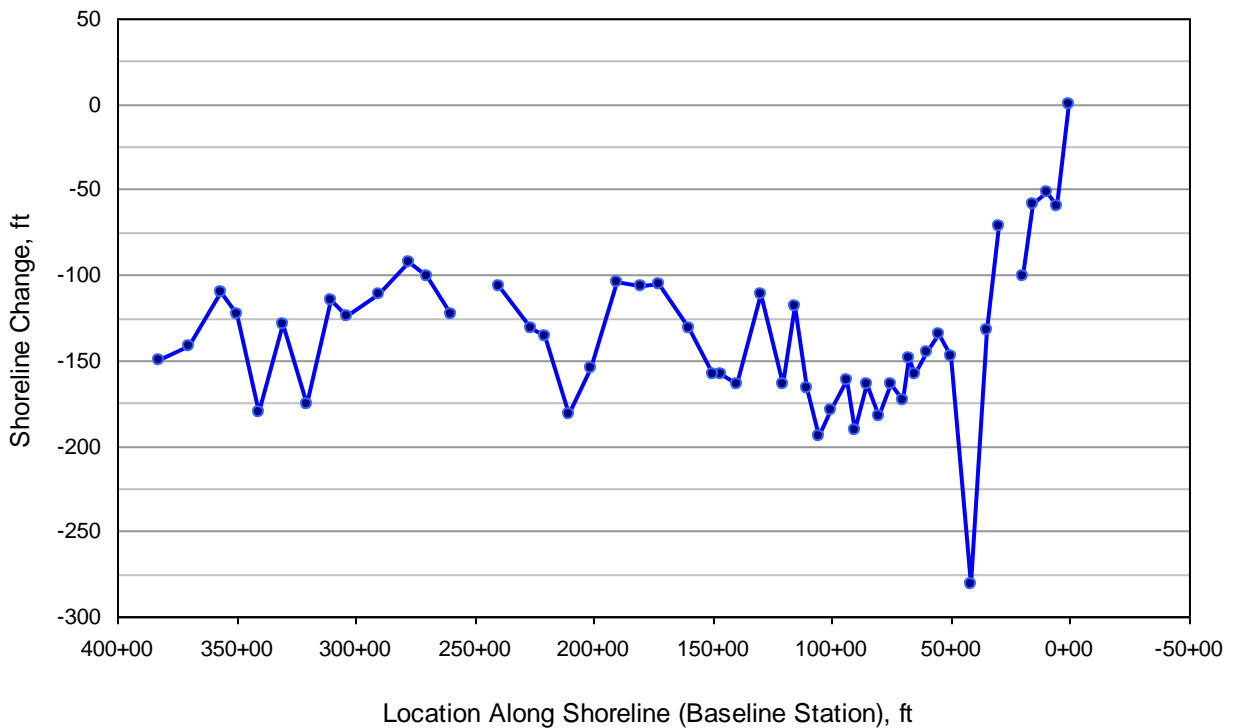
Figure 3.14 Change in shoreline position between August and November 2008 (HDR 2009).

Shoreline erosion and beach volume change within 7.6 miles immediately west of the seawall were calculated based on surveys conducted in August and November 2008. As shown in Figure 3.14, shoreline erosion varied from a maximum of 280 ft, 4,140 ft west of the west end of the seawall where a small lagoon was breached, to a minimum of 50 ft, about 1,000 ft west of the seawall. Average erosion within the study area was 135 ft. Surveyed shoreline erosion appears to be less than observed in the aerial photographs. Note that the beach survey was performed several weeks after the aerial photography, allowing more time for beach recovery. In addition, survey comparison calculates changes at a specified elevation rather than differences in lines interpreted from aerial photographs. More detailed analysis to quantify shoreline change using a standard methodology based on LIDAR is presented in Section 4.

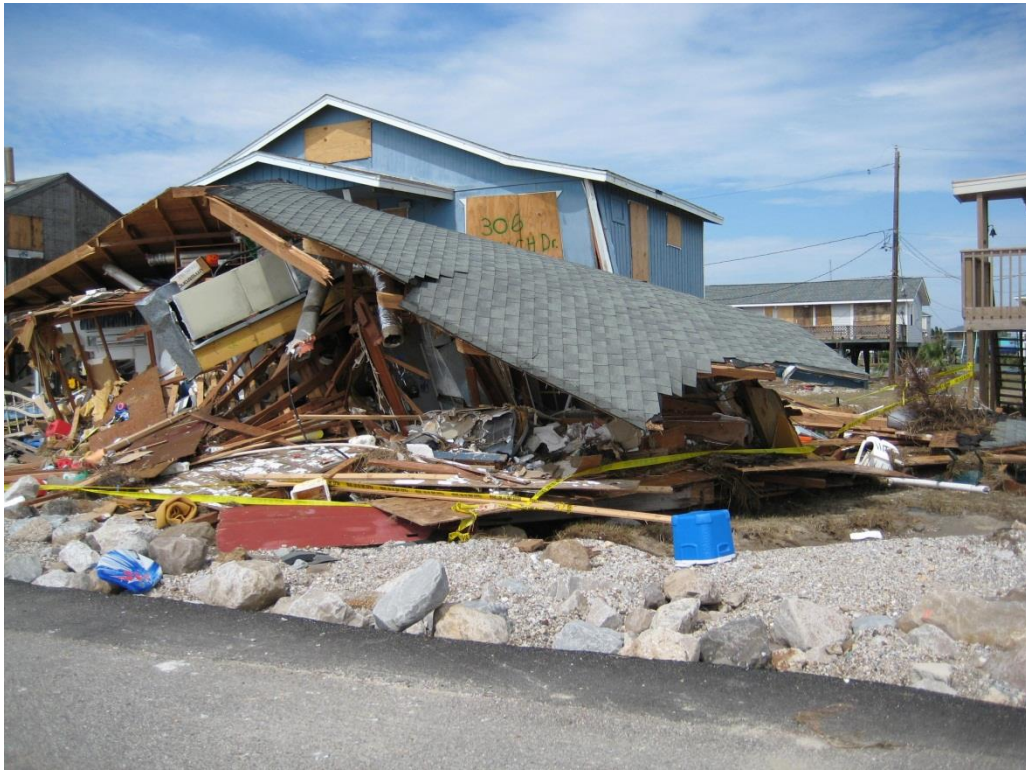
Figure 3.15 Home damage in Surfside, TX.

Erosion in the town of Surfside, an area suffering from long term erosion, averaged about 180 ft during the storm with higher erosion at the northeast end of town. Figure 3.15 shows a home damaged in Surfside. HRI (2009) analysis indicates that Follets Island experienced average shoreline erosion of 215 ft with a peak of over 400 ft.

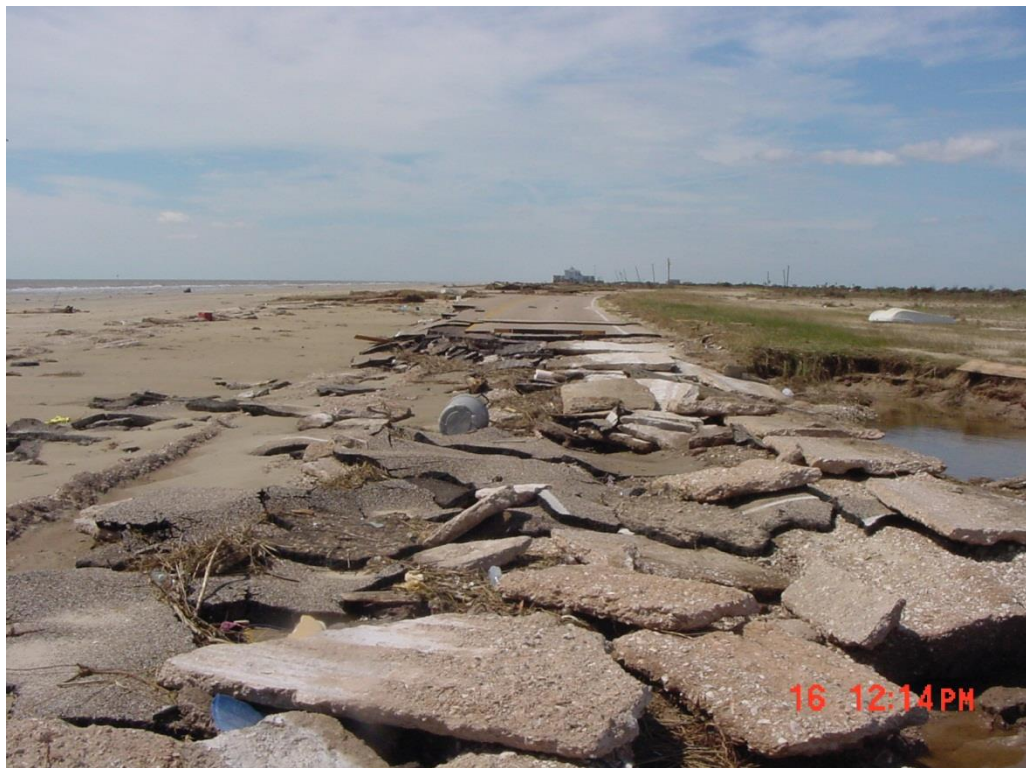
Figure 3.16 Damage to Blue Water Highway on Follets Island.

Damage was extreme along Blue Water Highway (CR 257) as shown in Figure 3.16. Much of this reach experienced significant scour of the beach and dune system, evident in the pre and post-Ike photo comparison in Figure 3.17. Much of the beach and dune scour likely occurred after passage of the storm as water from within the back bays of Christmas Bay and Drum Bay returned to the Gulf. The scour was the cause of significant damage to Blue Water Highway and complete destruction of some sections of the road.

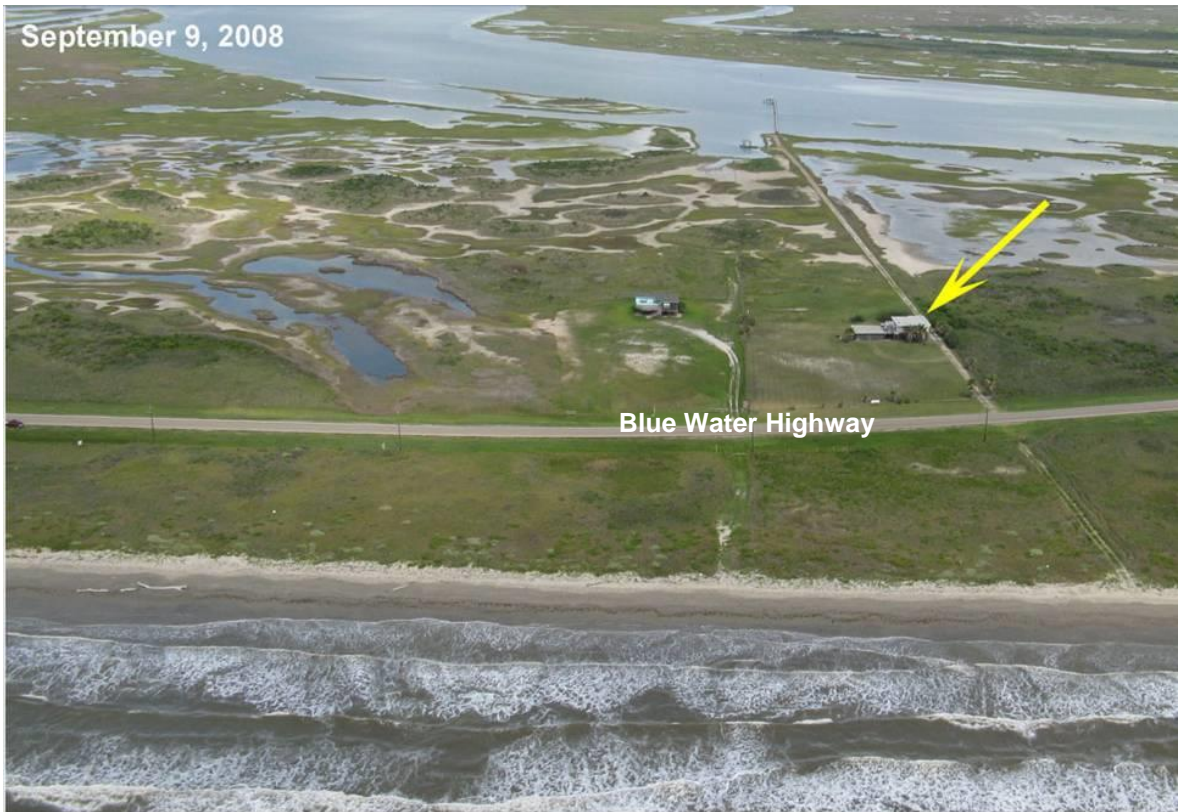
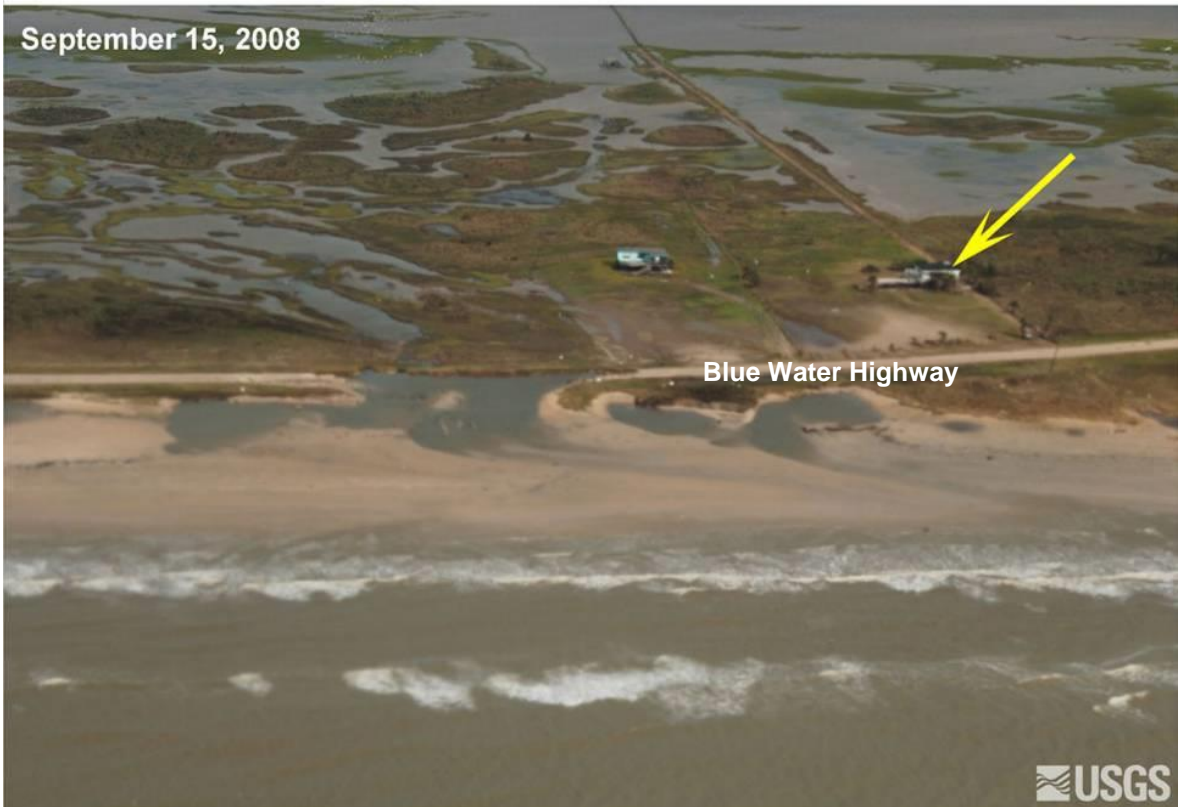
Figure 3.17 Pre and post storm photo comparison at Follets Island (USGS 2008).

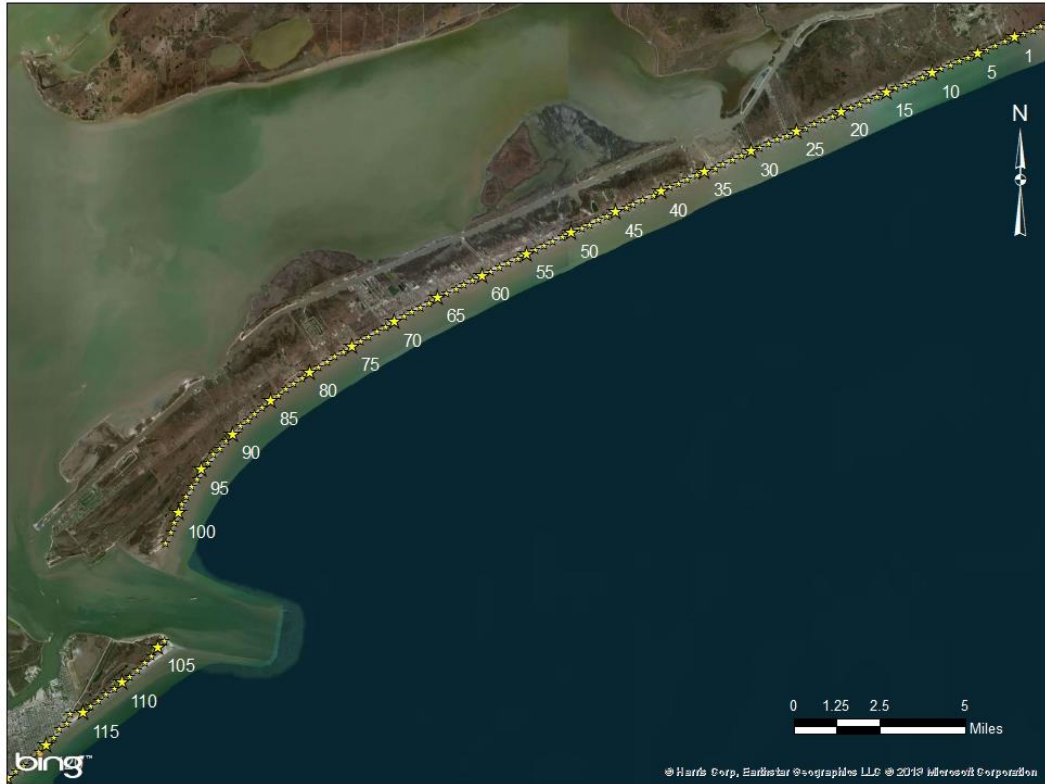
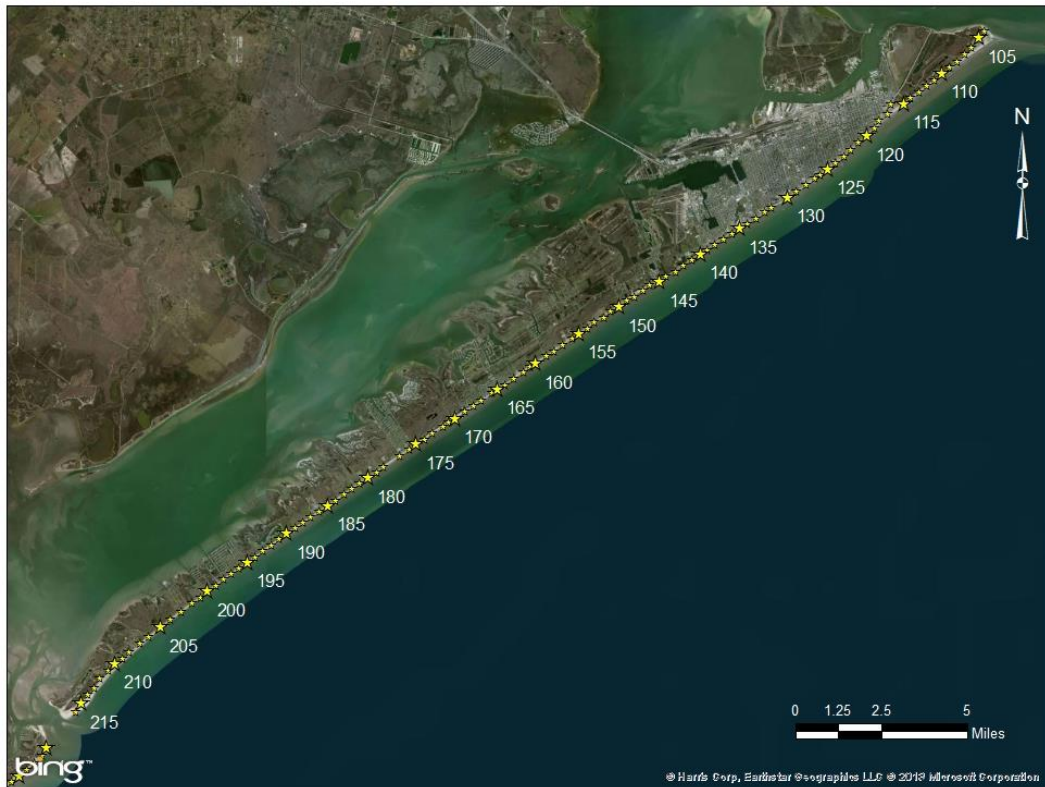
Figure 4.1 Virtual Monument locations within Galveston County.
