Beach and Shoreline Changes Along the Upper Texas Coast: Recovery from Hurricane Ike

HDR Engineering, Inc.
Texas Registration No. 754
555 N. Carancahua, Suite 1600
Corpus Christi, TX | 78401
HDR Project No. 166742

March 17, 2014

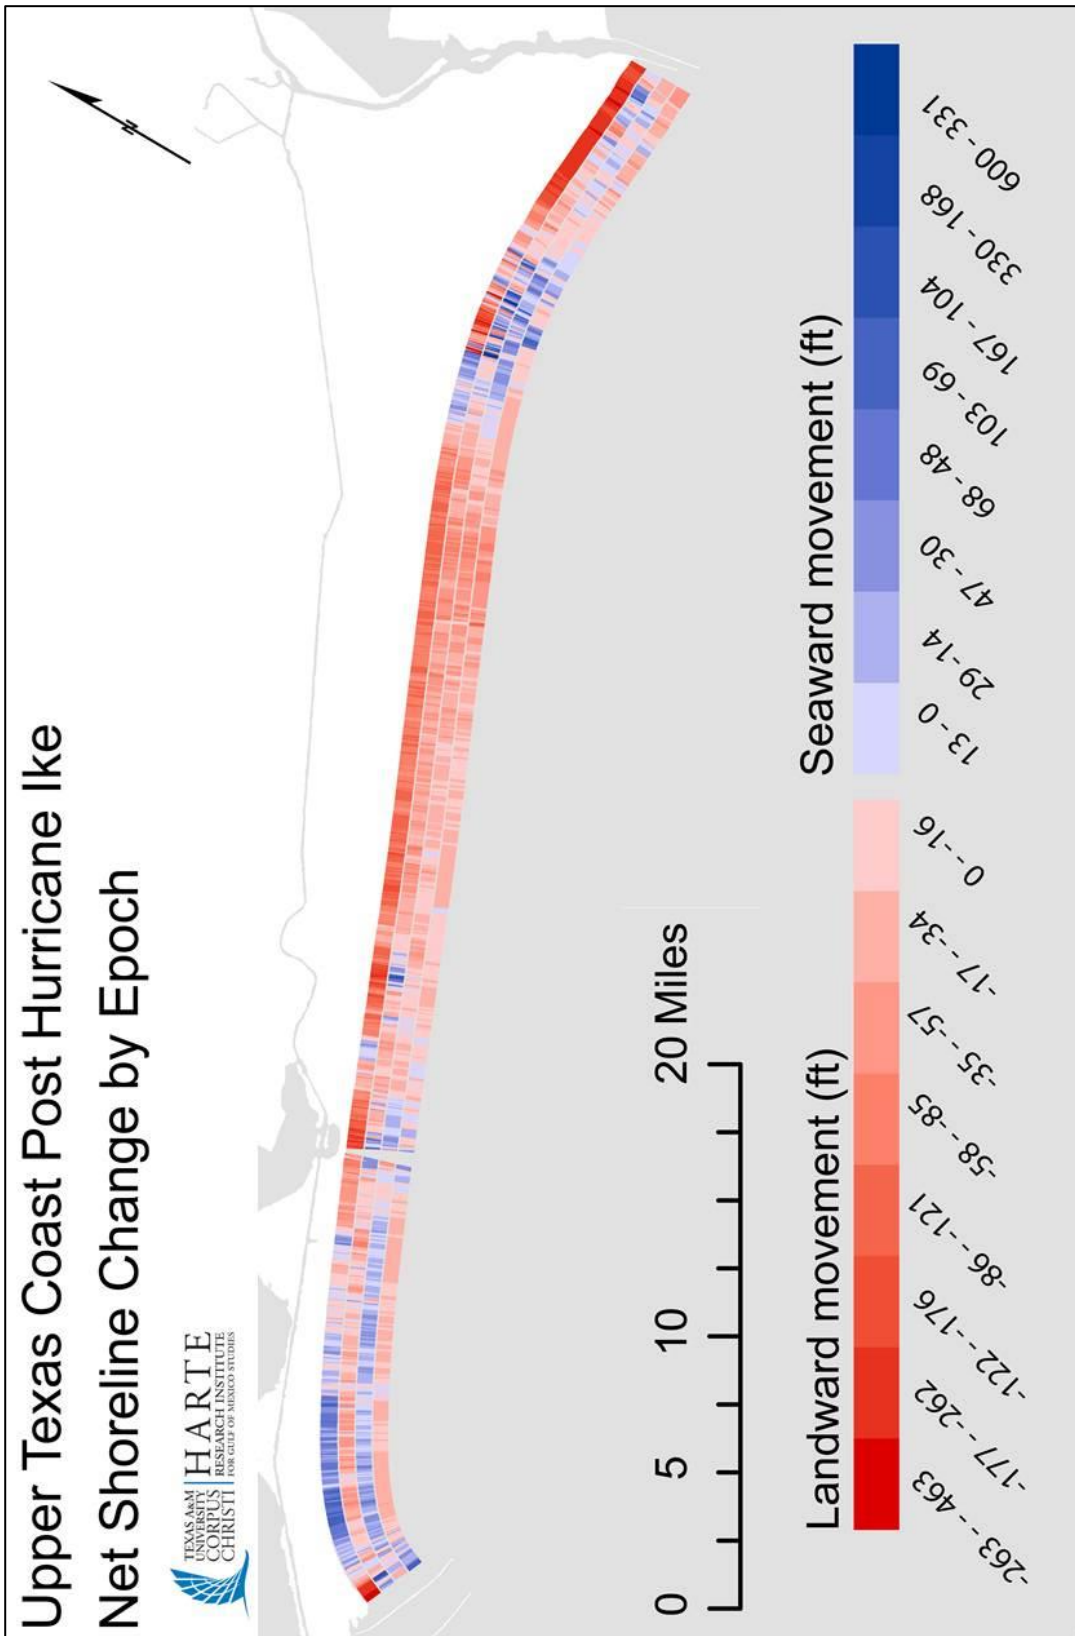
Figure 5.1 Shoreline Change Results – Sabine through Bolivar Peninsula (HRI).

The shoreline change analyses along the upper Texas discussed herein will typically be based on the results of the LIDAR comparisons described above, unless otherwise noted. A summary of the overall changes are provided in Table 5.2 and Figures 5.1 and 5.2 below. Table 5.1 provides the average shoreline change between LIDAR surveys, as well minimum and maximum shoreline changes for each region. The minimum and maximum values are reported in terms of shoreline recession, with maximum values representing the maximum shoreline recession measured for a survey period, and minimum values indicating the most shoreline advance. In addition, the shoreline change rates per year for each section are listed. Figures 5.1 and 5.2 provide an overall graphical representation of the average shoreline changes along the study area. Further review of the changes per shoreline section (similar to the shoreline sections described in Section 3) are presented in subsequent sections.

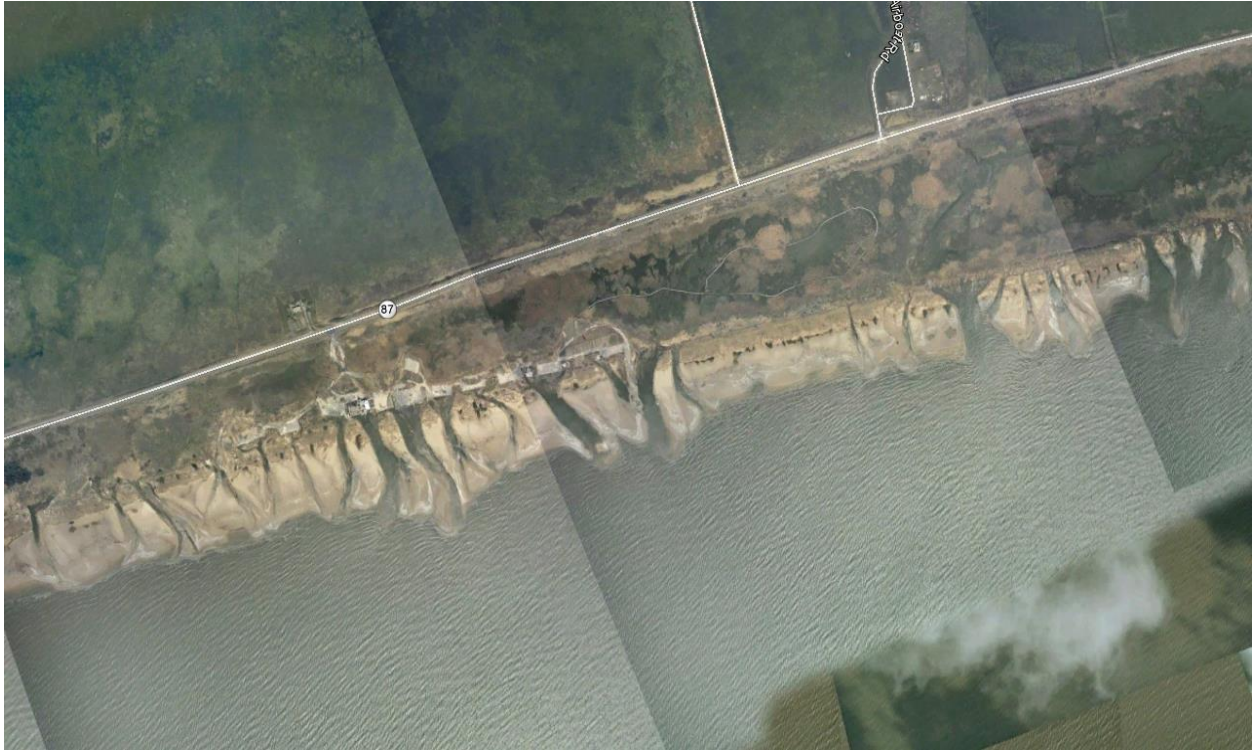
Figure 5.4 Sea Rim park and eroded channels post Ike (Google Earth, 2008).

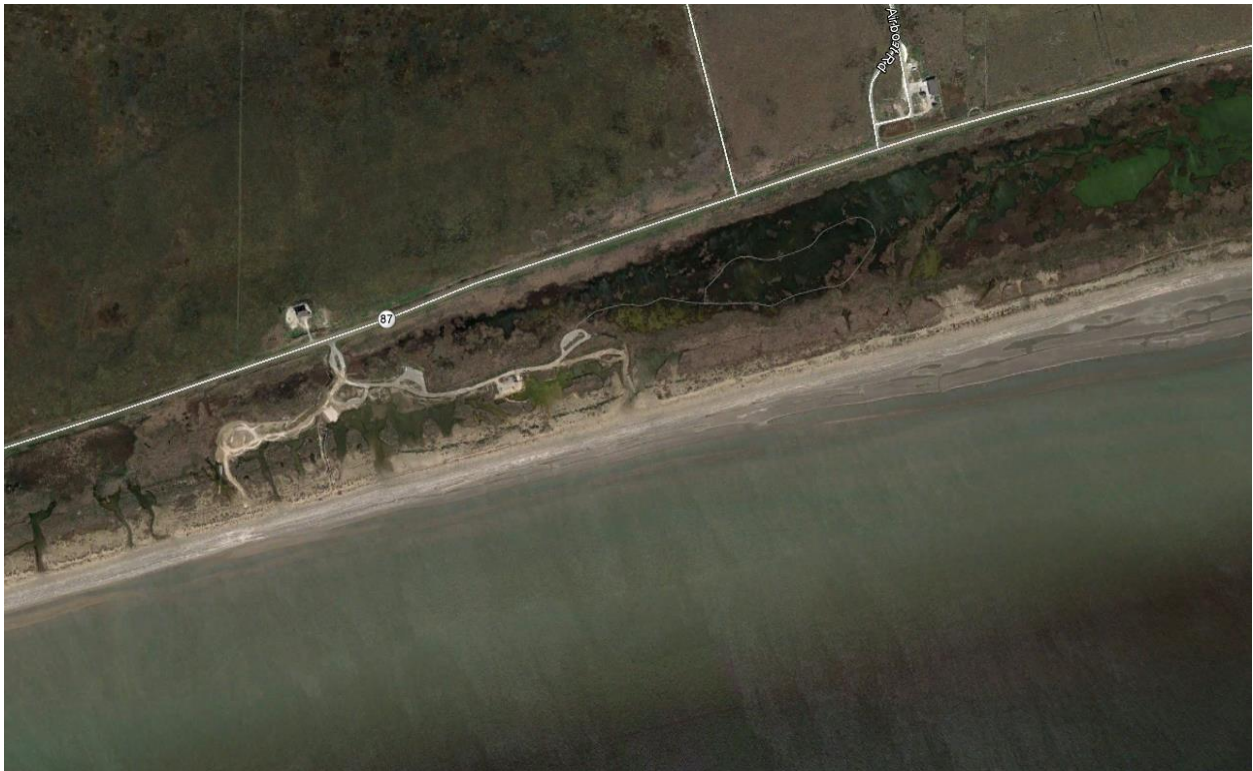
Figure 5.5 Sea Rim park and eroded channels post Ike (Google Earth, 2013).

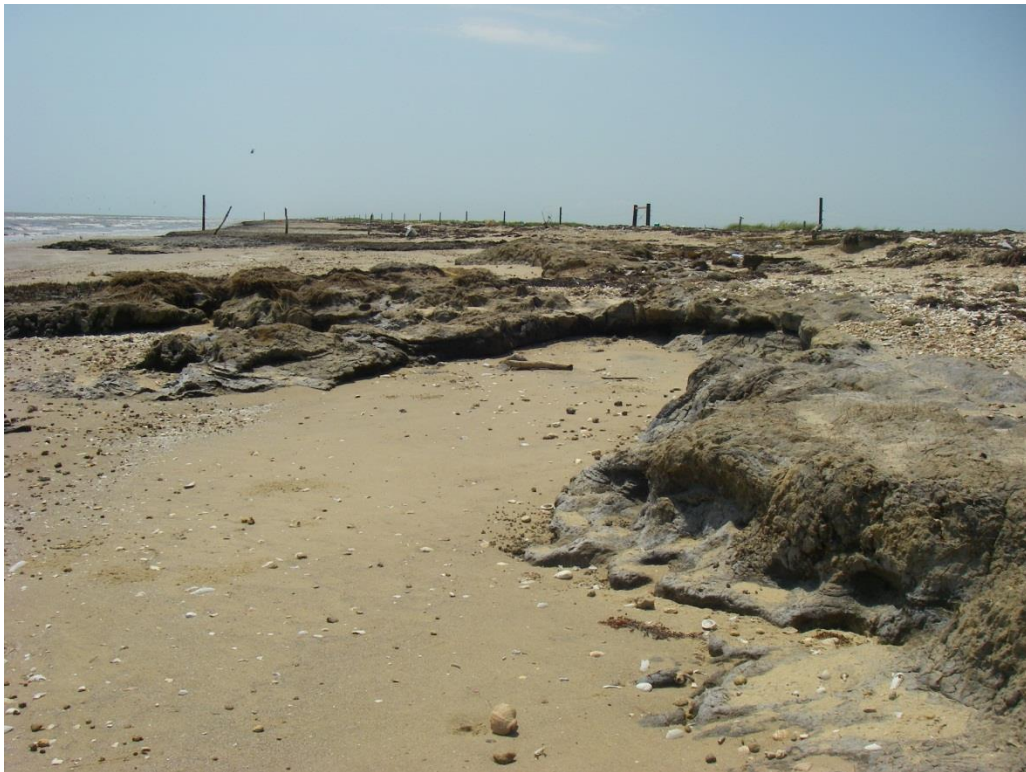
Figure 5.7 2011 Shoreline near western edge of Jefferson County (Monument J98).

During a site visit in 2010, much of the area was eroded to the extent that the shoreline typically consisted of exposed clay (Figure 5.6) such as at monument J98 (approximately station 133000 in Figure 5.3). By the summer of 2011 (Figure 5.7), some sand had returned to shore; however, much of the clay was still exposed and no dunes were present. Figure 5.8 shows the 2011 condition of the shoreline near High Island, where much of the clay has been covered with a thin veneer of sand.

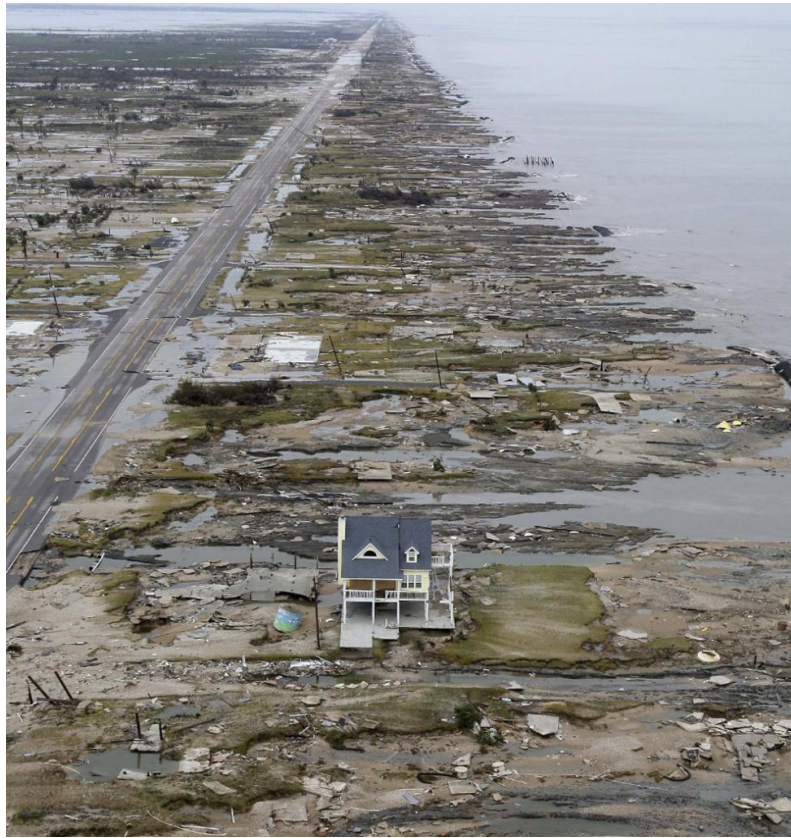
Figure 5.10 Rollover Pass area Post-Ike looking east (2008, photo by AP).

Figures 5.10 and 5.11 show the immediate post-Ike and 2011 conditions (from site visit) east of Rollover Pass. Prior to Ike, this area consisted of narrow beaches with a geotextile core dune to provide protection to upland properties. The geotextile tubes and dunes were destroyed when the storm passed. The remnants of the tubes are observable in Figure 5.10. Survey results show that this area has not returned to pre-storm shoreline conditions; however, the photo in Figure 5.11 shows a fairly wide beach. This is due to a property buyout program implemented by Galveston County. The area around Rollover is not expected to fully recover due to sand being lost to washover into Rollover Bay and transported west as a result of wave action during Ike. In addition, the loss of sand from the areas east of Rollover (High Island and Sabine) has resulted in minimal sand being available for typical east to west transport.

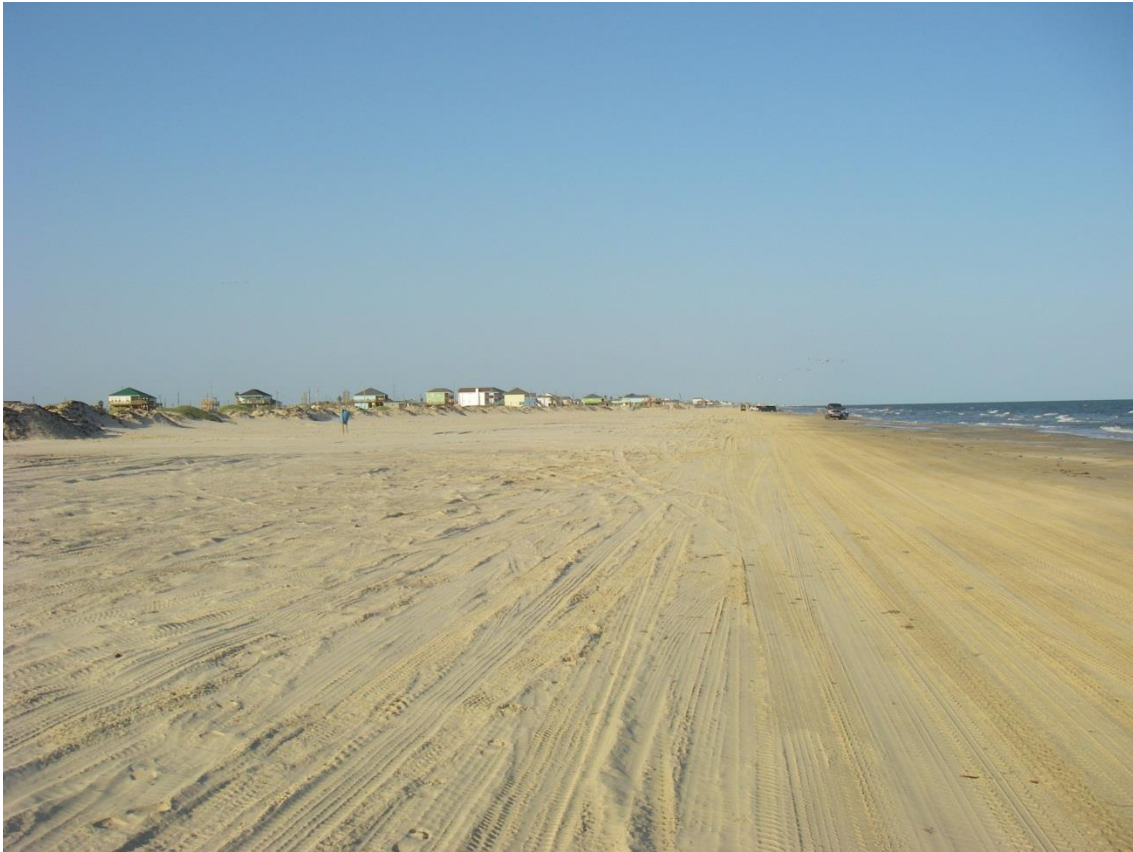
Figure 5.12 Looking east at G72 (2011) towards Crystal Beach area shown in Figure 3.6.

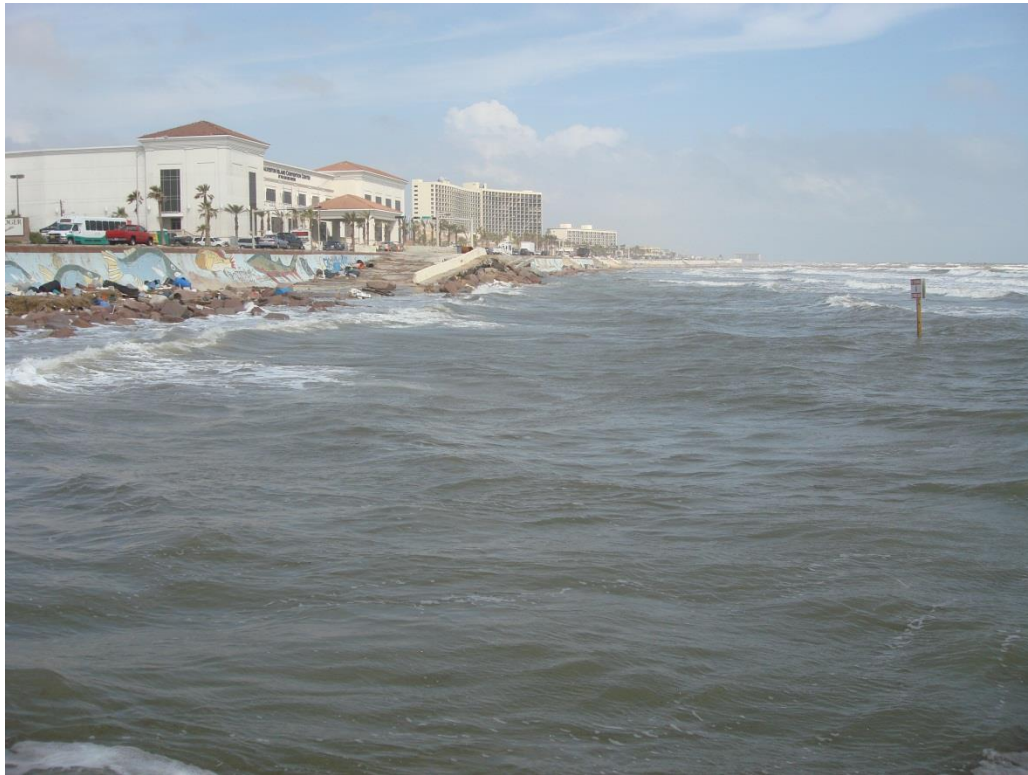
Figure 5.15 Area fronting Galveston Seawall and Convention center immediately post-Ike.

Shoreline changes along the Galveston Seawall west of 10th Street were not calculated due to beach nourishment activities immediately following Ike influencing the shoreline position. As described in Section 3.1.4, the area along the seawall was significantly eroded during Ike and little, if any, beach remained after the storm passed. The loss of beach meant a loss to Galveston Island's primary economy (tourism) as well as increased concerns about potential scour of the seawall's foundation. Therefore, the Galveston Island Park Board of Trustees and the GLO implemented a beach nourishment project at the end of 2008 (only several months after the passage of Ike) that placed approximately 500,000 cy of sand to create a 70 to 100-ft wide beach, similar to what existed prior to the storm. Figures 5.15 and 5.16 show the post-storm and post-nourishment conditions of the seawall beach in front of the Galveston Island Convention Center.

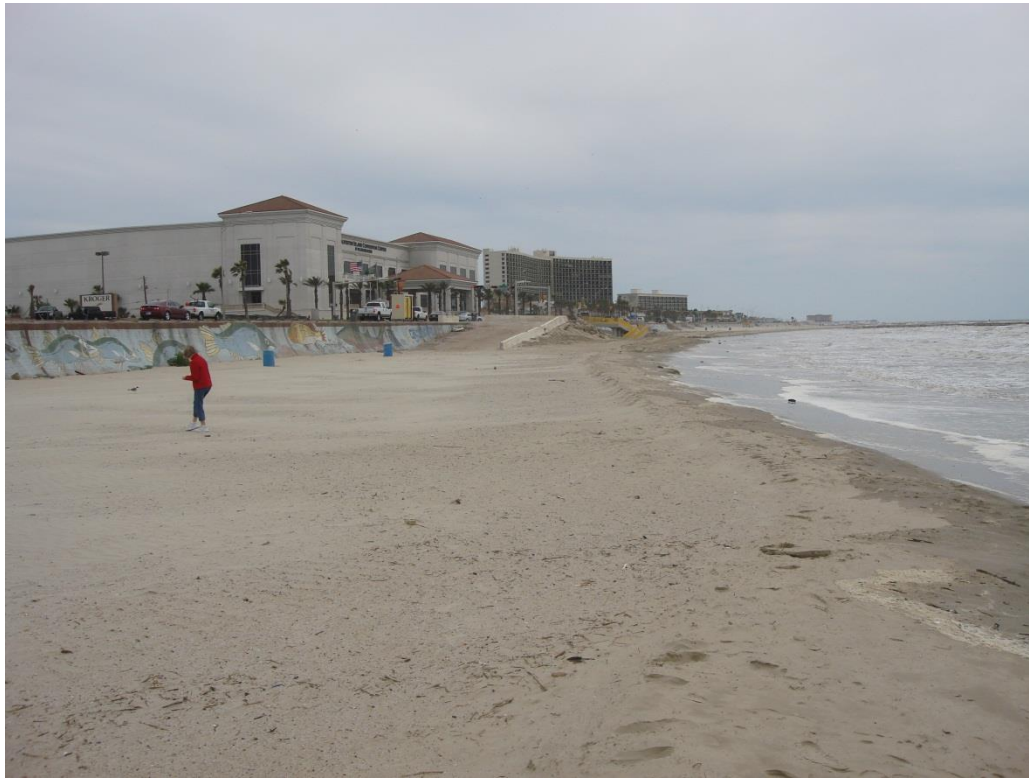
Figure 5.16 Area fronting Galveston Seawall and Convention after beach nourishment.

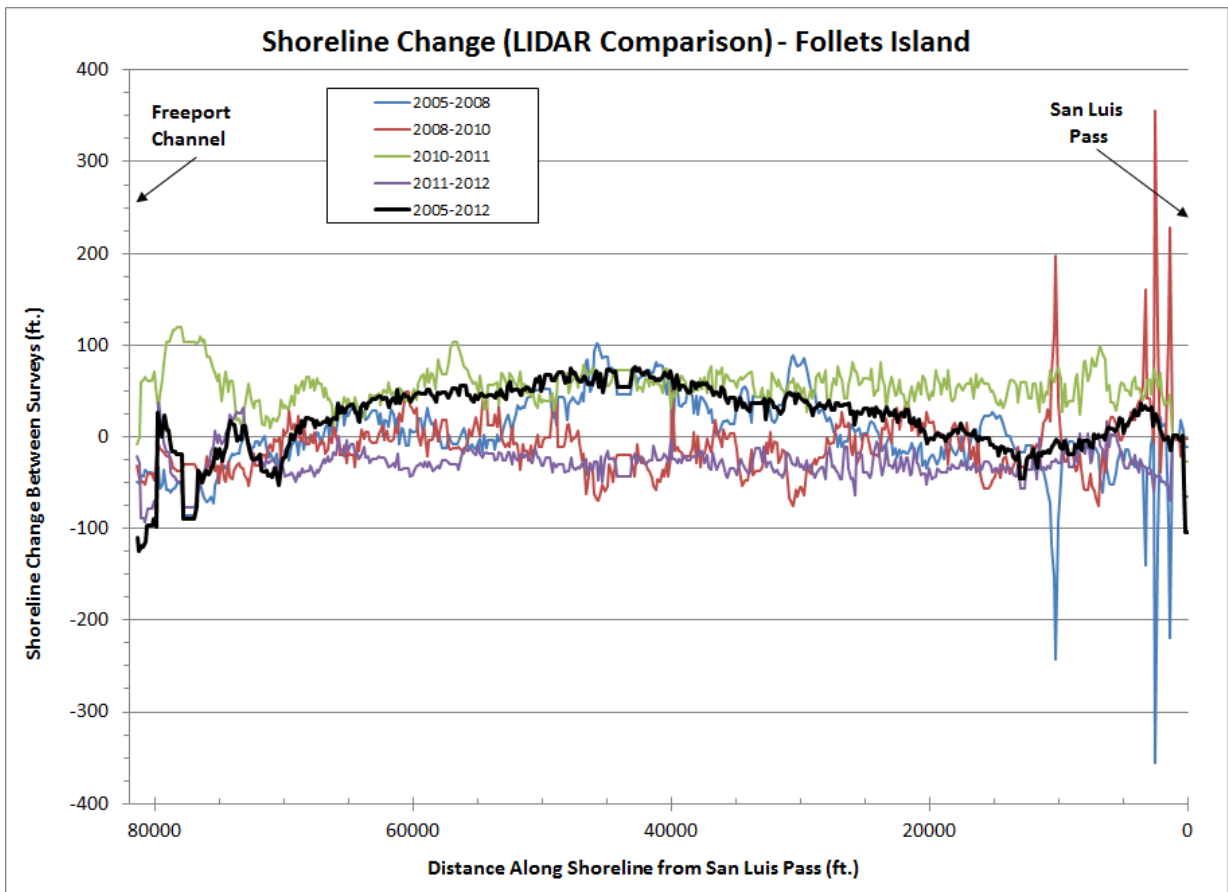
Figure 5.21 Shoreline change results along Follets Island.

Follets Island also experienced areas of shoreline retreat and advance. Post-Ike the shoreline near San Luis Pass and Surfside experienced shoreline retreat, yet the mid-island stretch of beach experienced seaward movement. The following years were mixed between shoreline recovery and recession. These varying trends may be due to the fact that Ike eroded much of the foredune and upland complex between the beach and CR 257 (Bluewater Highway). Impacts included significant damage and scouring of Bluewater Highway both during the storm from wave attack and as water levels in the bays north of the island emptied and flooded across the island once the storm moved inland (Figure 5.22). This severe erosion of the dunes and uplands is expected to have contributed to the measured shoreline advance observed immediately following Ike in 2008. Between 2008 and 2010, most of Follets Island shorelines experienced some shoreline recession as the beaches sought equilibrium and recovered from the storm. However, the overall shoreline remains advanced of the pre-Ike location. It is believed that this is due to the slow rebuilding of the dunes along the island, causing the sand lost to the dunes to remain in the upper and active beach profile.

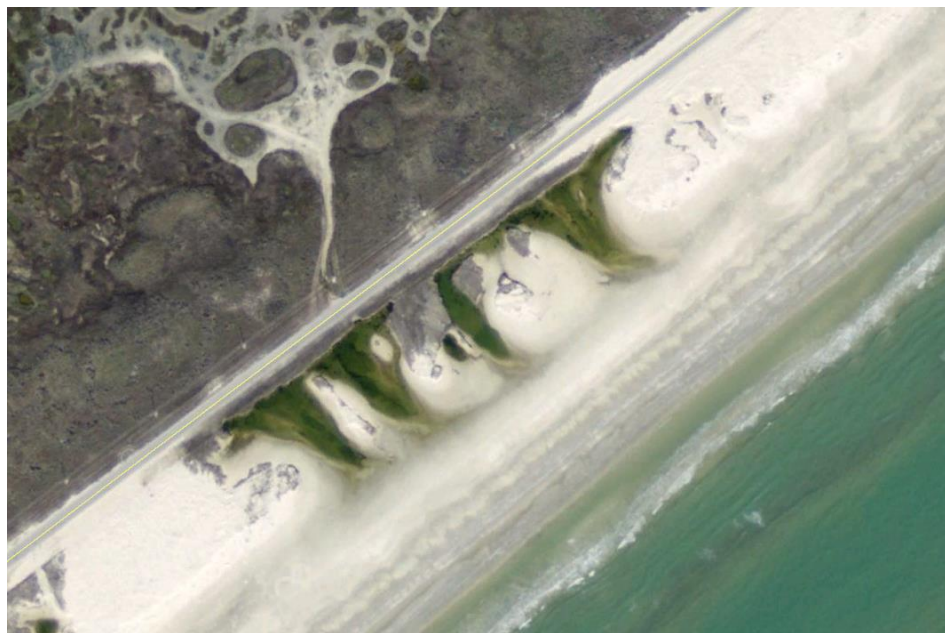
Figure 5.22 Vertical Aerial in 2009 (Google Earth) of area in vicinity of Monument B26. Note erosion of dune and scour areas along Bluewater Highway.

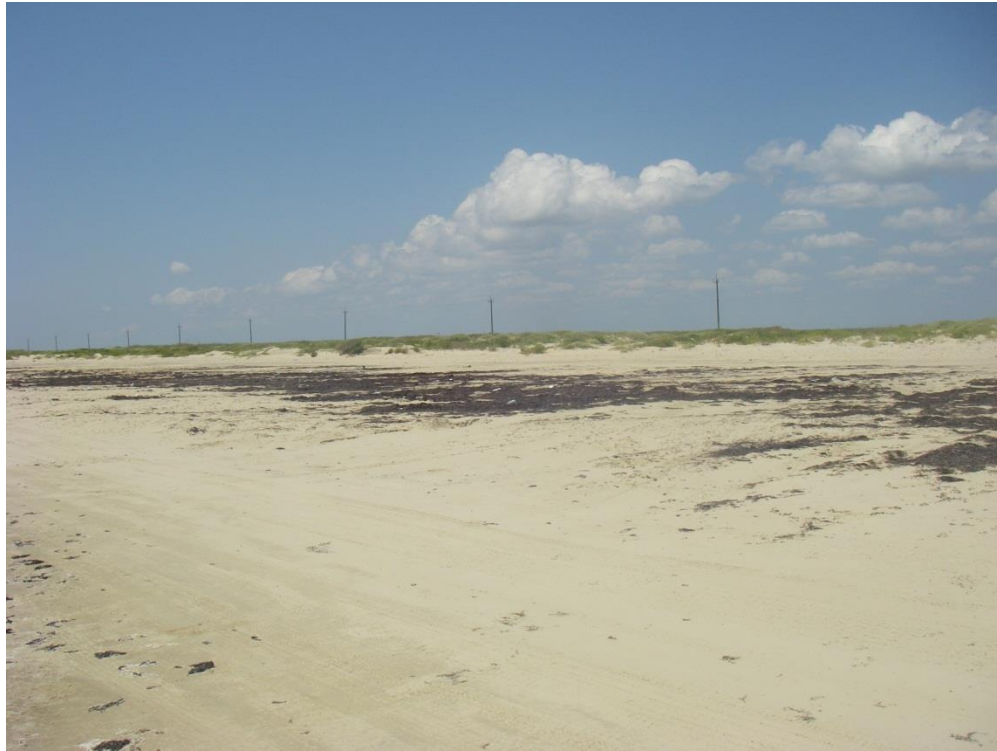
Figure 5.23 Central section near Monument B26 of Follets Island (2011). Note dune beginning to recover, but still further landward of pre-storm locations.

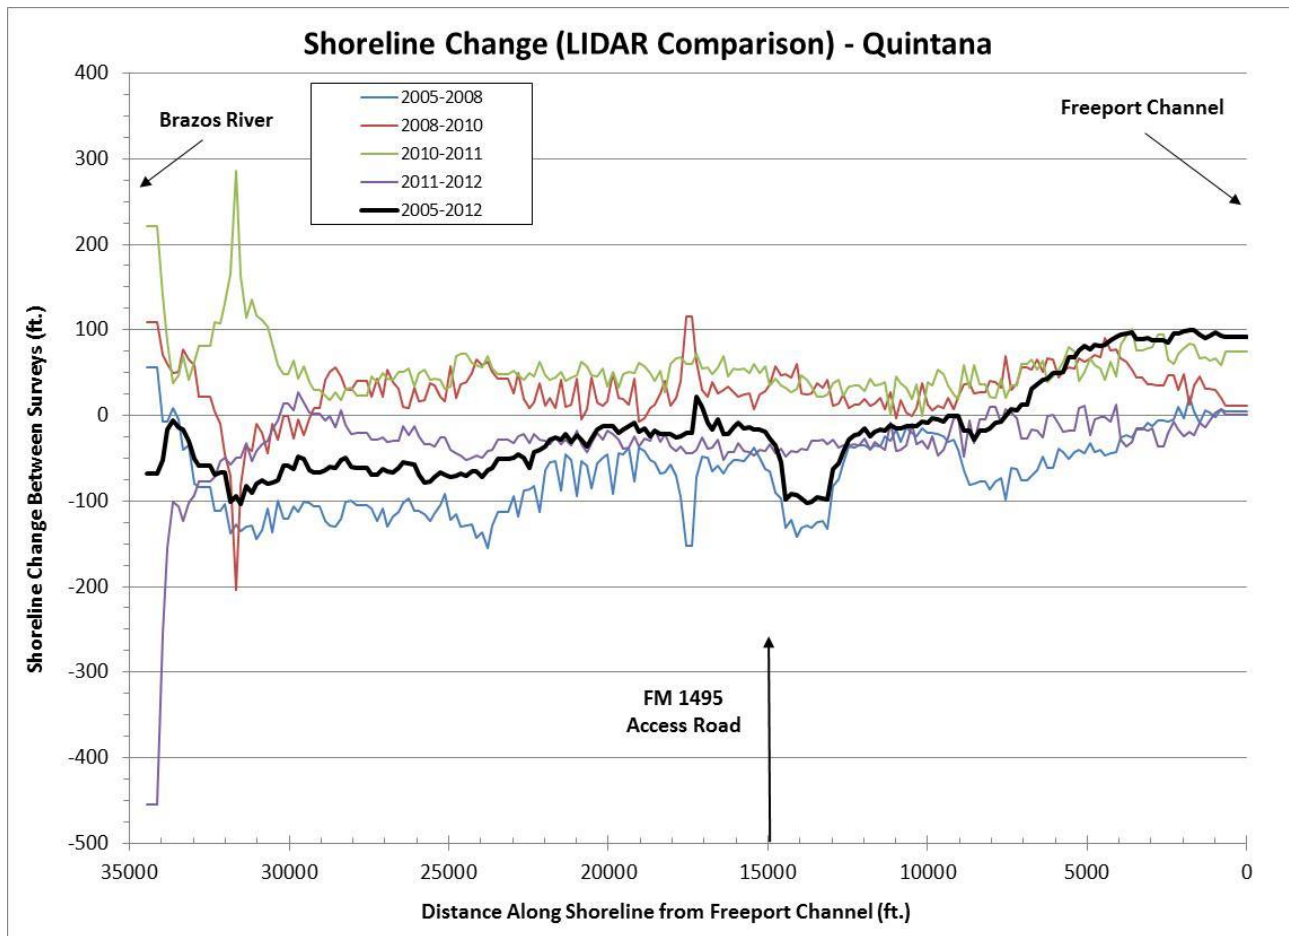
Figure 5.24 Shoreline change results for Quintana shoreline.

The Quintana section of shoreline extends from the west jetty at Freeport channel to the mouth of the Brazos River. Much of the area is undeveloped in regards to homes near the beach; however there are several leveed areas adjacent to, or immediately landward of, the beach. During Ike, much of the shoreline experienced recession, averaging -68.2 ft across the study area. As shown in Figure 5.24, some area receded over 100 ft. Between 2008 and 2011, the beach profile began recovering from the storm impacts as sand transported offshore moved back into the upper beach profile. One area of note is a 1,400 ft section east of the FM 1495 access road. This segment of shoreline is immediately adjacent to a leveed placement area and experienced significant erosion during Ike, and limited recovery, similar to a shoreline immediately downdrift of a coastal structure. Overall, the Quintana shoreline has not returned to pre-storm locations and is an average of -35.2 ft landward of the 2005 survey. The exception is the area west of the jetty where sand was likely deposited as waves transformed around the Freeport jetties.

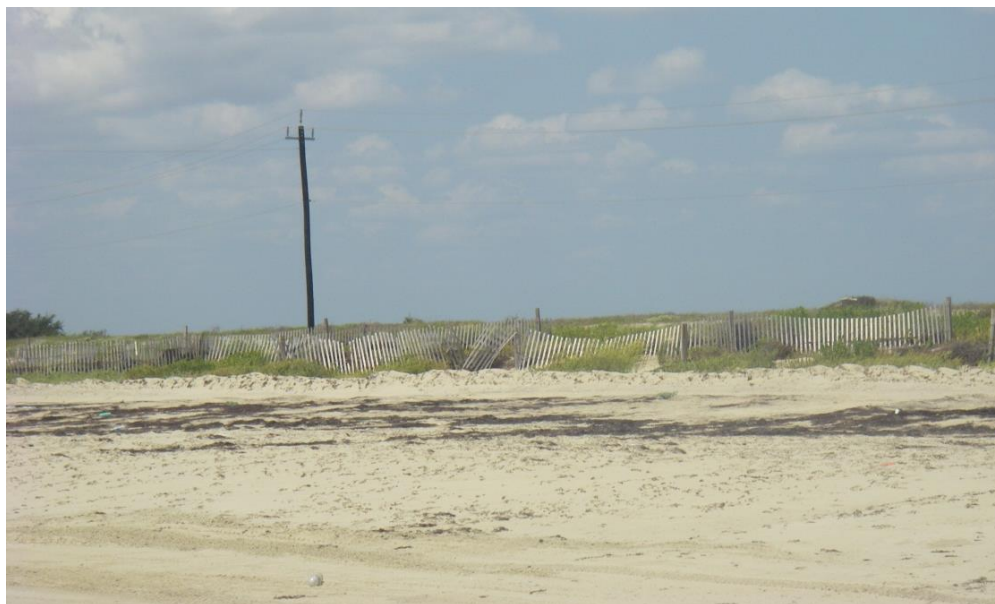
Figure 6.8 Sand fencing along central portion of Follets Island to assist dune recovery.

All regions experienced an average net recovery in foredune sediment volume following the Ike impact except for two regions, Follets Island and High Island to Sabine Pass. Follets Island had a minor average net loss in volume per length of beach of approximately -0.2 cy/ft indicating a relatively stable period of foredune development (i.e. minimal recovery on average). However, this seems to contrast with observations along Follets Island during the site visits of 2010 and 2011. Local projects were implemented during this time to help rebuild the dunes that were mostly scoured out during Ike. These projects included placement of Christmas trees and sand fencing to help capture and promote dune development (Figure 6.8). The reason for the low foredune recovery measurement from this analysis may be due in part to the foredune calculation only extending 25 m (82 ft) from the 1.27 m (4.1 ft) elevation contour. Most of the dune formation projects were closer to Bluewater Highway and beyond the calculation area. It should be noted that recent visits to this area in 2013 show that the dune and upland features are quickly developing with the help of these local projects.
