Mustang and North Padre Island Beach Maintenance Impacts and Recommendations for Best Management Practices

August 2015

A Report to the General Land Office under GLO Contact No. 14-246-000-8341. CEPRP Project No. 1593

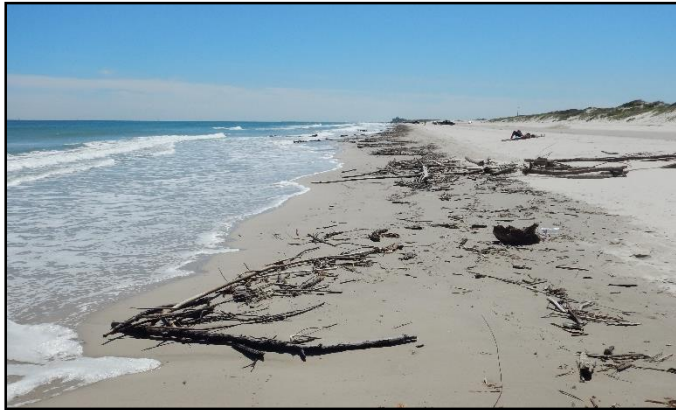
FIGURE 1. BEACH WRACK ALONG TIDELINE ON MUSTANG ISLAND

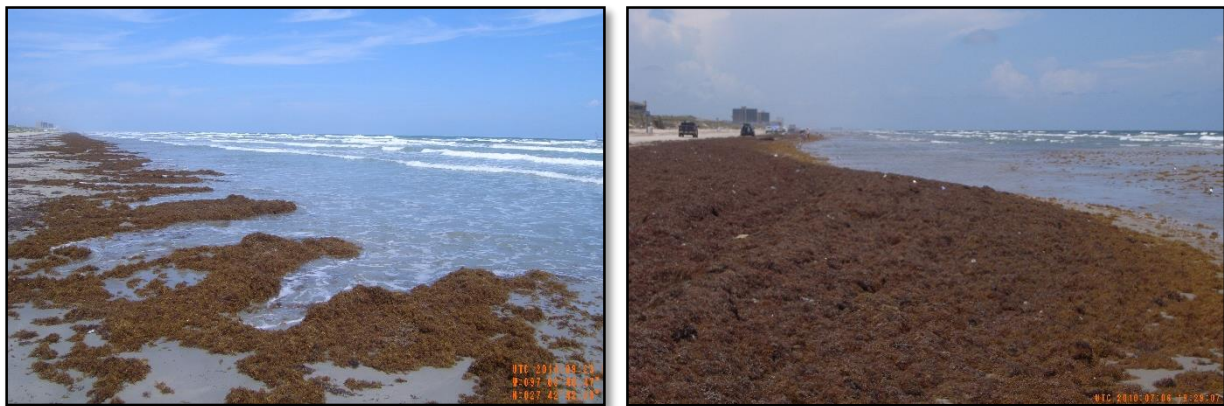
FIGURE 2. *SARGASSUM* AT THE TIDELINE ON MUSTANG ISLAND, TEXAS.

along the Caribbean and the Gulf of Mexico (Figure 2). *Sargassum* can be unsightly and can release a foul odor as it begins to decompose on beaches. Further, beach-cast *Sargassum* can pose a health and safety risk if trash caught within the seaweed contains sharp objects or other hazardous materials. Because of

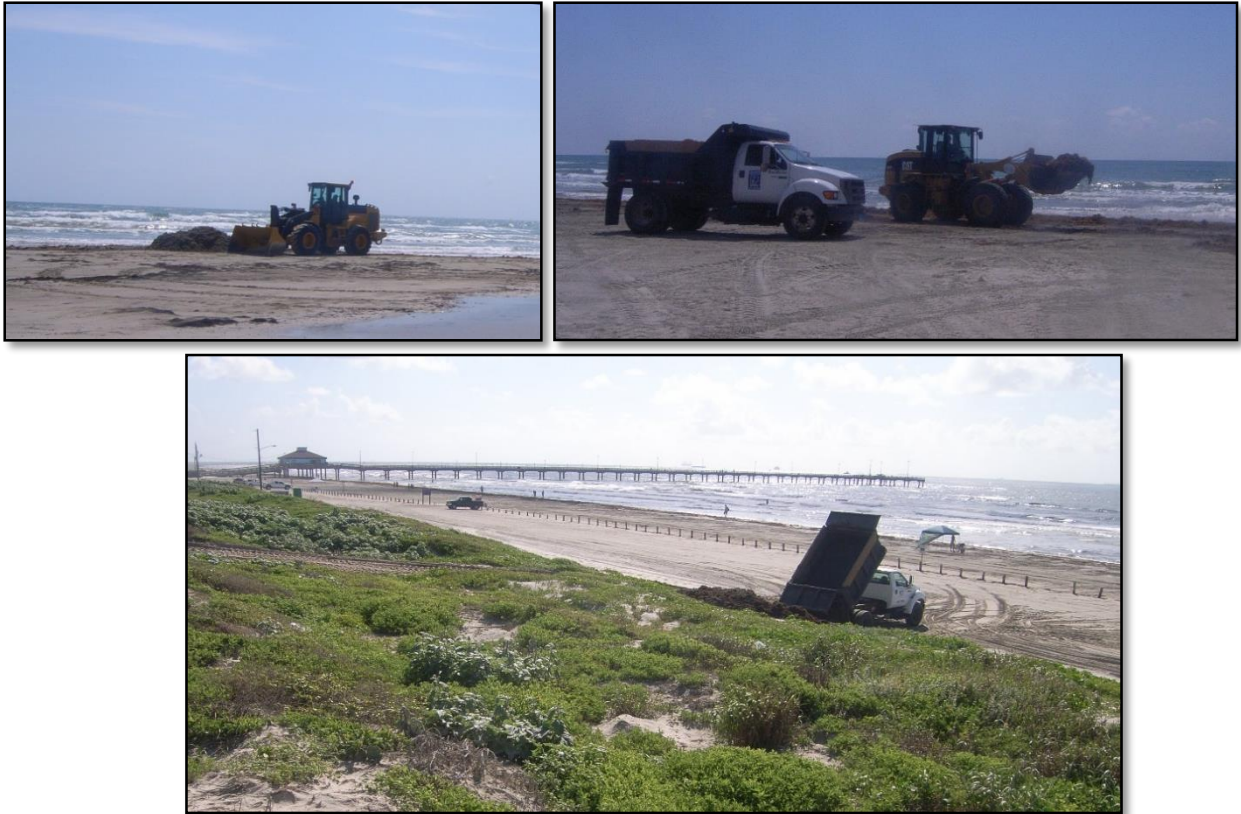
FIGURE 3. REMOVAL OF *SARGASSUM* FROM THE BEACH (TOP) AND DEPOSITION AT DUNE TOE (BOTTOM) IN CITY OF PORT ARANSAS. *SARGASSUM* REMOVAL TECHNIQUES AND EQUIPMENT VARY AMONG JURISDICTIONS.

this, coastal managers are faced with the decision to remove seaweed as part of their beach maintenance efforts or to leave it in place (A. Williams, Feagin, and Stafford 2008). If removed, seaweed is raked or scraped from the beach and deposited offsite or may be pushed up toward the dunes (Figure 3). Heavy machinery is frequently used.

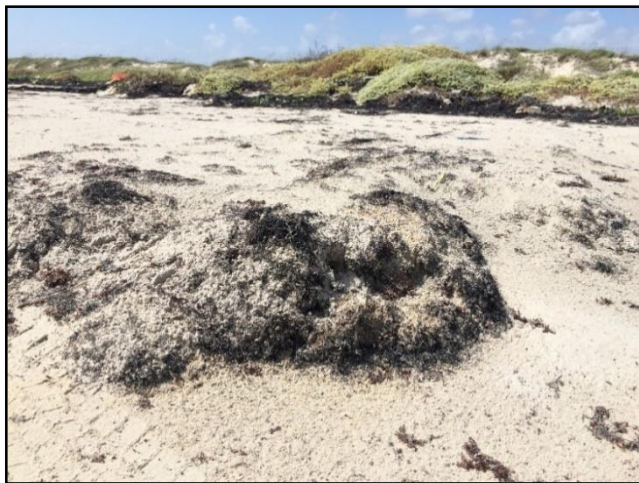
FIGURE 4. AEOLIAN SAND DEPOSITION ON *SARGASSUM* WRACK AT MUSTANG ISLAND STATE PARK.

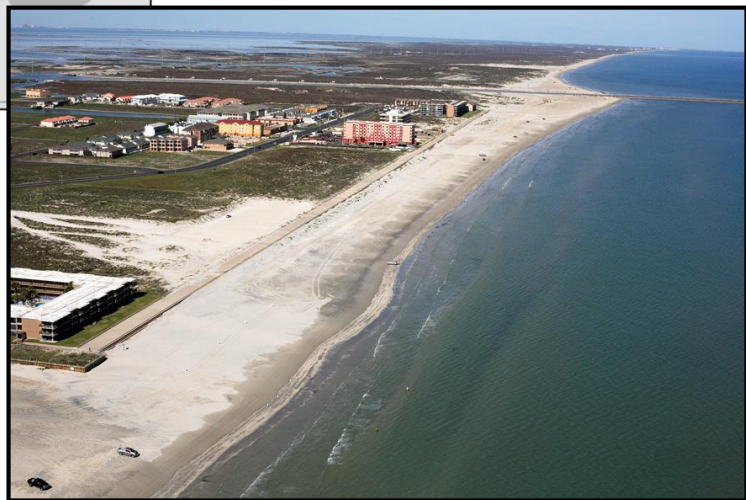
FIGURE 6. BEACH AFTER 2012 NOURISHMENT. PHOTO BY LANMON AERIAL PHOTOGRAPHY INC. AVAILABLE ONLINE AT [HTTP://WWW.CBI.TAMUCC.EDU/CHRGIS/NORTH-PADRE-BEACH/](http://www.cbi.tamucc.edu/CHRGIS/NORTH-PADRE-BEACH/)

erosion of the beach limits beach public access in this area (Williams and Kraus 2011). As a result of this, vehicular access is periodically restricted by shore-perpendicular bollards for 305 m (1,000 ft) at the south-end of the seawall. The bollards are removed when the width of the beach from the seawall to mean high tide is greater than 45.7 m (150 ft). As an erosion-response measure, beach nourishment of this section of beach is conducted from sand dredged from Packery Channel. The first beach nourishment was completed between 2005-2006, during the construction of Packery Channel (Williams and Kraus 2011). The second nourishment was completed during the 2012 dredging event (Figure 6).

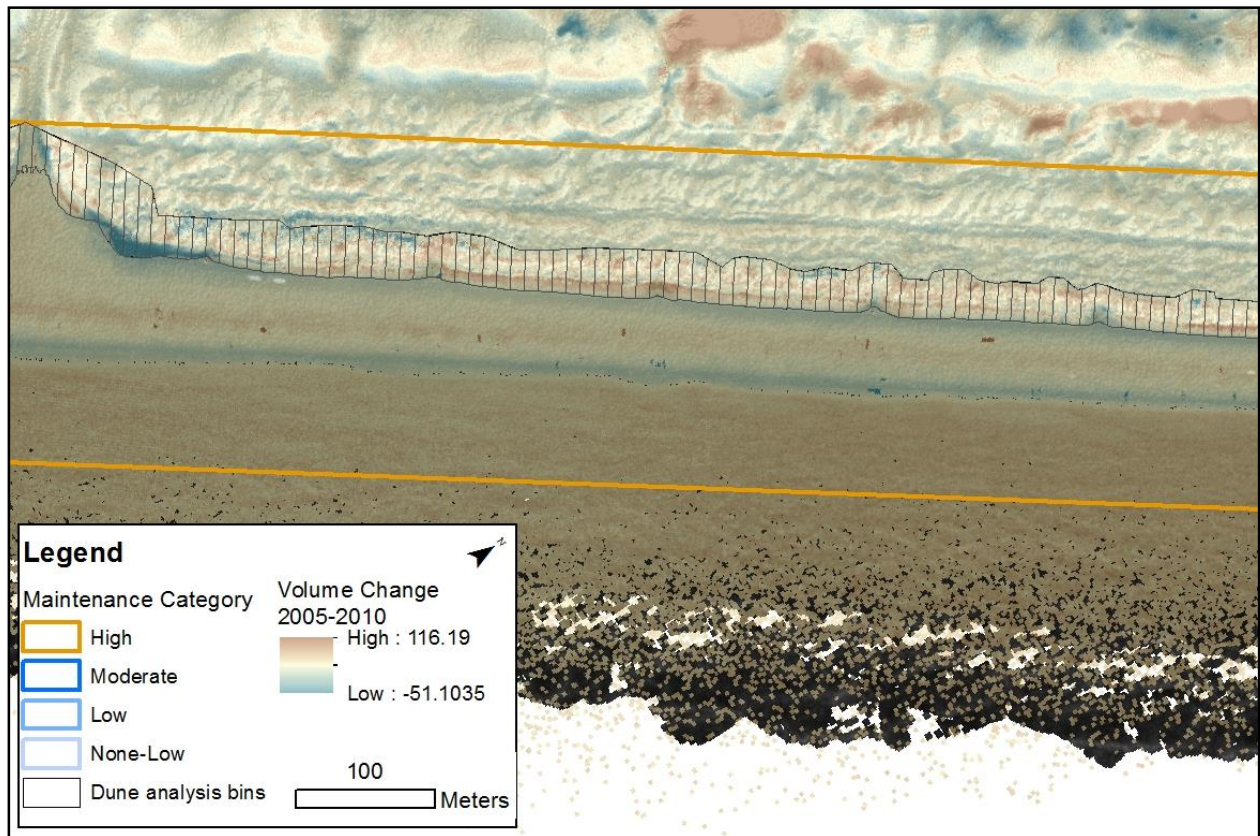
FIGURE 11. EXAMPLE OF FOREDUNE BINS FOR VOLUME ANALYSIS.

Volume calculations of the foredune were performed for the foremost vegetated dune ridge in the backshore; this section may include coppice mounds if present. The foredune landward boundary was mapped using aspect and elevation values extracted from lidar-derived DEMs. Areas of significant volume change from 2005-2010 were considered in the mapping of the foredune. The seaward boundary of the foredune was established using the Potential Vegetation Lines as mapped by the University of Texas Bureau of Economic Geology (BEG) (Paine, J. G, Caudle, and Andrews 2013). The 2010 line was used as the seaward boundary and edited where there was a need to be more inclusive. Foredune polygons were bisected using cross-shore transects 10 m apart (**Error! Reference source not found.**). Volume calculations for each available year were obtained for each 10 m wide bin. Dune walkover structures were removed from the volume calculations.

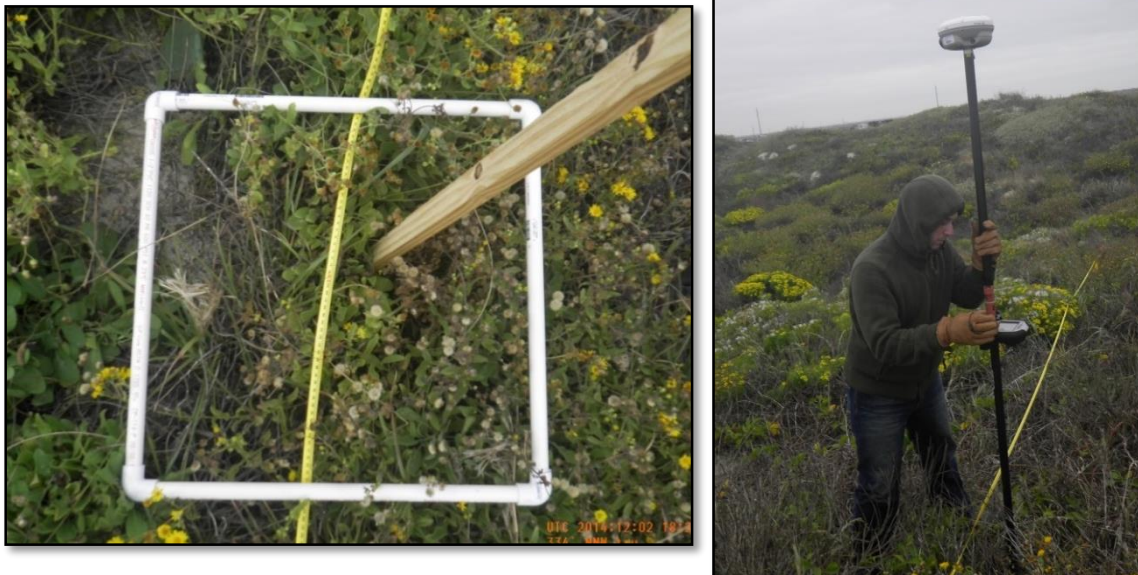
FIGURE 12. EXAMPLE OF QUADRAT USED FOR SAMPLING OF VEGETATION (LEFT). HRI STAFF TAKING RTK-GPS COORDINATE MEASUREMENTS.

Vegetation diversity was estimated and vegetation cover measured using a quantitative sampling method at seven locations in the study area (**Error! Reference source not found.**). At each location, two transects were established from the seaward boundary of the vegetation (or dune toe if vegetation was not present), landward across the foredune into the dune slack or vegetated flat. The distance between transects was set at 10 m. Each transect was sampled at three-meter intervals with a sampling quadrat of 0.5 m². At each sample location vegetation type, percent cover, and height were collected. In addition, topographic data was collected at each sample site using a Trimble R8 Real Time Kinematic (RTK) system. Vegetation classification was based on Richardson (2002). Surveys were conducted in December 2014 and July 2015.

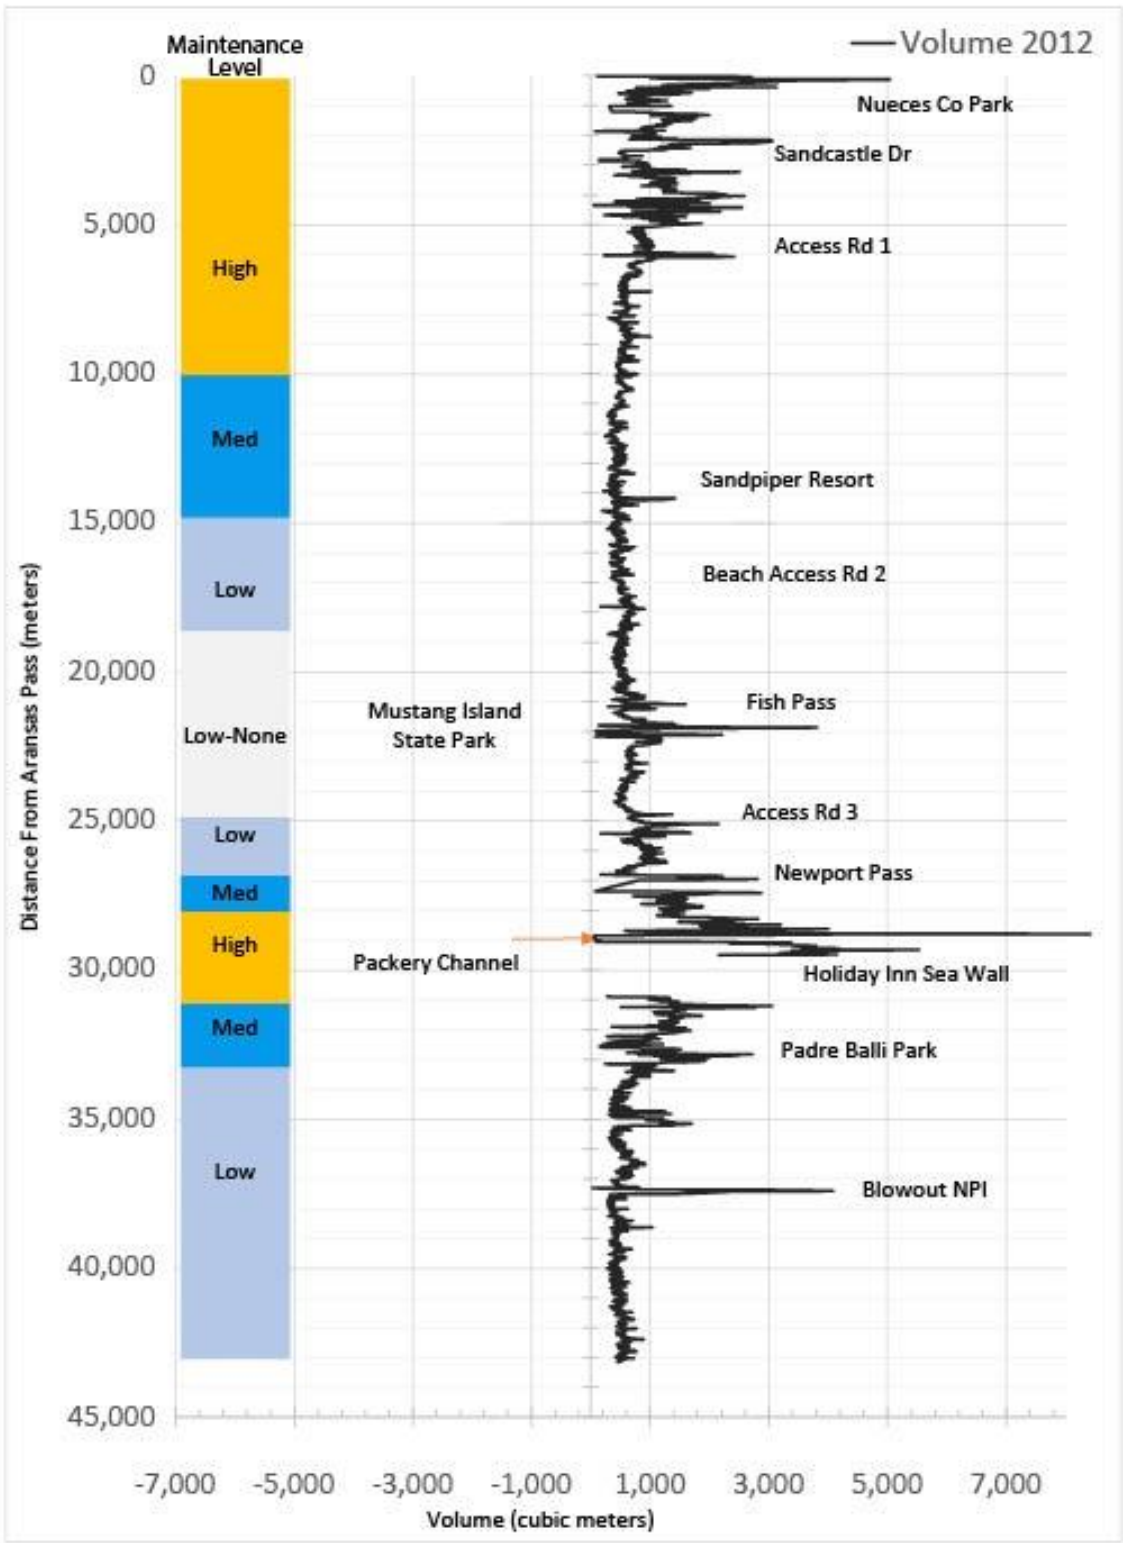
FIGURE 16. NET DUNE VOLUME FOR THE YEAR 2012.

Foredune volume changes were estimated between the Epochs of August 2005-February 2012, April 2010 – April 2011, and April 2011 -- February 2012. **Error! Reference source not found.** presents the net volume within each 10 m wide section of foredune for the study area. Foredunes closer to inlets, also corresponding to high and moderate maintenance areas, have larger dunes or dunes with more volume per width of beach. Other areas of high volume are blowouts, foredunes of Mustang Island State Park, and dunes adjacent to Newport Pass.

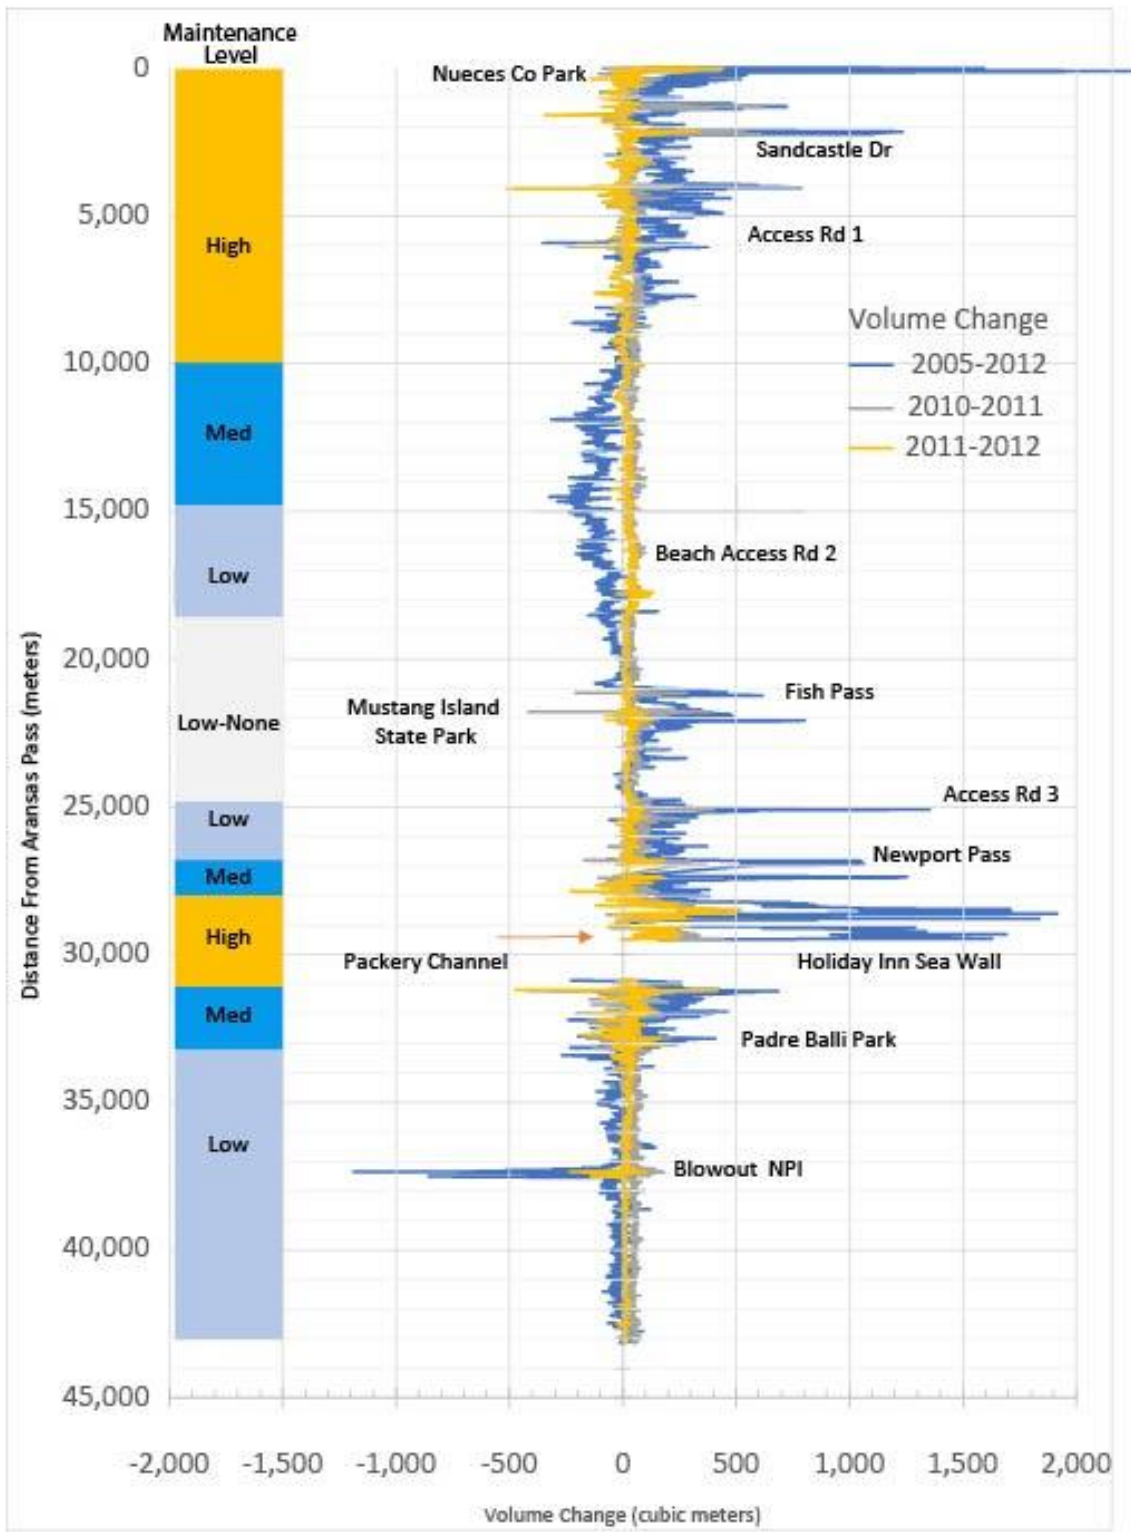
FIGURE 17. DUNE VOLUME CHANGE, CUBIC METERS.

Volume change is graphed alongshore in **Error! Reference source not found.** and the mean of dune volume change for each maintenance category is plotted in **Error! Reference source not found.** Over the 6.5 year period between Lidar datasets (2005 to 2012) the foredune ridge along the study area experienced variable net volume change. The quantity of volume change corresponds with the size of the foredune: large foredunes accumulated greater volume. When grouped by maintenance category (**Error! Reference source not found.**, top right), the high maintenance group had the highest average dune volume change (227 m³), as well as a high standard deviation. The low maintenance group had an average dune volume change of -11 m³, and may correspond with areas of shoreline retreat along Mustang Island. Visual observation of volume change patterns confirmed retreat of foredune due to scarping across most of Mustang Island and on the southern portion of the study area. Dune expansion occurred near jetties of Aransas Pass, Fish Pass, and Packery Channel.

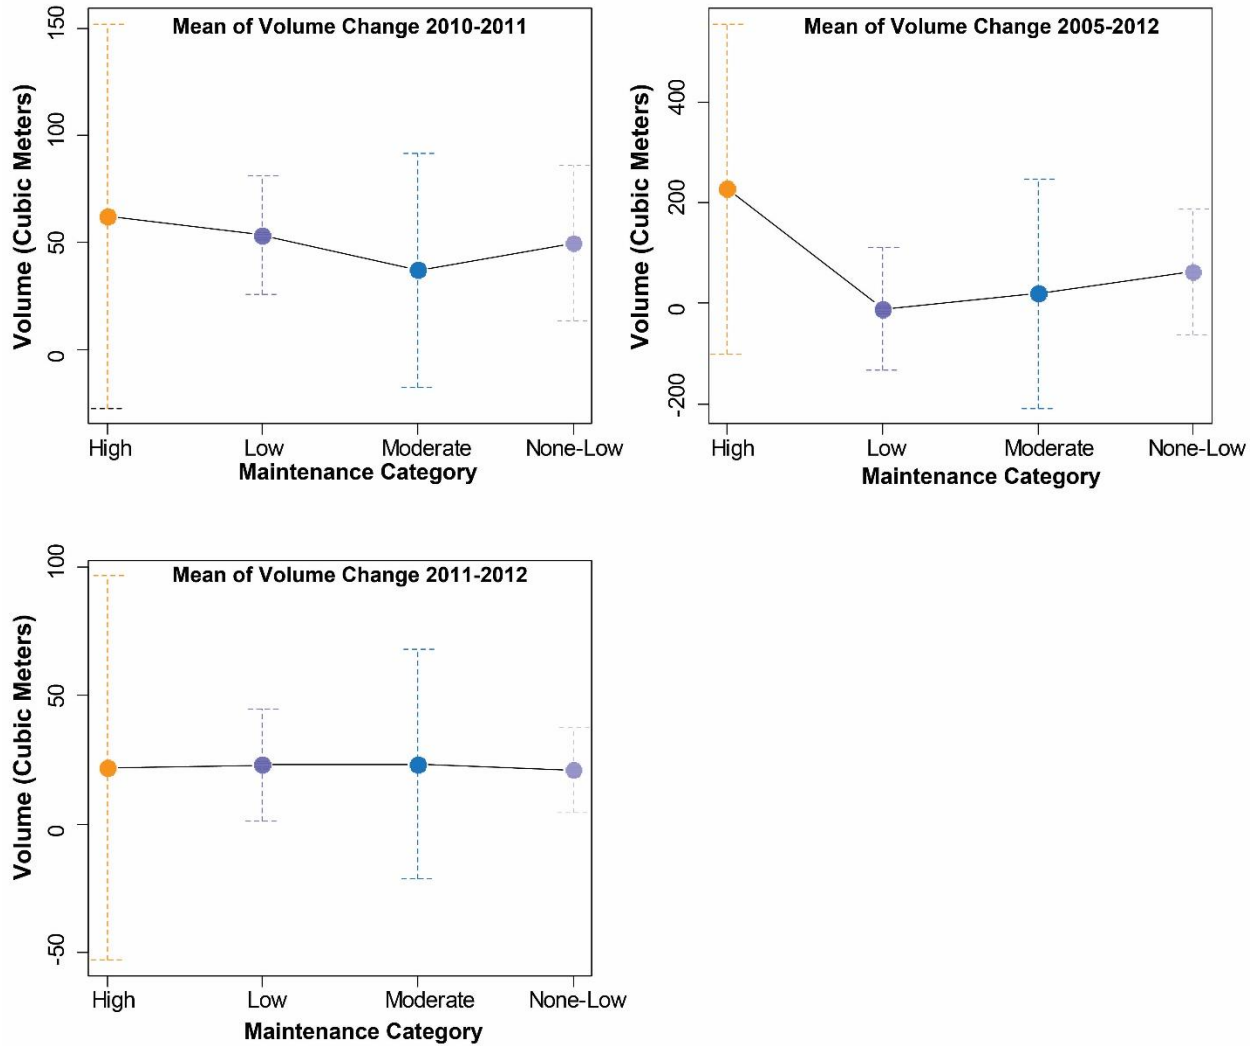
FIGURE 18. VOLUME CHANGE BY MAINTENANCE CATEGORY FOR TIME PERIODS 2010-2011 (TOP LEFT), 2011-2012 (BOTTOM LEFT), AND 2005-2012 (TOP RIGHT). HIGH AND MODERATE MAINTENANCE AREAS EXPERIENCE HIGH SPATIAL VARIABILITY IN DUNE VOLUME CHANGE THROUGH ALL TIME PERIODS.

From April 2010 to April 2011, there was an overall increase of dune volume across the study area. During this year, mean dune volume change was very similar between high, low, and low-none maintenance categories (62 m³, 53 m³, and 49 m³, respectively). In the most recent epoch from April 2011- February 2012, all maintenance categories had an average increase in dune volume: 22 m³, 23 m³, 23 m³, and 21 m³ for high, moderate, low and low-none maintenance categories, respectively. Similar to other time periods, high and moderate maintenance categories had high standard deviations (**Error! Reference source not found.**) and many of the areas experiencing high volume loss were located in high maintenance areas. Much of the volume gain could be attributed to accretion at the dune toe. From 2011-2012, the variability of volume on the high maintenance section near Aransas Pass was attributed to back stacking and dune notching. High variability in moderate maintenance areas south of Mustang Island State Park and around Padre Balli Park was due to development of localized foredune blowouts.

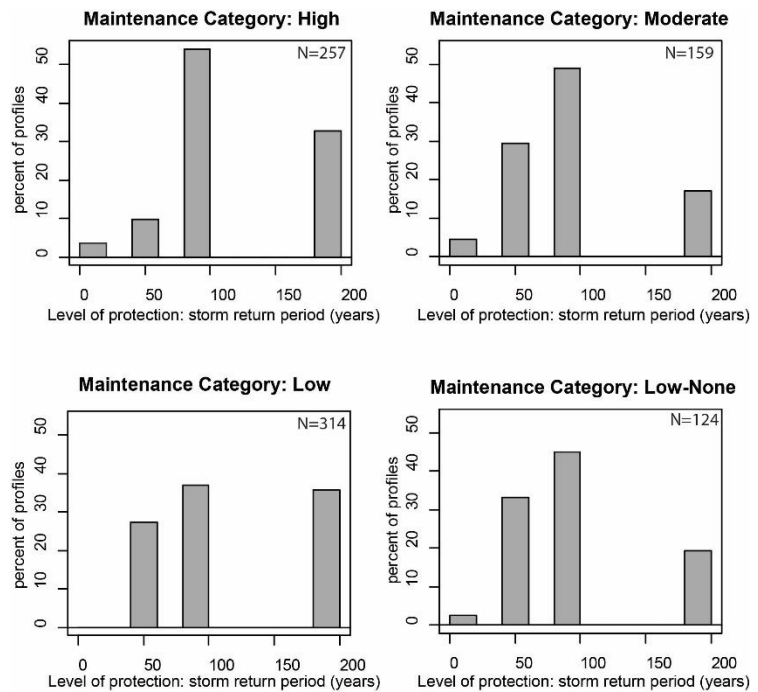
FIGURE 19. PERCENT OF BEACH PROFILES WITHIN EACH MAINTENANCE CATEGORY THAT HAVE A 0-, 50-, 100-, 150-, AND 200-YEAR STORM RETURN PERIOD PROTECTION FROM FLOODING AND EROSION.

The results for assessment of storm protection along the study area are presented in **Error! Reference source not found.** and **Error! Reference source not found.** Storm protection generally corresponds with the volume of the foredune and varies along the study area. The greatest number of profiles featured in the SSI analysis offer a storm level of protection for a 100 year storm (45%), followed by 200-year storm protection (29%) and 50 year-storm protection (23%). When compared by maintenance level, approximately 85% of high, 65% of moderate, 75% of low, and 65% of low-none profiles offer at least 100-year

(10%) compared to other categories (~30%). The low maintenance category did not exhibit profiles with 0-year storm protection, all others exhibit less than 10%.

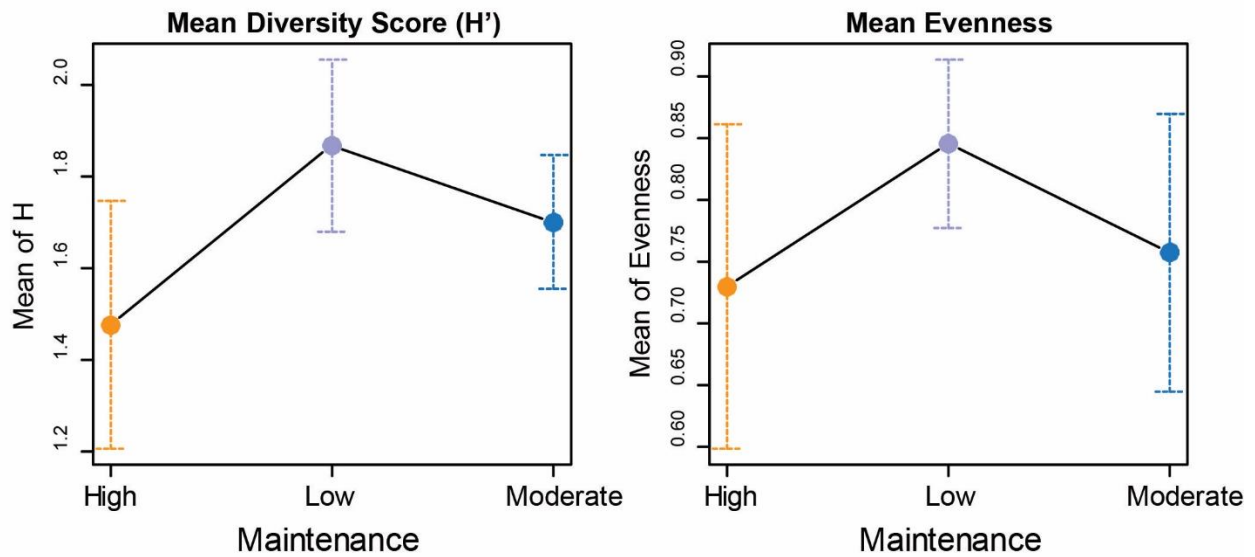
FIGURE 22. PLOT OF MEANS FOR DIVERSITY H' (LEFT) AND EVENNESS SCORE (RIGHT). ERROR BARS REFLECT STANDARD DEVIATION.

Because data was replicated among sites for two different time periods, a nested ANOVA was conducted to test significance between maintenance levels. ANOVA results show significant difference in mean diversity score (H') at a significance level <0.001 , plot of means is shown in Figure 22. The ANOVA results also show a significant difference in evenness among maintenance levels at a significance level of 0.05. Evenness values are very similar for high and moderate sites. Overall, low maintenance sites experience higher diversity and evenness scores, when compared to areas of high or moderate maintenance.

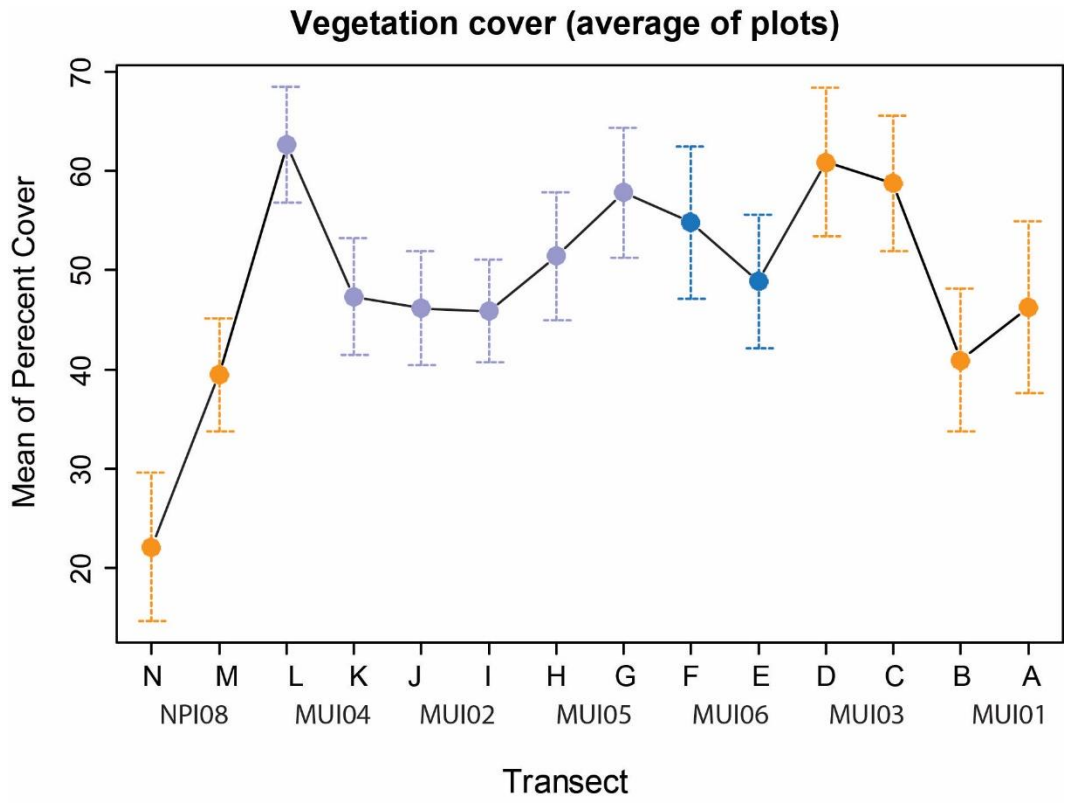
FIGURE 23. MEAN PERCENT COVER OF TRANSECT SITES.

ANOVA of vegetation cover did not result in a significant difference between maintenance categories, mainly because of the contrast between high maintenance sites. High maintenance profiles on Mustang Island average 40-60% in vegetation cover (excluding dead vegetation), while the high maintenance profile on North Padre shows a significantly lower percent cover of 25-35%. Although high on vegetation cover, MIU03 is the site of lowest diversity, where Silverleaf Sunflowers cover most of the foredune. Moderate and low maintenance beaches have an average range of 45-65% cover.
