Exploration Green Public Access Development and Ecosystem Restoration

GLO Contract #: 17-191-000-9828

FINAL REPORT August 24, 2018

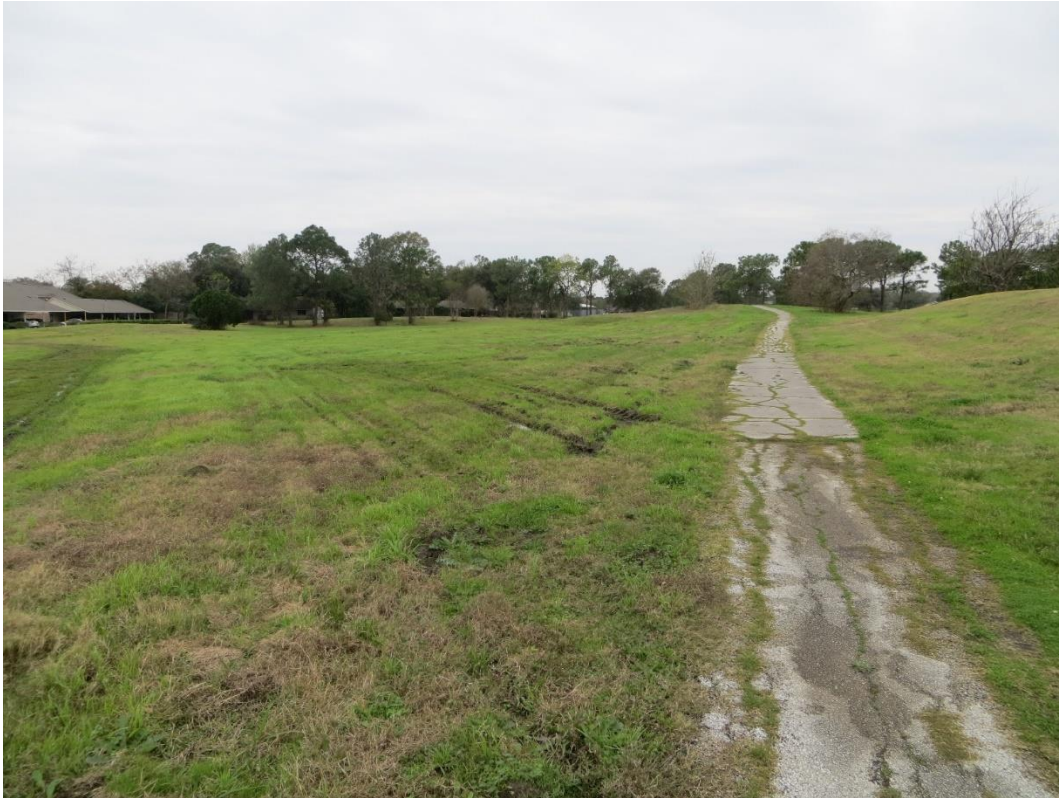
Figure 1. Phase 1A Pre-construction showing old golf cart path

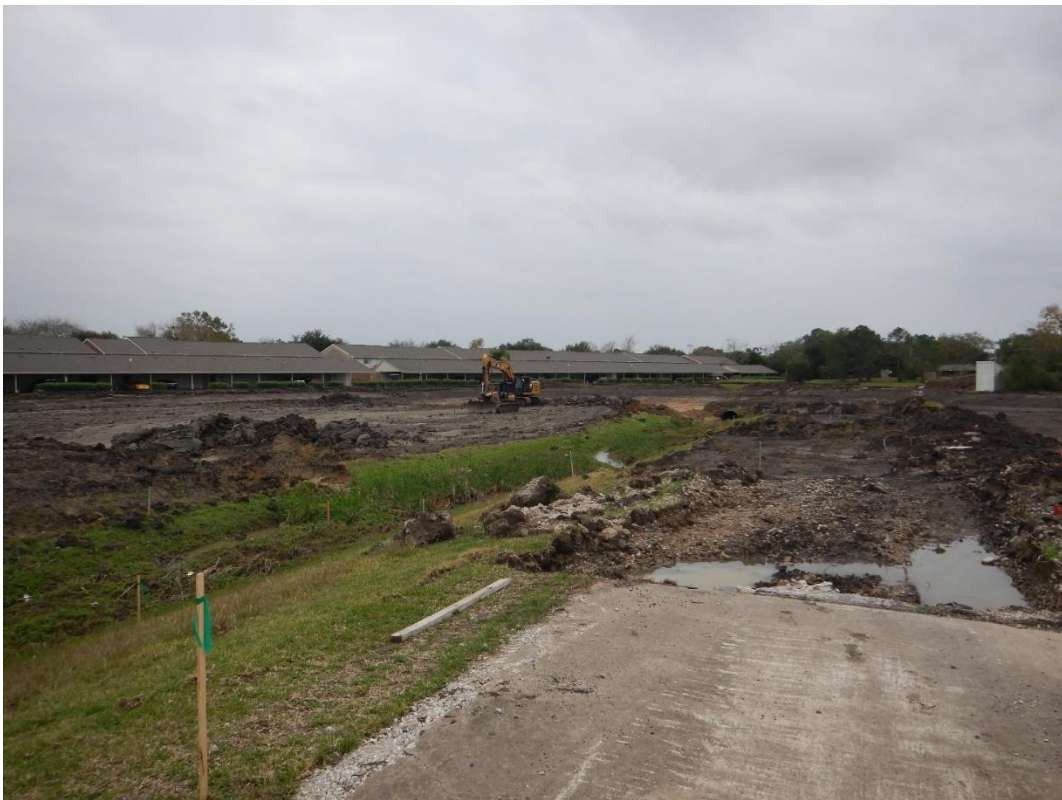
Figure 4. Phase 1A excavation

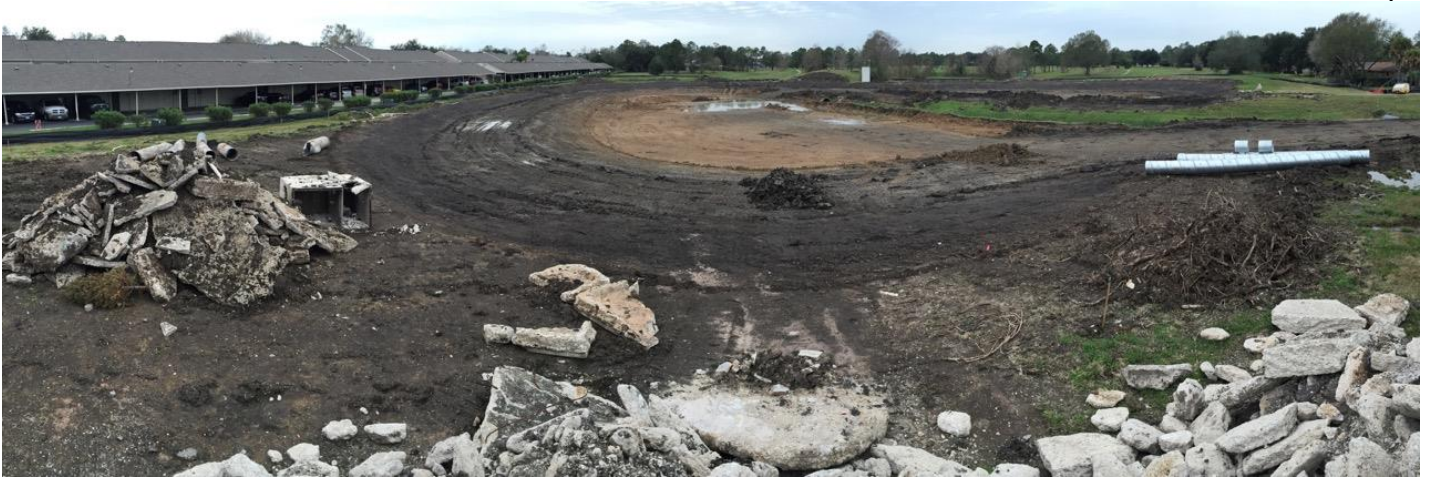
Figure 5. Phase IA excavation

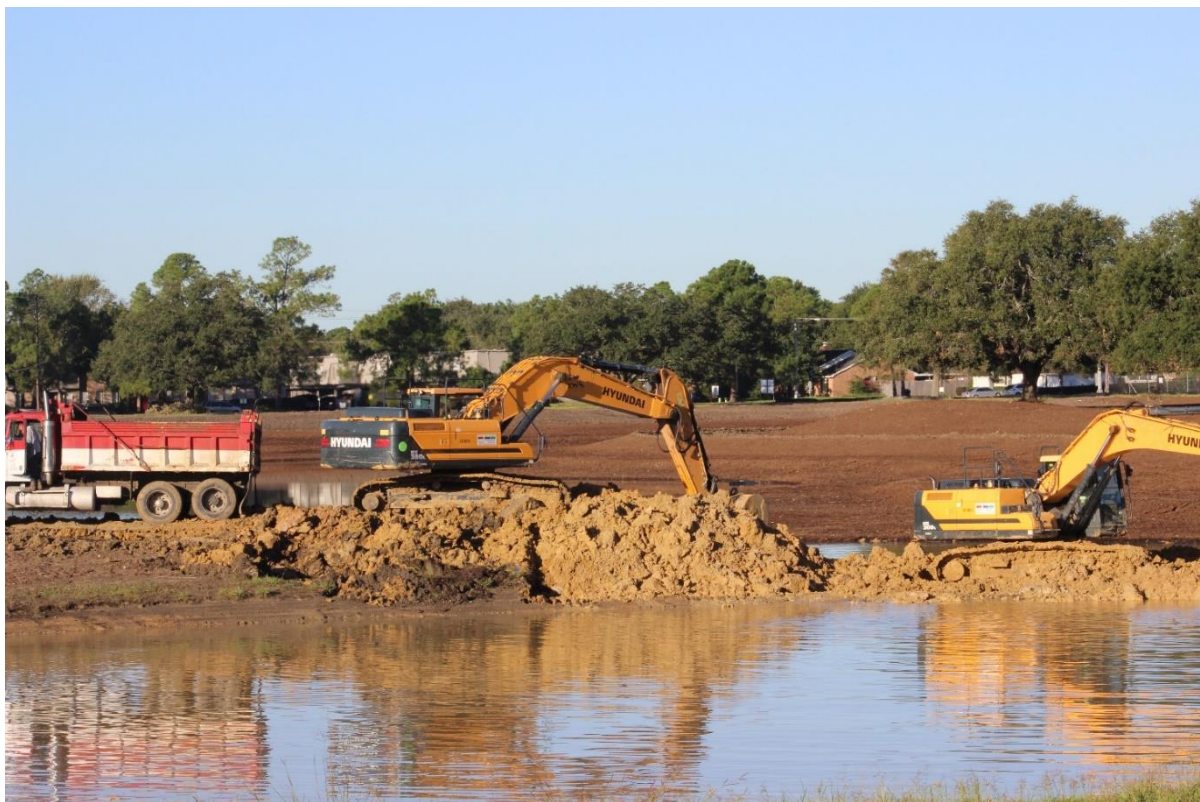
Figure 6. Phase I construction

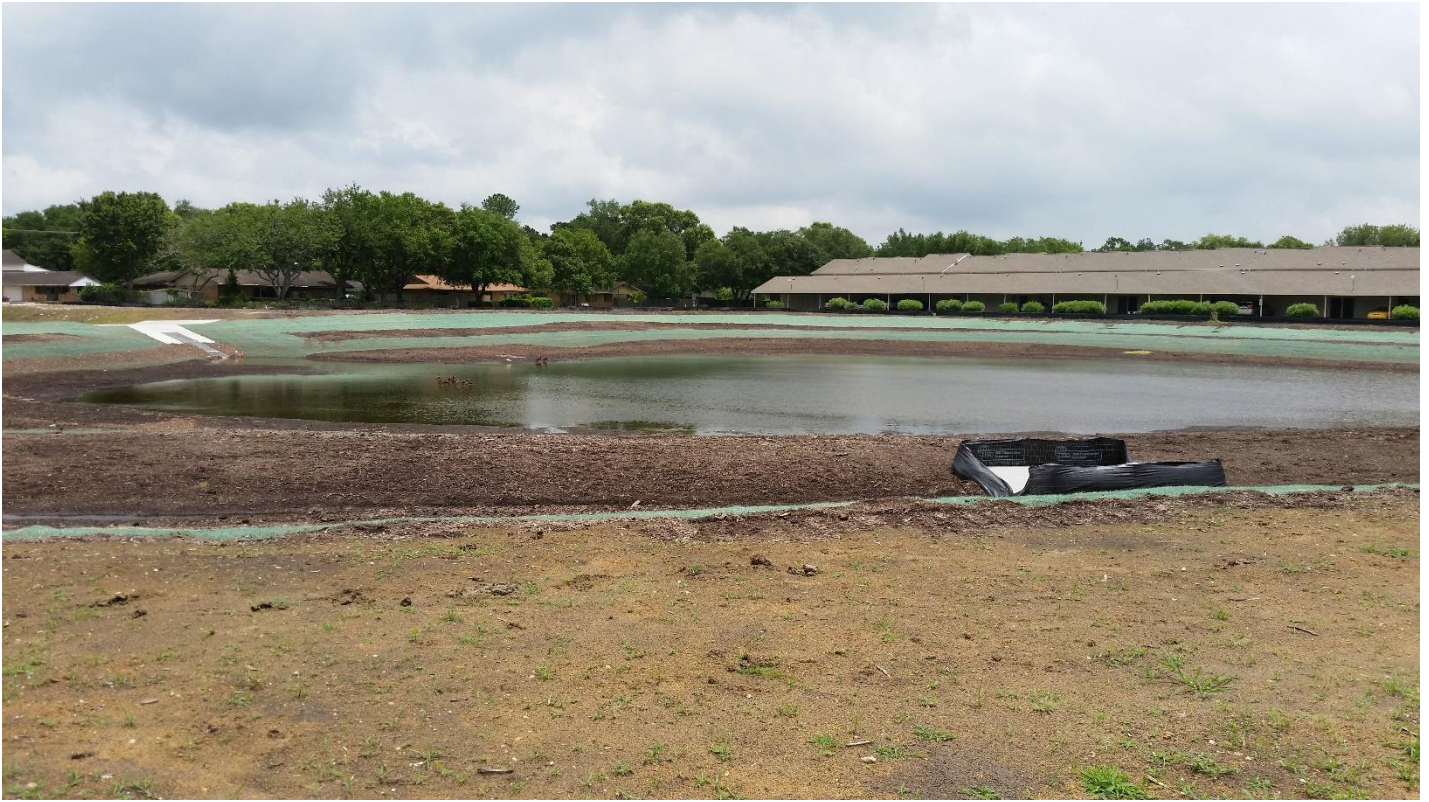
Figure 7. Construction of Phase 1A after seeding.

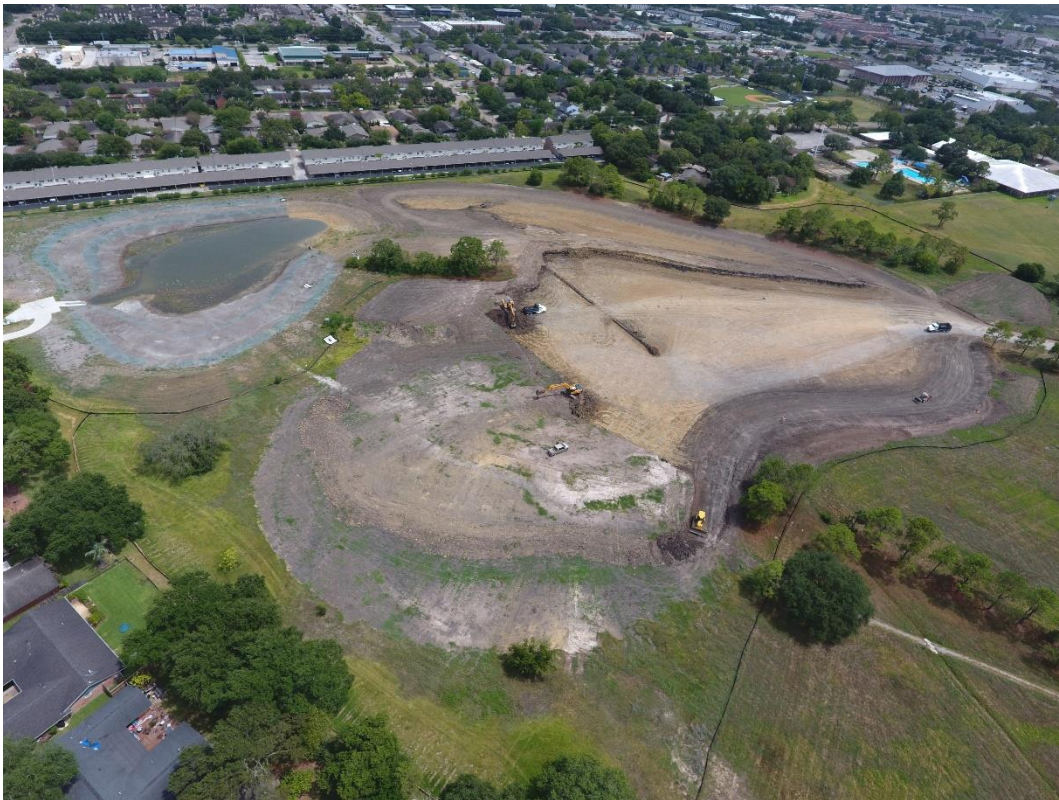
Figure 8. Phase 1B construction site.

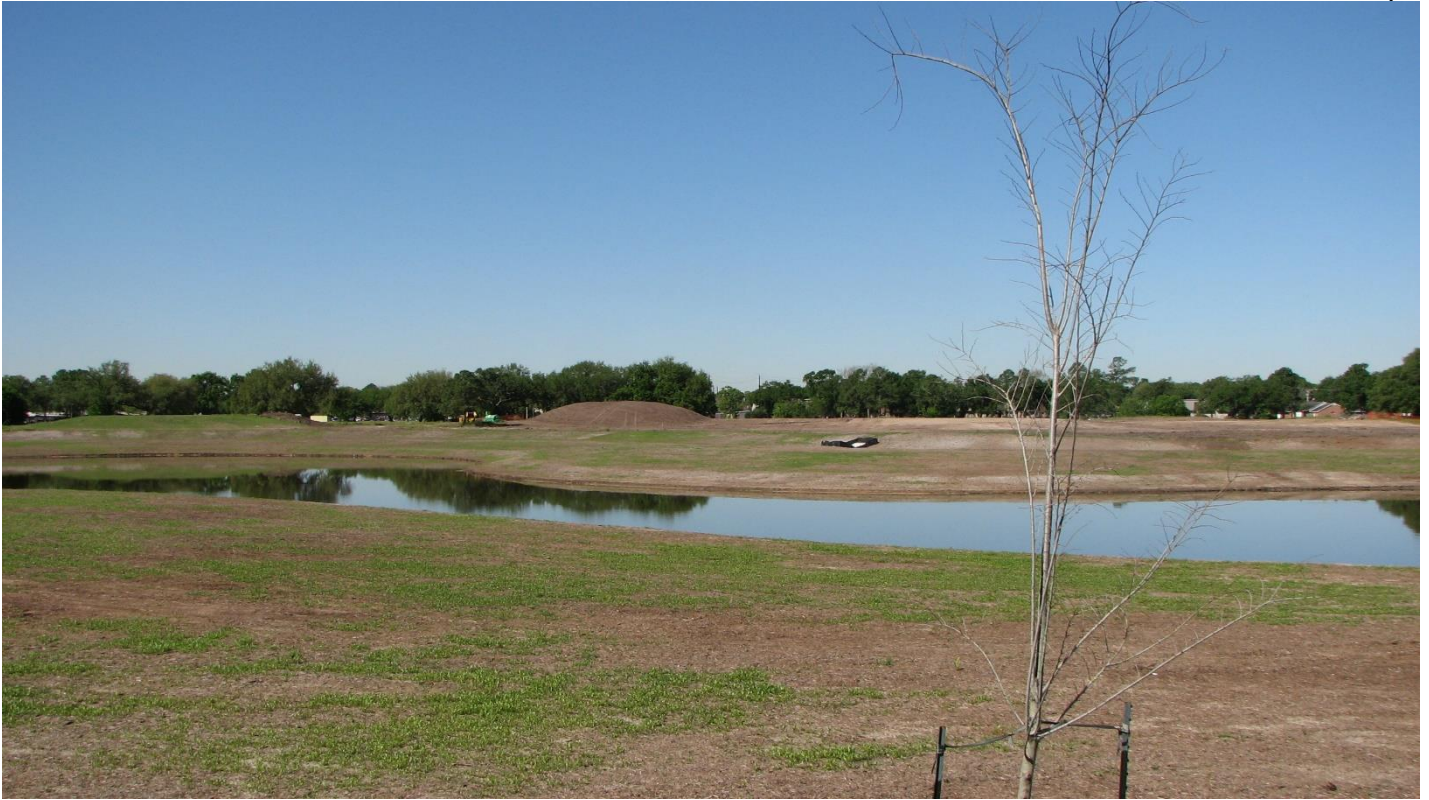
Figure 9. Phase 1B before habitat island was constructed.

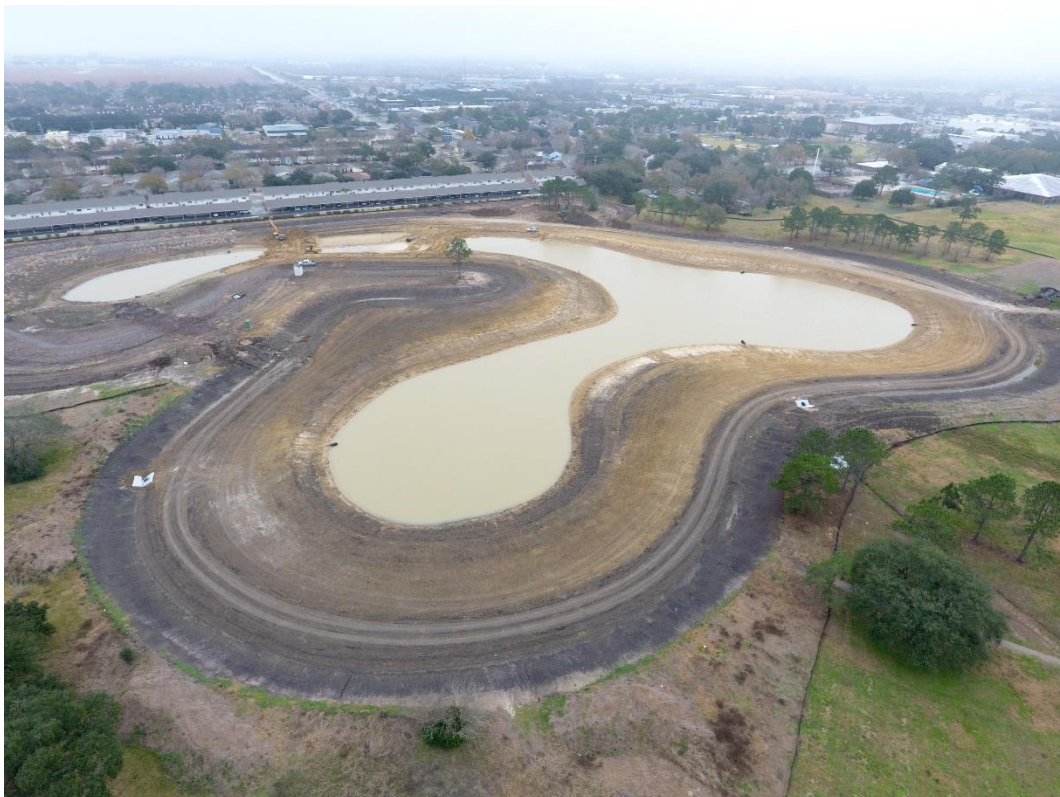
Figure 10. Phase 1A and 1B before 1C excavation.

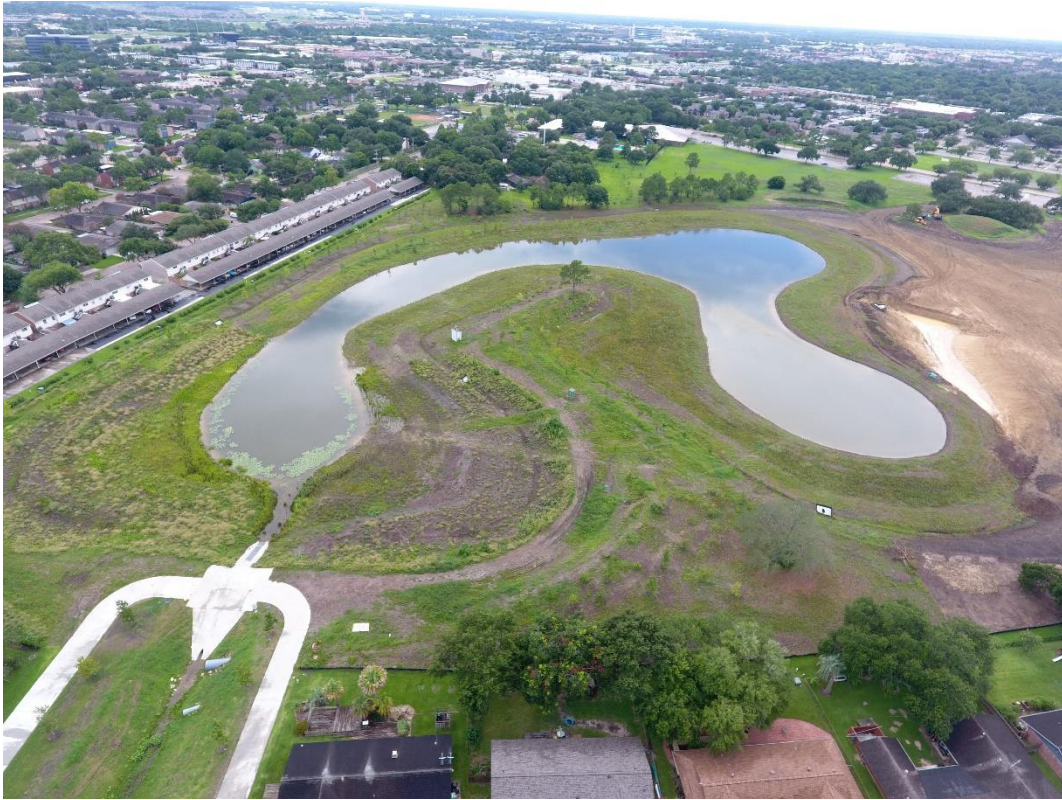
Figure 11. Phase 1A and 1B after seeding and during 1C construction.

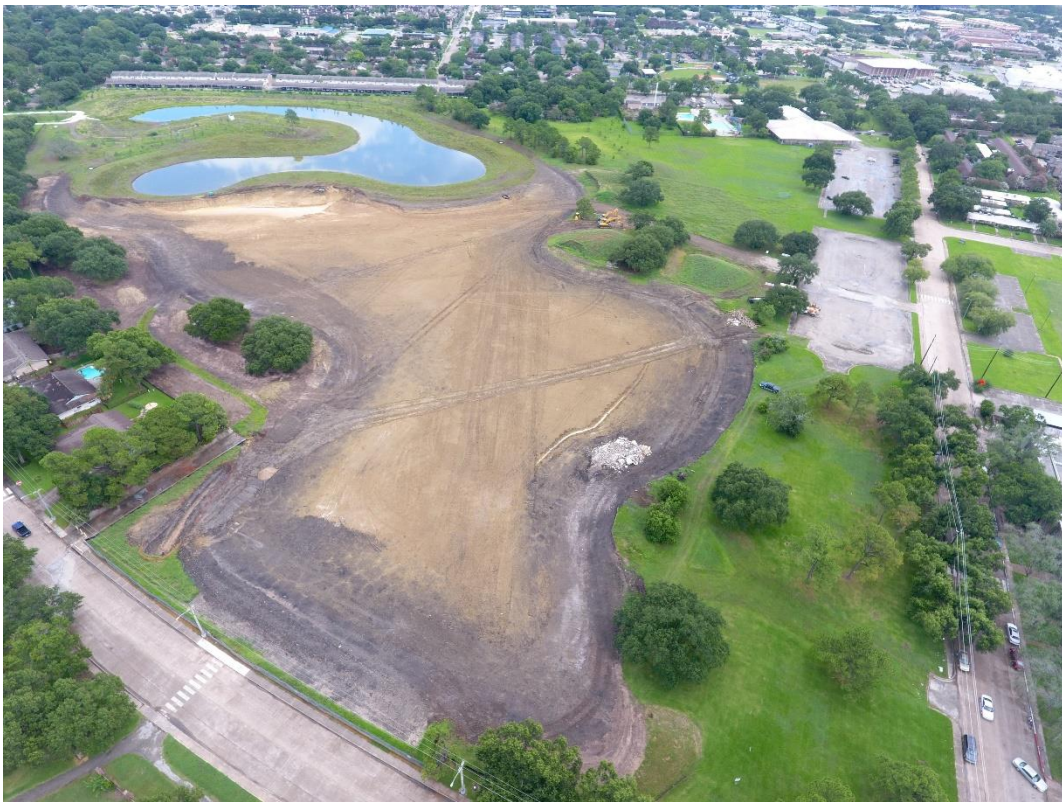
Figure 12. Phase 1C construction

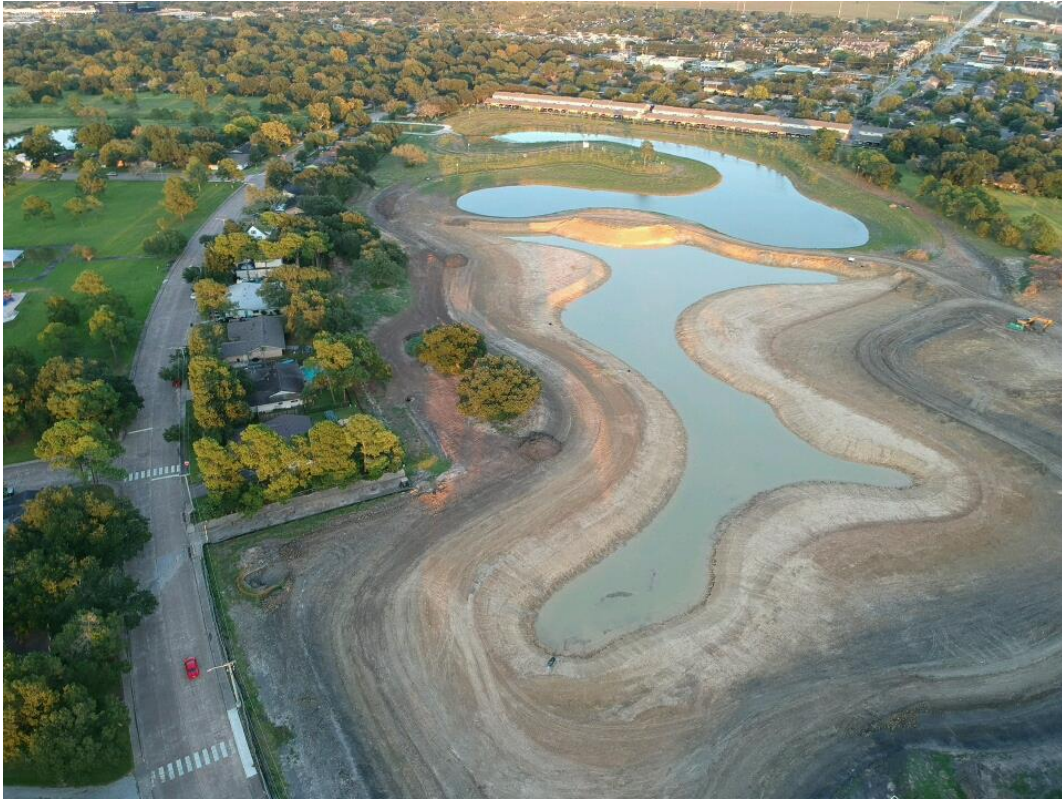
Figure 13. Phase 1A through C with land bridge to habitat island.

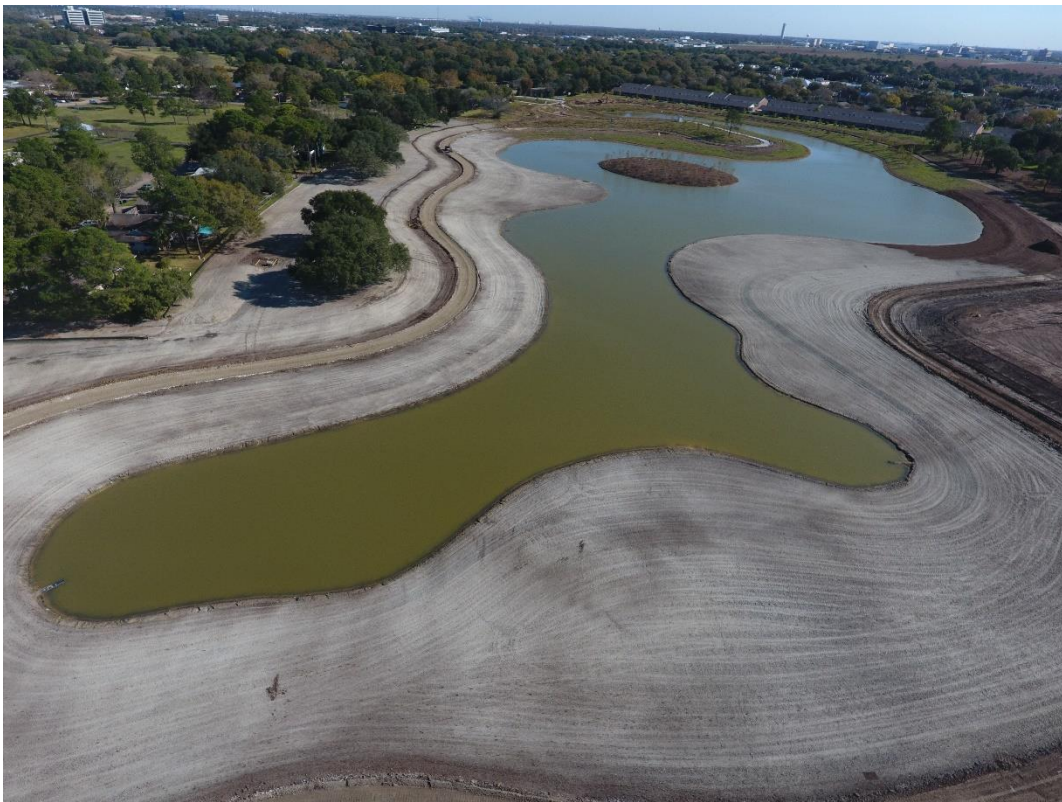
Figure 14. Phase 1A through C facing east after land bridge was removed from habitat island.

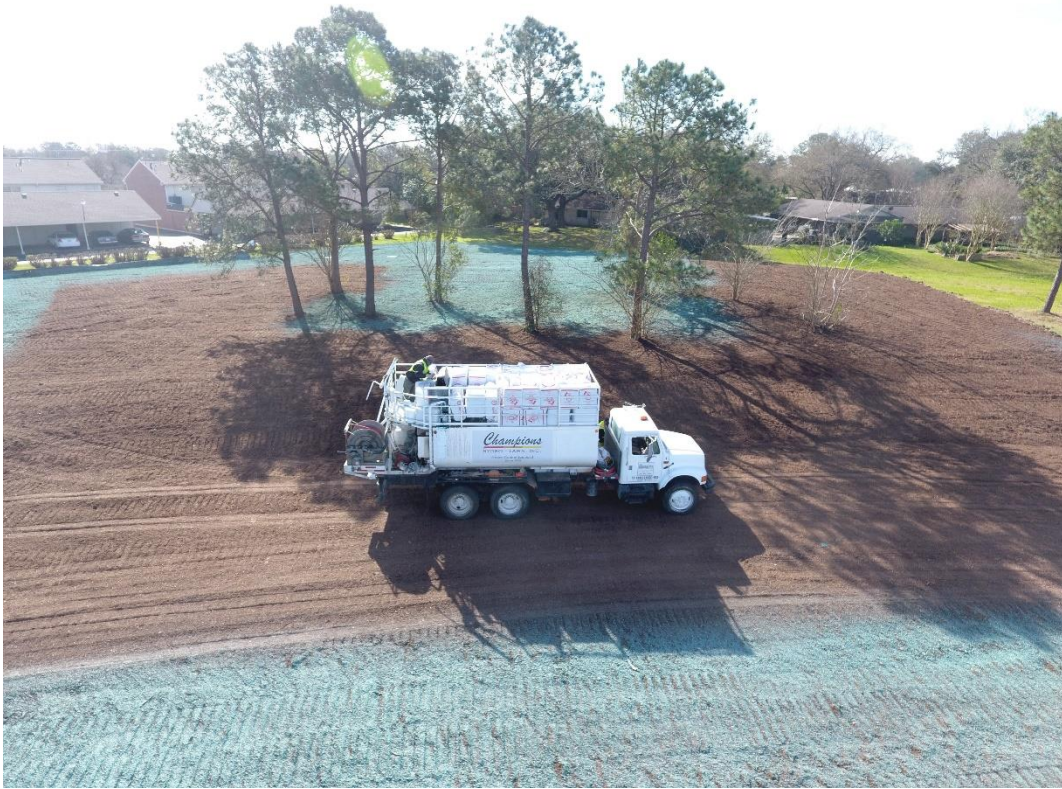
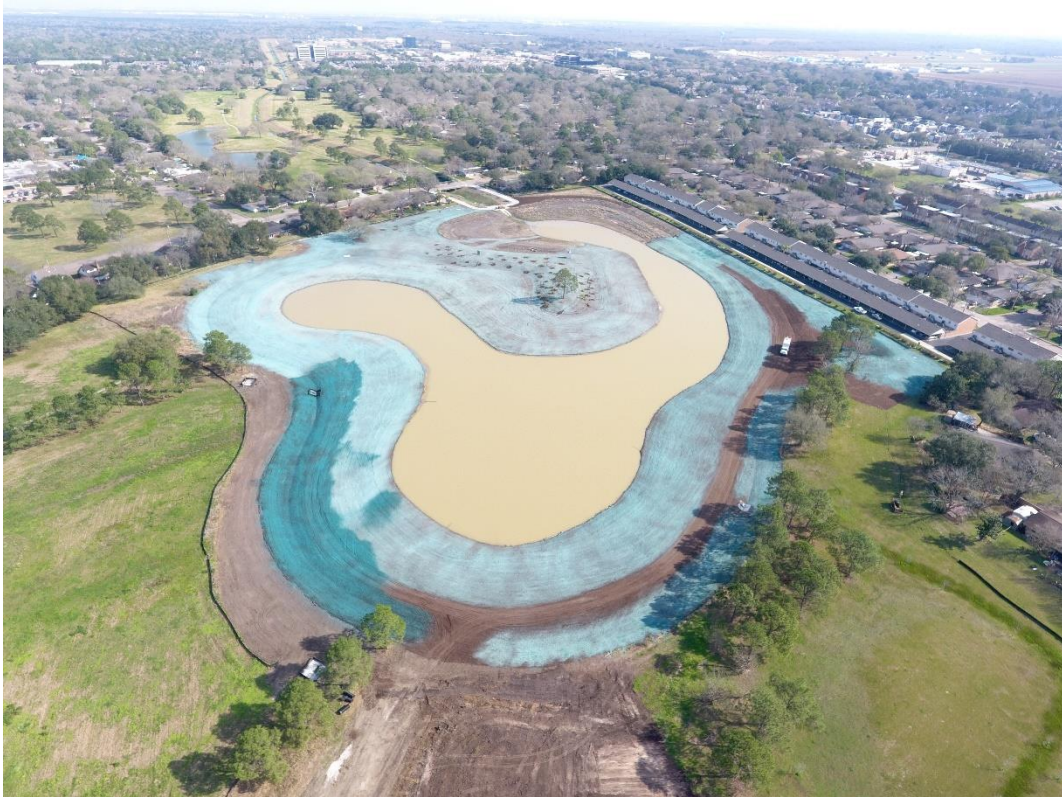
Figure 15. Hydroseeding Phase 1A.

Figure 16. Hydroseeding Phase 1A.

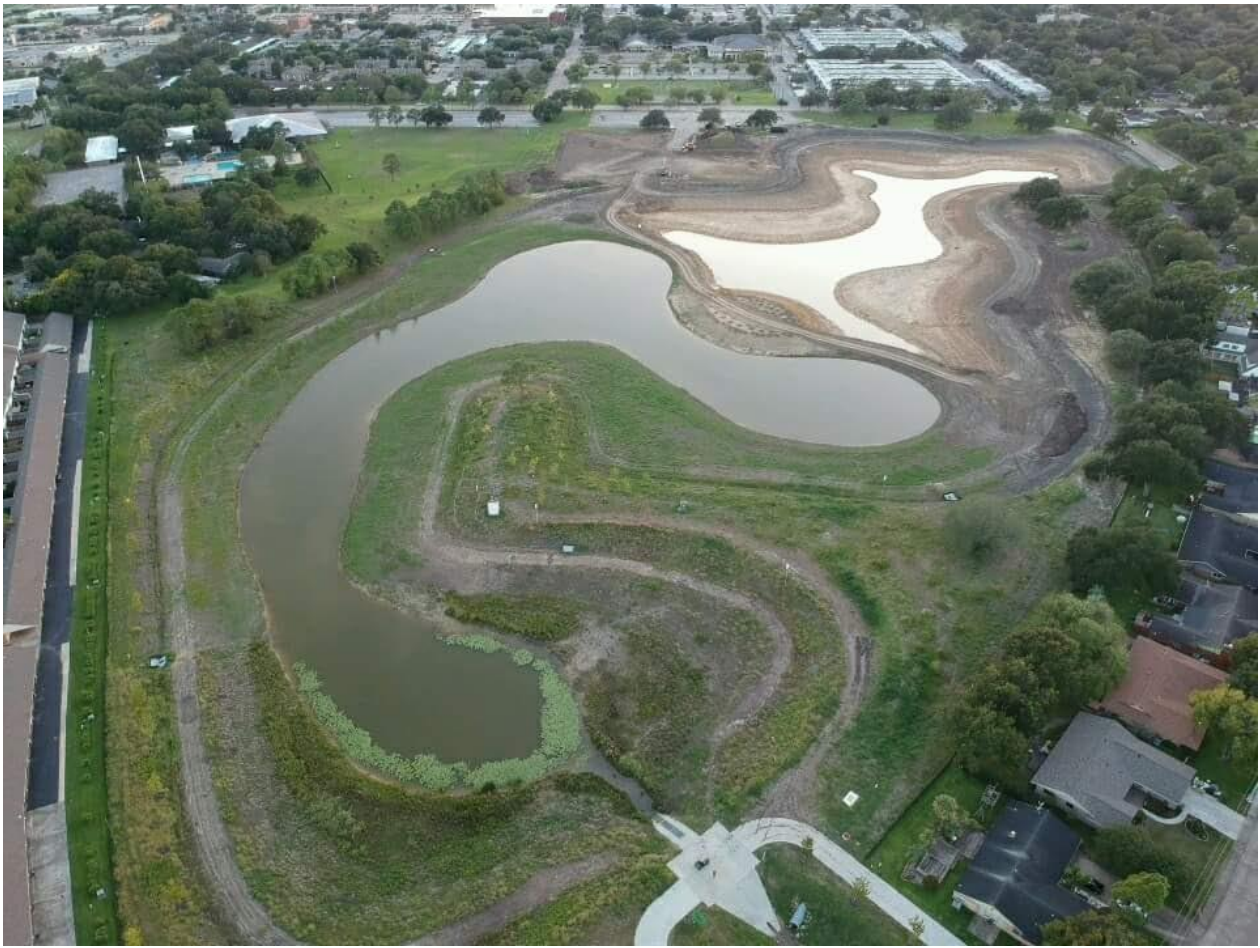
Figure 22. Phase 1 habitat island construction, land bridge still intact.

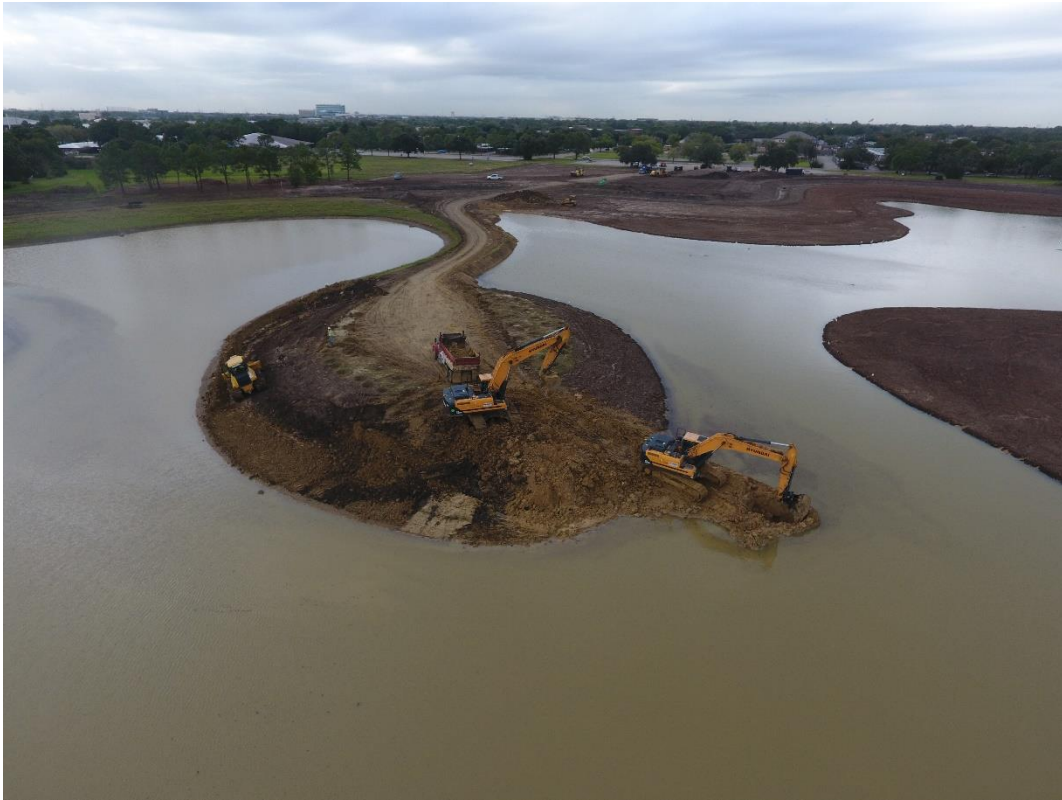
Figure 23. Removal of habitat island land bridge.

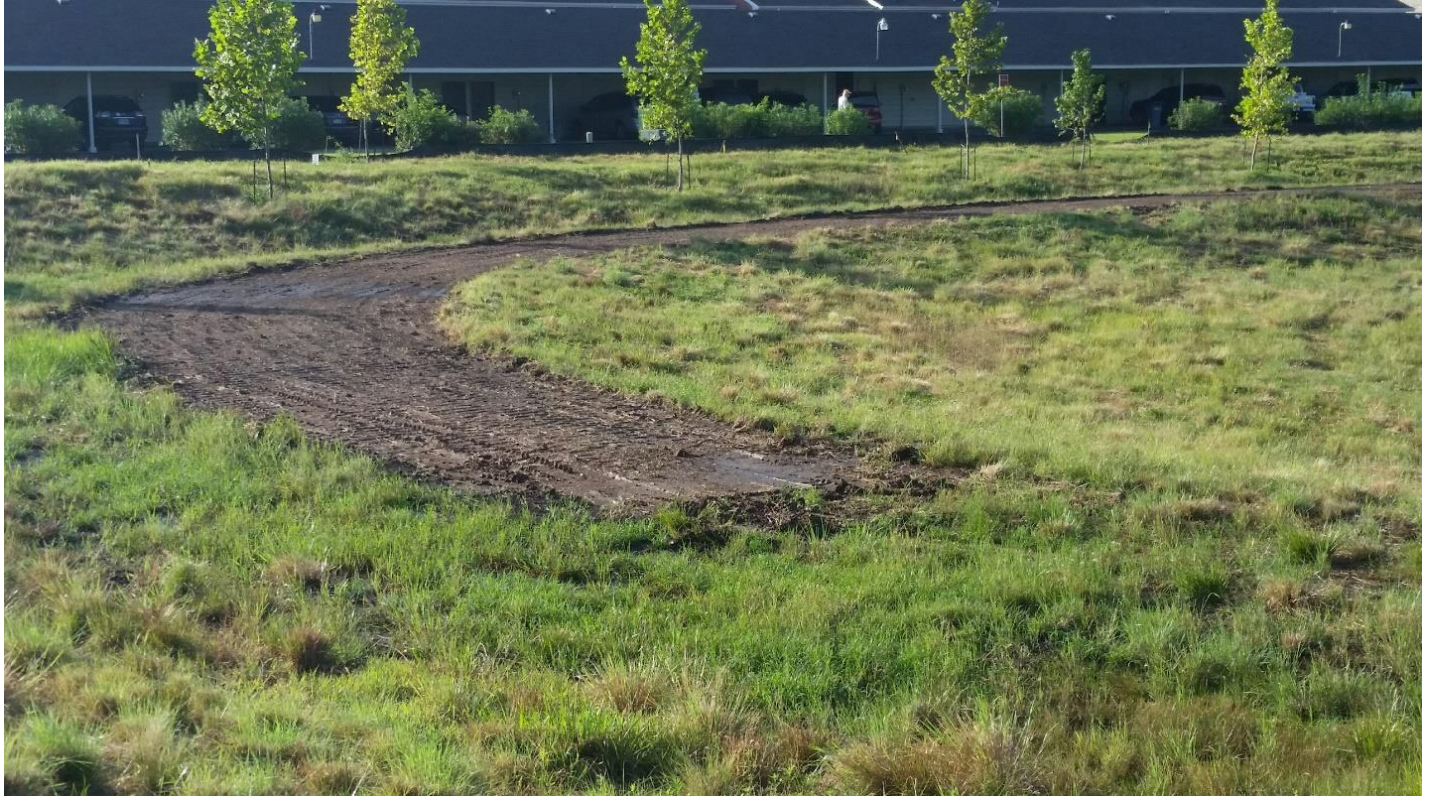
Figure 26. Initial Phase 1 trail construction.

- Provide a brief description of status of the task.
 - Phase 1 ADA compliant trail was completed in March of 2018 and measures 10 feet wide and 1.1 miles. All CMP funded Phase 1 habitat related activities were completed in May of 2018. At which time restoration efforts included seeding with a native seed mix, planting 700 native trees and shrubs as well as assisting with planting over 16,000 wetland plants through volunteer workdays. As part of the restoration efforts, 11,500 feet of reuse irrigation line was installed to help promote growth of the native vegetation.

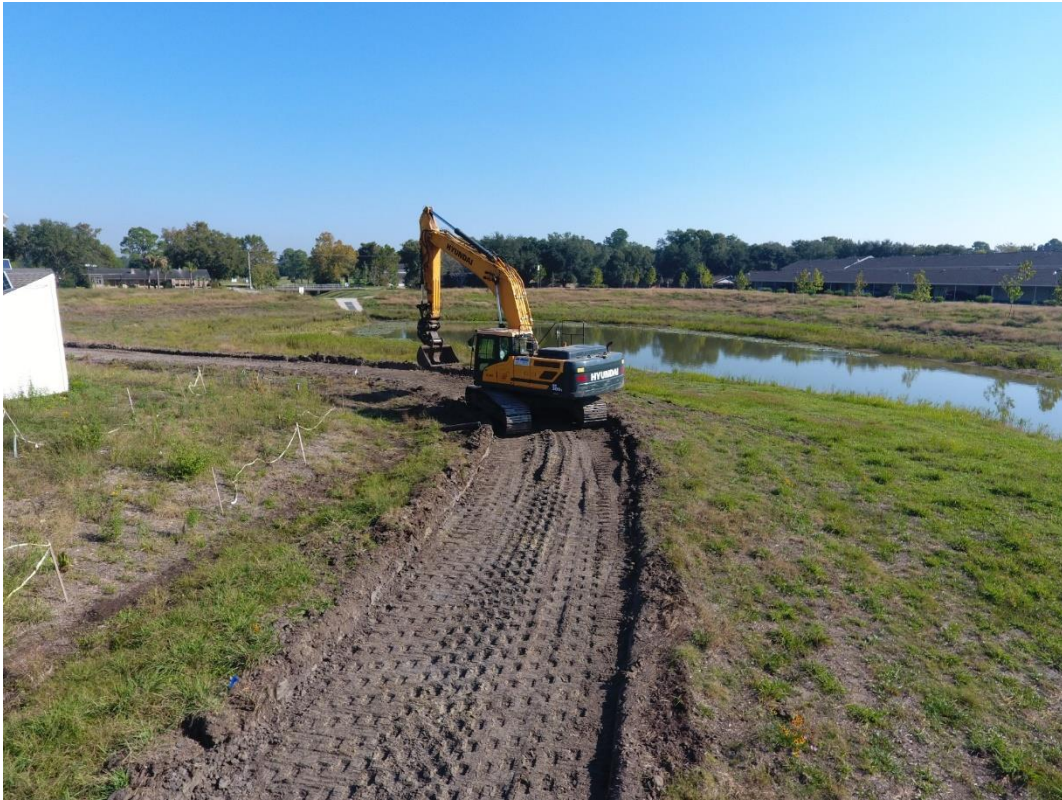
Figure 27. Trail construction around Phase 1A.

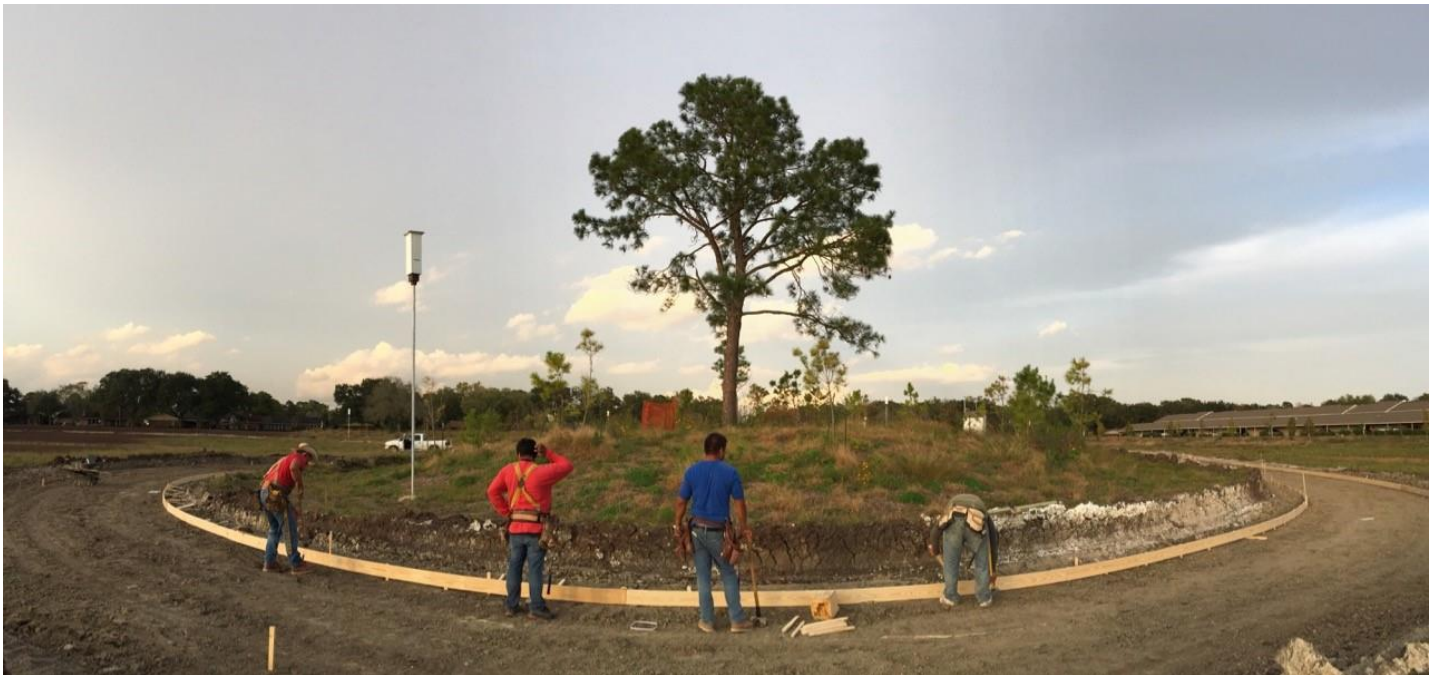
Figure 28. Trail construction around Phase 1A with bat box installed by a boy scout as a separate project.

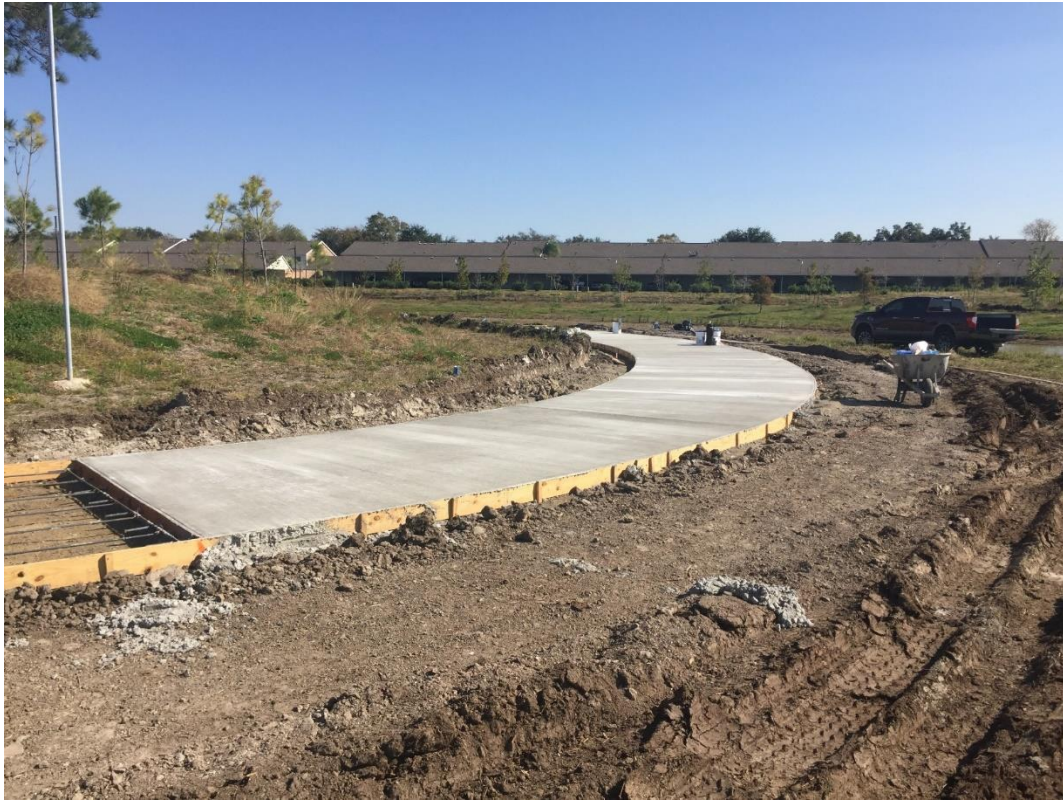
Figure 29. Trail construction with concrete poured.

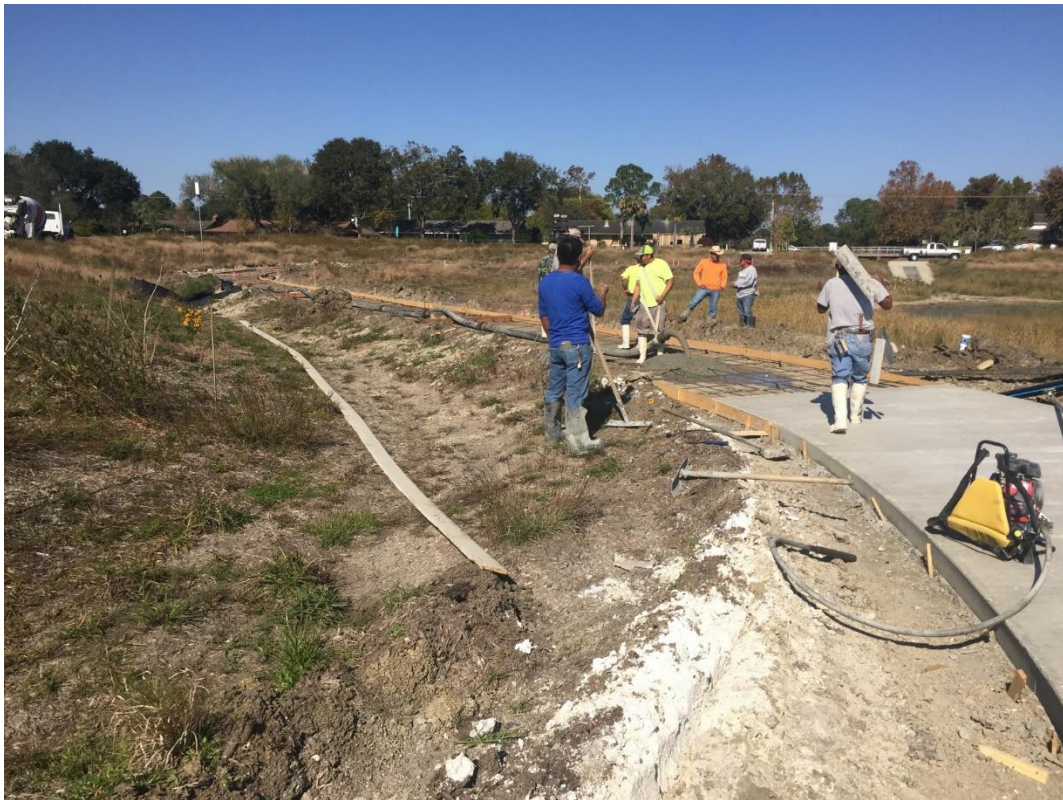
Figure 30. Trail construction, pouring concrete at Phase 1A.

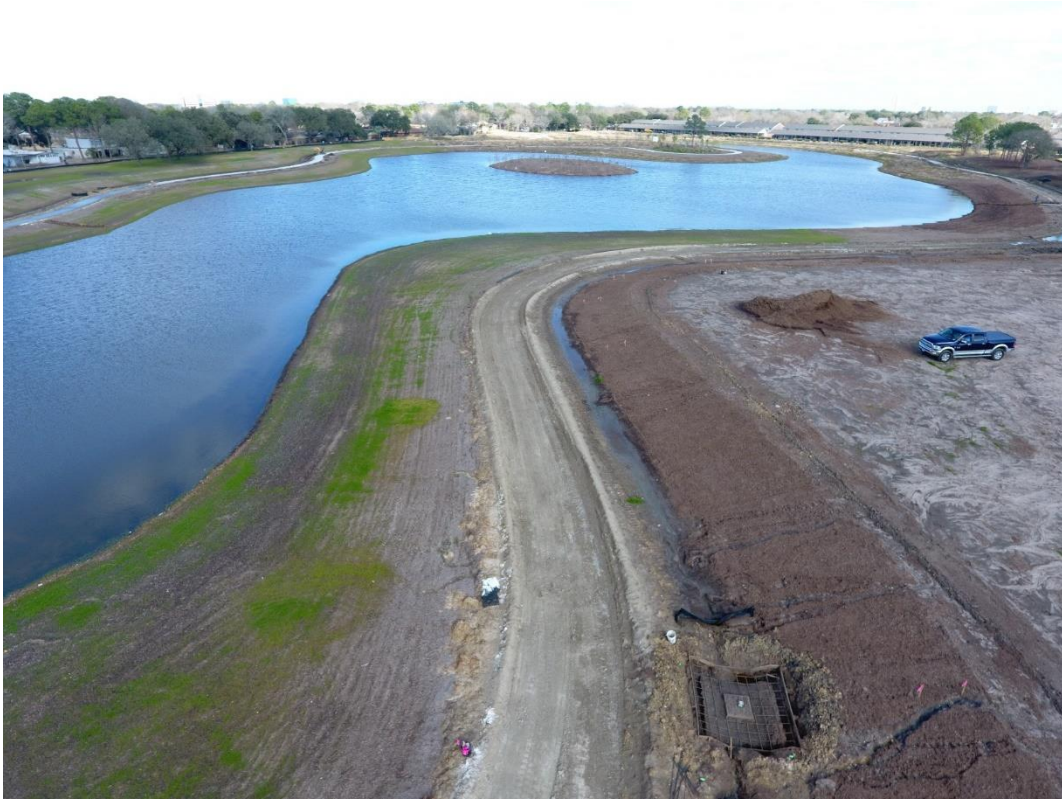
Figure 31. Trail construction phase 1C.

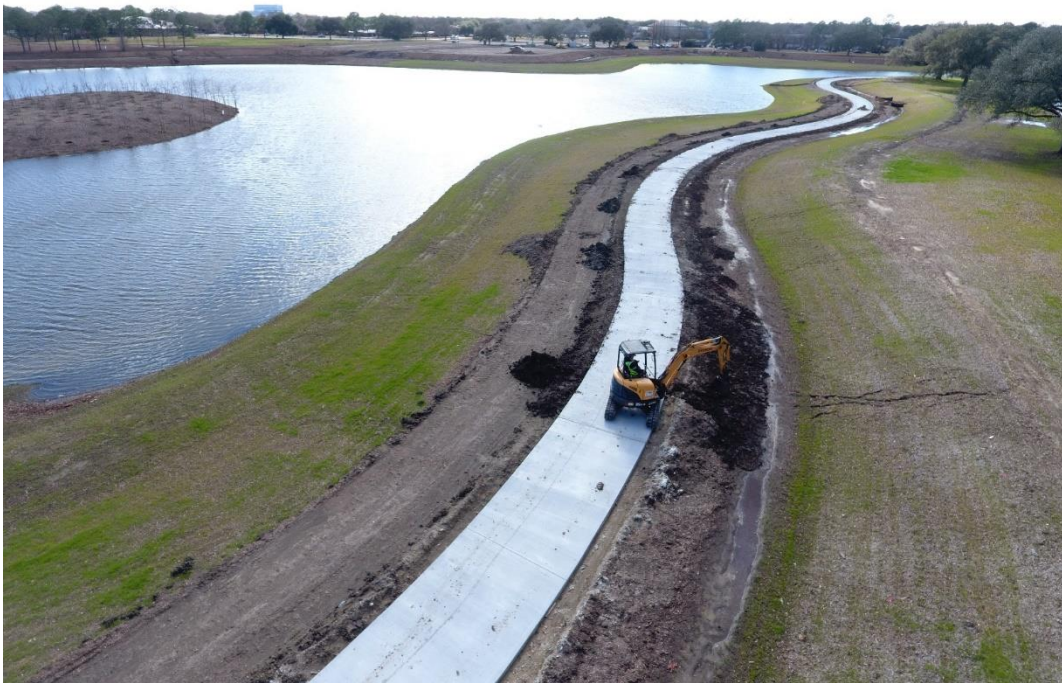
Figure 32. Trail construction Phase 1B.

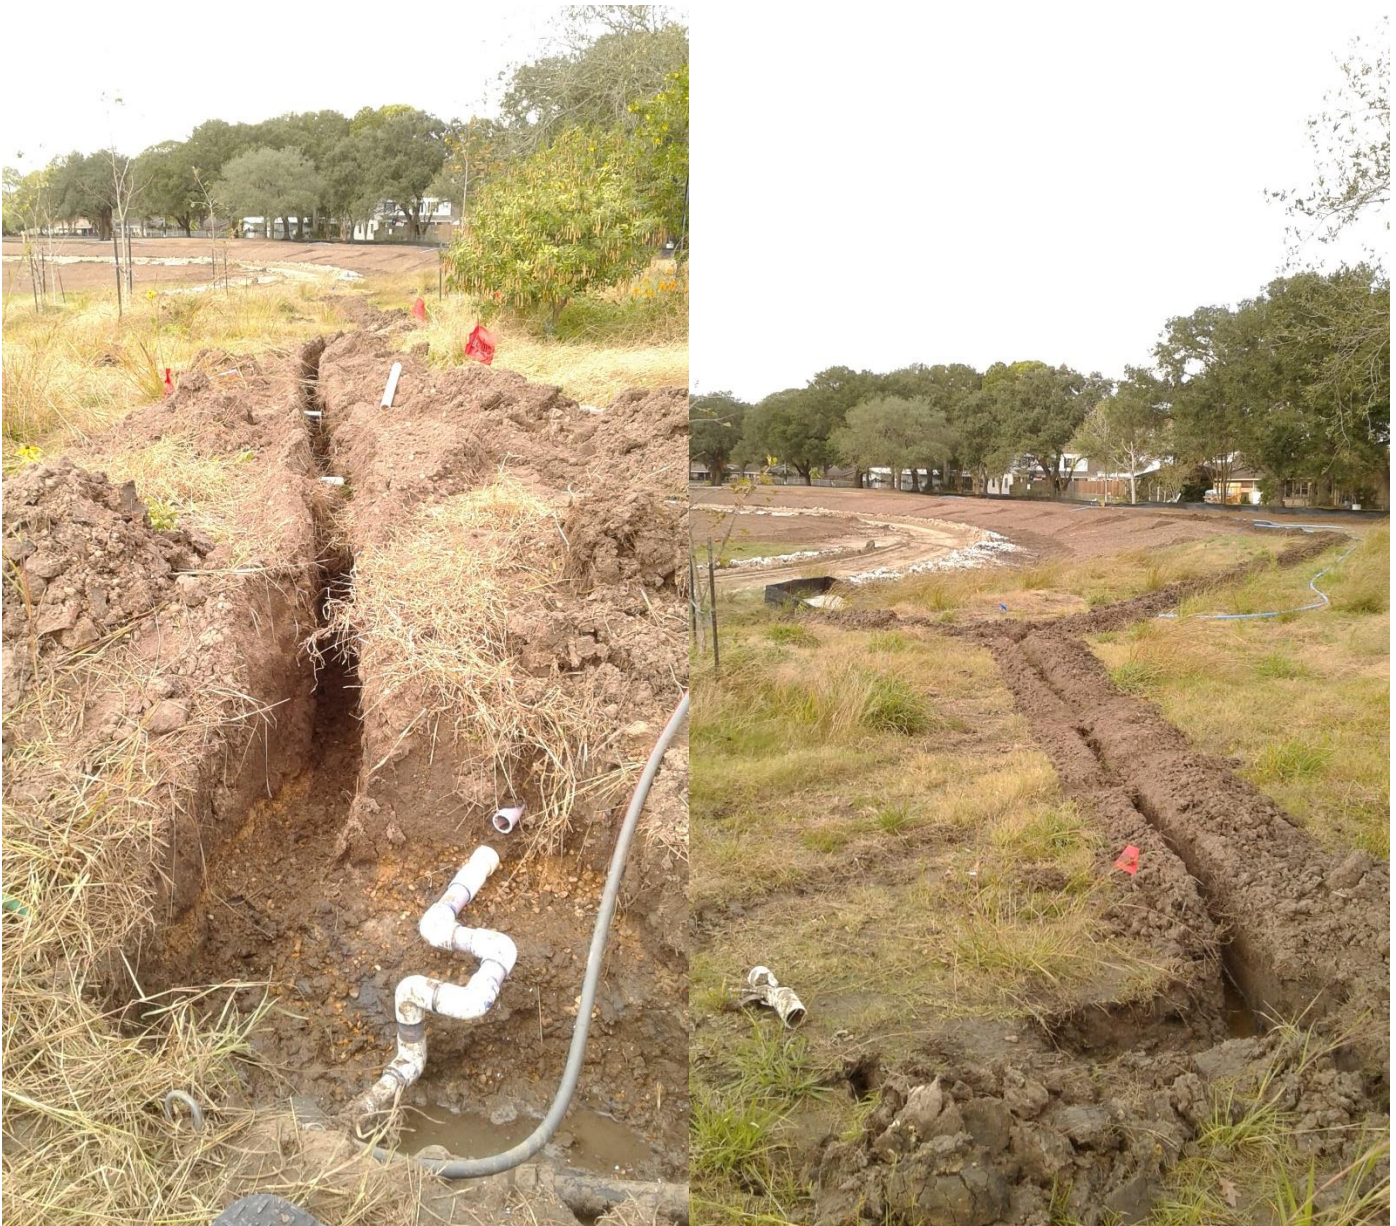
Figure 33. Trenches for irrigation lines to water trees and shrubs.

A portion of CMP funding was designated for the installation of an irrigation system to support the newly planted native vegetation. To date, irrigation lines span 11,500 feet leading to trees and shrubs throughout Phase 1. Irrigation lines range in pipe size from ½" to 1 ¼" as needed. Lines are maintained by EGC.
