Exploration Green Public Access Development and Ecosystem Restoration

GLO Contract #: 17-191-000-9828

FINAL REPORT August 24, 2018

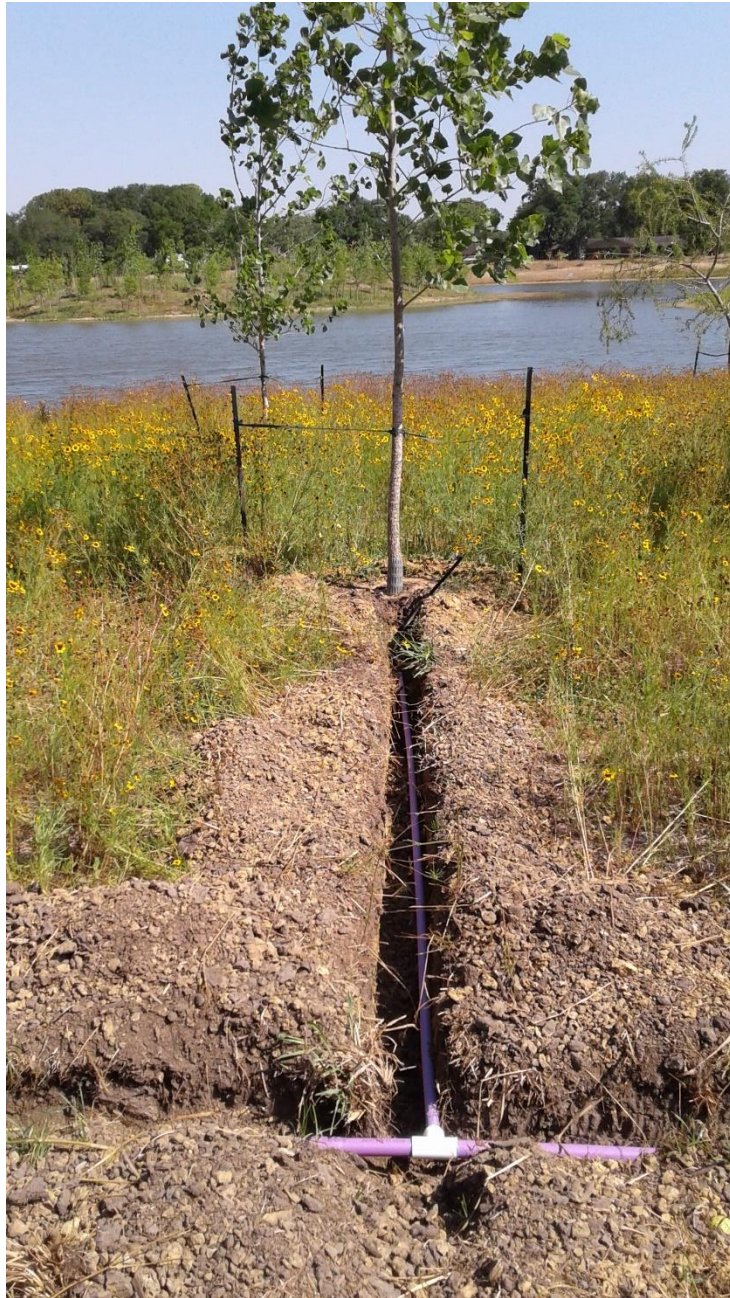
Figure 34. Irrigation lines

A portion of CMP funding was designated for the installation of an irrigation system to support the newly planted native vegetation. To date, irrigation lines span 11,500 feet leading to trees and shrubs throughout Phase 1. Irrigation lines range in pipe size from ½" to 1 ¼" as needed. Lines are maintained by EGC.

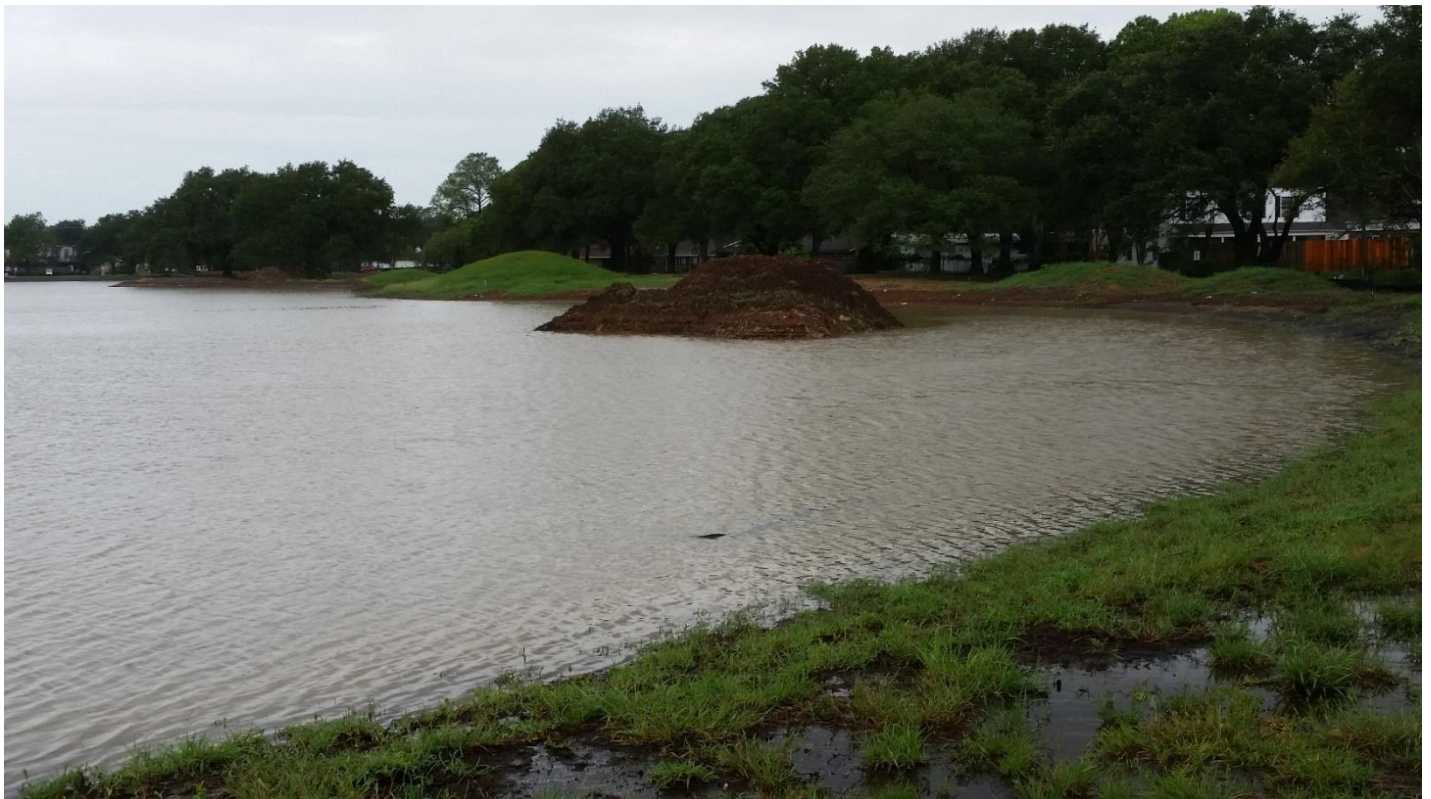
Figure 46. During Hurricane Harvey Phase 1 prevented approximately 150 homes from flooding.

Phase 1 saw many weather-related setbacks as the project progressed. Extensive rainfall caused delays during all Phases of the project due to ground saturation preventing use from heavy machinery. One such weather delay was Hurricane Harvey. In August of 2017, Hurricane Harvey hit the Houston area causing additional setbacks to project development. Although not complete at the time, the Phase 1 detention pond worked as planned and prevented approximately 150 homes from flooding.

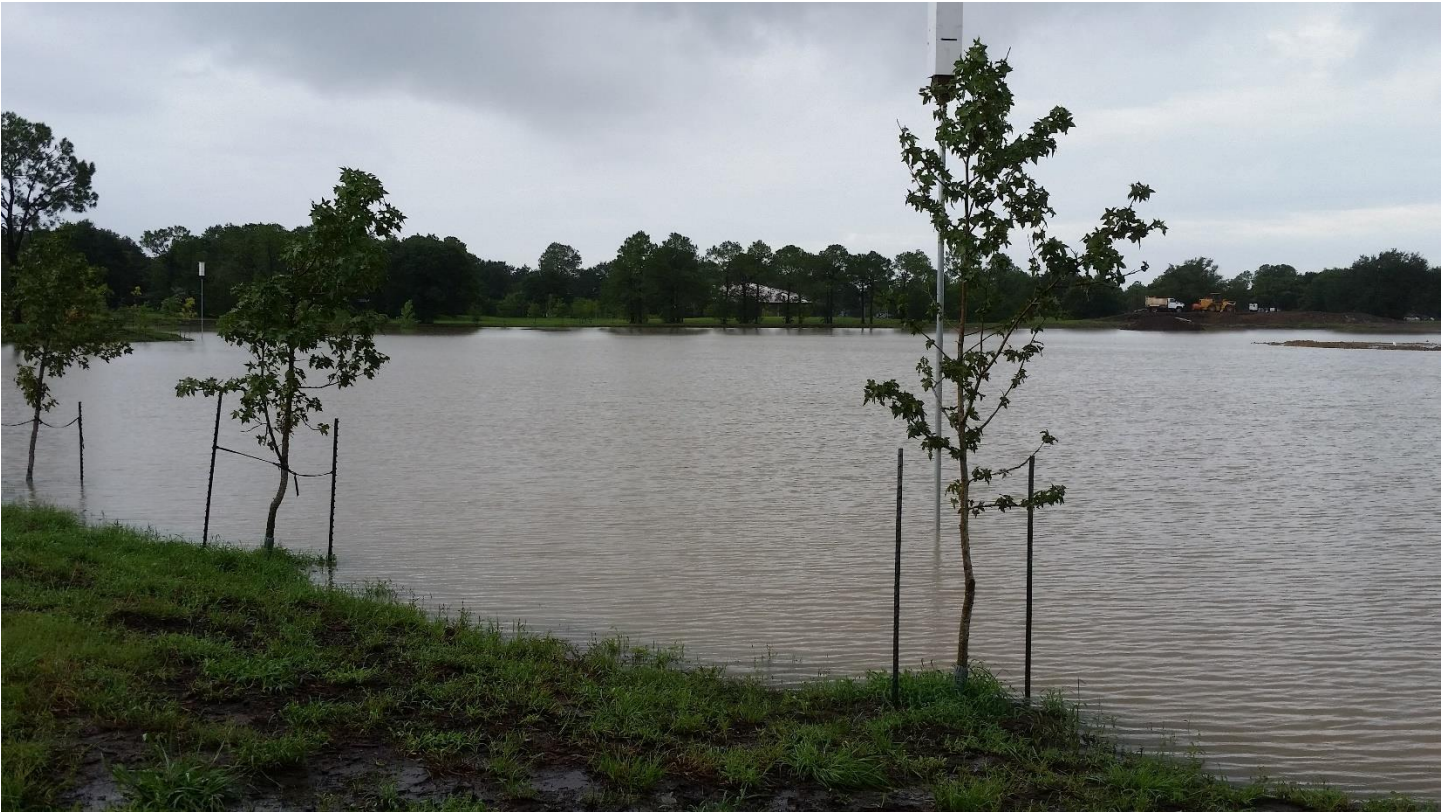
Figure 47. Phase 1 during Hurricane Harvey

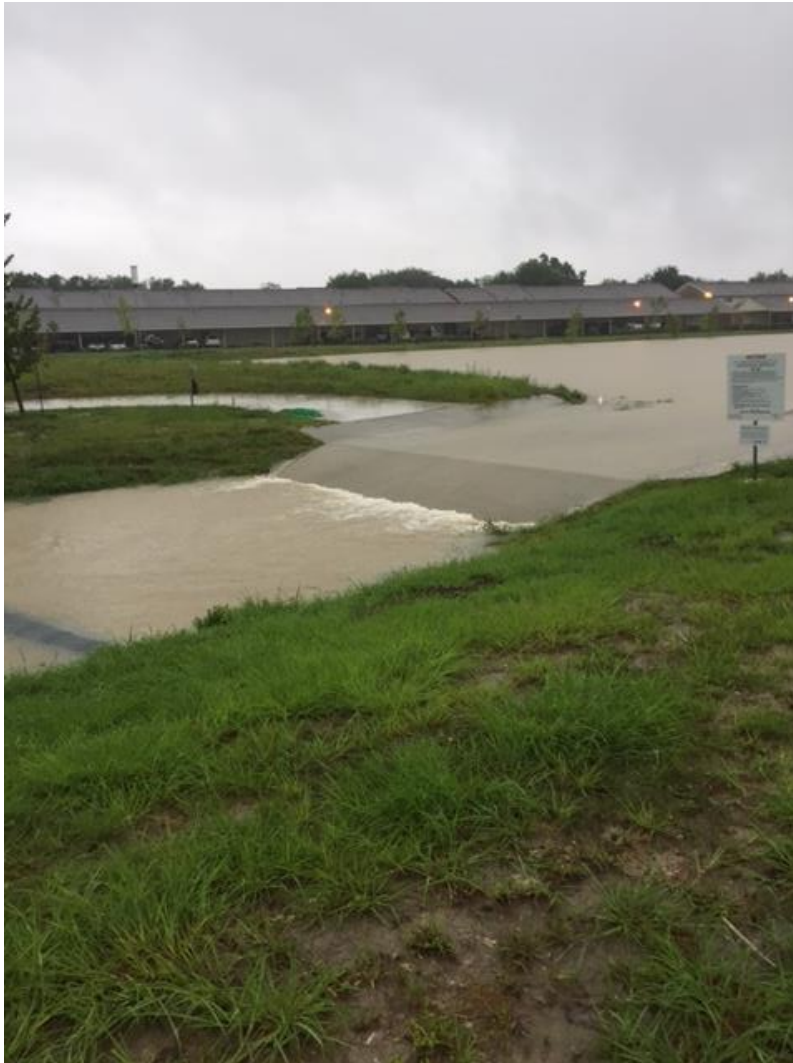
Figure 48. Phase 1A spillway during Hurricane Harvey.
