Nueces River Authority

Baffin Bay Tributaries Study

Final Report for
CMP Project # 20-029-000-B736

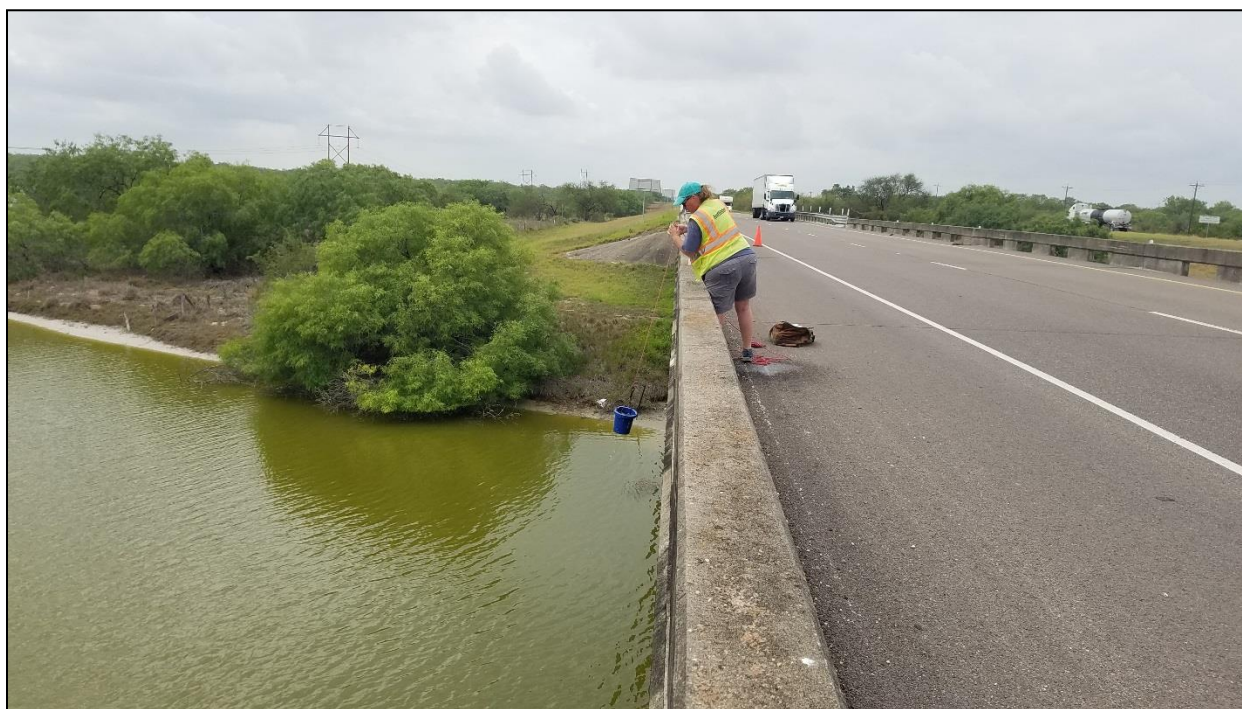
Figure 13. Sampling from the bridge at Los Olmos Creek Tidal Station 13034

Sample collection - Surface water quality data including field and laboratory data were collected on a monthly basis from January 2020 through December 2020 at Los Olmos Creek Tidal Station 13034. Rain event sampling took place over two days immediately following a rain event on May 16th and 17th. Field data including water depth, water temperature, pH, dissolved oxygen and specific conductance were obtained using a Hydrolab MS5 datasonde according to the latest version of the TCEQ SWQM Procedures Manual (RG-415, 2012). The datasonde was calibrated before each sampling event and post calibrated immediately after returning from the field. Water samples were taken from the centroid of flow (point of maximum flow) at each station using a sample bucket that was pre-rinsed with site sample water. Surface water quality samples were collected, preserved with acid when applicable, stored on ice, and delivered to the laboratories that afternoon for analysis.

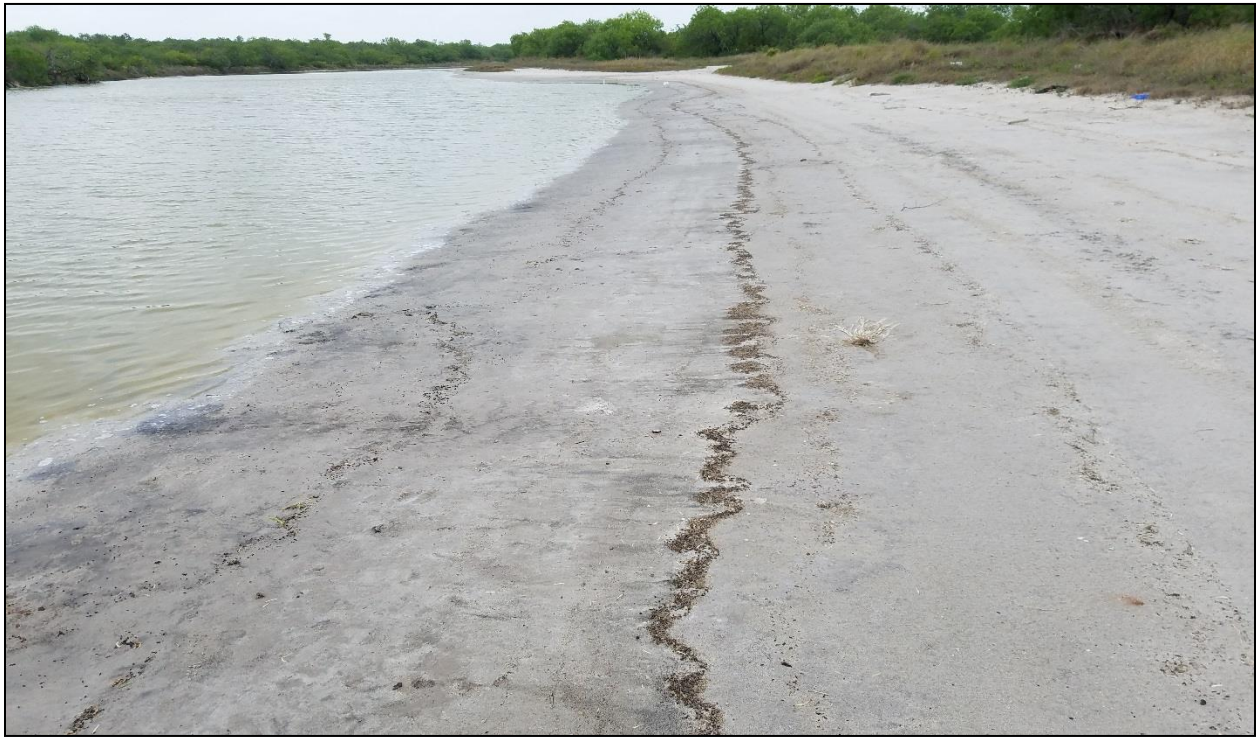
Figure 14. Bat guano droppings on the high tide lines on Los Olmos Creek Tidal

Site Observations – Bat guano was observed on the bank of Los Olmos Creek Tidal during site visits contributing bacteria and nutrients (nitrogen and phosphorus) to the waterbody.

Bacteria – Bacteria concentrations over the course of the study were highly elevated and likely at least partially attributed to the bat colony that resides under the bridge

NRA recommends a continuation of data collection efforts on Los Olmos Creek Tidal to further characterize the water quality to account for seasonal and climactic variability. Due to the proximity of the bat colony to the sampling location, it is recommended that the sampling station be moved away from the bridge crossing.

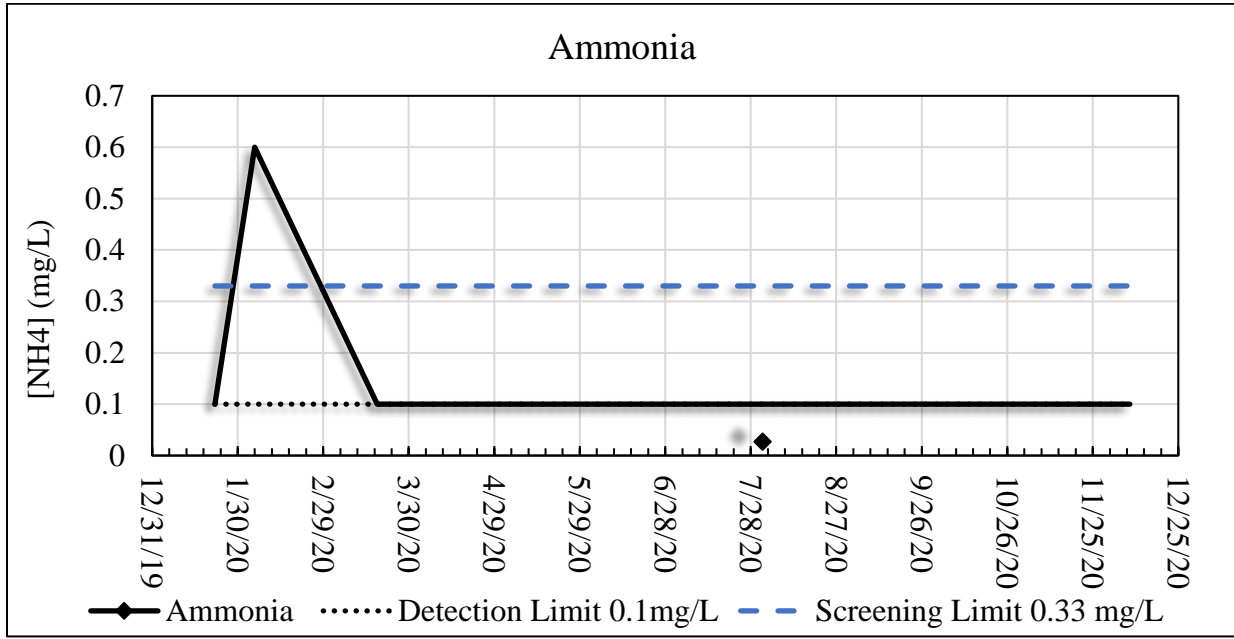
Figure 18. Monthly ammonia concentrations on Los Olmos Creek Tidal

Ammonia nitrogen – Ammonia concentrations ranged from less than 0.1 mg/L to 0.6 mg/L. The limit of quantification (LOQ) for ammonia is 0.1 mg/L and the TCEQ screening level is 0.46 mg/L. Ammonia nitrogen concentrations were very low in the segment with 11 out of 12 samples being below the limit of detection of laboratory equipment. The mean concentration was < 0.14 mg/L.

Ammonia – Ammonia concentrations in the Los Olmos Creek Tidal Watershed were very low throughout the study period. The highest concentration occurred during dry weather monitoring in February with a value of 0.6 mg/L.

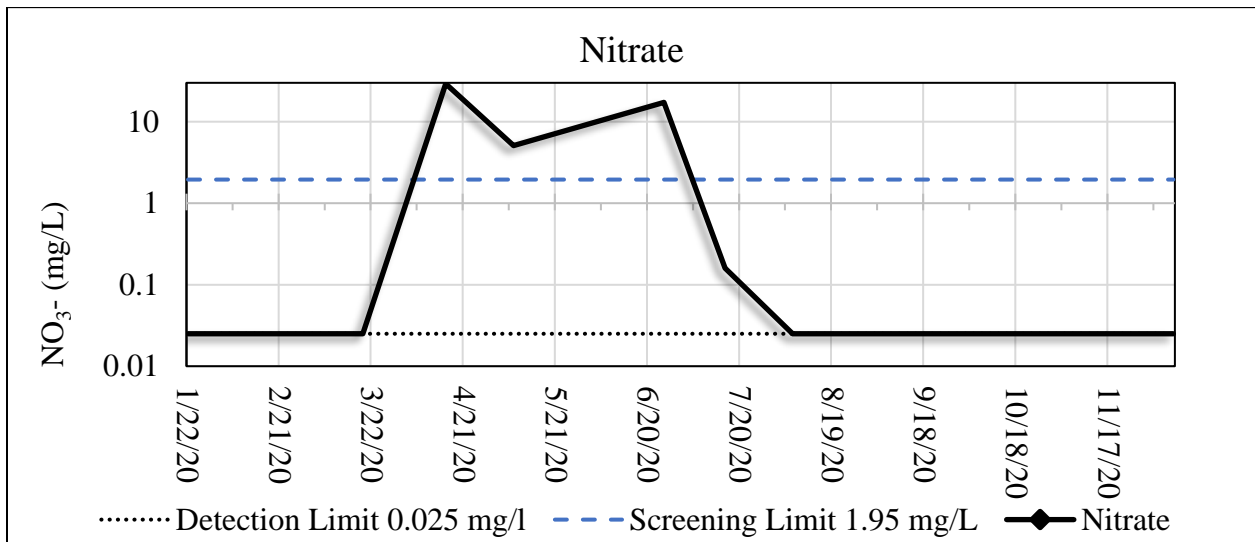
Figure 19. Monthly nitrate nitrogen concentrations on Los Olmos Creek Tidal

Nitrate Nitrogen – Nitrate nitrogen concentrations ranged from less than 0.025 mg/L to 29.2 mg/L. The LOQ for nitrate nitrogen is 0.025 mg/L and the TCEQ screening level is 1.10 mg/L. Out of 12 nitrate samples collected, 8 were below the LOQ and 3 were above the screening level. The annual mean nitrate nitrogen concentration in Los Olmos Creek Tidal was 4.32 mg/L. The highest concentrations occurred from April to June 2020.

Nitrate Nitrogen – Nitrate nitrogen results over the year-long study showed a strong seasonal trend with the highest numbers occurring during the spring months (April – June). However, 8 out of 12 samples collect were below the detection limit of laboratory equipment. Due to the extremely elevated concentrations collected from April through June, the average concentration of nitrate was 4.32 mg/L.

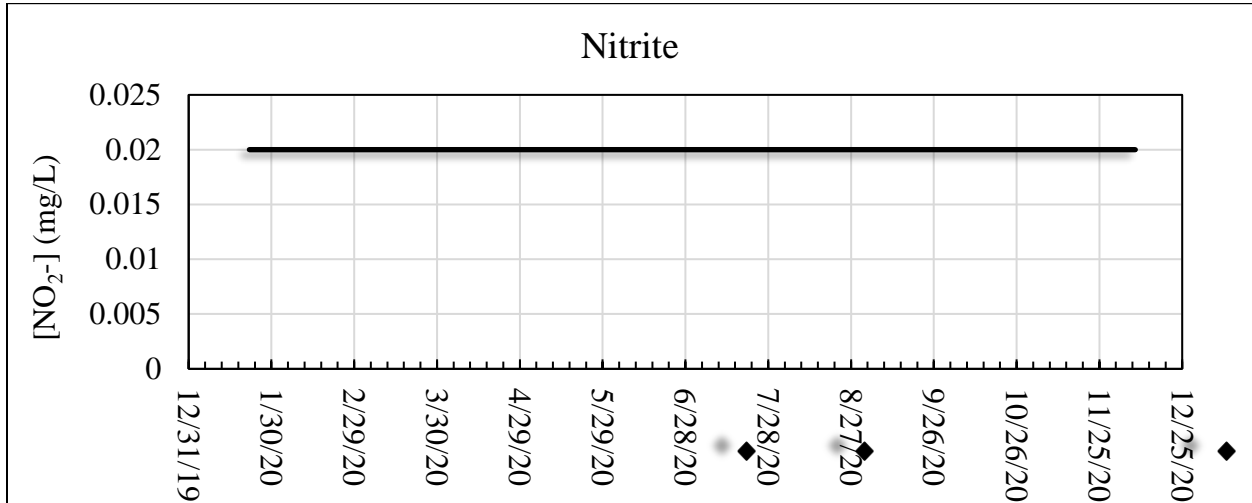
Figure 20. Monthly nitrite nitrogen concentrations on Los Olmos Creek Tidal

Nitrite Nitrogen – Nitrate nitrogen concentrations ranged were all less than 0.02 mg/L. The LOQ for nitrite nitrogen is 0.02 mg/L, however no TCEQ screening level exist for this parameter.

Nitrite Nitrogen - Nitrite nitrogen results were all very low during the study period. Values were all below the detection limits of laboratory equipment which is 0.02 mg/L. In Texas, screening levels for this parameter does not yet exist.

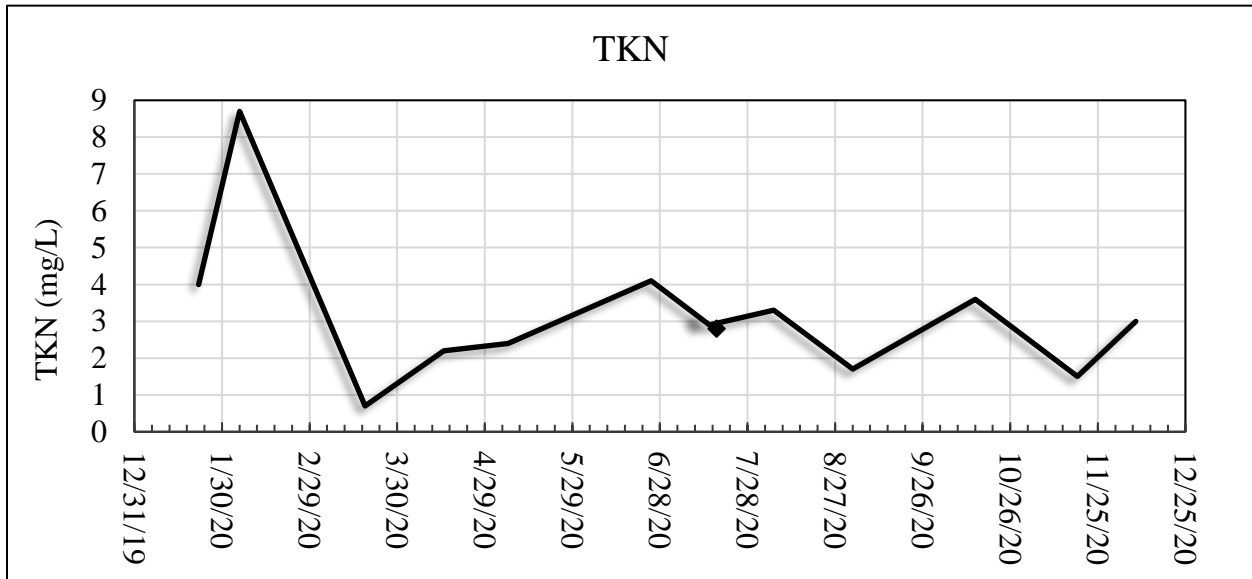
Figure 21. Monthly TKN concentrations on Los Olmos Creek Tidal

Total Kjeldahl Nitrogen (TKN) – TKN concentrations ranged from 0.7 mg/L to 8.7 mg/L. The LOQ for TKN is 0.2 mg/L, however no TCEQ screening levels exist for this nutrient parameter. The annual mean TKN concentration of Los Olmos Creek was 3.18 mg/L.

Total Kjeldahl Nitrogen - Total kjeldahl nitrogen concentrations showed moderate variability with no seasonal trend or correlation to other forms of nitrogen.

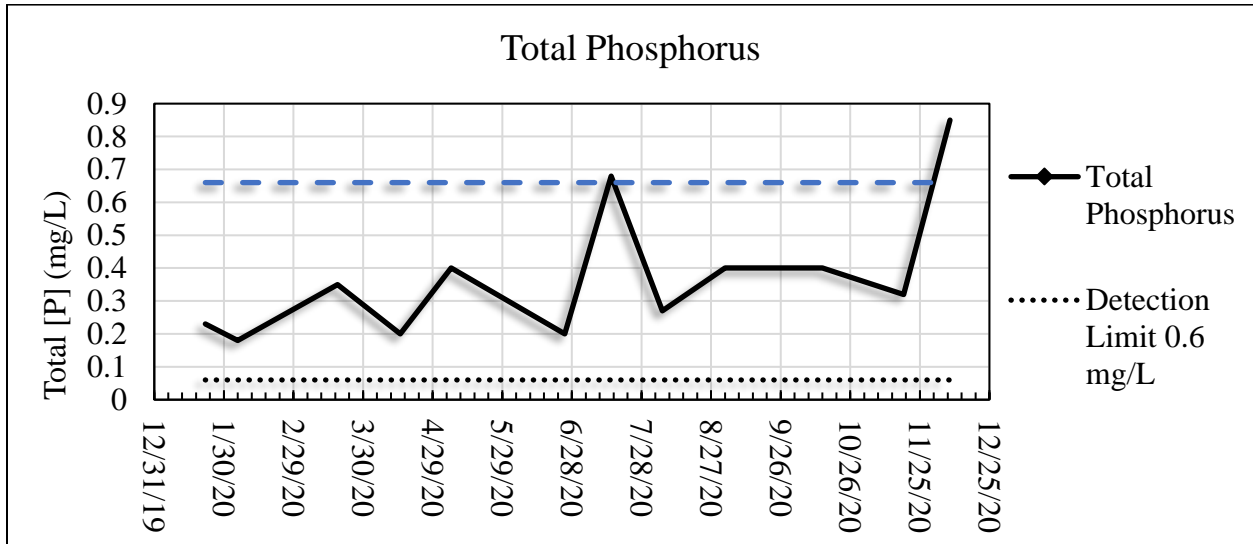
Figure 22. Monthly total phosphorus concentrations on Los Olmos Creek Tidal

Total Phosphorus – Total Phosphorus concentrations ranged from less than 0.2 mg/L to 0.85 mg/L. The LOQ for total phosphorus is 0.06 mg/L and the TCEQ screening level is 0.66 mg/L. Out of 12 total phosphorus samples submitted for analysis, only one was above of the screening level. The annual mean concentration of total phosphorus concentration in Los Olmos Creek Tidal was 0.37 mg/L.

Total Phosphorus – Total phosphorus results indicated moderate concentrations and minimal variability for this parameter. The average concentration over the course of the study was 0.37 mg/L, which is below the screening level of 0.66 for Los Olmos Creek Tidal.

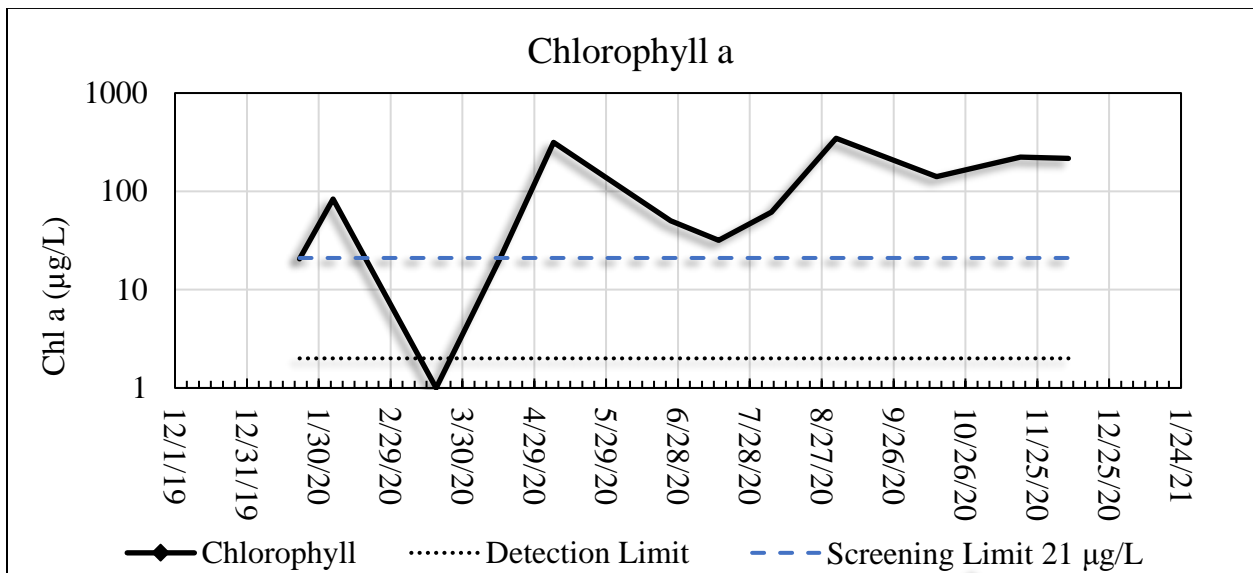
Figure 23. Monthly chlorophyll-a concentrations on Los Olmos Creek Tidal

Chlorophyll a – Chlorophyll a concentrations ranged from less than 2.0 µg/L to 346.3 µg/L. The LOQ for chlorophyll is 2.0 mg/L and the TCEQ screening level is 21.0 µg/L. Out of 12 total samples submitted for analysis, one was below the LOQ and 11 were at or above the screening level. The annual mean concentration of chlorophyll-a concentration in the main stem of Los Olmos Creek Tidal was 125.6 µg/L.

Chlorophyll a – Chlorophyll *a* concentrations over the course of the study were highly elevated and likely attributed to nitrate, TKN, and total phosphorus concentrations.

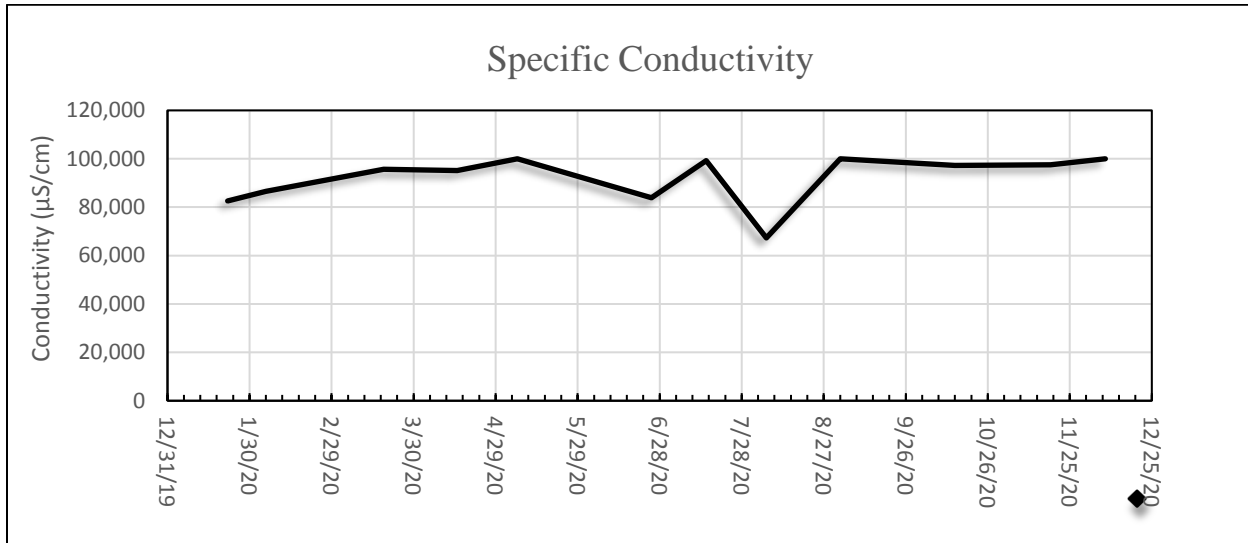
Figure 24. Monthly specific conductance concentrations on Los Olmos Creek Tidal

Specific Conductance (SpC) - Specific conductance ranged from 67,300 $\mu\text{mhos/cm}$ to $>100,000$ $\mu\text{mhos/cm}$ which is the maximum value that can be measured by NRA's Hydrolab datasonde. The lowest result for SpC was recorded in August one week after a high tide event that was associated with the passage of Hurricane Hannah just south of the study area in late July 2020.

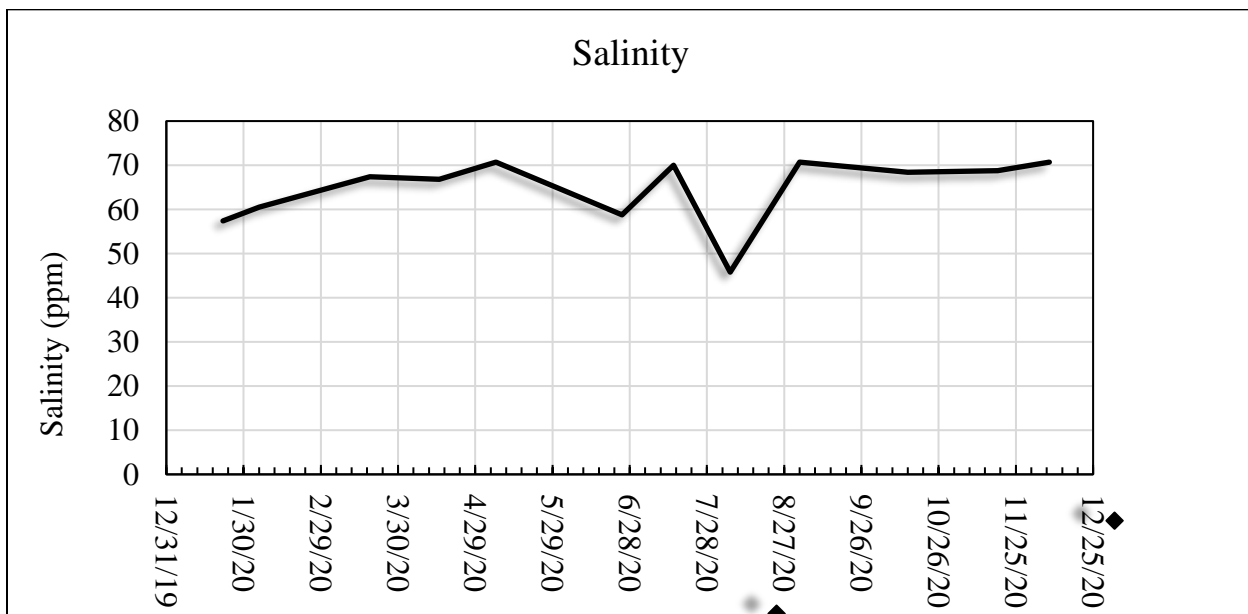
Figure 25. Monthly salinity concentrations at Los Olmos Creek Tidal

Salinity – Salinity results ranged from 45.8 psu to >70.7 psu which is the maximum value that can be measured by NRA's Hydrolab datasonde. Values greater than 70.7 occurred in May, September, and December. The lowest recorded measurement occurred in August one week after a high tide event that was associated with the passage of Hurricane Hannah in late July 2020.

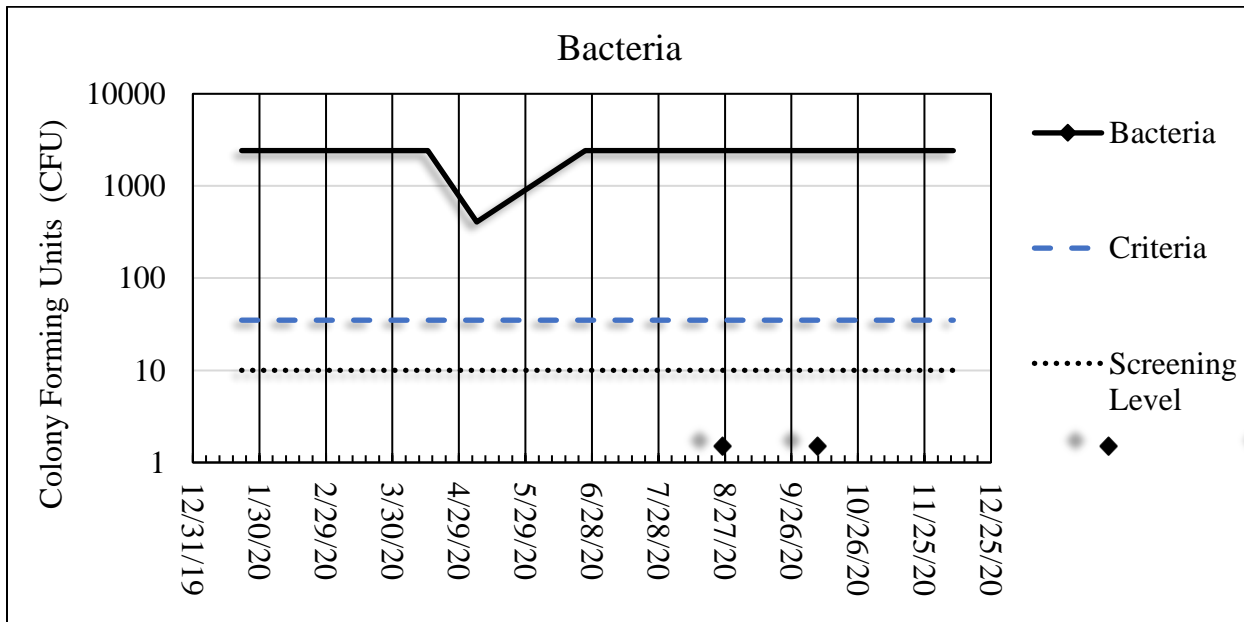
Figure 27. Monthly bacteria (enterococcus) concentrations on Los Olmos Creek Tidal

Bacteria – Bacteria results values ranged from 407 cfu/100 mL to greater than 2,419.6 cfu/100 mL (enterococcus). Twelve out of twelve monthly routine samples collected for the study were over TCEQs contact recreation standard of 35 cfu/100 mL.

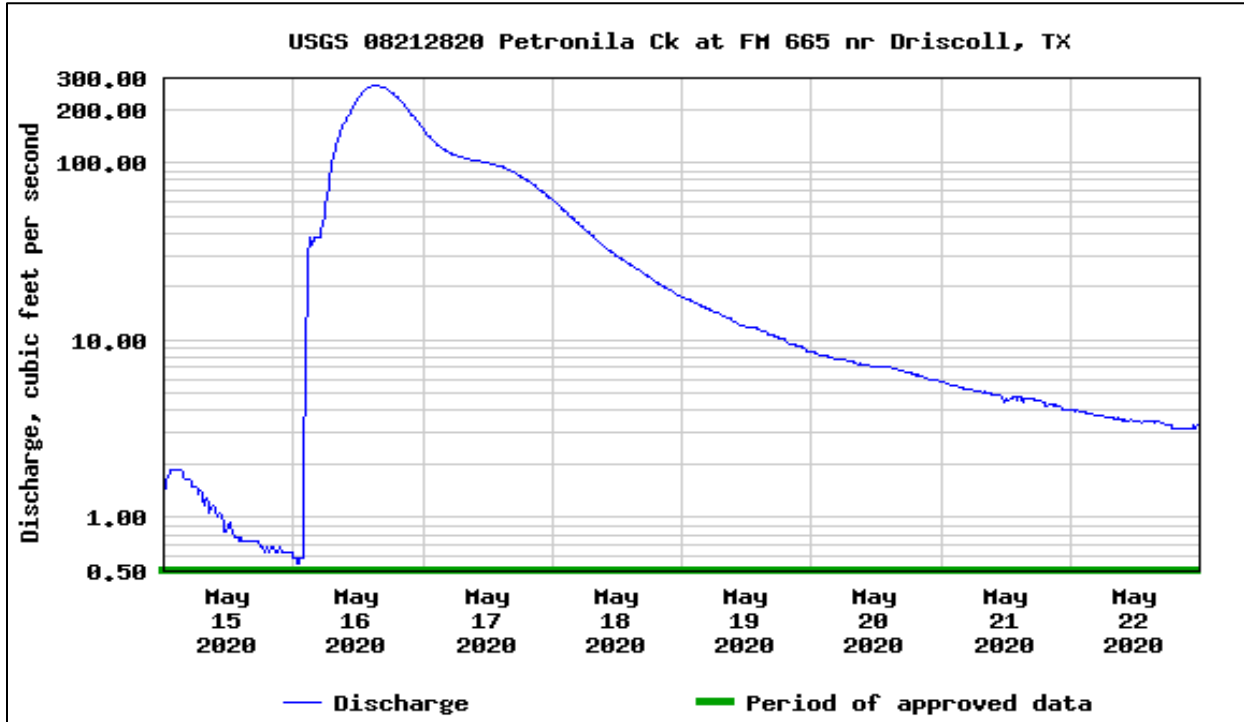
Figure 29. USGS sourced high flow data on Petronila Creek at FM 665 near Driscoll

High Flow at Petronila Creek Above Tidal - A USGS streamgage located on Petronila Creek at FM 665 (Station 13094) was used to verify a high flow event. Samples from Station 13094, which is approximately 10 miles downstream, were taken at 9:45am on May 16th at a flow rate of approximately 170 ft³/sec and again on May 17th at a flow rate of approximately 200 ft³/sec.

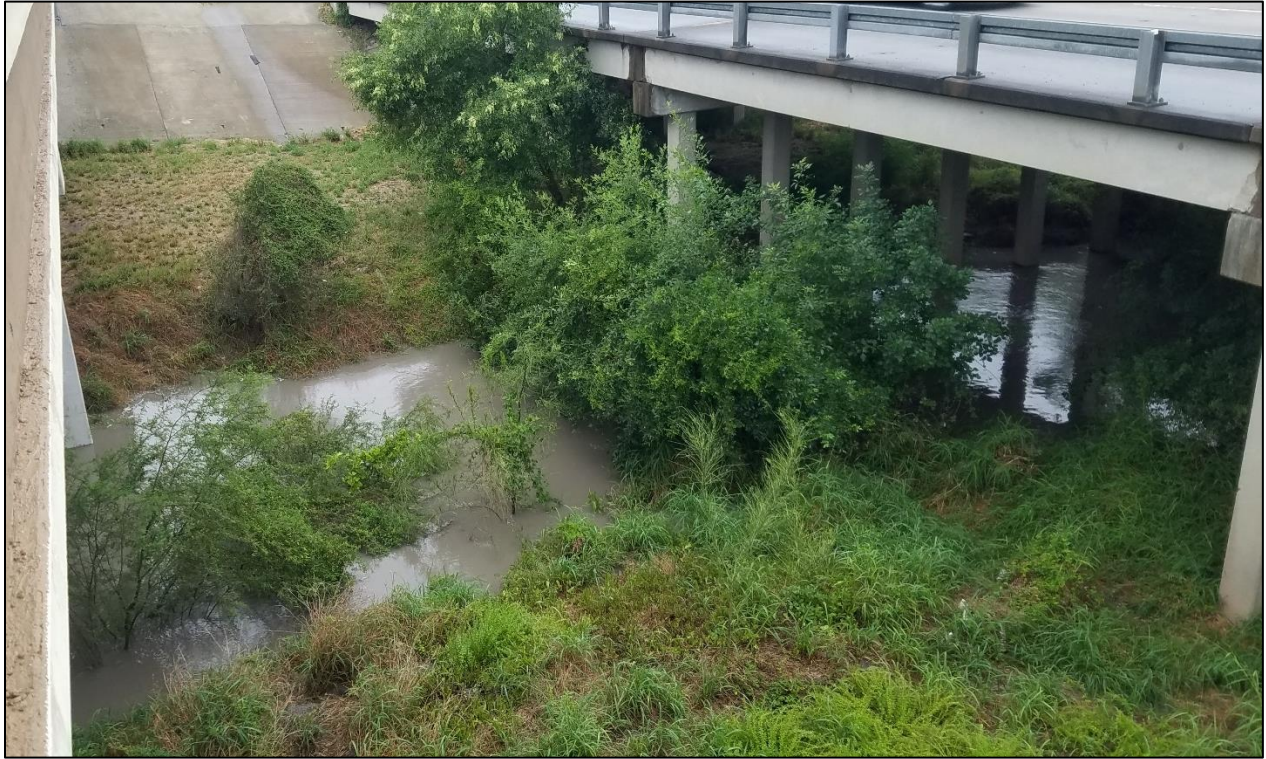
Figure 31. San Fernando Creek Above Tidal at approx. 300 ft³/sec on May 16th

High flow event at San Fernando Creek Above Tidal - Site reconnaissance on May 16th at Station 13034 on San Fernando Creek indicated a high flow event was underway. Samples were taken at 10:20 am at a flow rate of approximately 300 ft³/sec. A subsequent monitoring event occurred on the second day, May 17th, at a flow rate of approximately 200 ft³/sec.

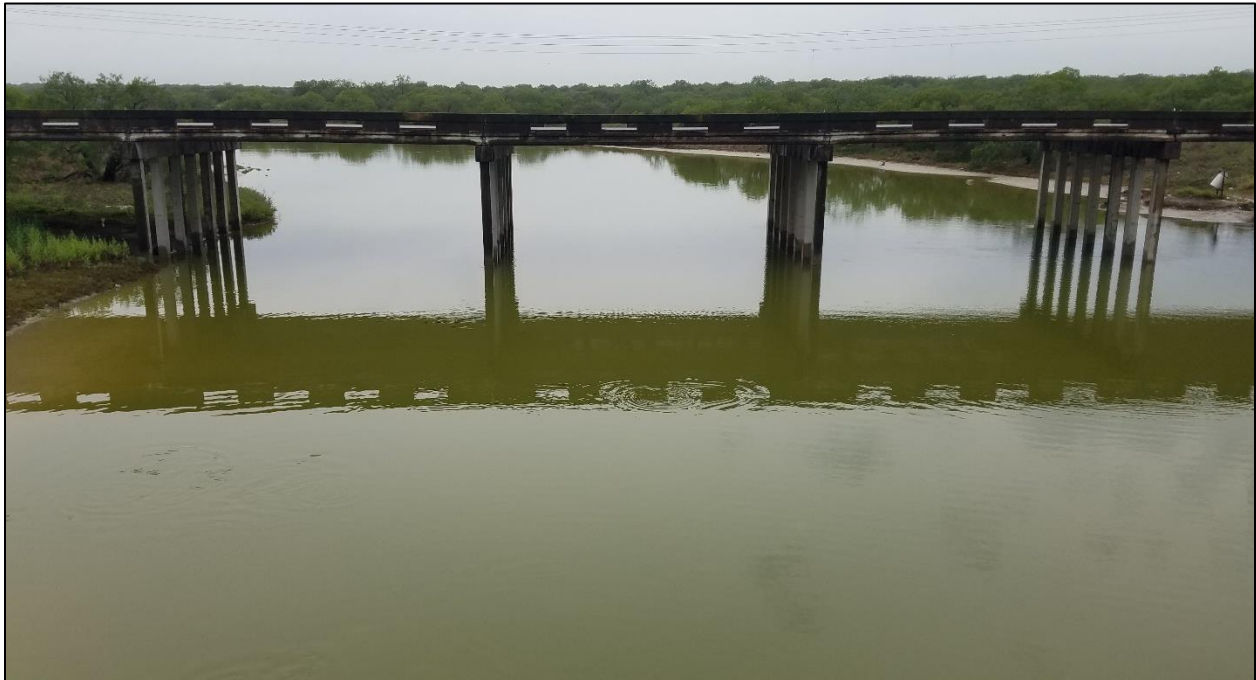
Figure 33. Los Olmos Creek Tidal (Station 13034) on May 16th

High Flow Event at Los Olmos Creek Tidal - Site reconnaissance on May 16th at Station 13034 on Los Olmos Creek Tidal indicated that the site had minimal freshwater inflow at the time of monitoring based on the still elevated salinity levels of 58.4 ppt. Datasonde values obtained on the monthly monitoring trip May 7th indicated a salinity greater than 70.7 ppt. The water level was slightly higher than past monthly site visits and the water appeared to be moving downstream, albeit slightly. The decision was made to take water samples for analysis on May 16th and 17th to complete the data set for the project.
