Fulton Beach Road Living Shoreline

20-030-000-B737

**Final Report
February 2022**

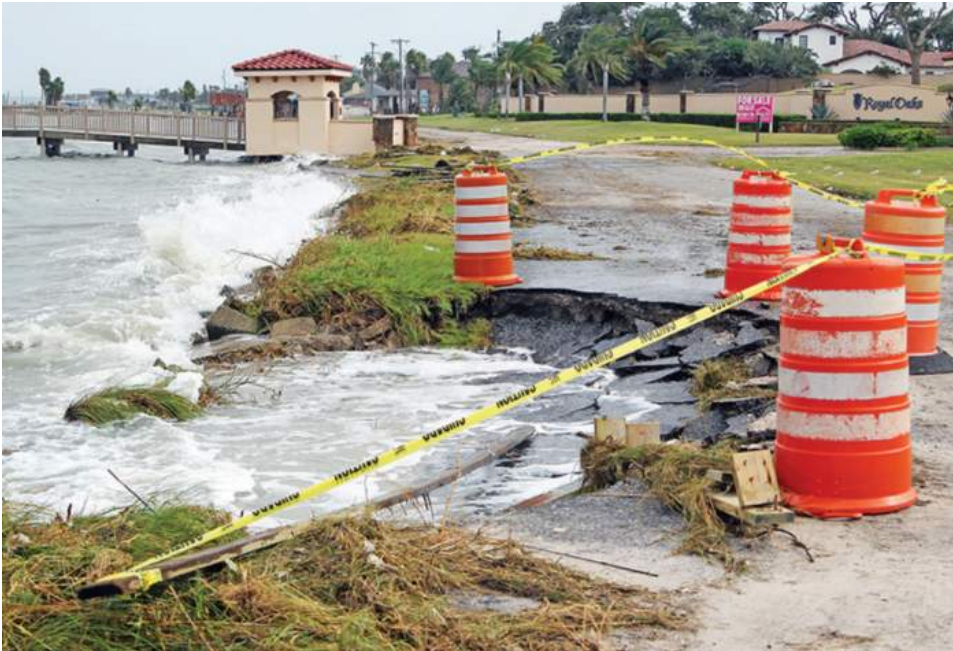
Figure 3. Damage at North Fulton Beach Road from Hurricane Hanna in July 2020 (Rockport Pilot, 2020).

The roadway within the project site area is currently exposed to high tide events and is frequently flooded during storm events due to the small vertical relief between the seaward edge of the road and the water line. The shoreline is currently lined in most areas with non-engineered concrete rubble that has been placed over time to help stabilize the shoreline but is not sufficient for coastal projection. This is evident in Figure 3 and Figure 4, which show shoreline damage and vulnerability to North Fulton Beach Road due to Hurricane Hanna in July 2020, and Tropical Storm Beta in September 2020, respectively.

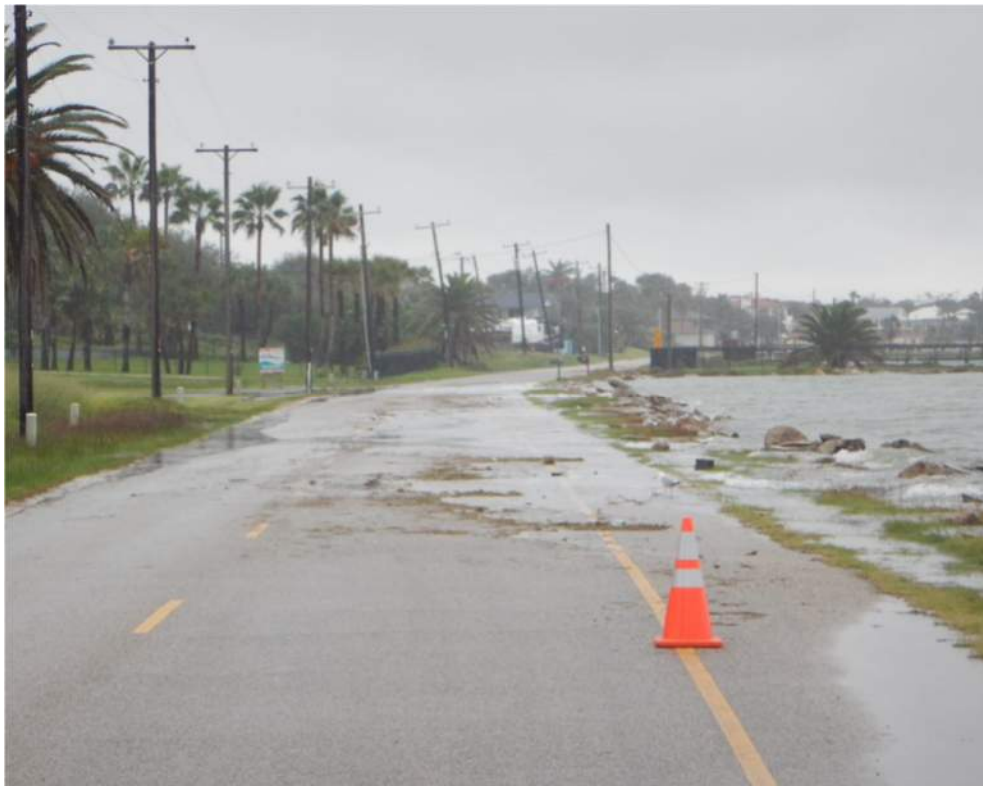
Figure 4. Flooding along North Fulton Beach Road due to Tropical Storm Beta in September 2020.

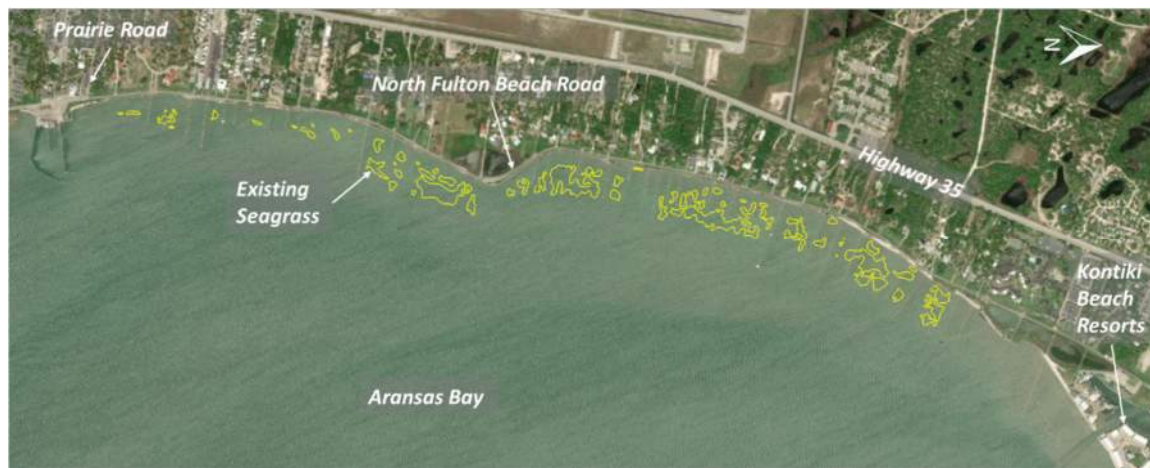
Figure 7. Areas of seagrass designated by the yellow polygons within the project site, based on the survey performed by T. Baker Smith during July 2020.

Environmental data pertinent to this scope includes the presence of seagrass and or oyster beds in the vicinity of the project. Identifying and mapping the spatial extents of any seagrass and oyster beds within the site is required in order to avoid impacts to these habitats. Seagrass and oyster bed surveys were conducted at the project site by T. Baker Smith in July 2020. The survey shows that no oyster beds currently exist within the project site. The survey also shows that there is a large presence of seagrass within the nearshore area; however, it is located far enough seaward of the shoreline where it is not expected to be impacted by the installation of a revetment along the shoreline. Figure 7 provides an aerial showing the extents of the seagrass presence within the surveyed area. The presence of seagrass will require the use of environmental best management practices such as silt curtains or turbidity fences during construction of the revetment, to mitigate any temporary impacts to the adjacent seagrasses. A report of the full survey results is provided in Appendix C.

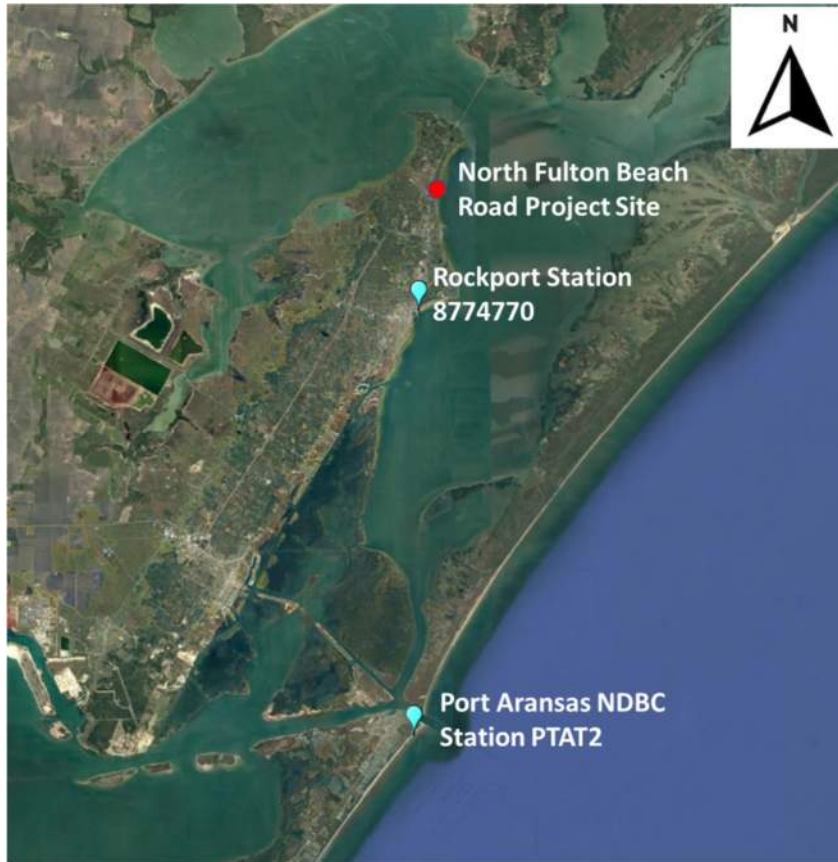
Figure 8. NOAA stations where wind and water level data were collected.

Fulton Beach Road. The approximate locations of these gauges are shown in Figure 8. The period of record for each gauge and interval at which data was recorded is shown in Table 2.

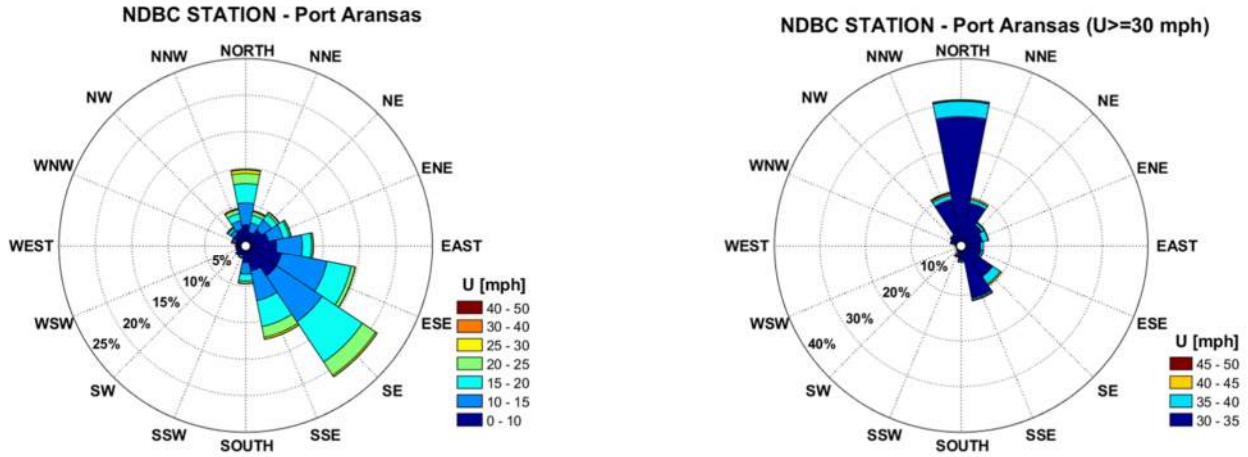
Figure 11. Wind roses for the NDBC Port Aransas station for (left) the full dataset, and (right) windspeeds 30 mph and greater.

Periods of record for this station is specified in Table 2. Wind roses, shown in Figure 11, were developed for the dataset. These plots illustrate the frequency of occurrence of events for 16 directional bins for various wind magnitudes and for the higher speed winds (> 30 mph) to understand the directional distribution of stronger winds which would be representative of design conditions at the site. According to this station's dataset, the highest winds typically come from north-northwest to north-northeast directions at this site, while the predominate winds are from the southeast direction.

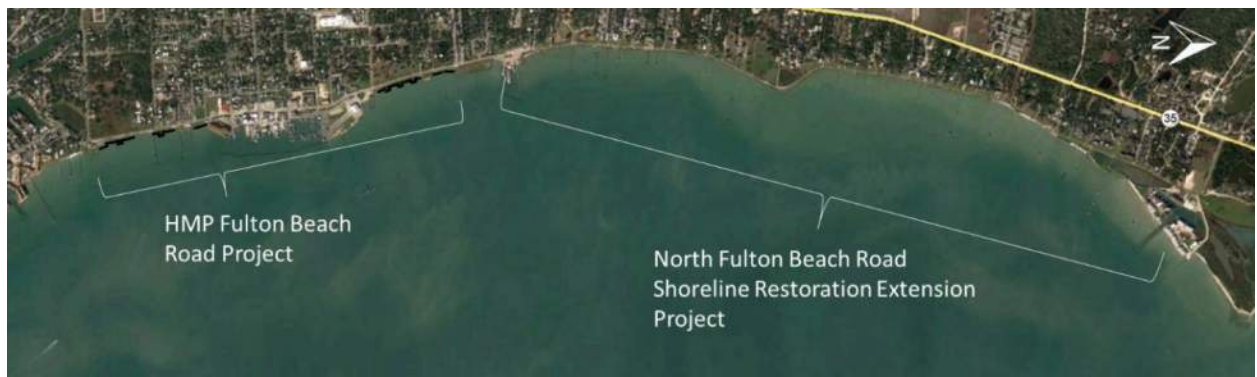
Figure 2. Project site map showing the location of the North Fulton Beach Road Shoreline Restoration Extension project extents relative to the previous HMP South Fulton project.

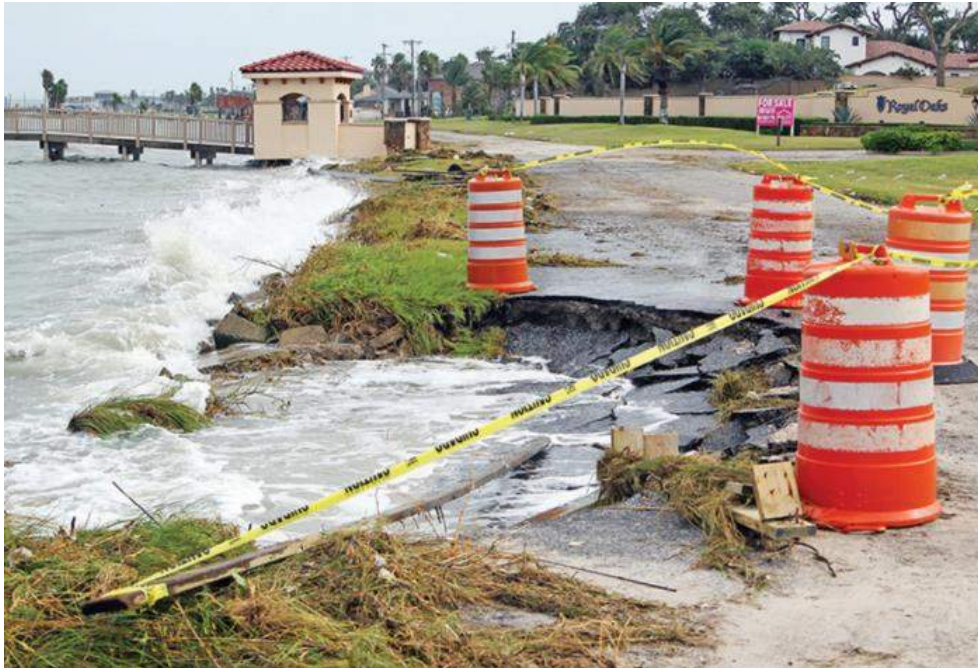
Figure 3. Photo taken by Rockport Pilot showing significant road damage from Hurricane Hanna.

The shoreline along North Fulton Beach Road has been vulnerable to damage from flooding and wave impact due to its close proximity to Aransas Bay, low elevation, and lack of continuous engineered shoreline protection. The erosion (especially after Hurricanes Harvey (2017) and Hanna (2020)) has been significant enough to damage the shoreline and undermine the road at several locations making it unsafe

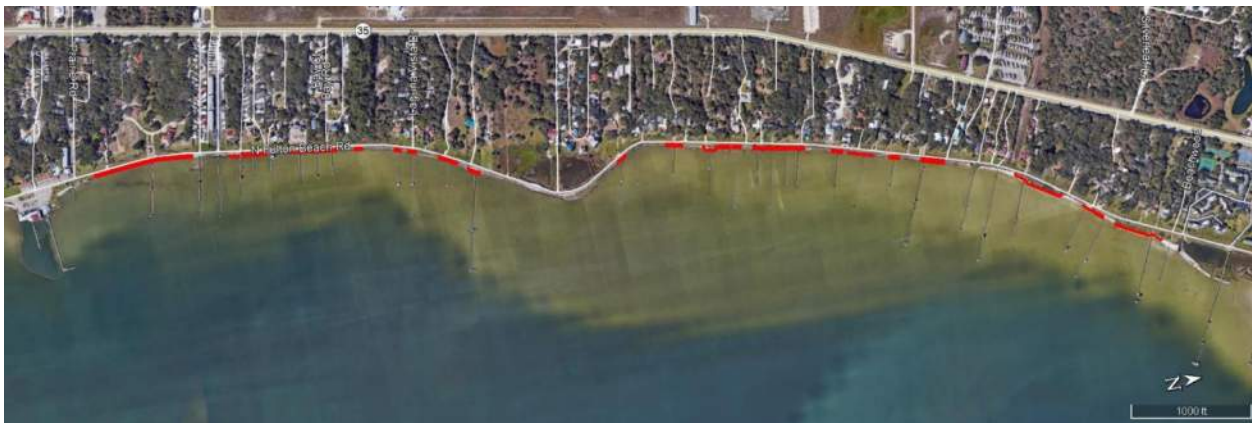
Figure 4. Areas along North Fulton Beach Road containing private leased shoreline structures delineated in red.

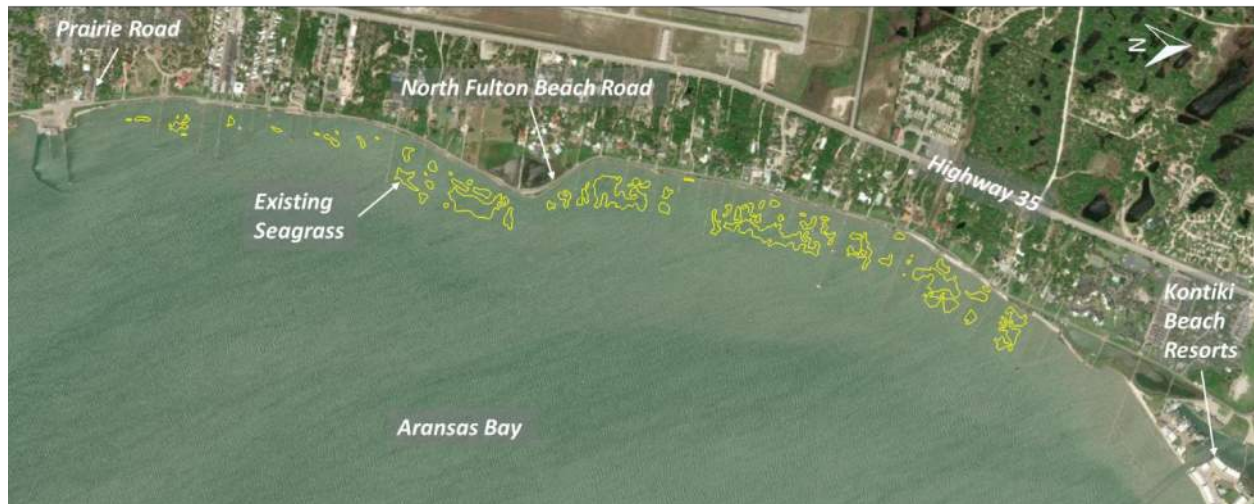
Figure 5. Areas of seagrass (green polygons) delineated measured during the July 13th survey. Note that seagrass extents shown are limited to the survey boundaries.

Mott MacDonald has collected a survey of seagrass, oysters, and marshes with data taken along bathymetric/wading transects to delineate extents of existing sensitive habitats within the project site on July 13, 2020. This data is necessary for preliminary design in order to minimize impacts of the proposed design and identify any mitigation that may be required. T. Baker Smith, LLC was contracted to complete the seagrass/oyster/marsh habitat survey. The extents of the seagrass found during the survey is shown in Figure 5, where the existing seagrass areas are delineated by the green polygons. Numerous areas of seagrass were found to exist within the nearshore zone, between approximately 10 ft and 500 ft offshore. To avoid mitigation, all shoreline protection structures must be constructed outside of the extents of the seagrass.

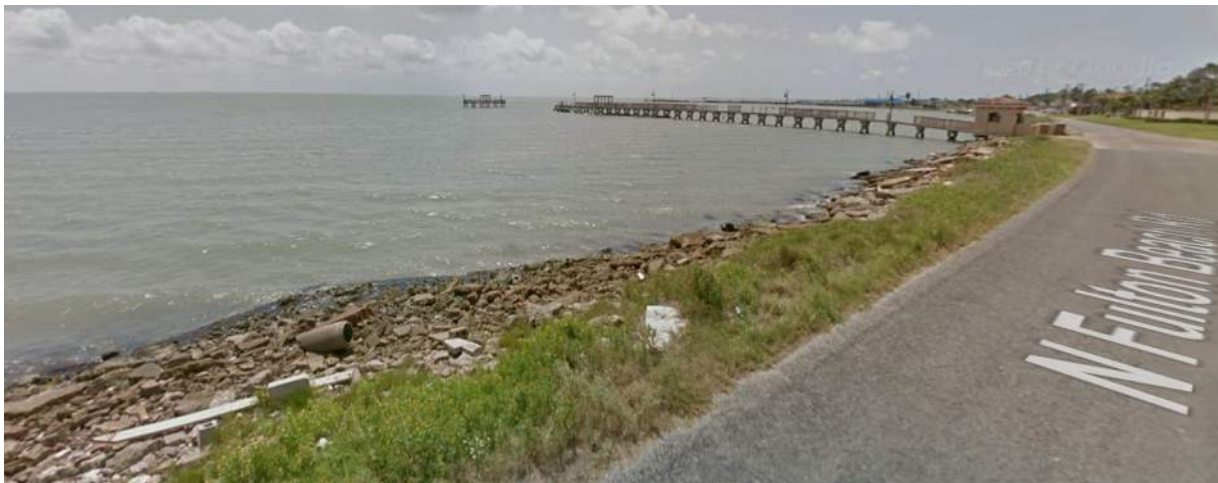
Figure 6. Google Street View photo from 2018 showing private residential wood piling pier and a section of North Fulton Beach Road lined with relic concrete and other debris.

There are numerous structures including bulkheads, revetments, groins, timber piers and drainage outfalls along the shoreline of North Fulton Road. Piers along North Fulton Beach Rd. are comprised of commercial and residential wood piling structures that extend seaward approximately 150 ft to 820 ft in some areas, shown in Figure 6. Bulkheads along the shoreline are constructed of concrete panels or sheetpile with concrete caps. An example bulkhead can be seen in Figure 7 and Figure 8. Stone rip-rap groins perpendicular to the shoreline that extend seaward approximately 100 ft have been constructed by private property owners along select areas of the shoreline. Concrete panel breakwaters approximately 100 ft seaward and parallel to the shoreline have also been constructed along select areas of the shoreline, shown in Figure 9 and Figure 10.

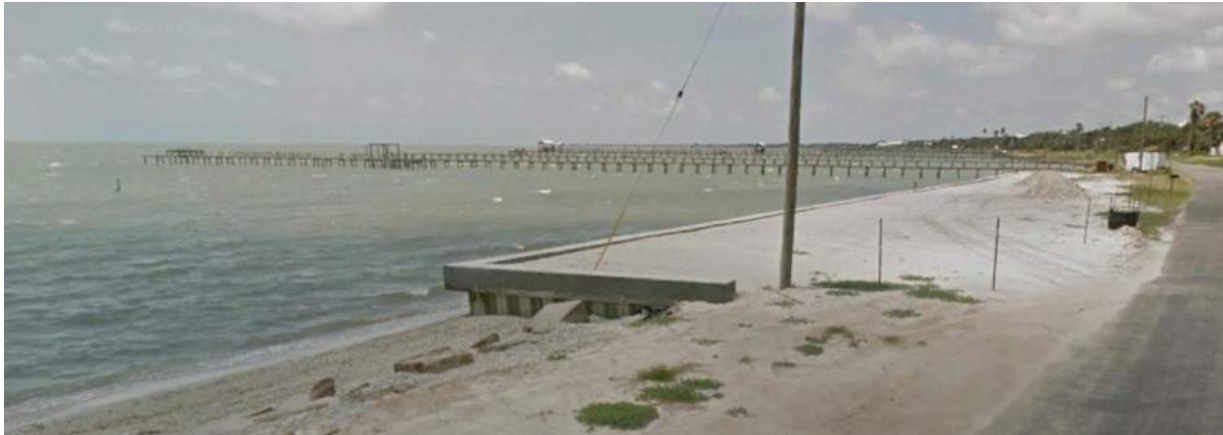
Figure 7. Google Street View Photo from 2018 showing a private sheetpile bulkhead and concrete cap along North Fulton Beach Road.

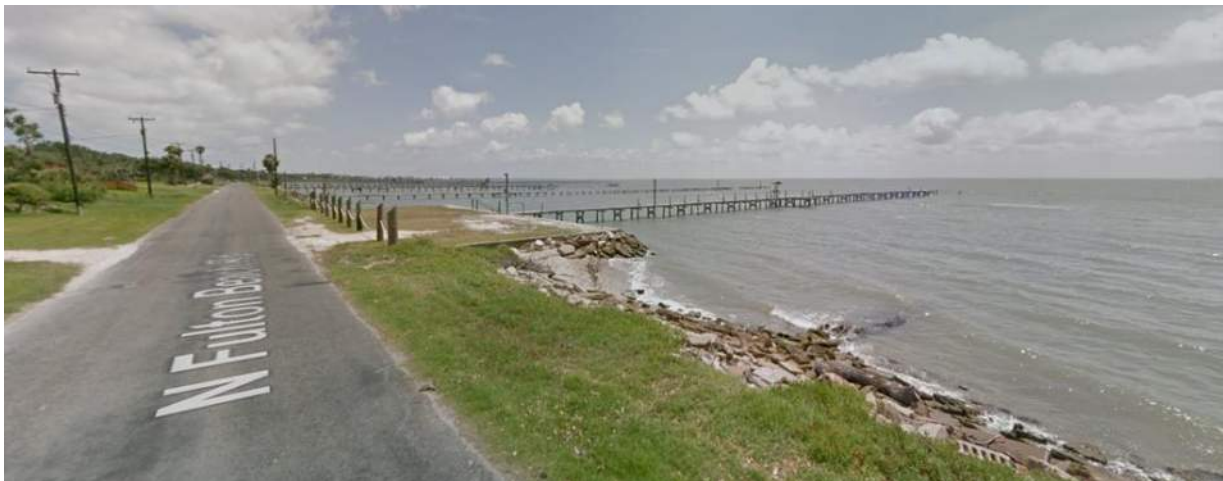
Figure 8. Google Street View Photo from 2018 showing a privately leased bulkhead and timber pier along North Fulton Beach Road.

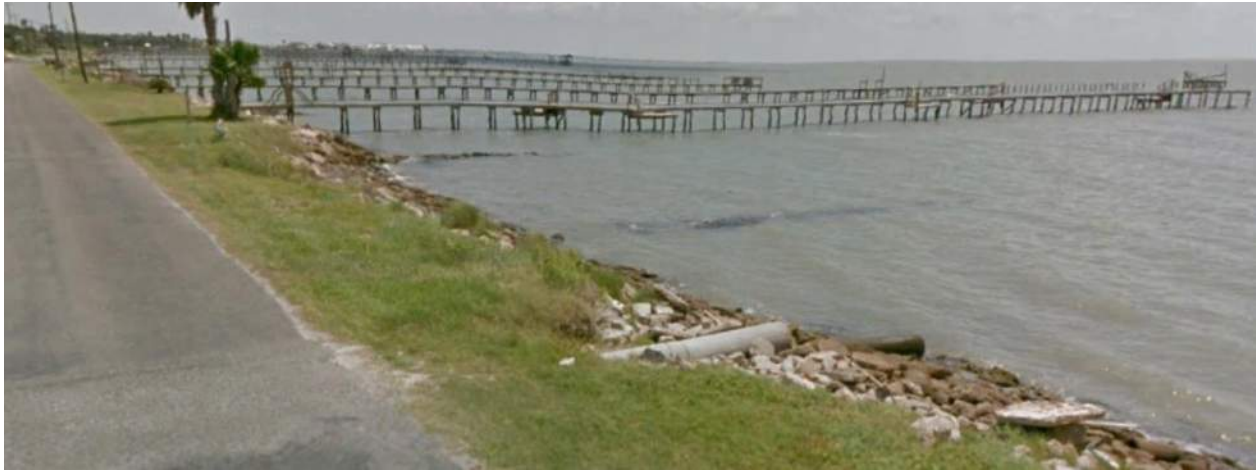
Figure 9. Google Street View Photo from 2018 showing privately leased timber piers and perpendicular groins along North Fulton Beach Road.

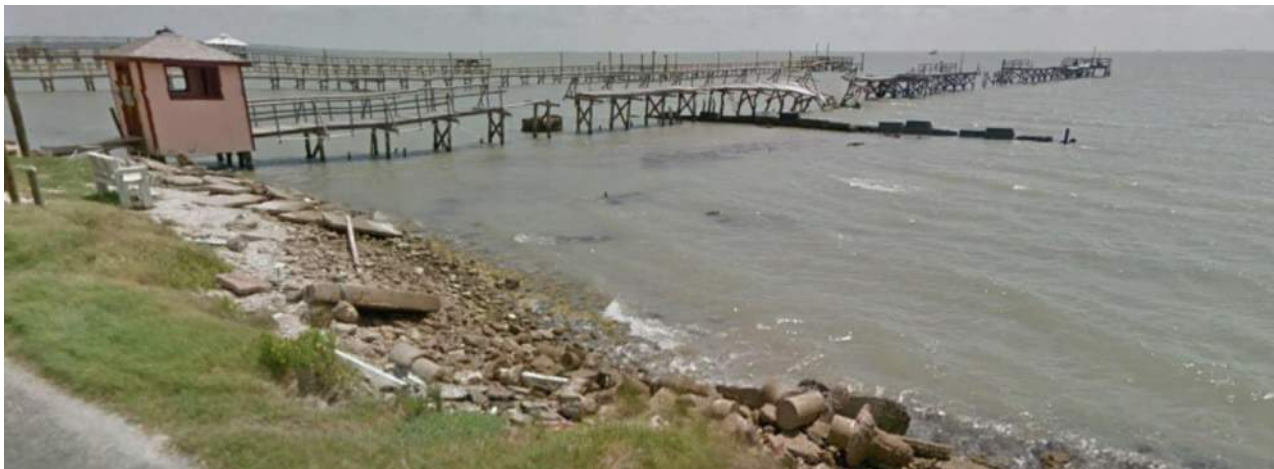
Figure 10. Google Street View Photo from 2018 showing privately leased timber piers and an offshore band on concrete rip rap along North Fulton Beach Road.

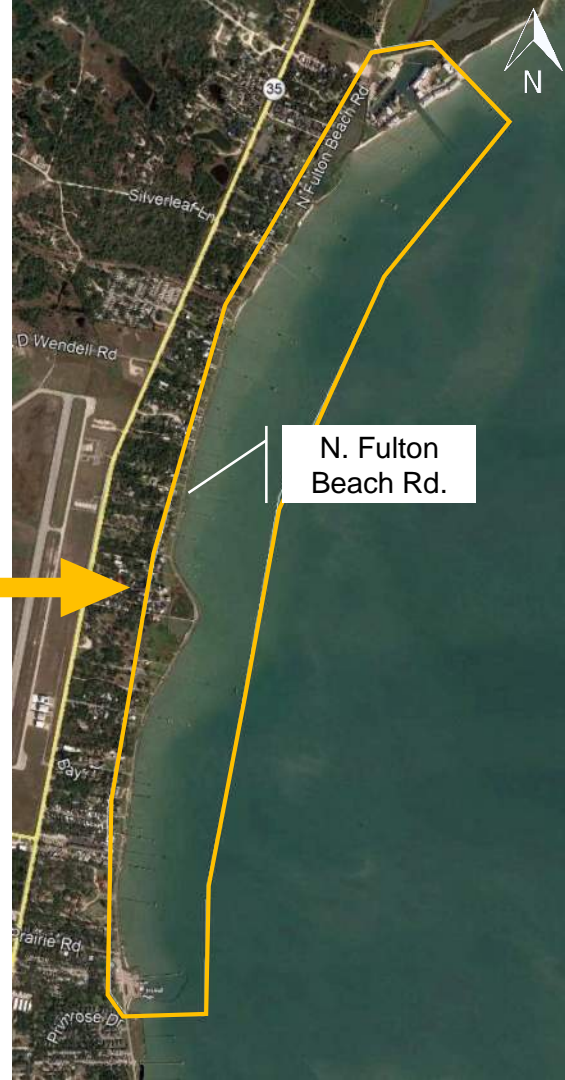
Site Conditions Post Hurricane Hanna

- Misplaced concrete/debris along shoreline
- Significant roadway damage
- Private bulkheads and sidewalks undermined
- Damage to timber pier structures
- Timber debris at the shoreline
- Sediment washout near shoreline
- Shoreline vegetation line pushed landward

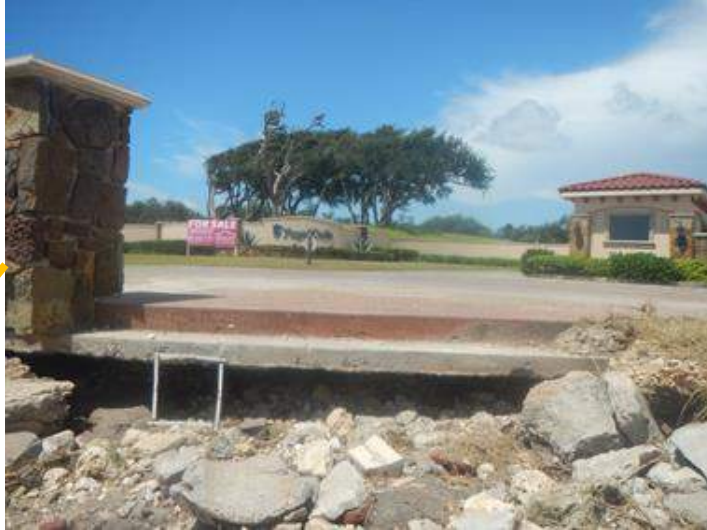
Undermined Concrete at N. Fulton Beach Road

- Lack of rubble in this area led to the undermining of this concrete slab of the roadway.
- Direct wave impact and runup scoured and washed out loose sediment.

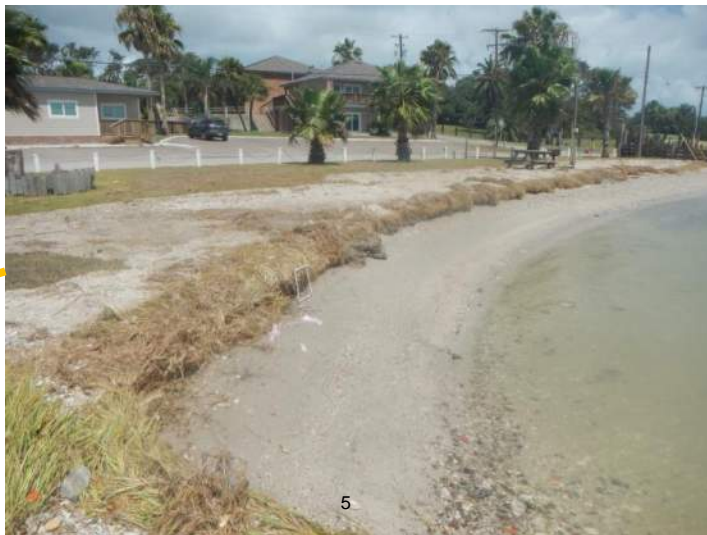
Significant Scarping along shoreline

- Lack of hard protection led to direct wave impact and sediment erosion, scarping the slope
- Sediment was pushed landward, covering vegetation.

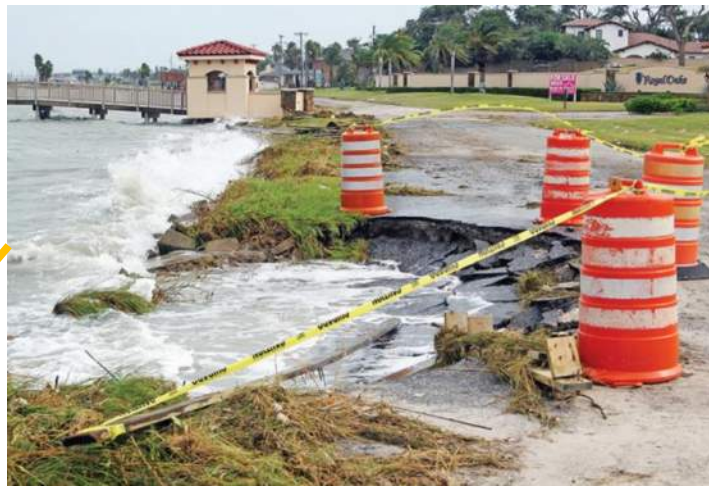
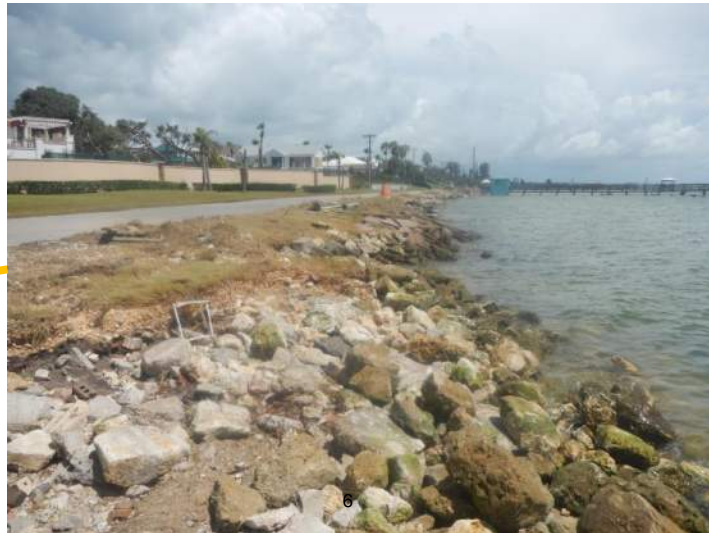
Damage to Roadway

- Overtopping of the concrete rubble led to washout of sediment and damage to the vegetation line.

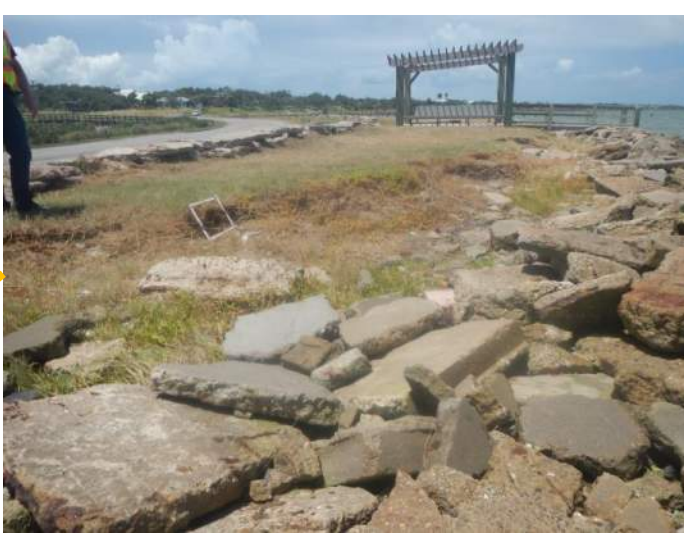
Significant Scarping along shoreline

- Overtopping of the concrete rubble led to washout of sediment and significant scarping along the shoreline.

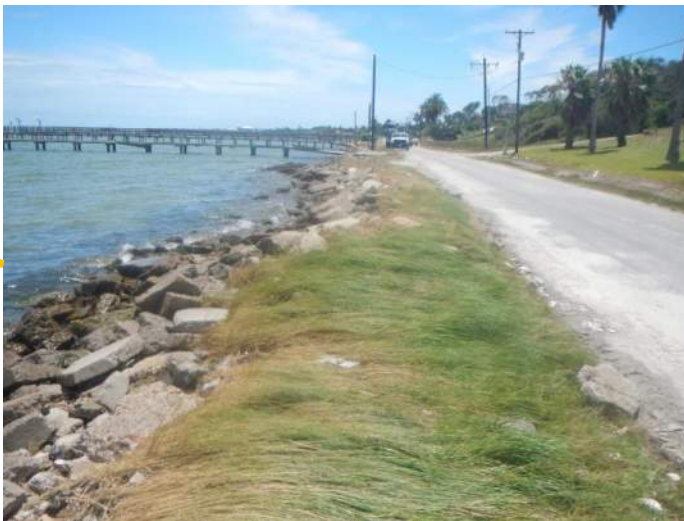
Damage to Vegetation Line

- Overtopping of the concrete rubble can be seen here, where grass has been pushed down by waves and rubble was found along the roadway.

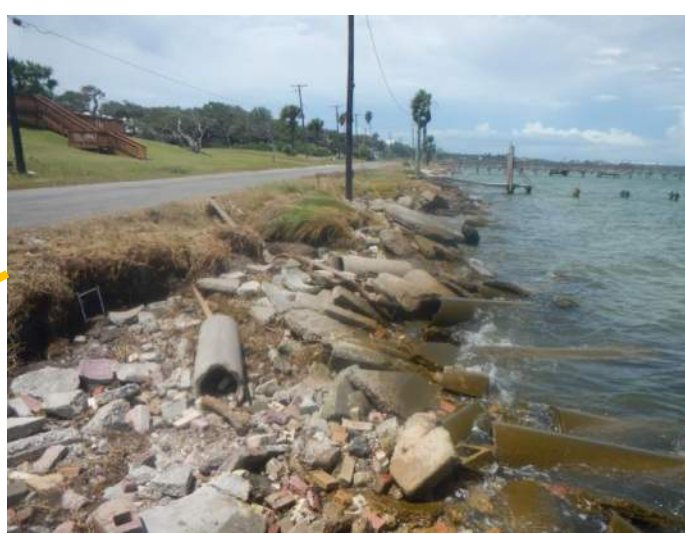
Significant Scarping along shoreline

- Overtopping of the concrete rubble led to washout of sediment and a erosion to the vegetation line.
- In some areas, this led to the exposure of the roadway to wave action.

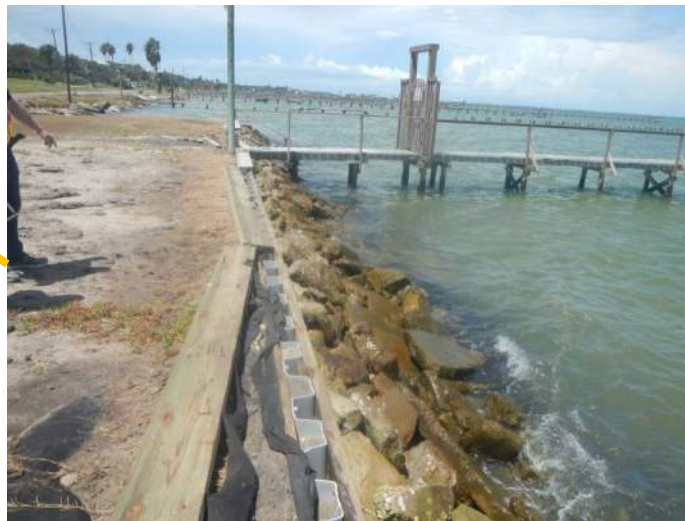
Private Bulkhead Damage

- Wave overtopping at this bulkhead led to the failing of the timber cap.

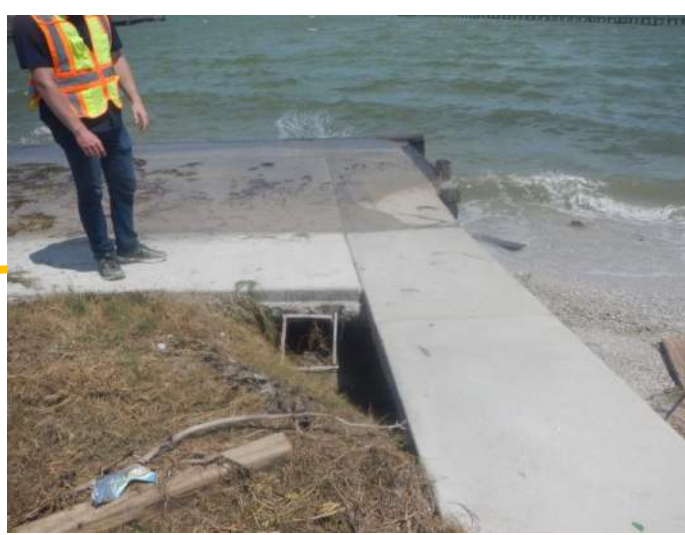
Private Bulkhead Damage

- Wave overtopping at this bulkhead led to the undermining the wall. As the water washed back out to the bay it caused additional scouring.

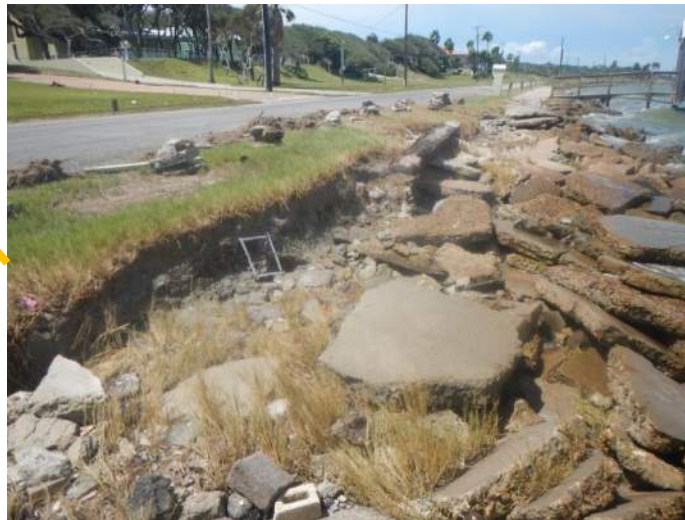
Significant Scarping along shoreline

- Overtopping of the concrete rubble led to washout of sediment and a erosion of the vegetation line.

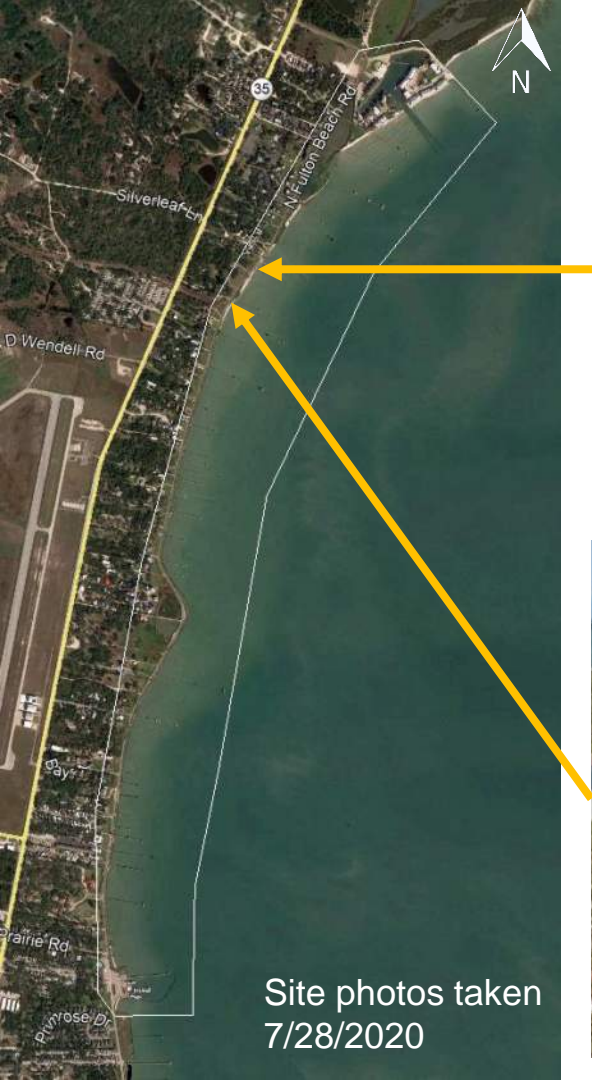
Private Bulkhead Damage

- Corners of bulkheads typically need significant protection as this area becomes a focus point of water rushing around the structure. This bulkhead was overtopped significantly, and sediment was scoured out behind the wall, exposing the tie backs.

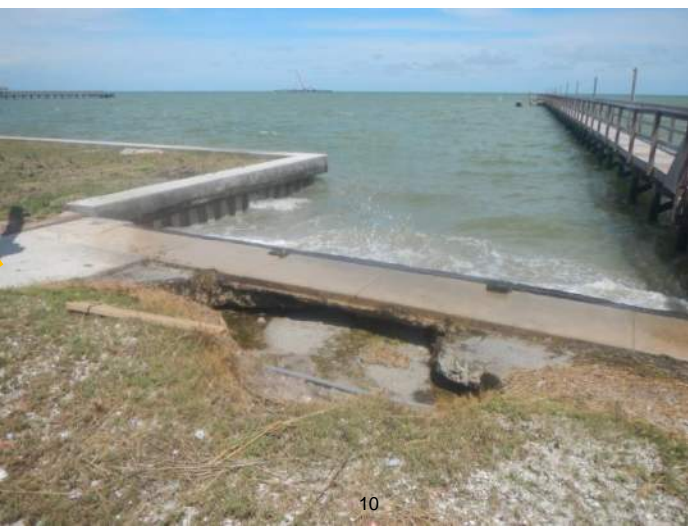
Private Bulkhead Damage

- Wave overtopping at this bulkhead led to the undermining the wall, where water washed back out to the bay resulting in significant scouring.

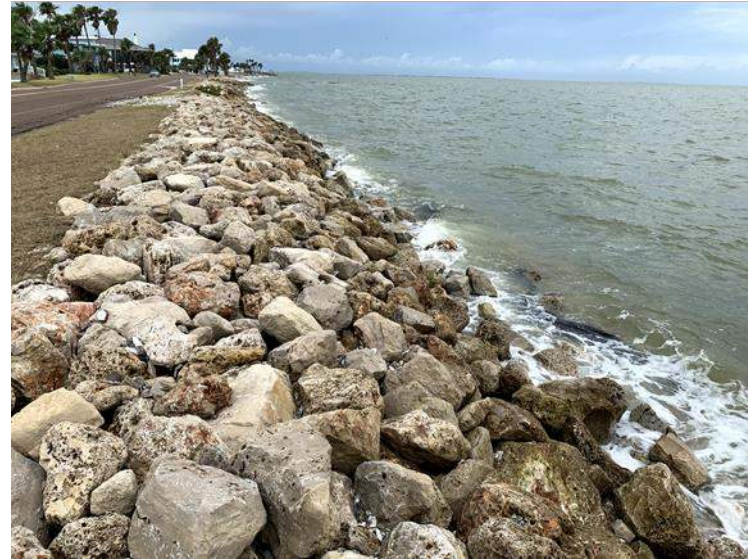
Figure A1. Stone Revetment Along Bayshore Drive Rockport, TX

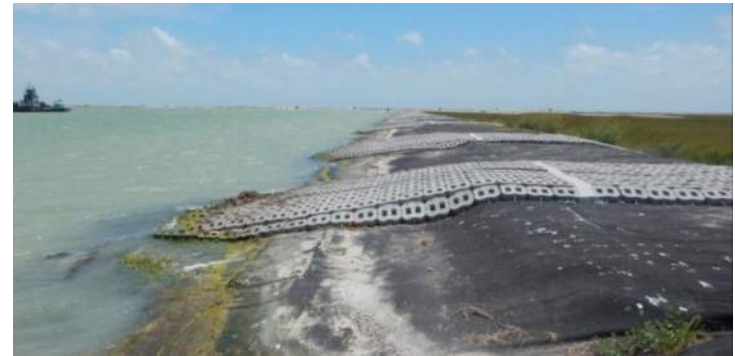
Figure A2. ACBM Revetment at La Quinta Terminal Berm

- Would need high crest elevation to prevent overtopping
- Will likely be no room for landward vegetation to grow
- Will present danger to those who wish to climb over to the water side
- Not durable in high energy conditions

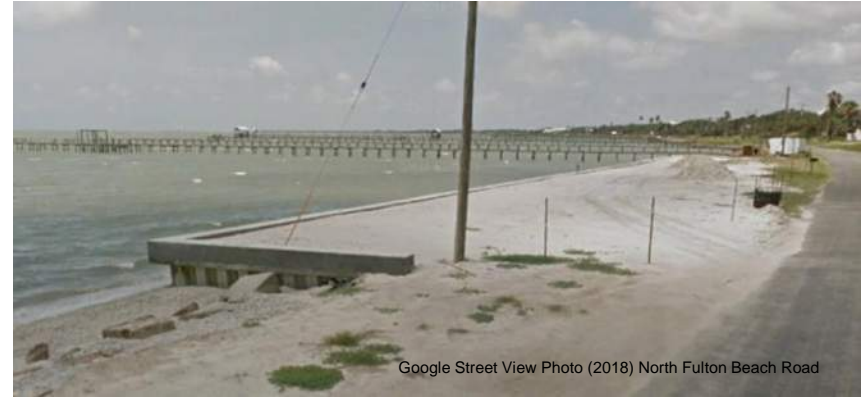
Figure A3. Private Sheetpile Bulkhead Along North Fulton Beach Rd. Rockport, TX

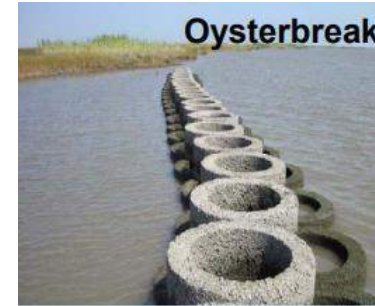
Figure A4. Potential Artificial Reef Units

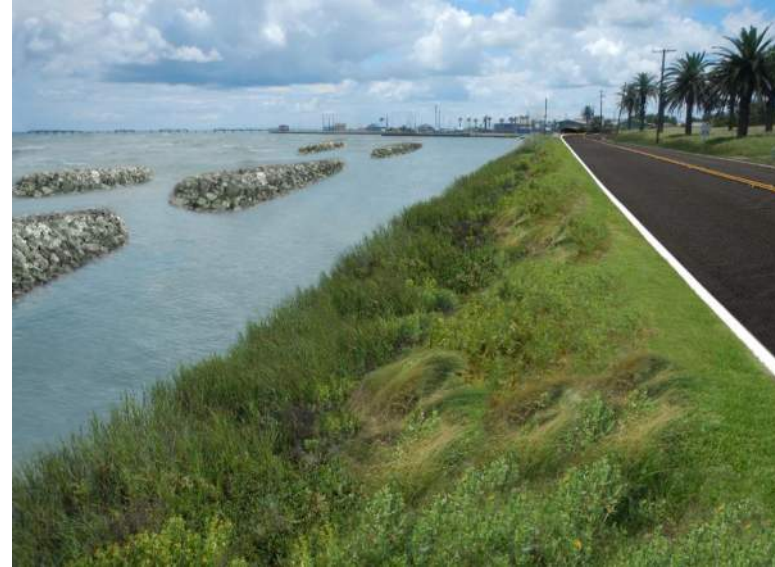
Figure A5. Rendering of South Fulton Breakwater & Living Shoreline Design

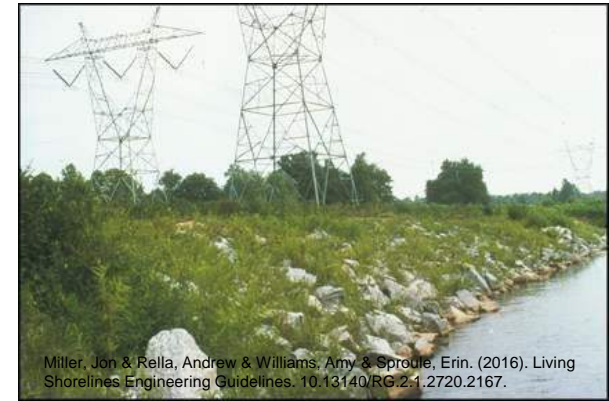
Figure A6. Example Joint Planting with Stone Revetment Design

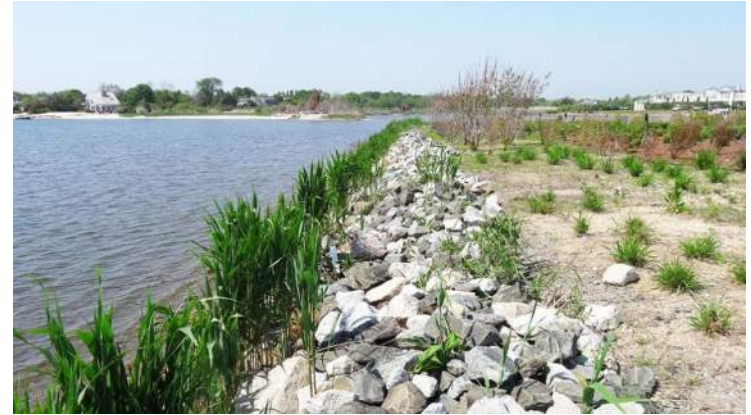
Figure A7. Example Stone Revetment with Toe Vegetation Planting Design

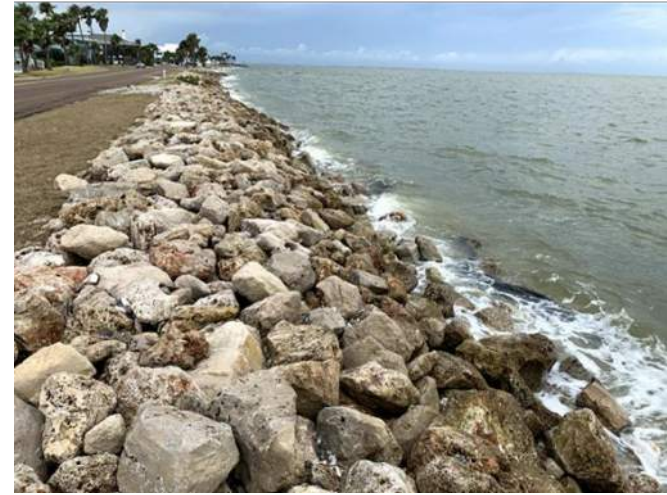
Figure A8. Stone Revetment Along Bayshore Drive Rockport, TX and Example Artificial Reef Units

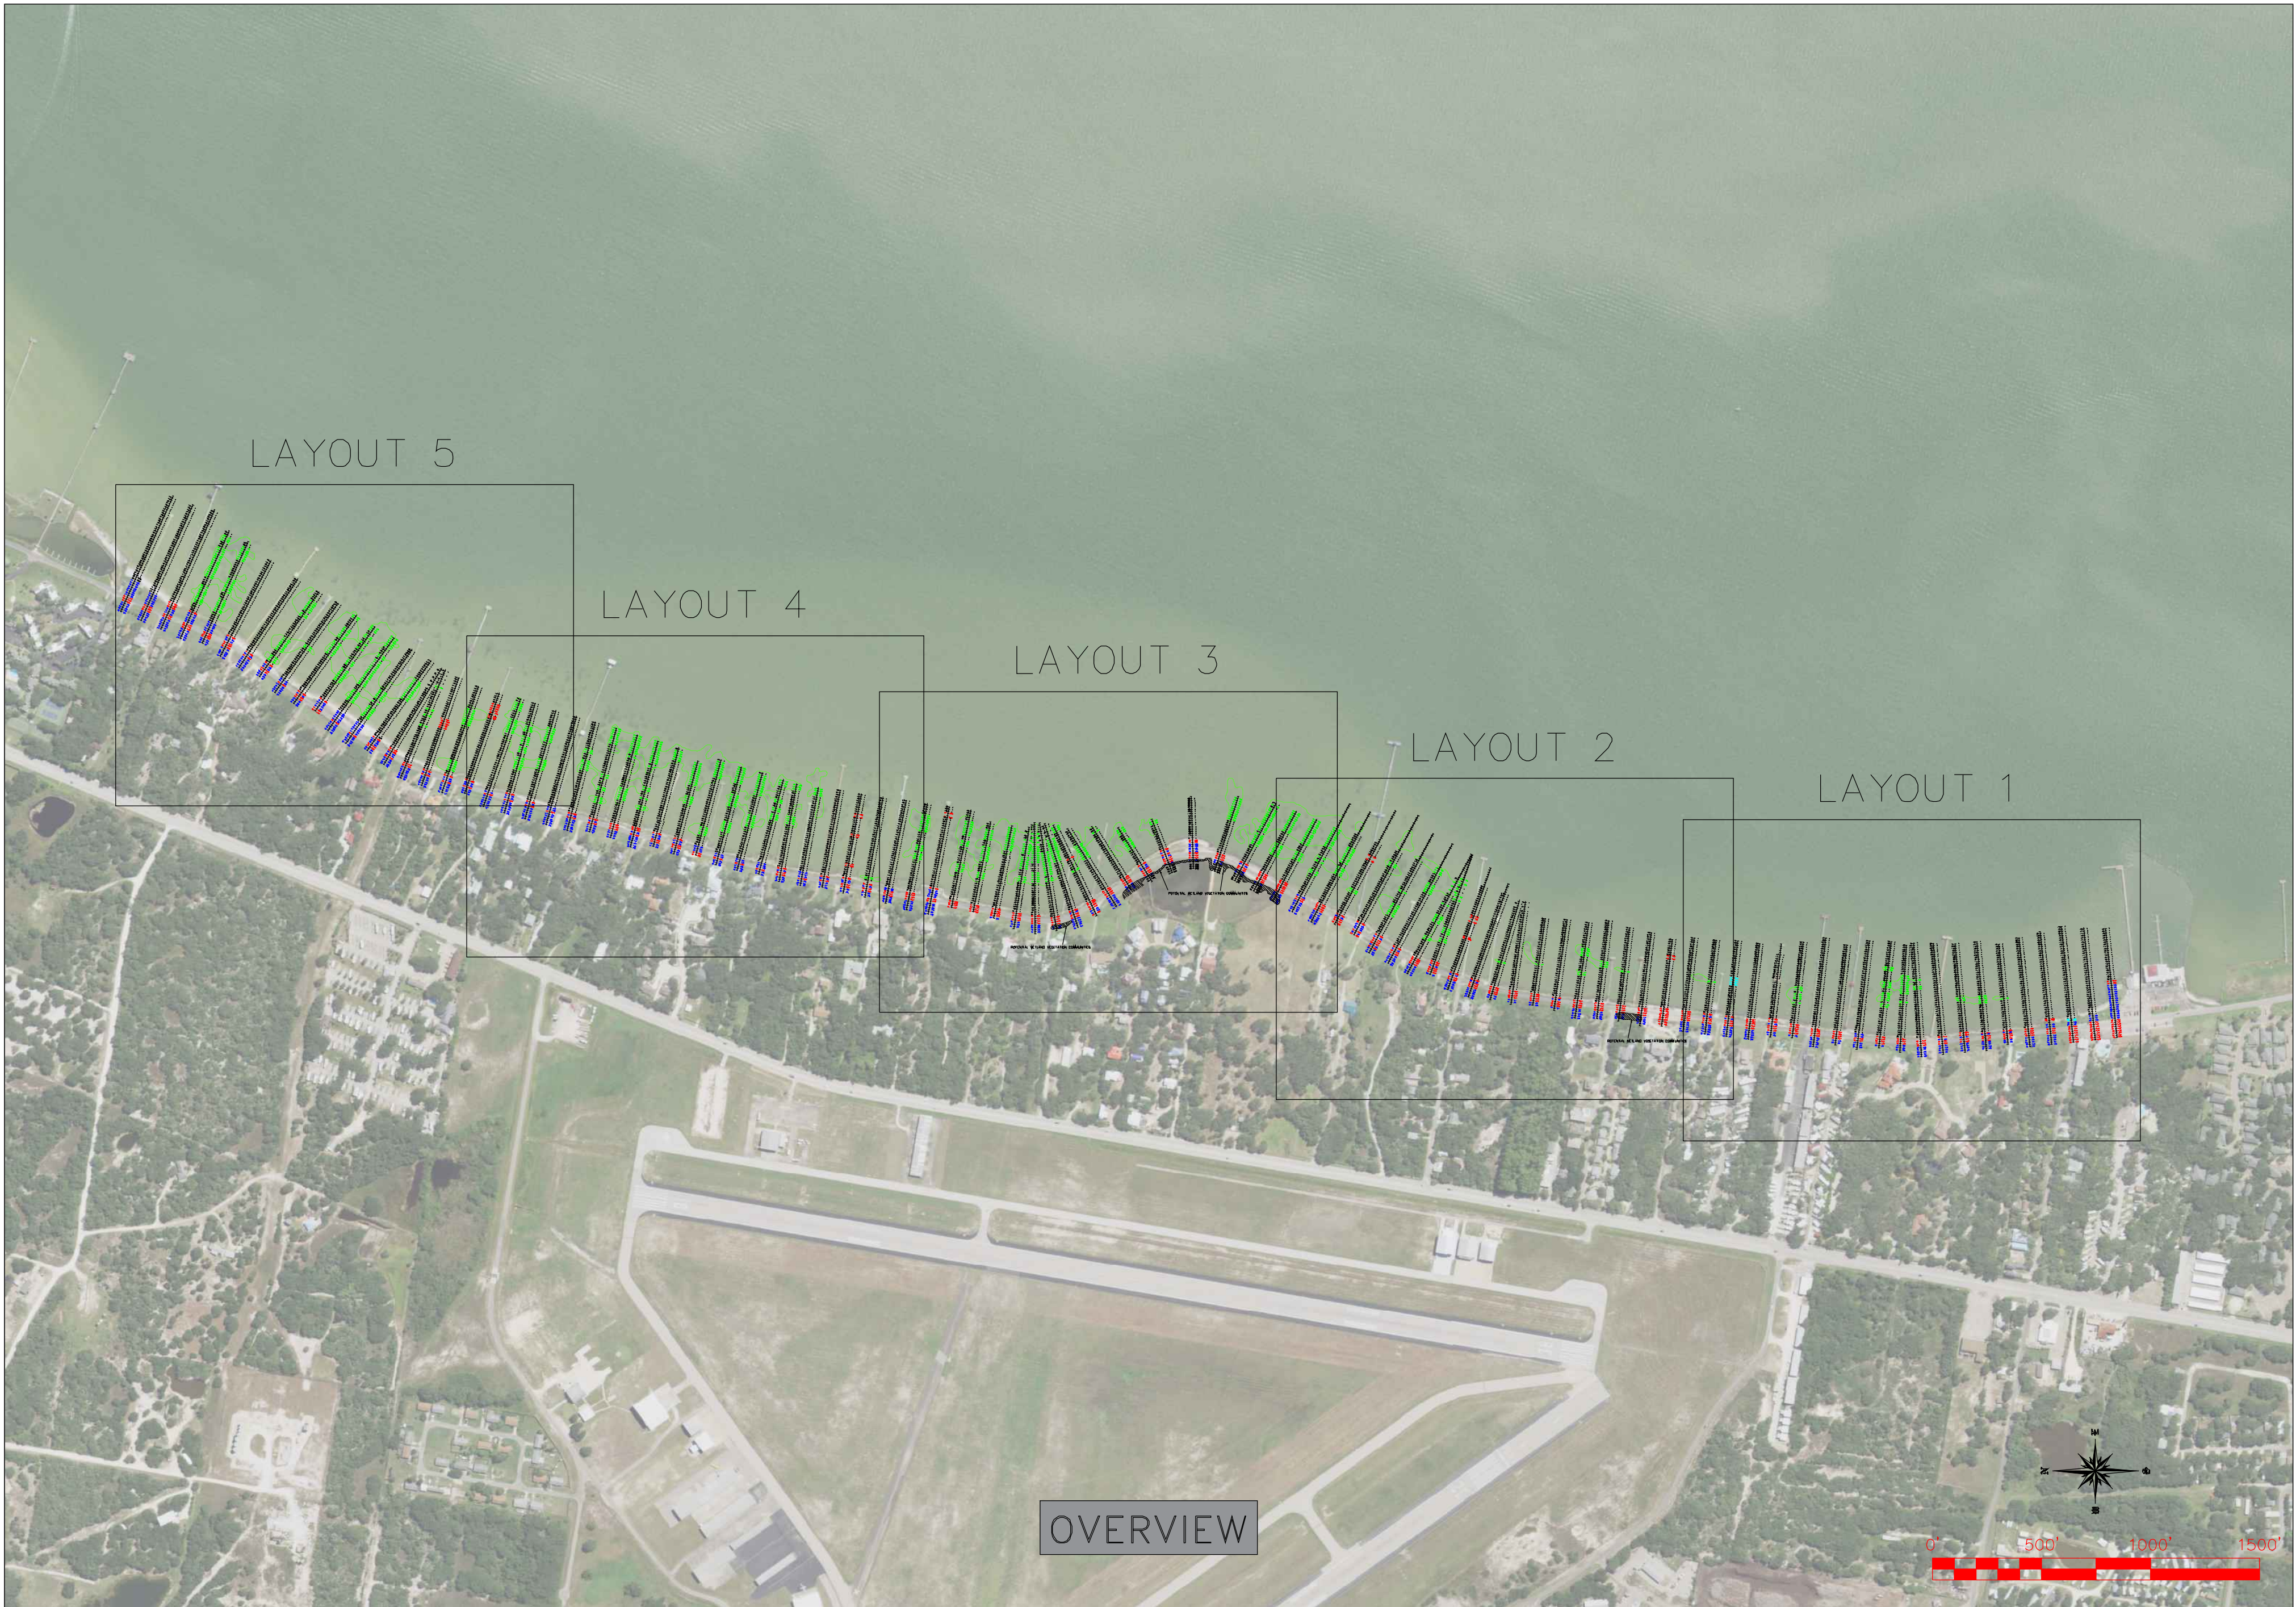
SCALE: 1"=500'	DATE: JUNE 2020
DMY. BY: WMP	SHEET 1 OF 6

MOTT MACDONALD
 FULTON BEACH ROAD
 SEAGRASS SURVEY
 FULTON, TX

Shoalgrass (*Halodule wrightii*) was the only seagrass species encountered during the survey. Figure 1 shows the sample point locations and bay bottom elevation at each sample point. Figure 1 also shows the location and boundaries of the three potential wetland vegetation communities delineated adjacent to Fulton Beach Road.
