Fulton Beach Road Living Shoreline

20-030-000-B737

**Final Report
February 2022**

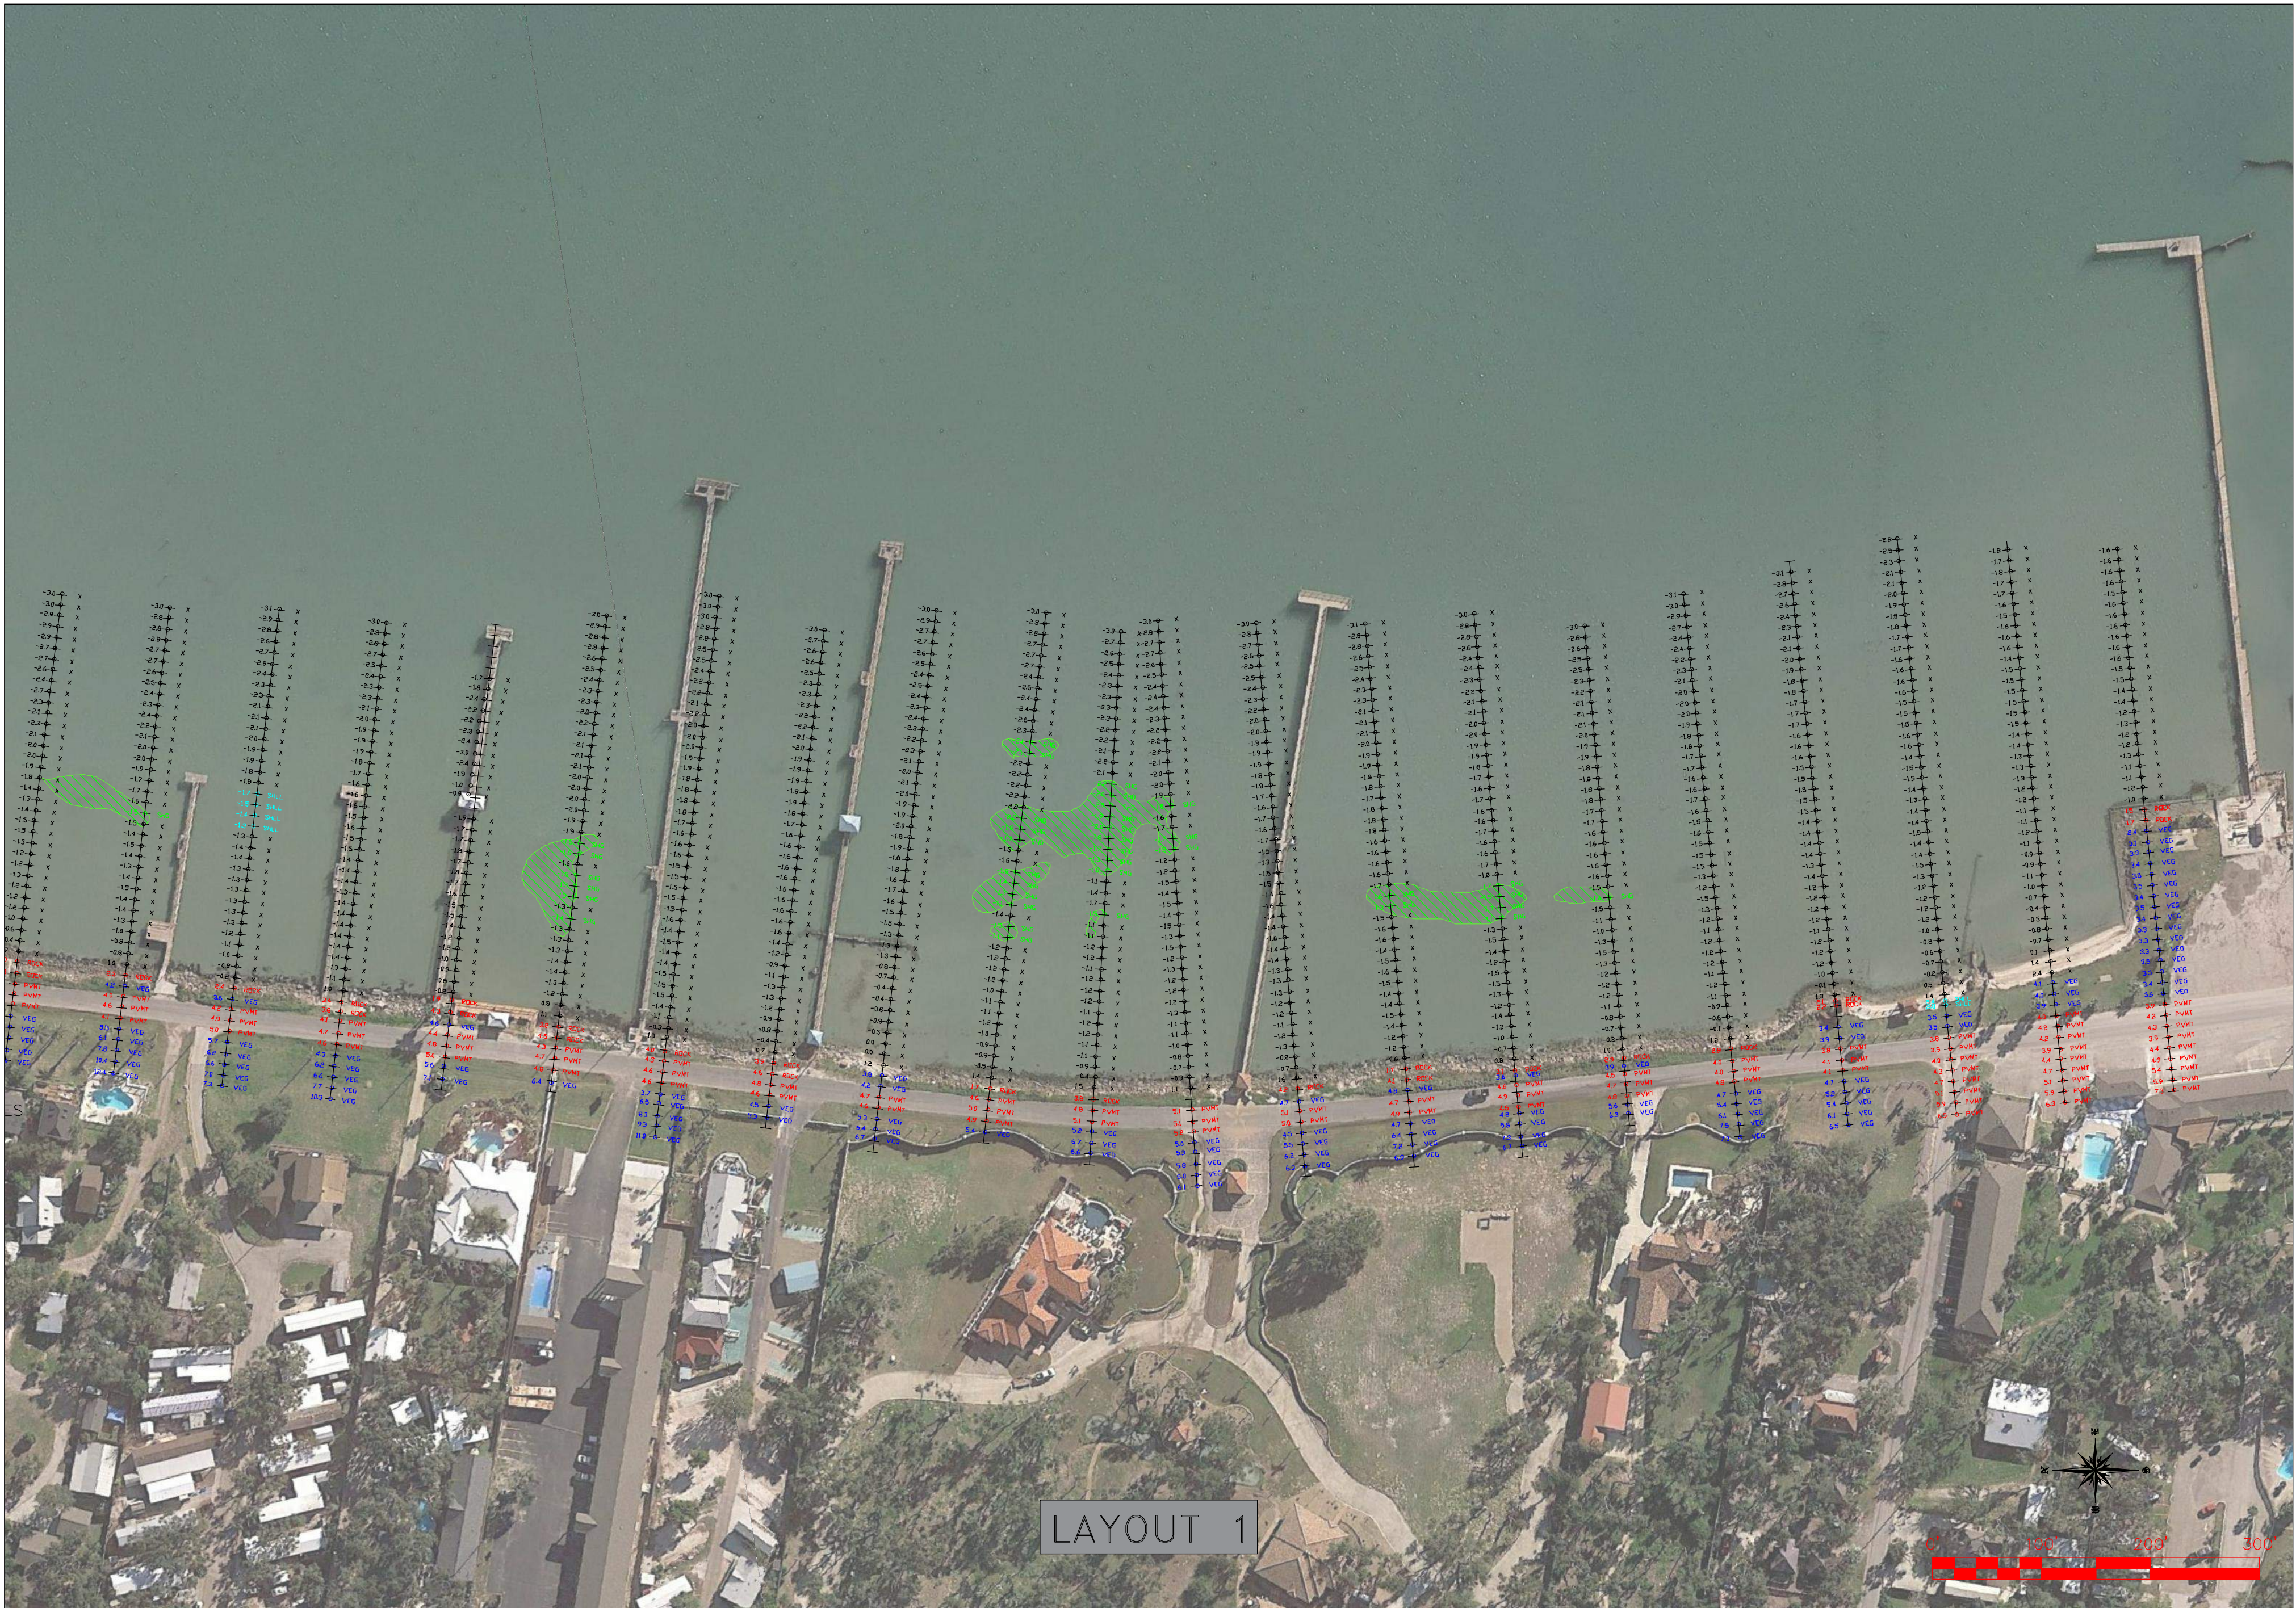
SHEET 2 OF 6
 DATE: JUNE 2020

X - BARE SUBSTRATE
 SHG - SHOALGRASS (HALODULE WRIGHTII)
 SHL - SHOALGRASS BEDS
 VEG - EMERGENT UPLAND VEGETATION
 SHLL - SHELL HASH
 ROCK/PVMT/CONC/WALL/GRVL/PIER - MAN-MADE STRUCTURE

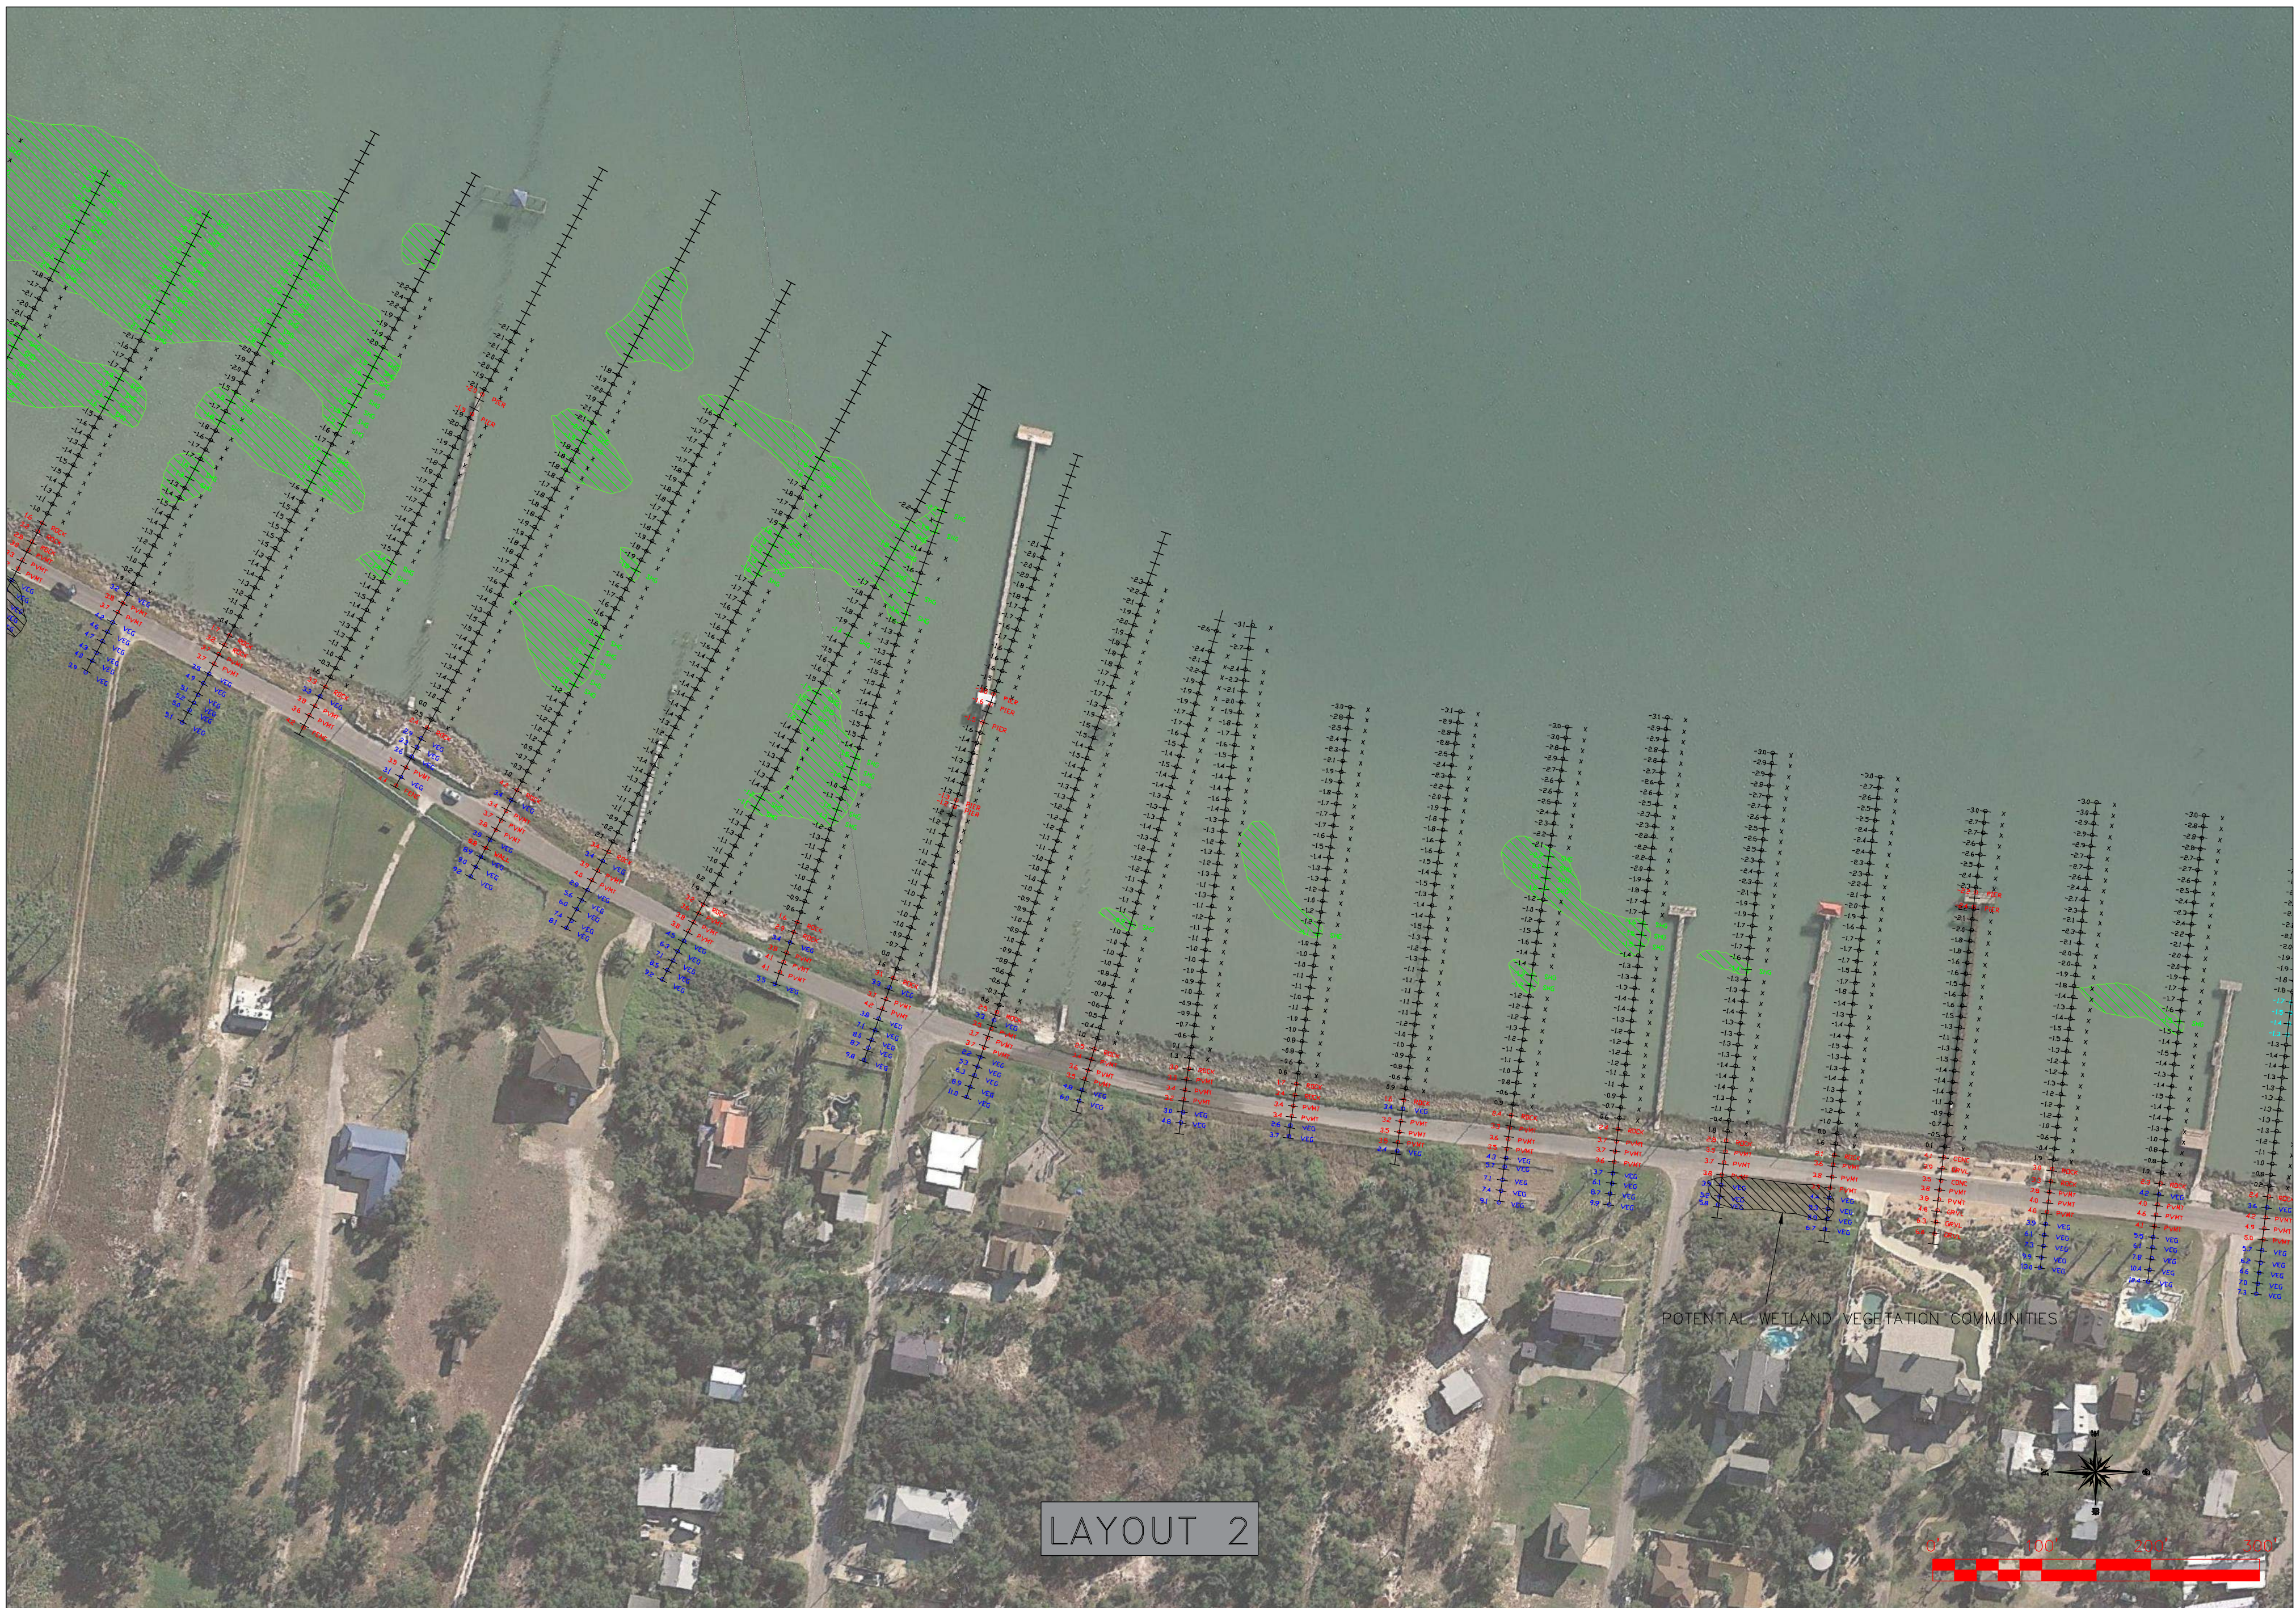
LAYOUT 2

POTENTIAL WETLAND VEGETATION COMMUNITIES
