Nueces Bay Portland Causeway Marsh Restoration CMP Cycle 15 Final Report

August 29, 2012

COASTAL BEND BAYS & ESTUARIES PROGRAM**PORTLAND CAUSEWAY MARSH RESTORATION (DREDGING)****SITE VISIT / CONSTRUCTION STATUS REPORT**

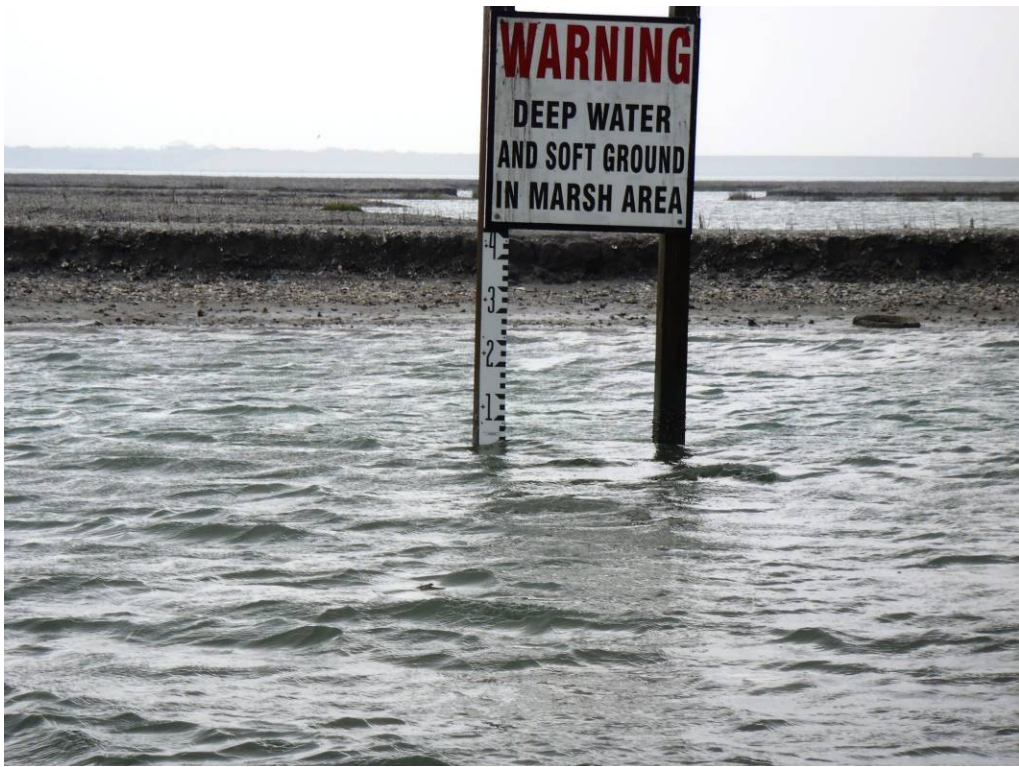
Tide staff installed by Contractor on existing warning sign.

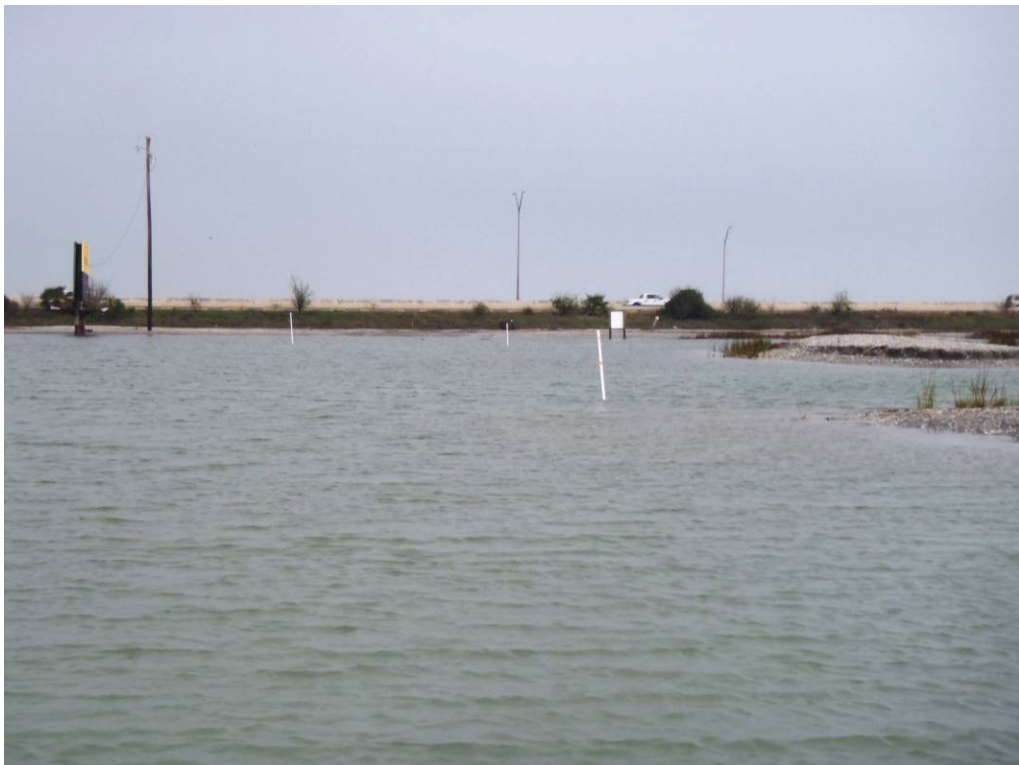
Temporary access corridor staked.

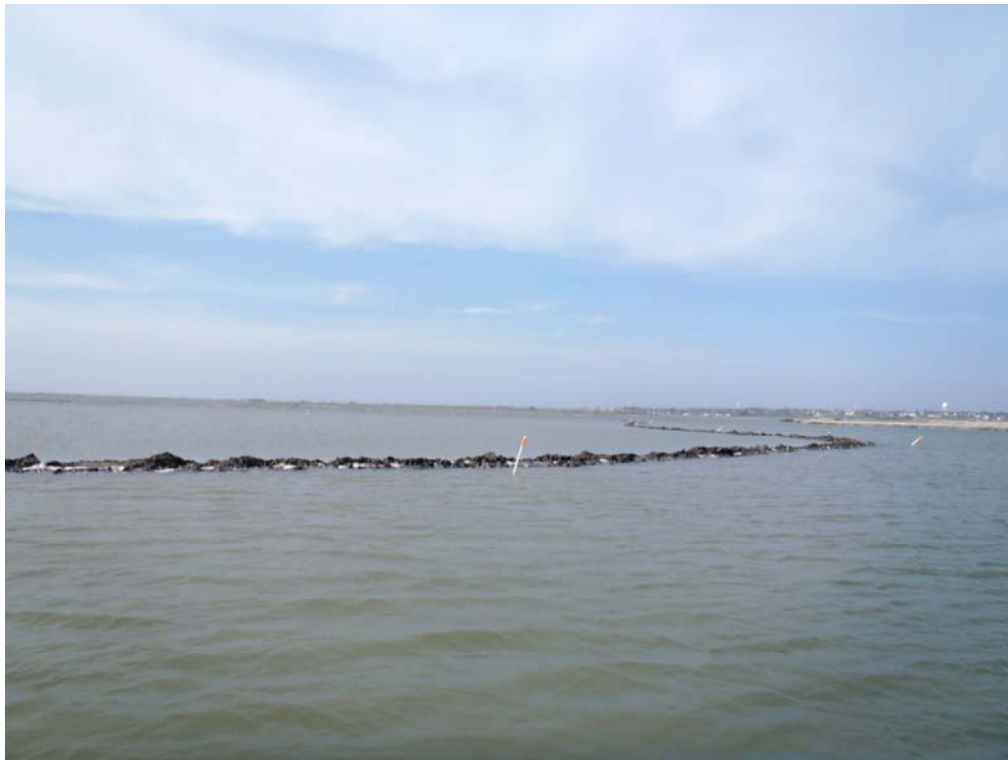
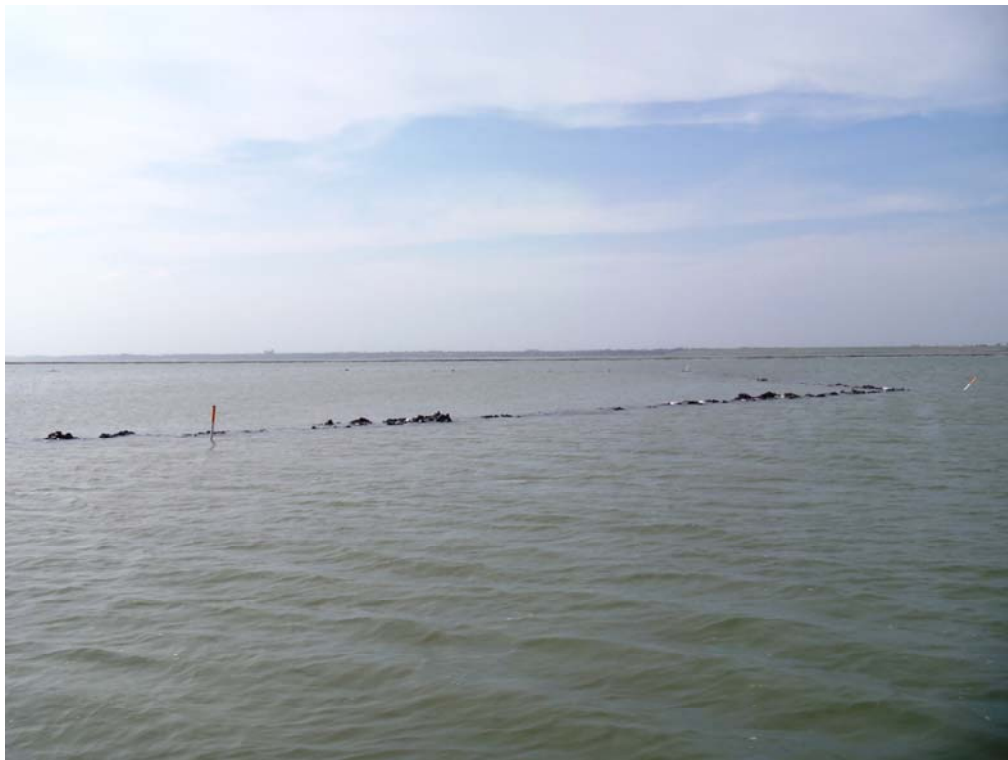
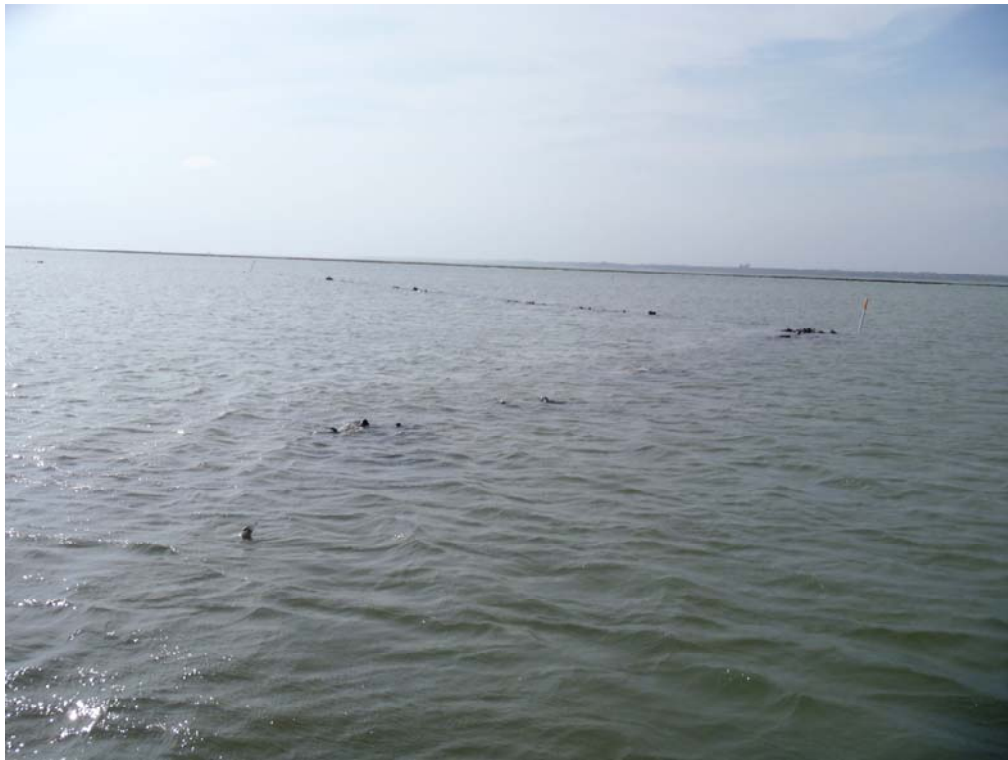
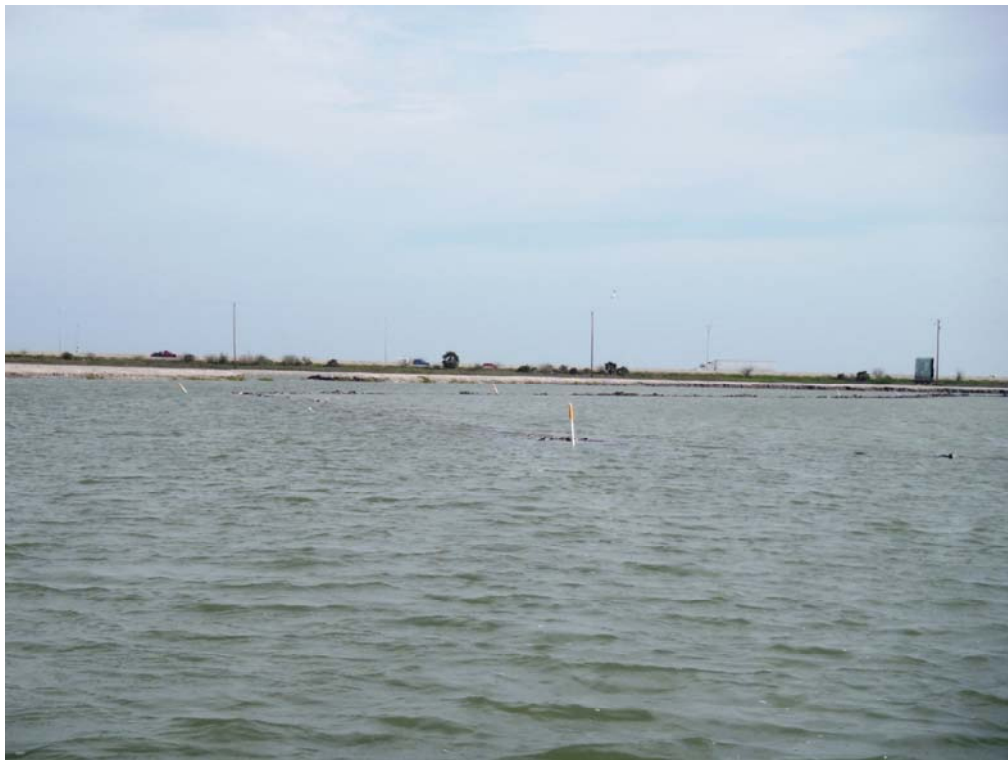
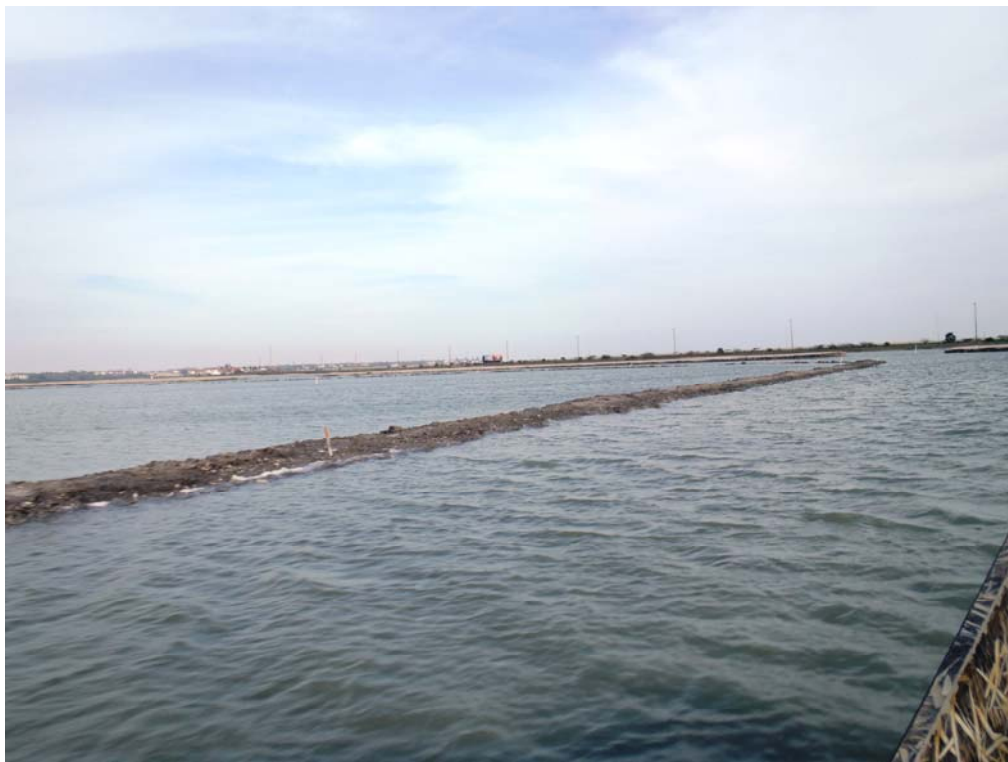
Cell 3 Toe Berm.

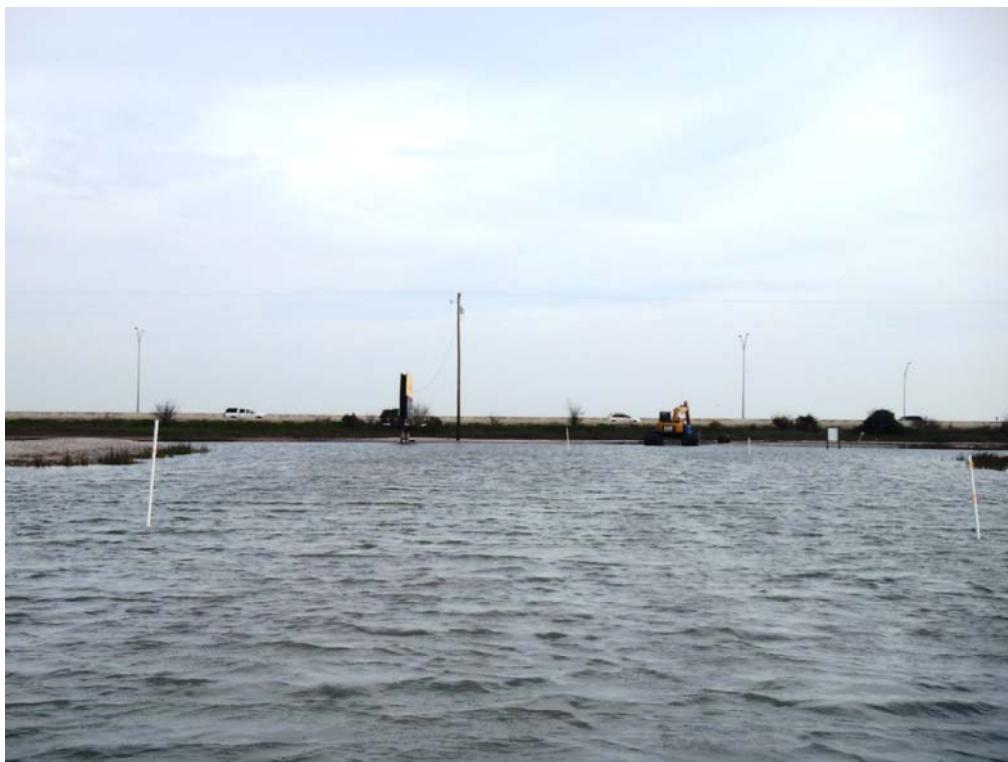
Temporary access corridor..

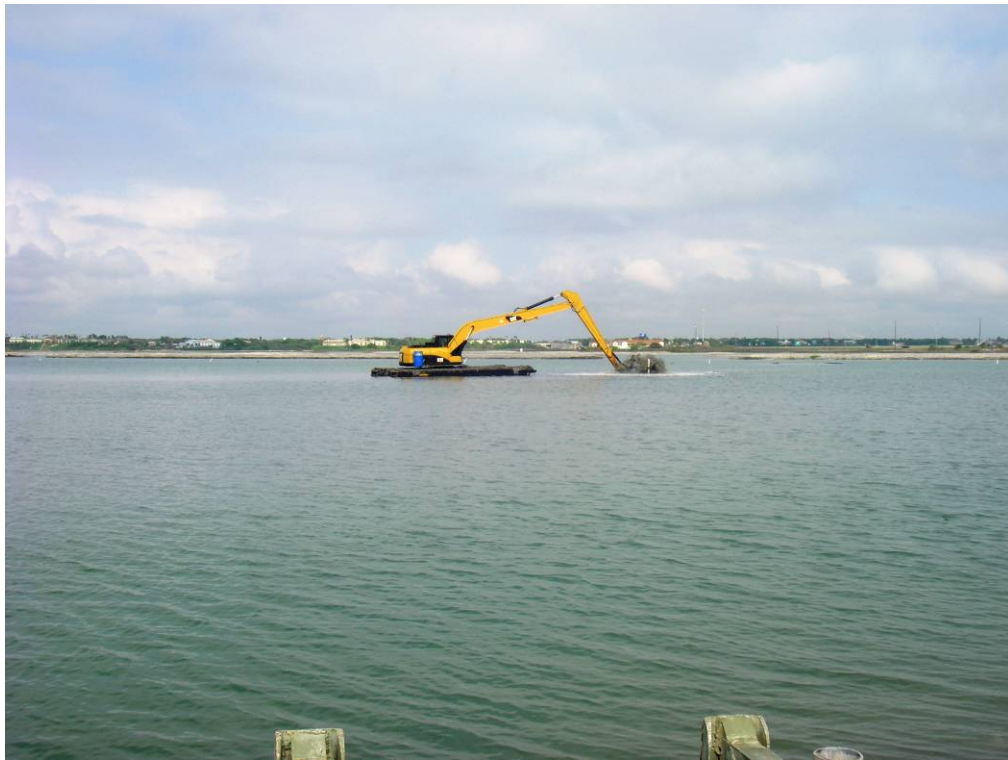
Marsh excavator securing dredge pipe at M11 discharge point.

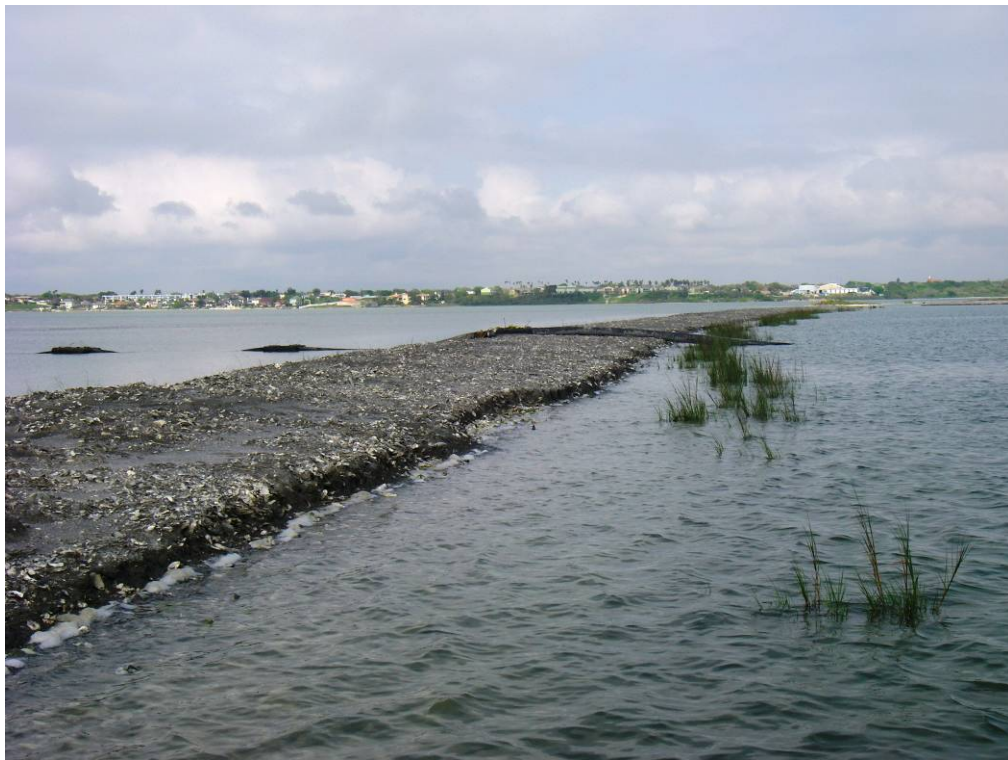
HDPE dredge pipe across outer berm.

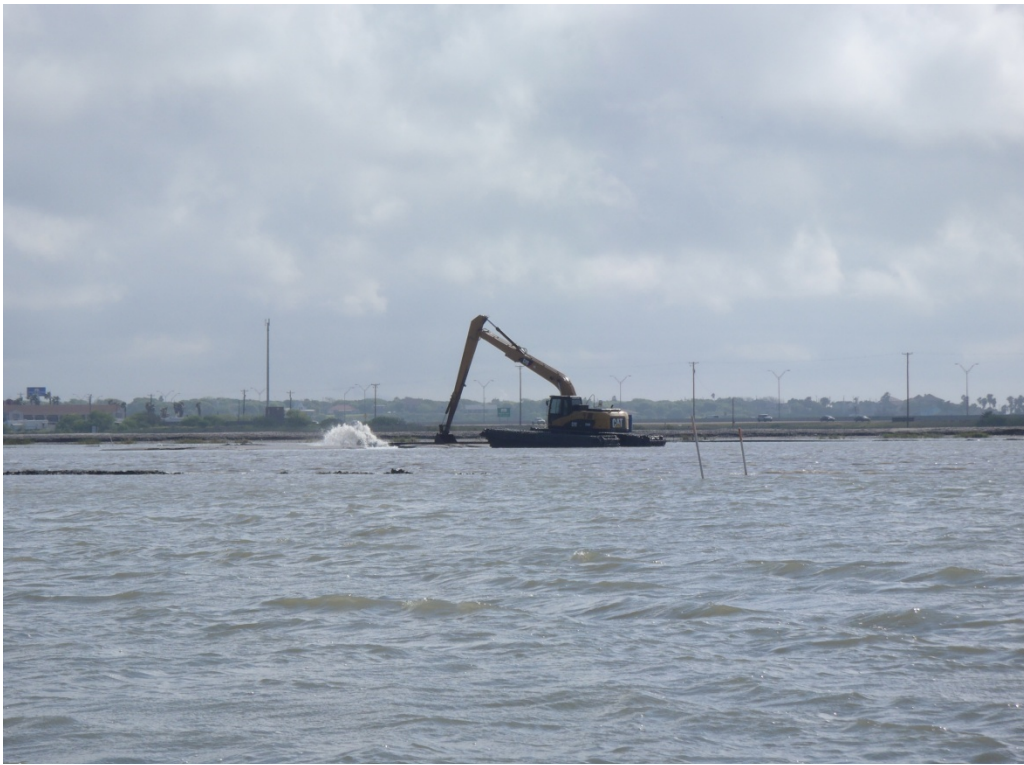
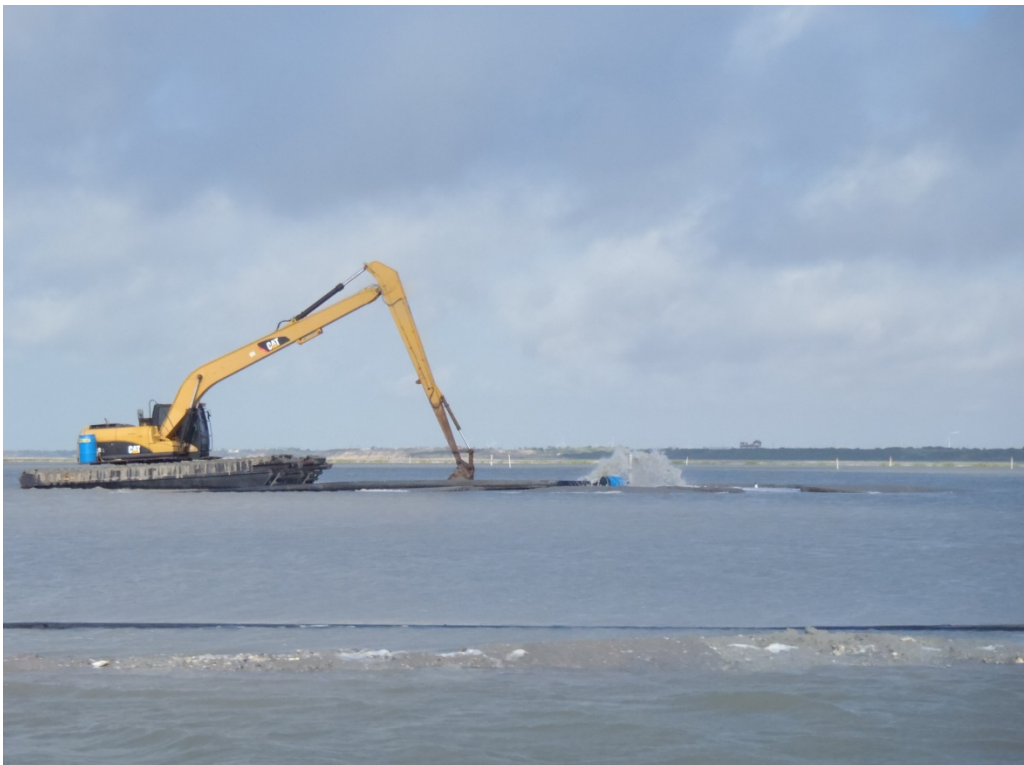
Construction of Marsh Mound M10.

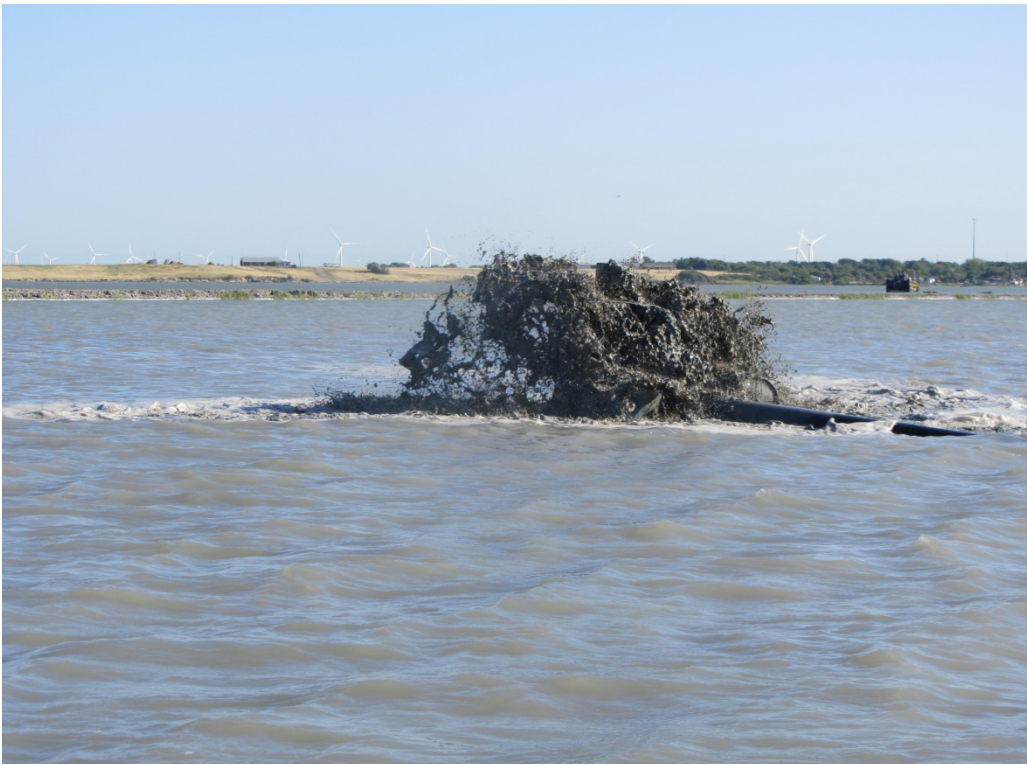
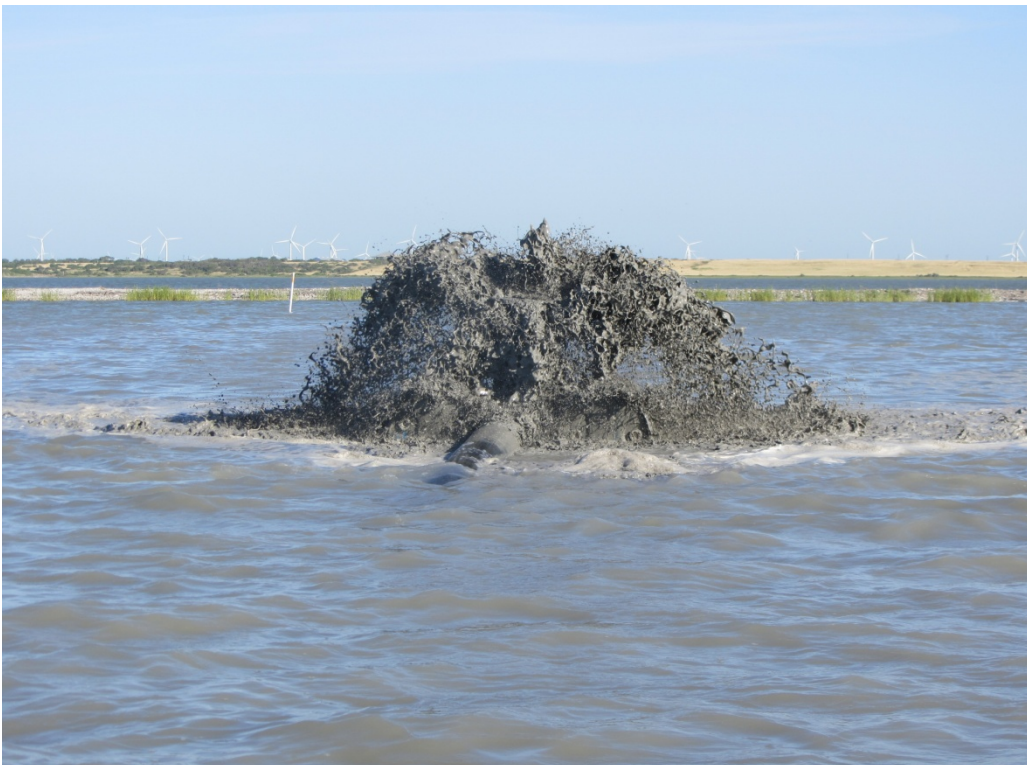
Dredge discharging at marsh mound M3.

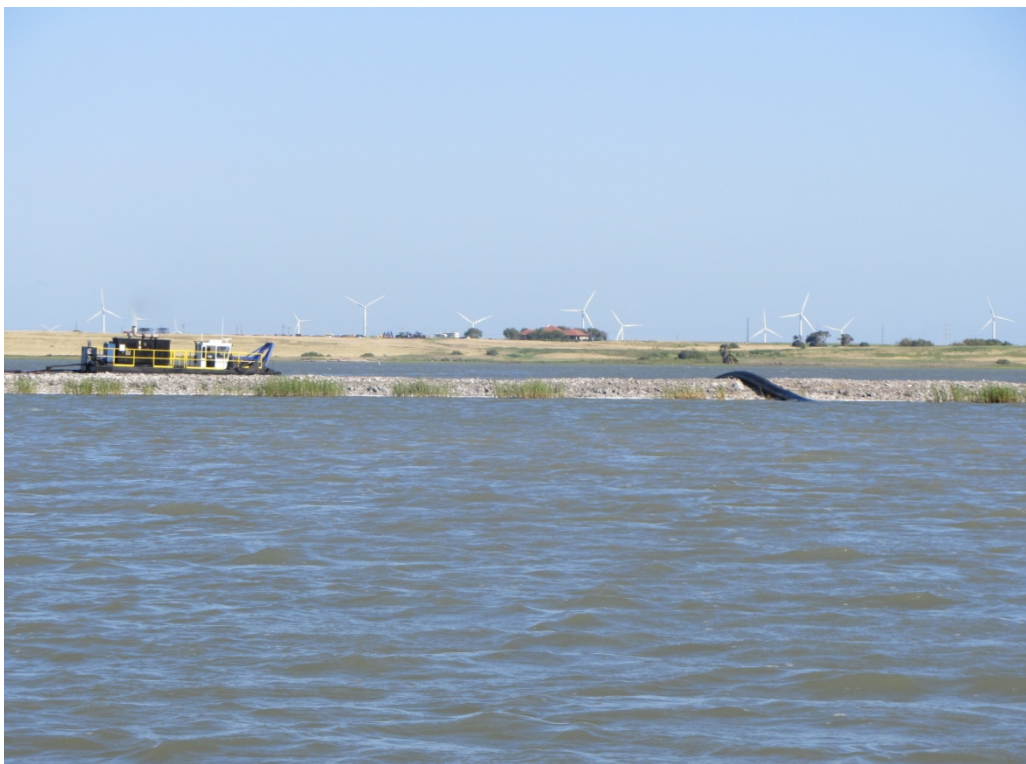
Dredge and discharge pipe over outer berm.

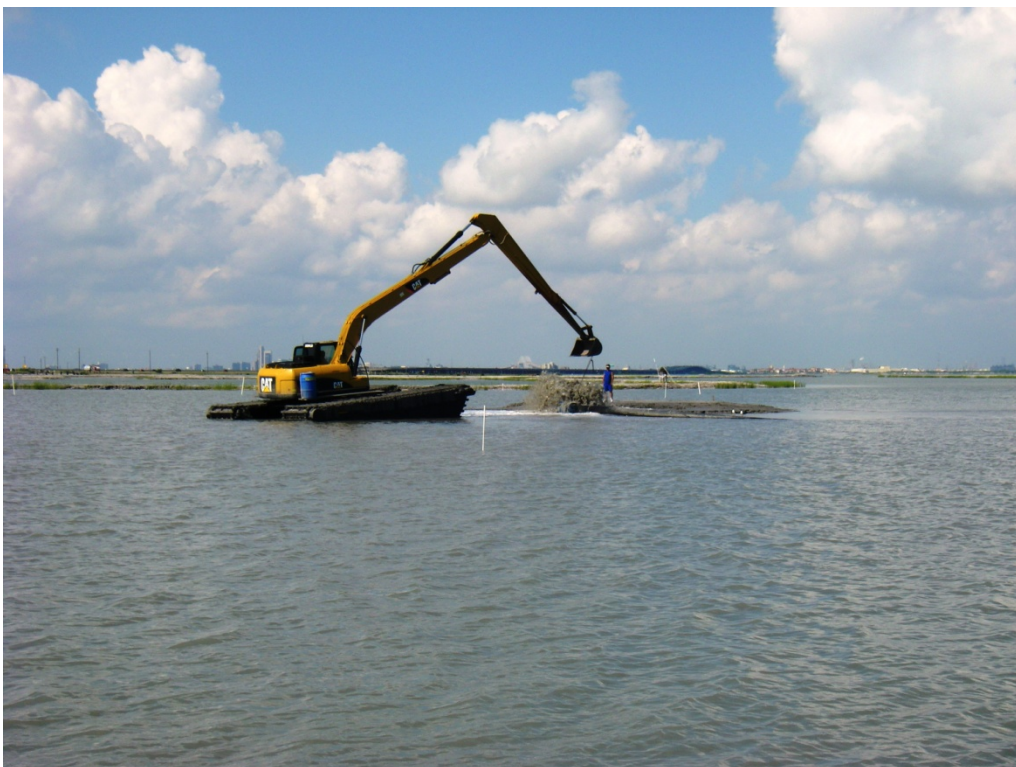
Dredge discharging at marsh mound M1.

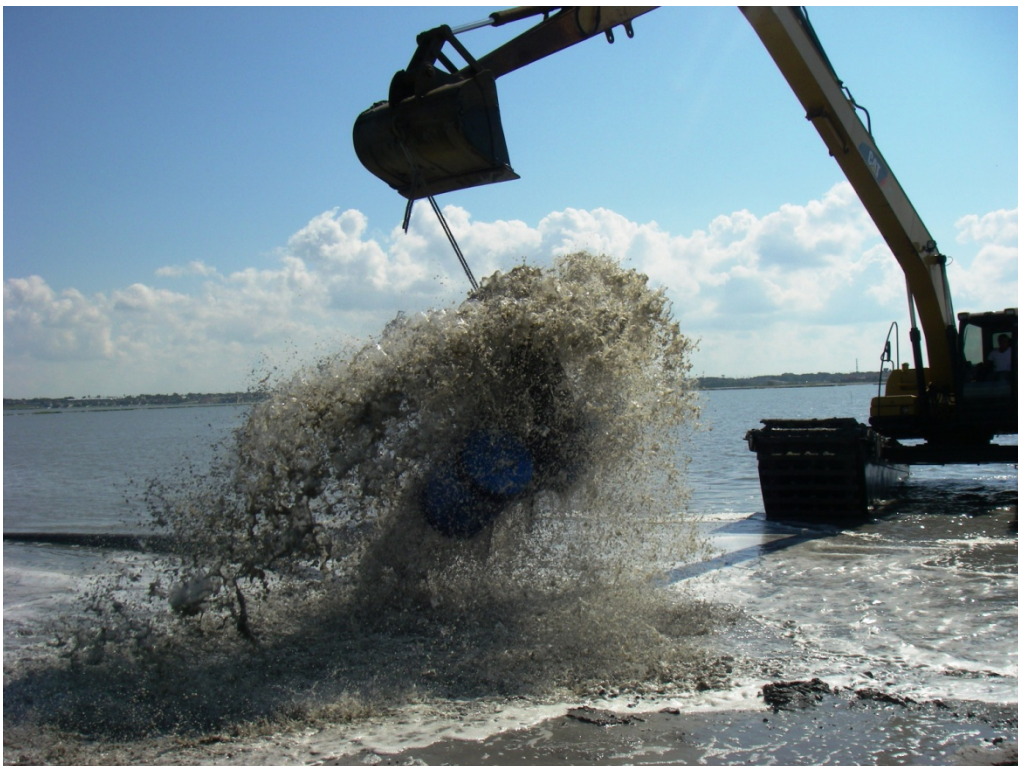
Relocating dredge pipe at marsh mound M1.

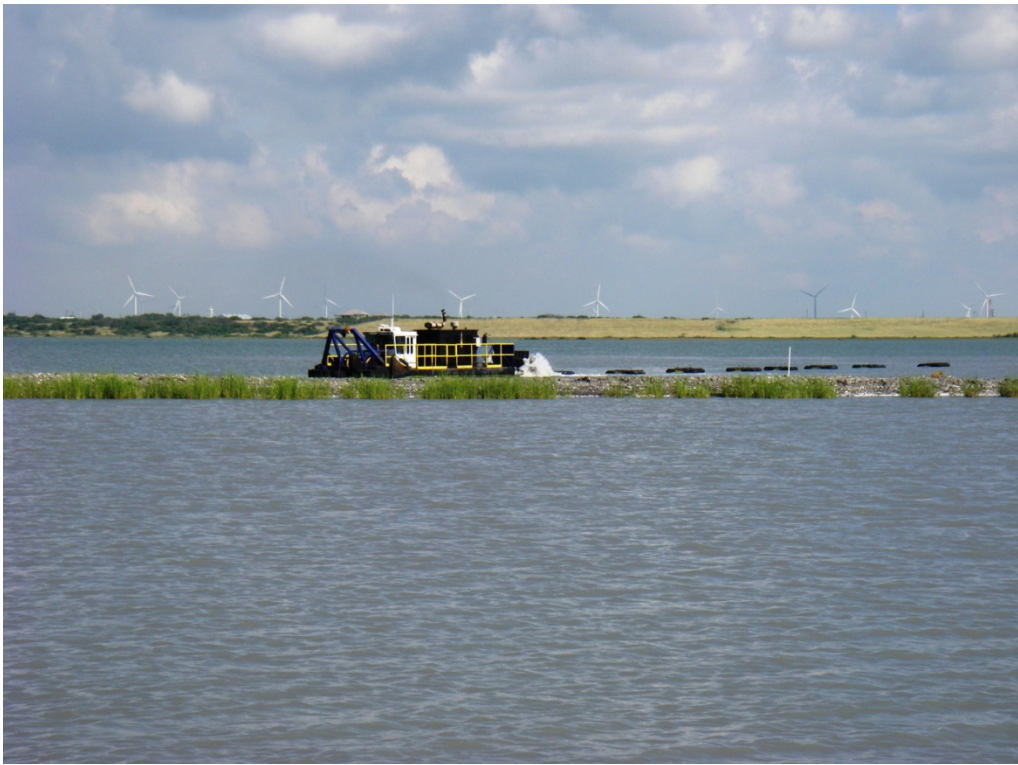
Ike dredging within Borrow Area A.

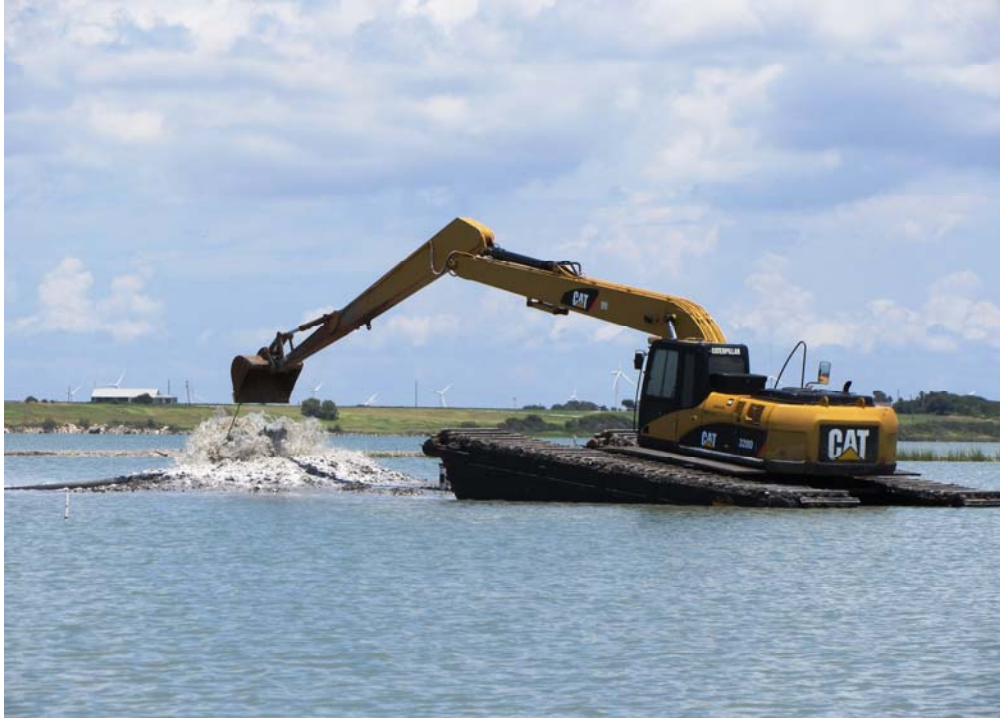
Construction of marsh mound M7.

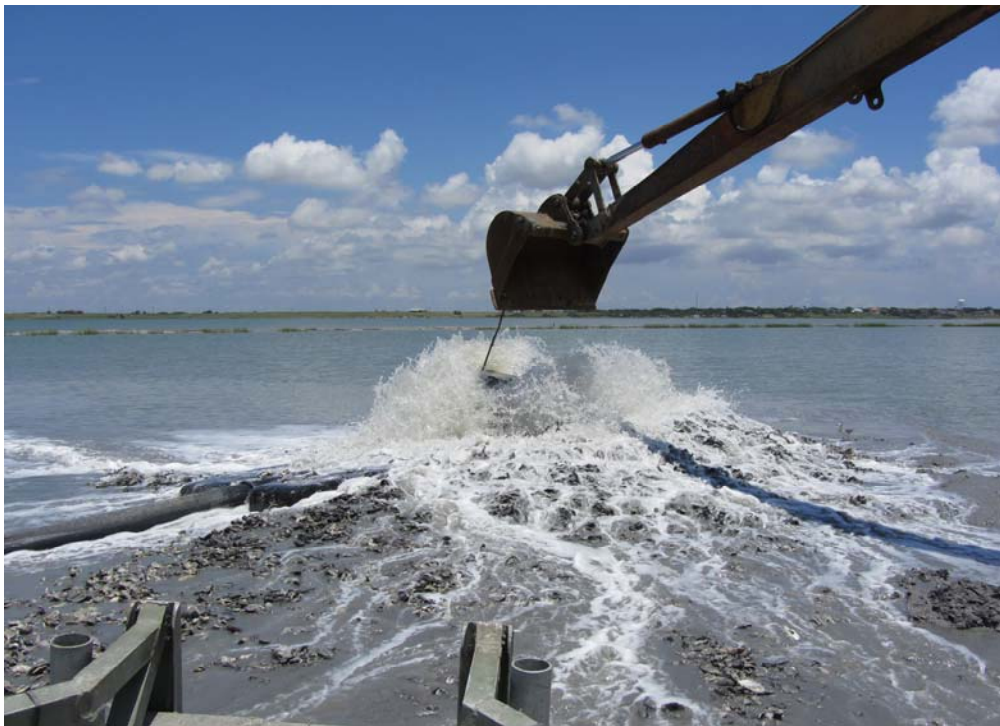
Construction of marsh mound M7.

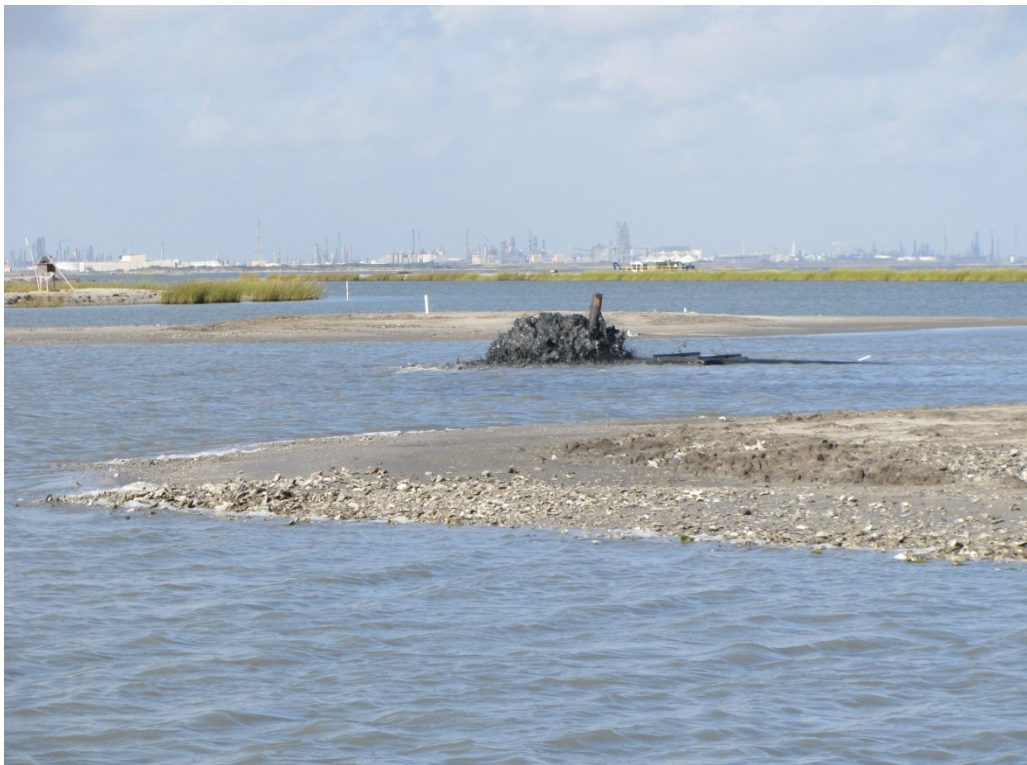
Material being pumped between M1 and M2.

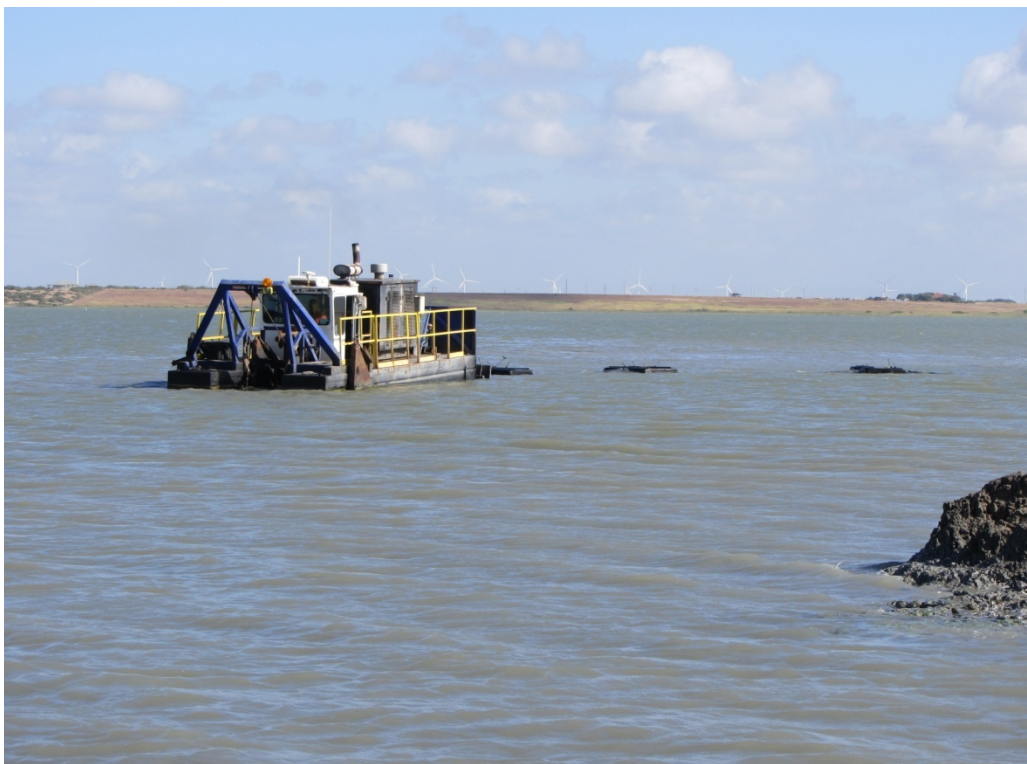
Dredge located near the end of Reach 1.
