PROGRESS REPORT

Cascade Park, Cameron County Drainage District #1

Task 1: Permeable pavement parking lot – Phase 2

**Cameron County Drainage District #1
Cascade Park
July 2015**

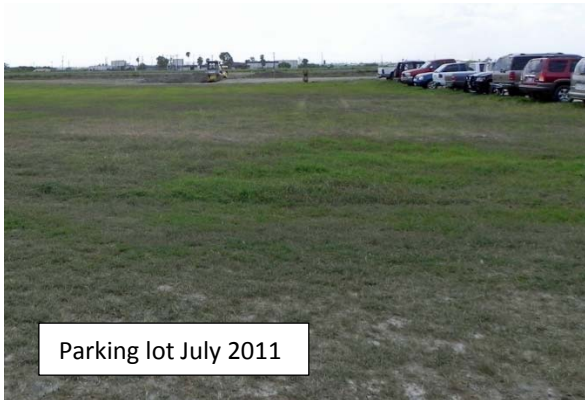
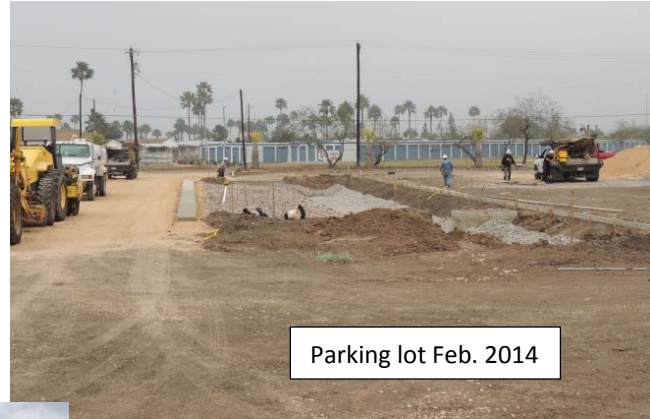
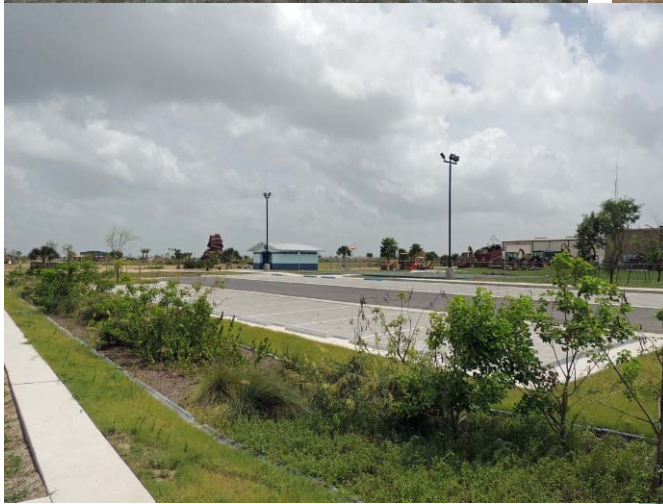
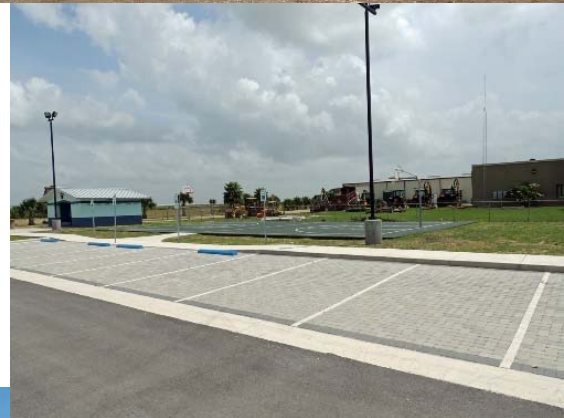
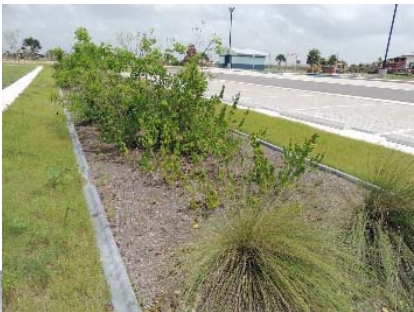
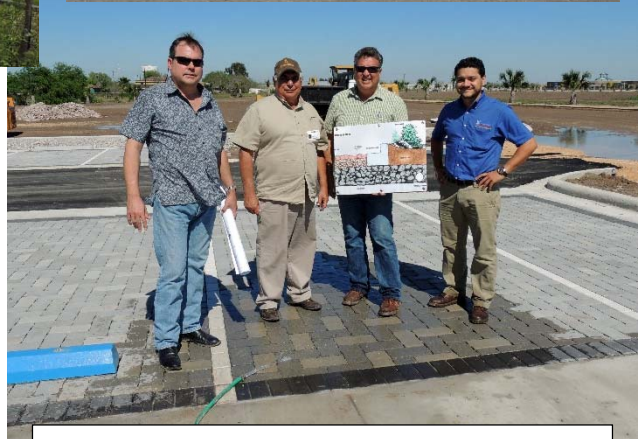
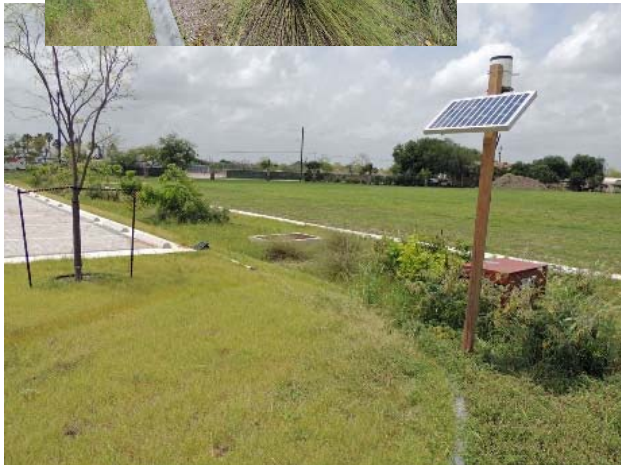
Parking Lot with Bioretention Areas and Native Vegetation

The innovative parking lot includes parking spaces that feature a permeable surface and underground stormwater retention. It is paired with a bioswale that incorporates many native plant species. Non-point source pollution reduction is being monitored by engineers and students from TAMUK. Solar energy powers monitoring equipment and a light in the park.

Construction of the 17,500 sq. ft. permeable surface parking lot is complete, including the bioswale and entrance. A photograph of the parking lot was presented as a good example of porous pavement in the Center for Research in Water Resources (UT-Austin) publication *Guidance for Sustainable Stormwater Drainage on the Texas Coast* (pg. 49).

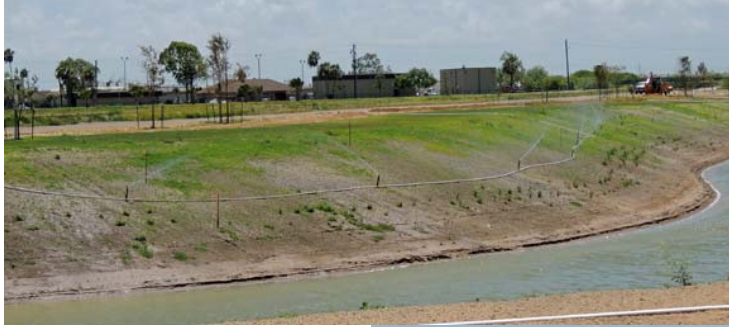
Summer 2015 - Native vegetation has been installed in and around the shallow wetland. Species include several Montezuma Baldcypress and Retama trees, along with emergent and riparian species that will recreate wildlife habitat and encourage ecotourism.

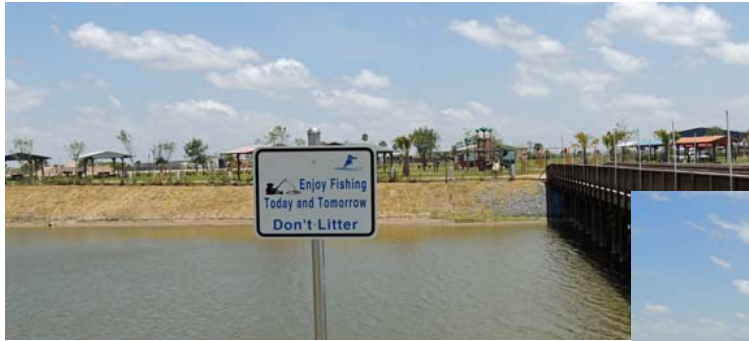
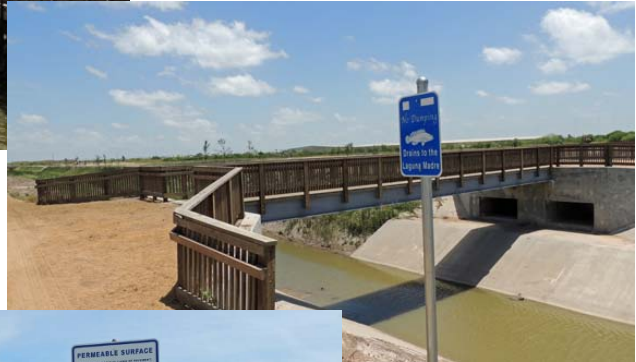
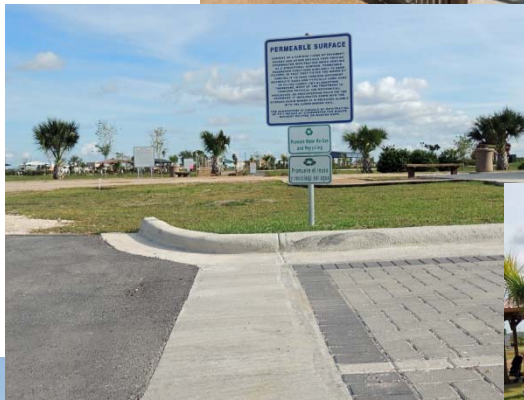
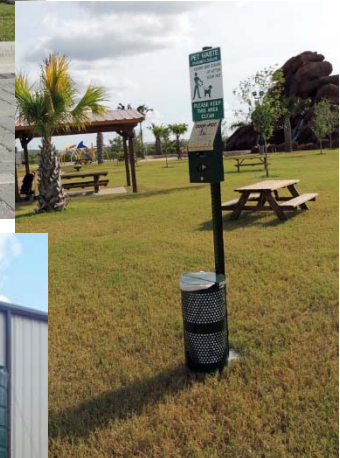
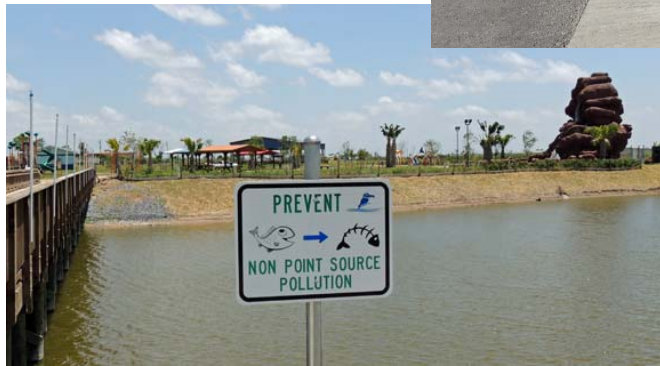
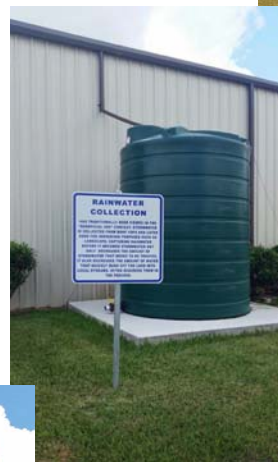
Educational Signage

In order to create awareness of water quality, water conservation, and flood management, signage has been installed in high traffic areas of the park. These have been developed in partnership with the LRGV TPDES Stormwater Task Force and Texas A&M University – Kingsville.

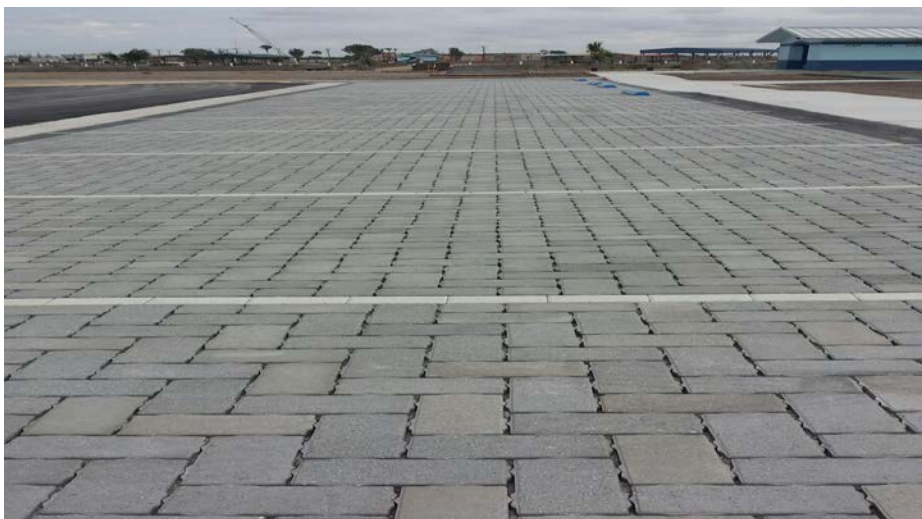
Figure 5.4. Cameron County Drainage District #1 Parking lot

Space between pavements is about 2 inches as shown above in figure 5.4. Flow measurements were taken with the aid of flumes and bubbler flow meters. Samples were manually grabbed. The

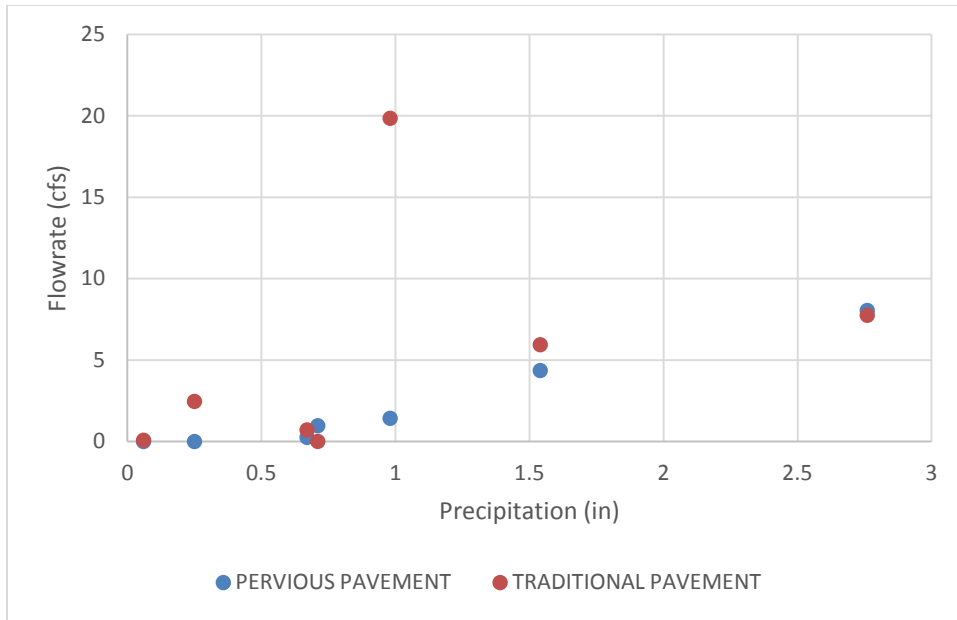
Figure 5.6. Runoff values for both pervious and traditional pavements

Flowrate values for the pervious pavement in CCDD#1 and the traditional pavement in La feria are shown in table 5.2. A comparison of both BMPs shows a trend in tandem with flowrates increasing correspondingly with precipitation. The graph in figure 5.6 depicts no significant difference in runoff values for the traditional and pervious pavements though the traditional pavement have slightly higher flowrate values.

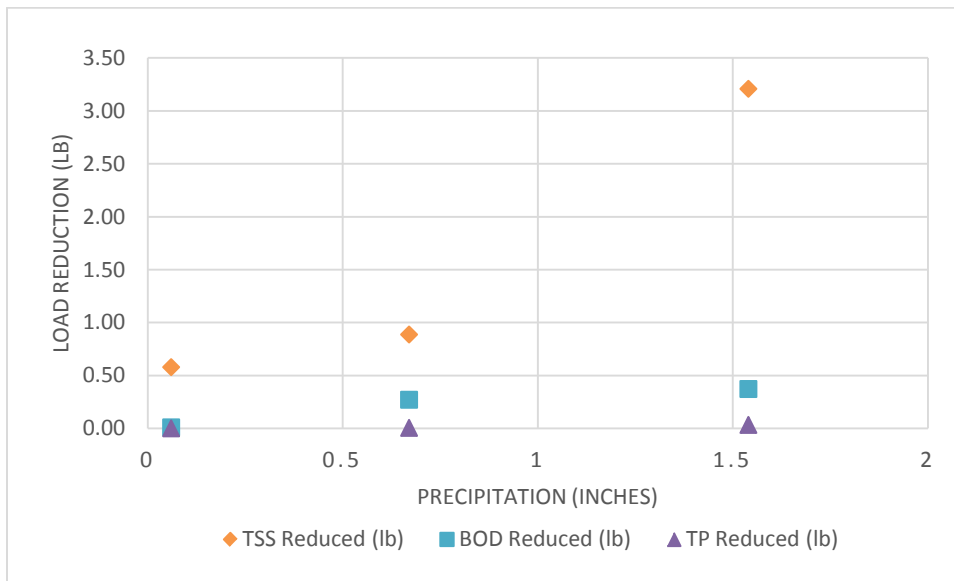
Figure 5.9. Load reduction and precipitation for TSS, BOD & TP

As can be observed in figure 5.9, for all parameters except TP, mass load reduction increased with an increase in precipitation. Total phosphorus seems to be the least responsive to the BMP treatment compared to other parameters. This can also be seen in the amount reduced in table 5.6, where it averaged the lowest mass reduced and the also the lowest percentage reduction value.
