**Tern Rookery Island Protection and Restoration, Phase I: Feasibility Study & Alternatives Analysis**

**GLO Contract No. 21-060-008-C668**

**Final Report**

# Feasibility Study & Alternatives Analysis Report

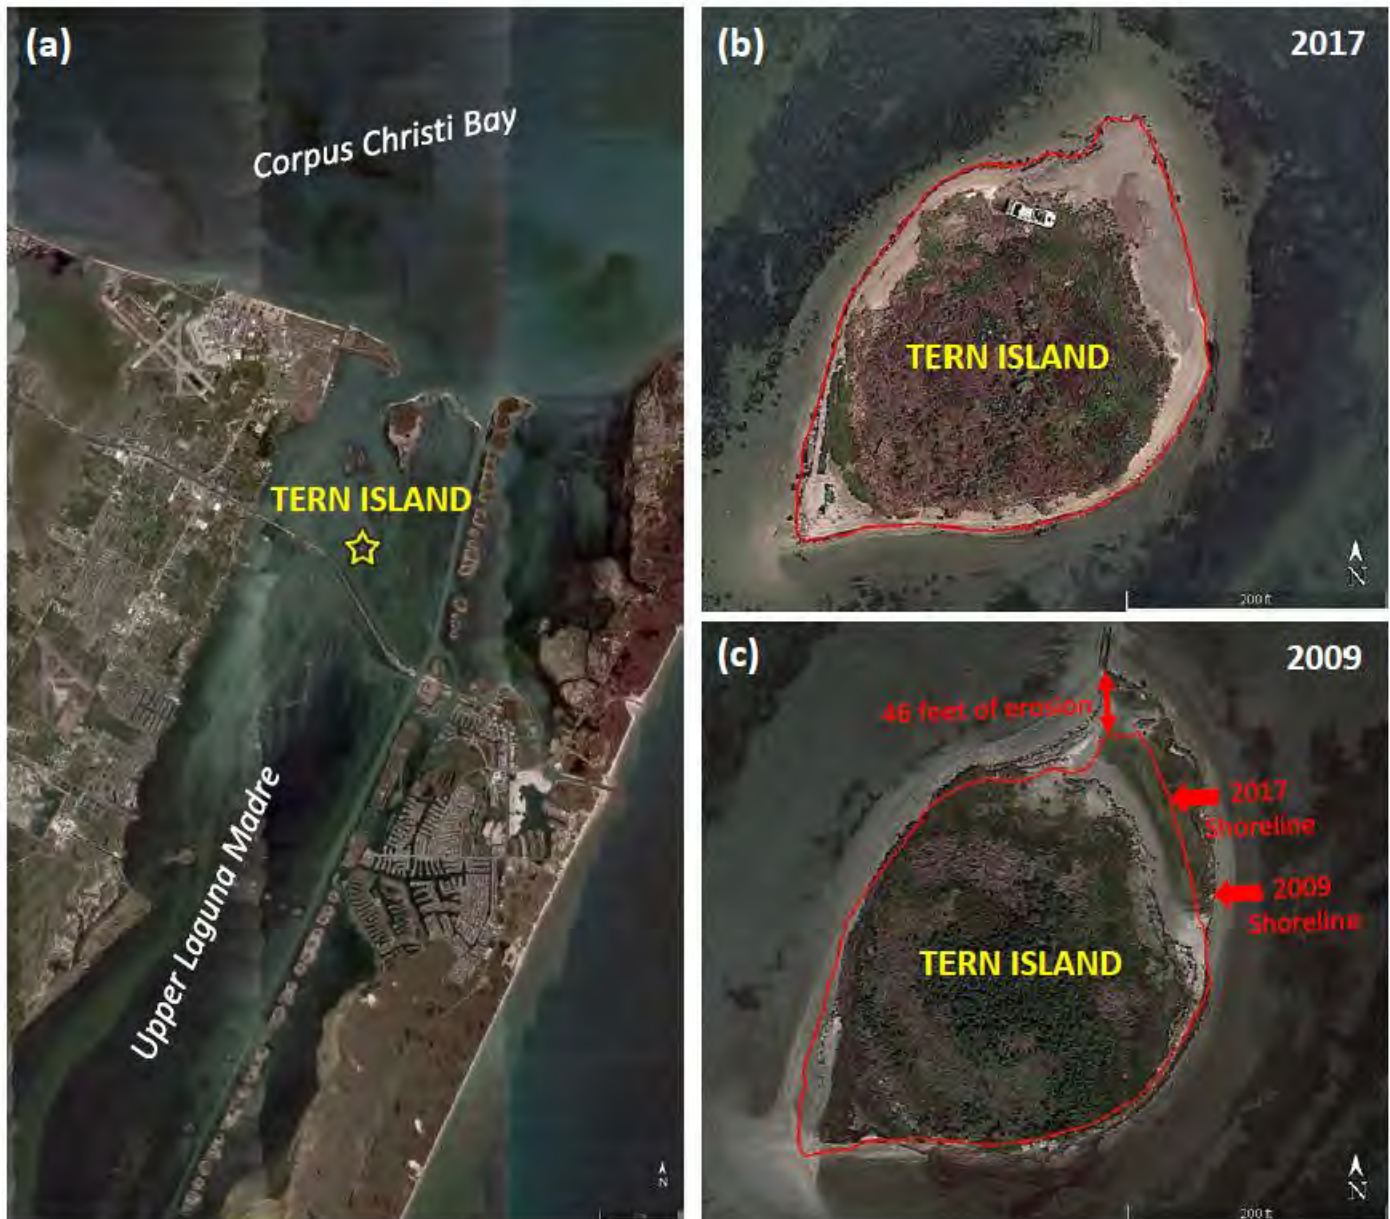
Figure 1. Vicinity map and aerial images of Tern Island depicting effects of erosion 2009 – 2017.

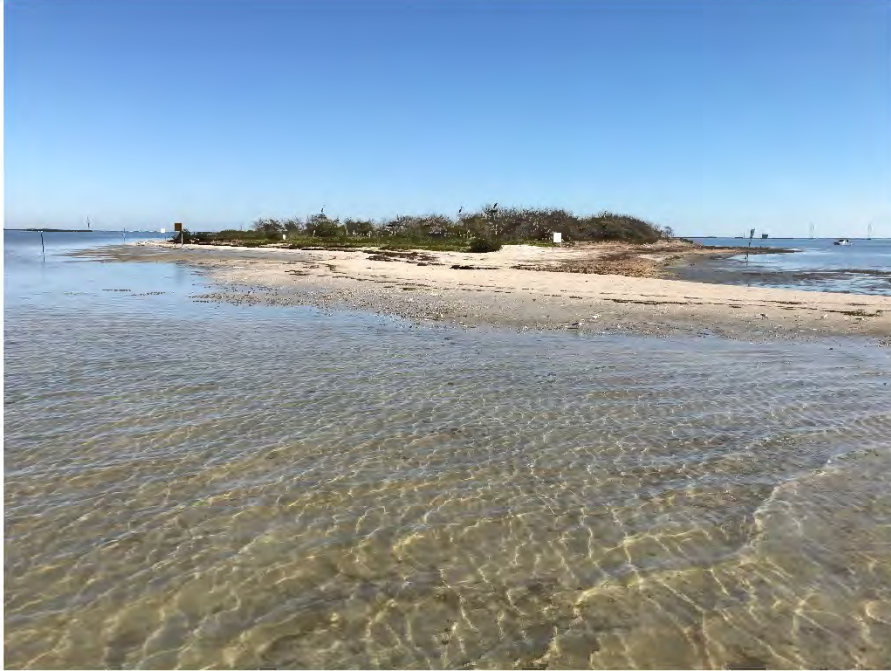
**Photo 1 –** Representative photo of Tern Rookery Island. Photo taken near T12 and south of the rookery island facing north.

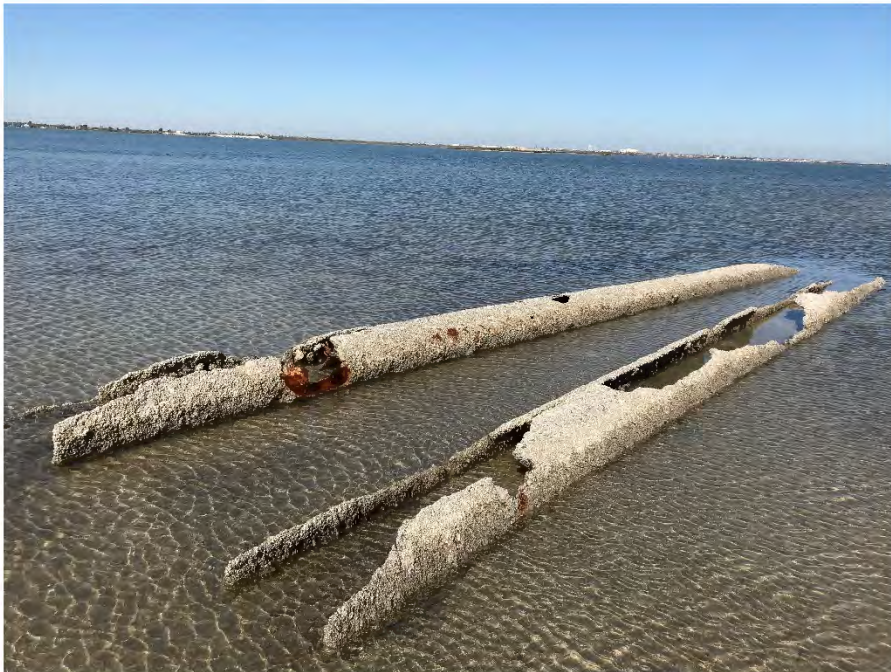
**Photo 2 –** Submerged debris observed between T1 and T2 located north of Tern Rookery Island and facing north.

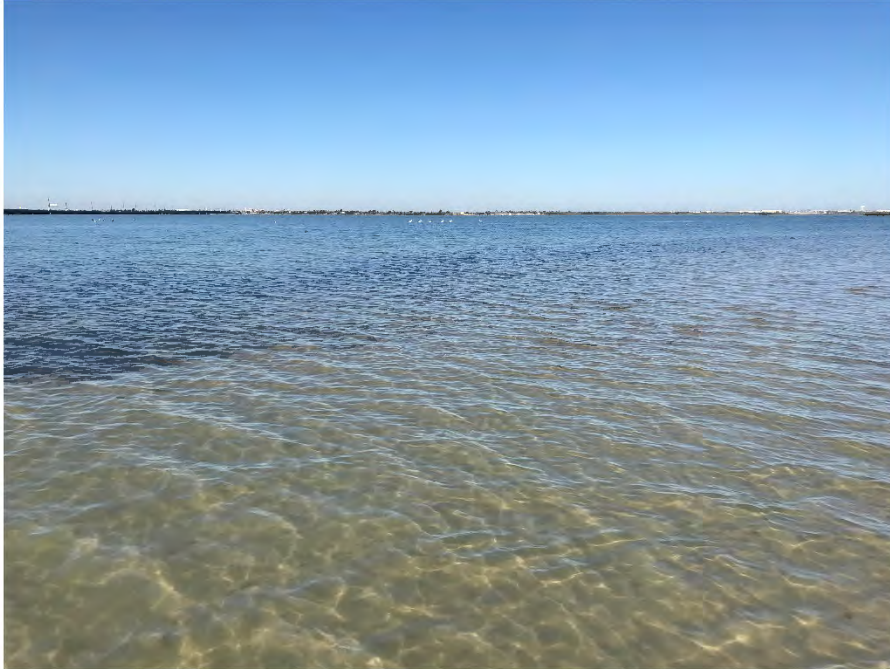
**Photo 3 –**  
Representative photo of bare bottom areas within shallow water (foreground) which transitions into patchy seagrass beds (background) located south of Tern Rookery Island. Photo taken along T11 facing south.

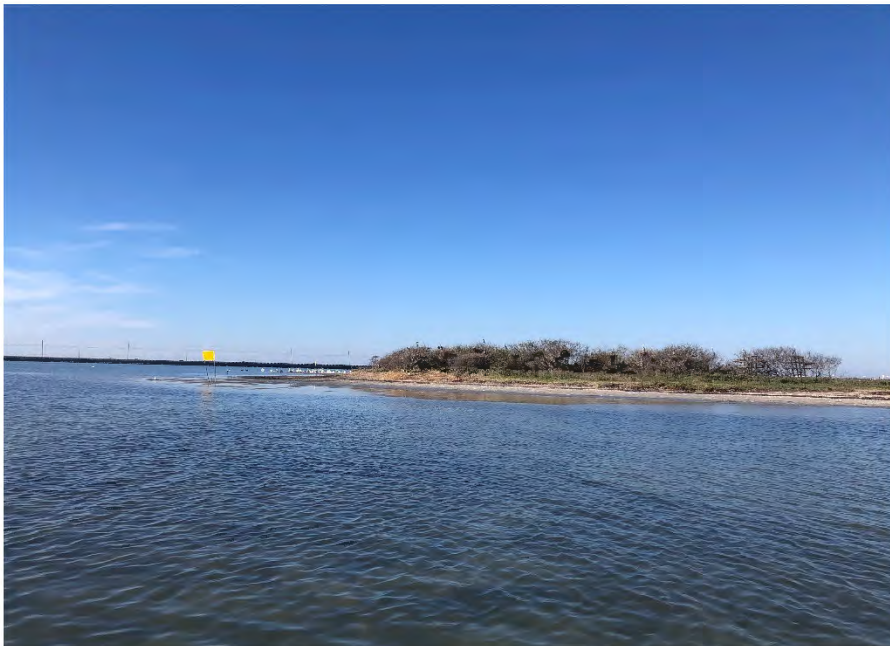
**Photo 4 –** Photo taken within a dense seagrass area along T6 east of Tern Rookery Island. Photo faces southwest.

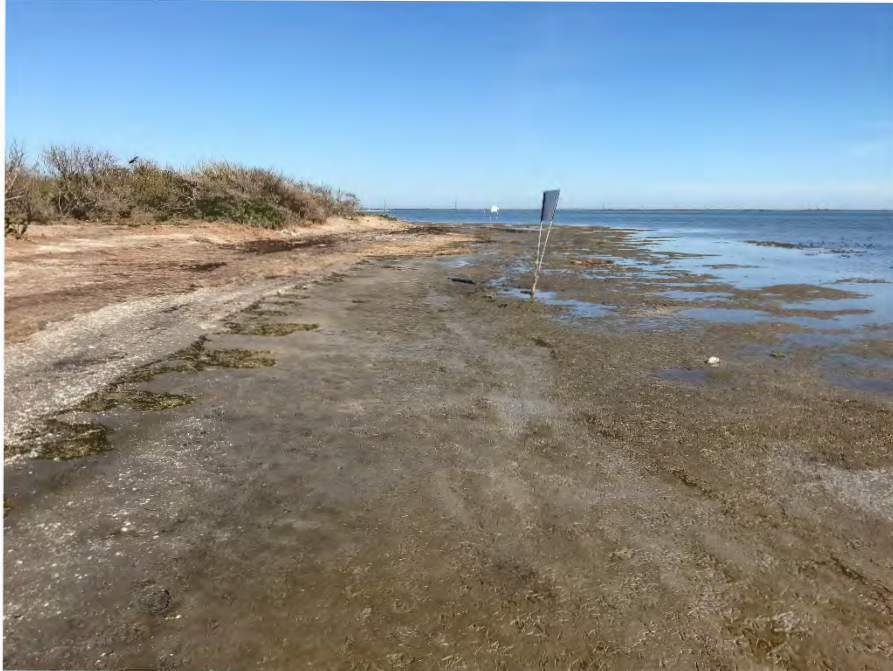
**Photo 5 –**  
Representative photo  
of the shoreline along  
Tern Rookery Island  
near T9 and facing  
northeast.

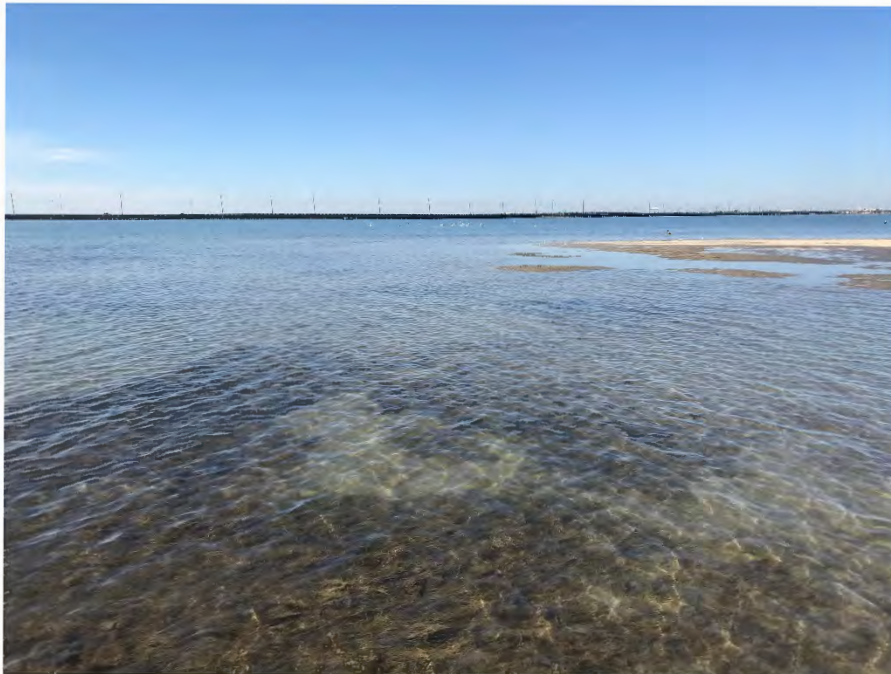
**Photo 6 –**  
Representative photo  
of patchy seagrass  
beds located south of  
Tern Rookery Island  
(right). Photo taken  
along T9 and facing  
west.

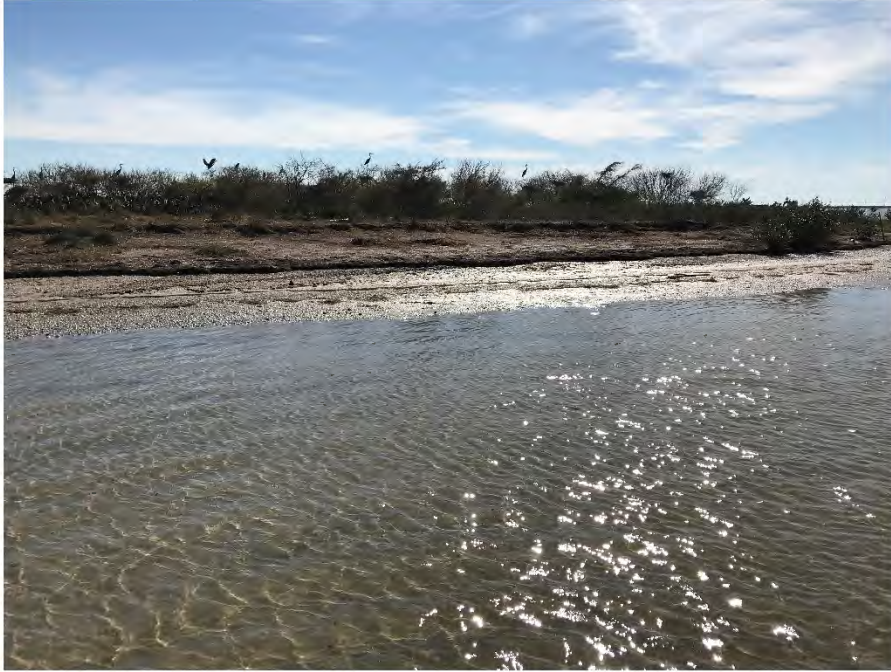
**Photo 7 –**  
Representative photo of bare ground (foreground) and great blue herons (*Ardea herodias*) beginning to roost on Tern Rookery Island (background). Photo taken along T15 west of the Rookery Island facing east.

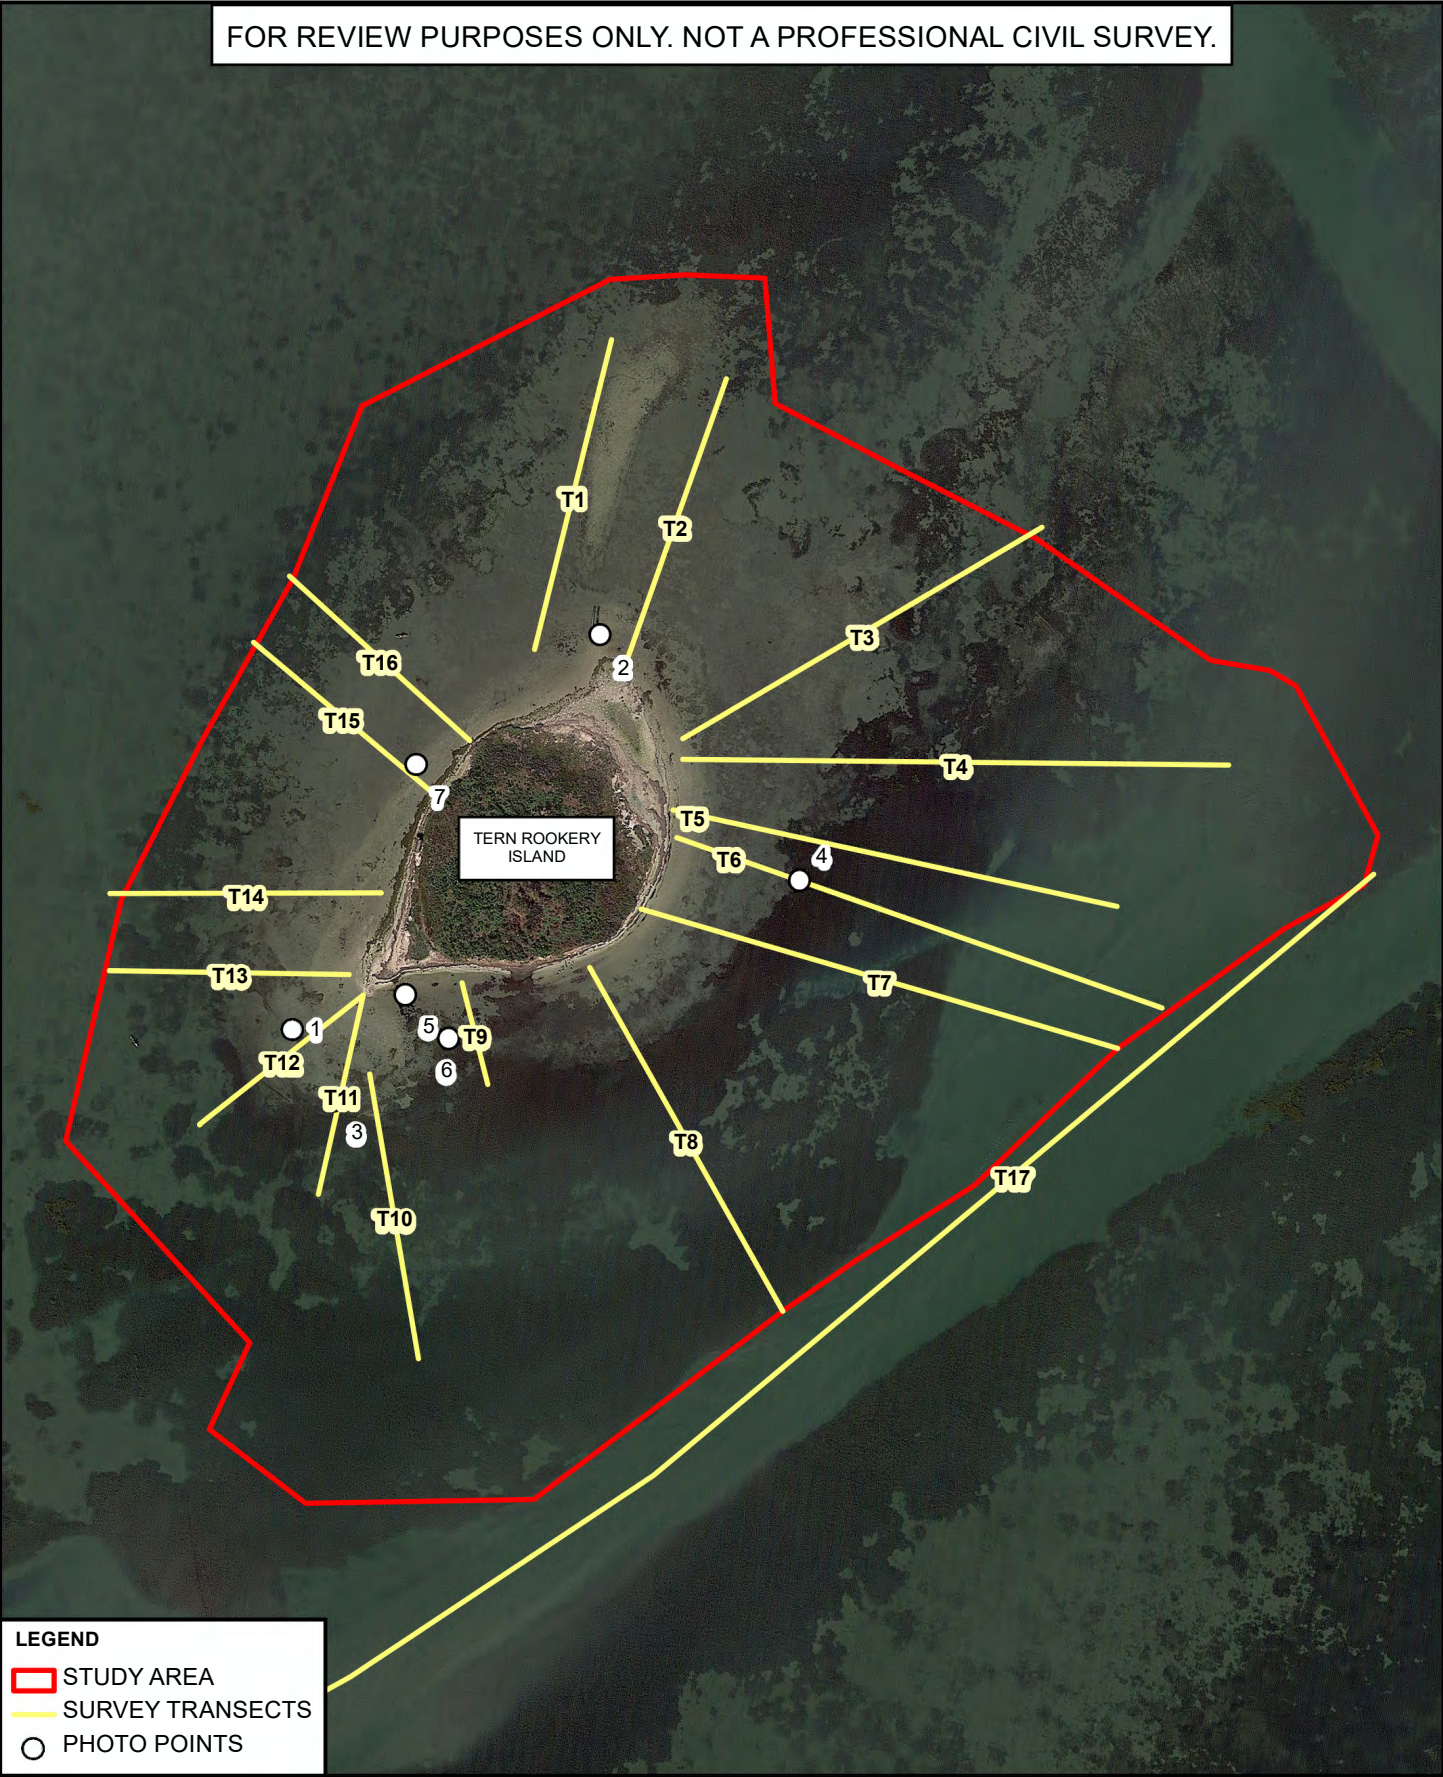
MAR 2021      FIGURE 1

- STUDY AREA
- SURVEY TRANSECTS
- PHOTO POINTS

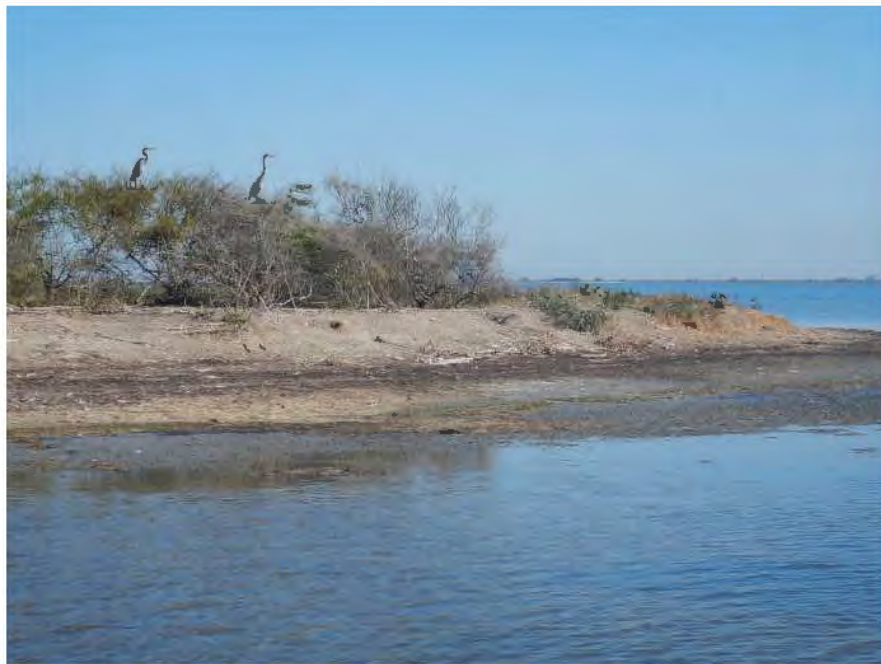
Photo 2: Close up of scarp face present on eastern side of Tern Rookery Island. Photo taken facing Flour Bluff.

2. Scarp face noticeable along eastern shore of Tern Rookery Island and to a lesser extent on the western side of the island (several layers of wrack lines present) suggesting wave induced erosion and forcing taking place. See Photo 2 (eastern side) and Photo 5 (western side).

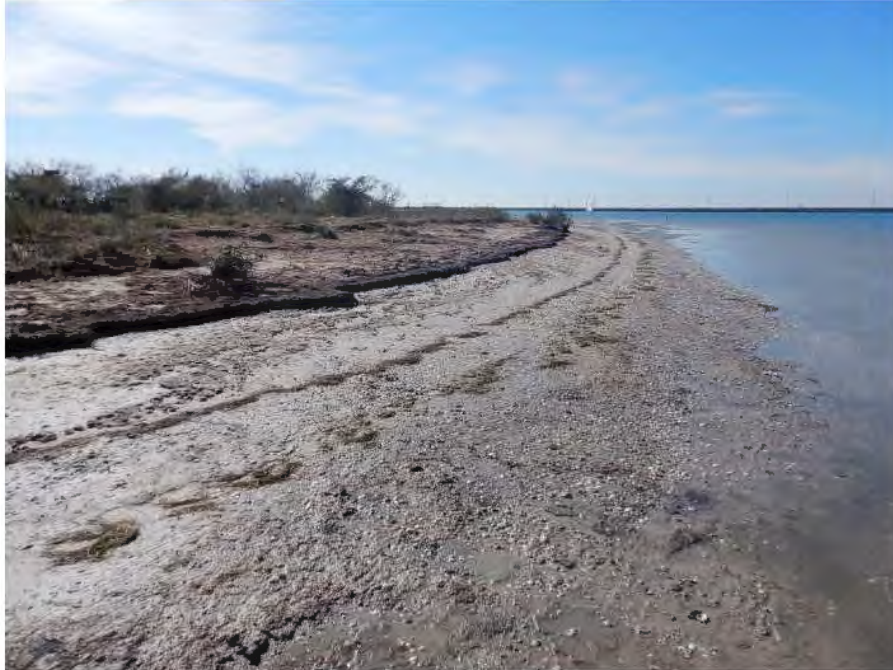
Photo 5: Close Up of wrack lines present along western side of Tern Rookery Island. Photo taken facing JFK Memorial Causeway.

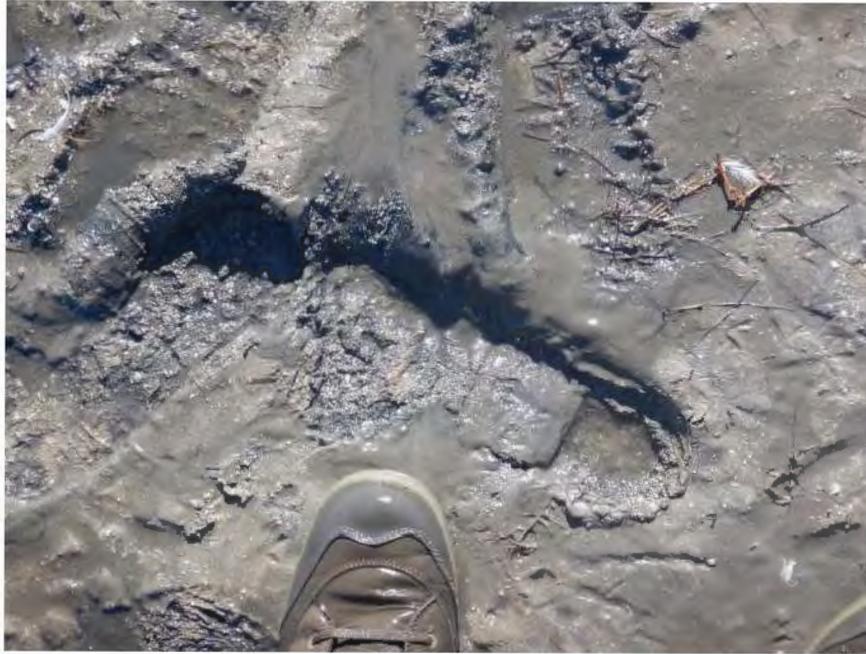
Photo 7: Example of cohesive soils around Tern Rookery Island.

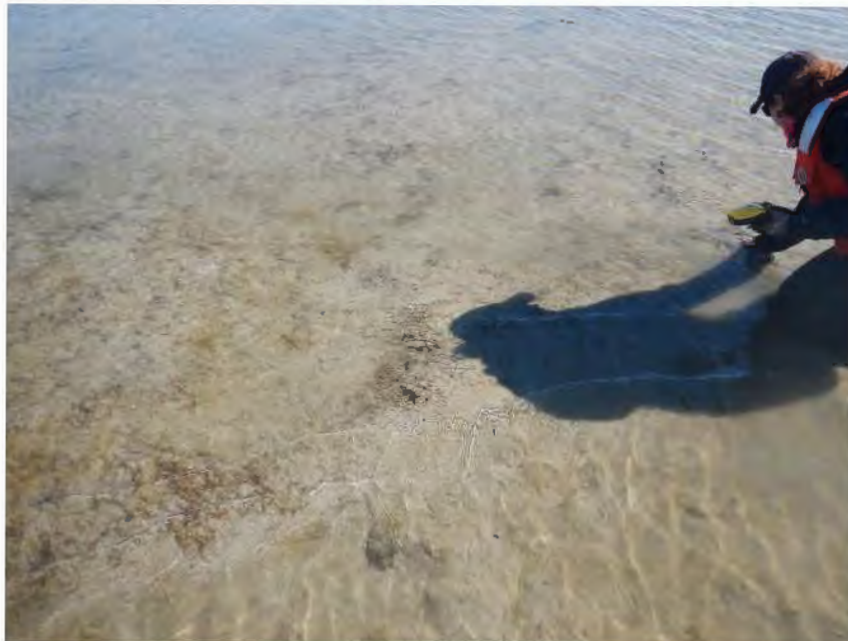
Photo 8: Example of sparse seagrass coverage found at shallow depths off Tern Rookery Island.

3. Seagrass beds of varying coverage densities surround Tern Rookery Island. Several clear patches are present along the southern and eastern side. Seagrass beds found in sparse outcroppings in shallow depths (1-2 ft) around Tern Rookery Island. See Photo 8.

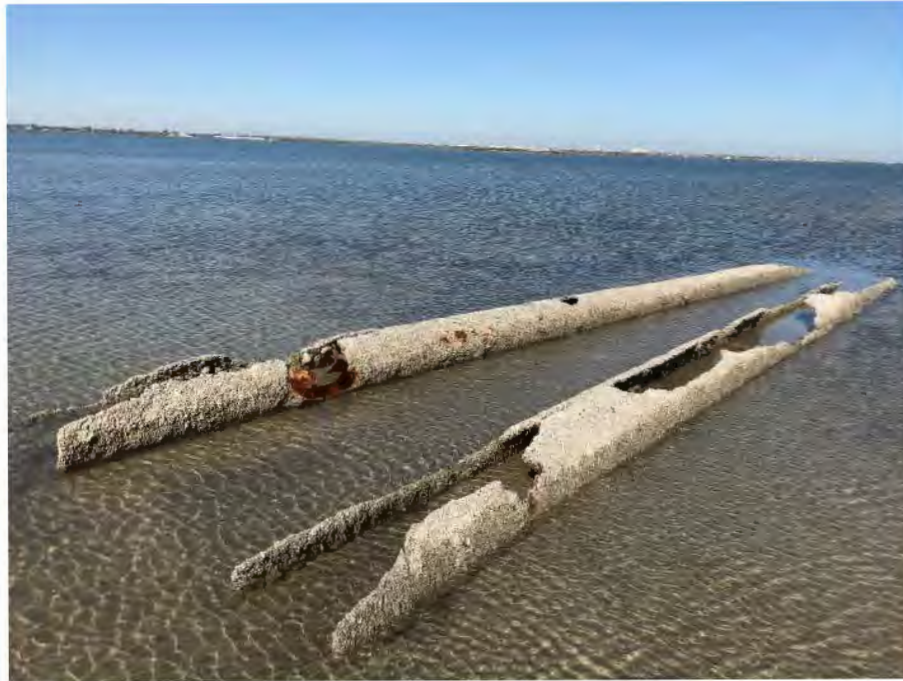
Photo 9: Deteriorating pipes on north side Tern Rookery Island.

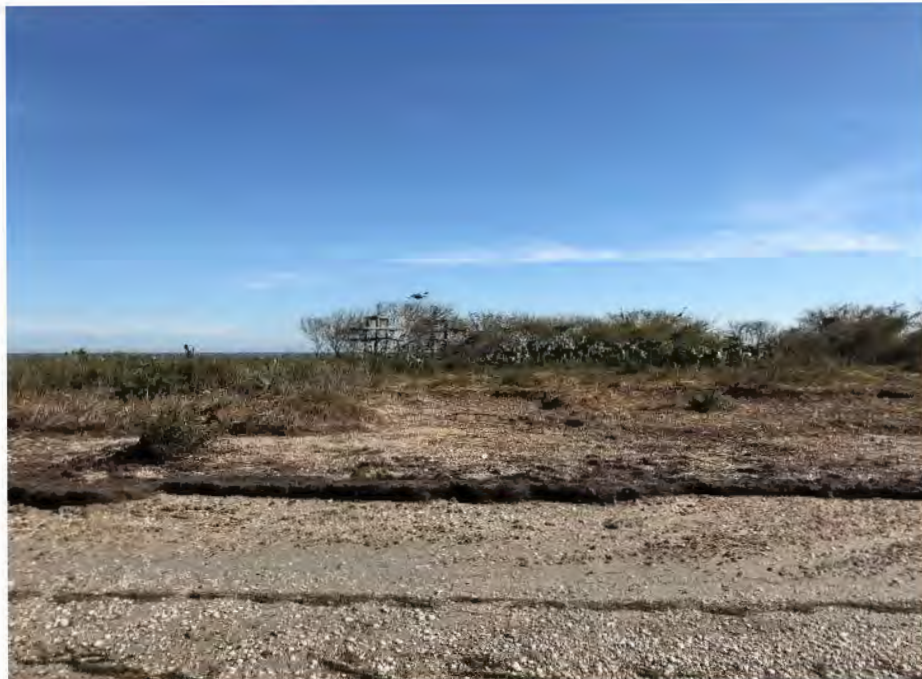
Photo 10: Nesting platforms on Tern Rookery Island.

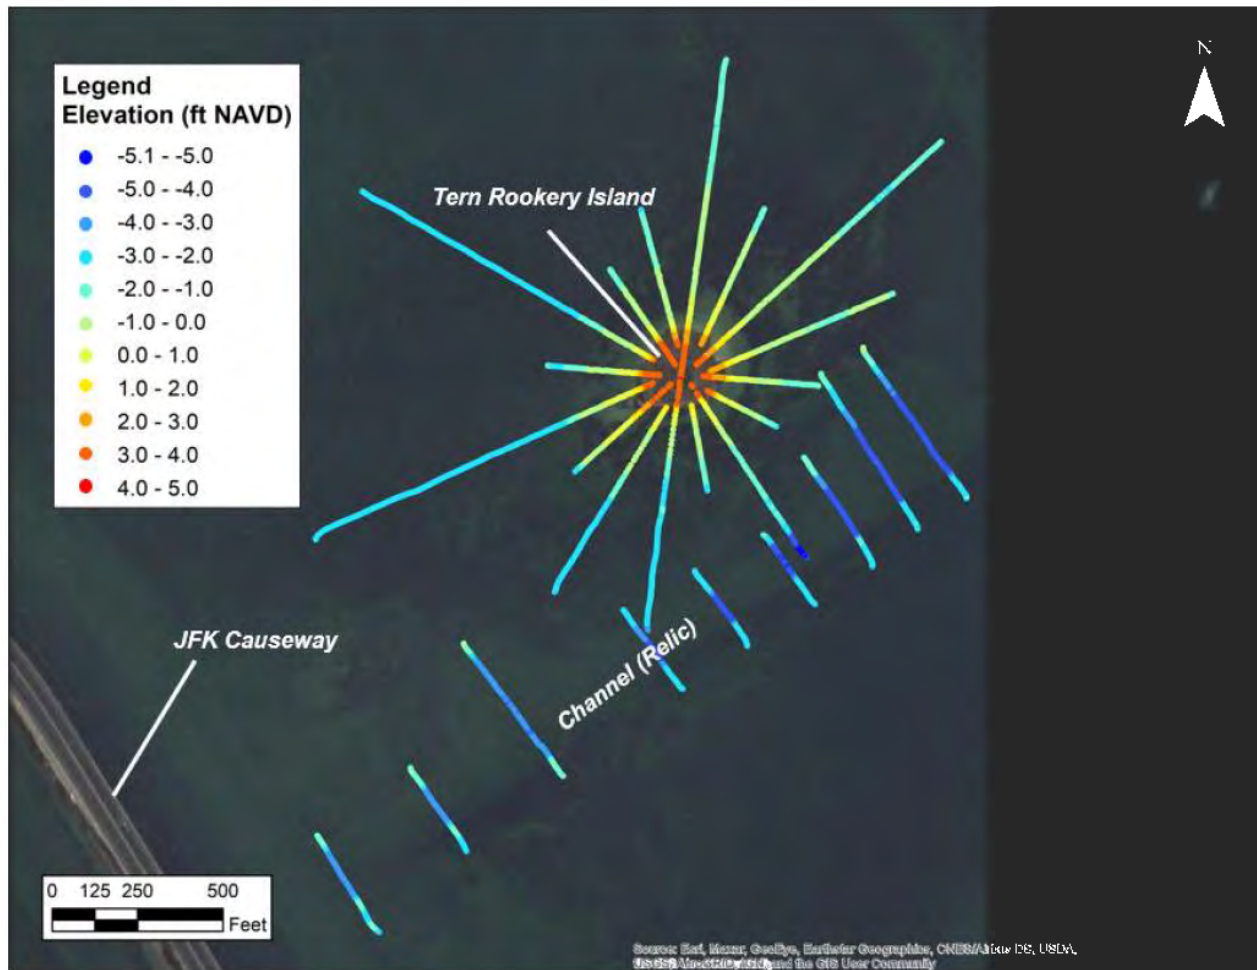
Figure 4. Bathymetric and topographic survey data for project area

Bathymetric, topographic, and magnetometer surveys were conducted by T. Baker Smith (TBS) in December 2020. Bathymetric and topographic surveys were conducted on transects around the island perpendicular to the shoreline and included one continuous transect that spanned the entire diameter of the island and the nearshore depths on each side. Additional survey transects were completed in the relic channel to the east of the island and along adjoining sections of the channel adjacent to the JFK Causeway. As shown in Figure 4, the beach profile gently slopes down to depths at or above -1.0 ft within approximately 200 ft of the shoreline. Shallower depths of -0.5 ft or less were observed on the southeastern side of the island. Topographic measurements from the center of the island revealed +3.0 ft to +4.0 ft of elevation. Transitioning down to the exposed portions of shoreline, elevations decreased to approximately +2.0 ft to

+0.7 ft. On the northern side of the island the beach extends out around 70 ft from the vegetation line, whereas the southern facing shorelines are more abrupt and show evidence of scarping and wave action. The highest measured elevation of +4 ft was observed in the center of the island.

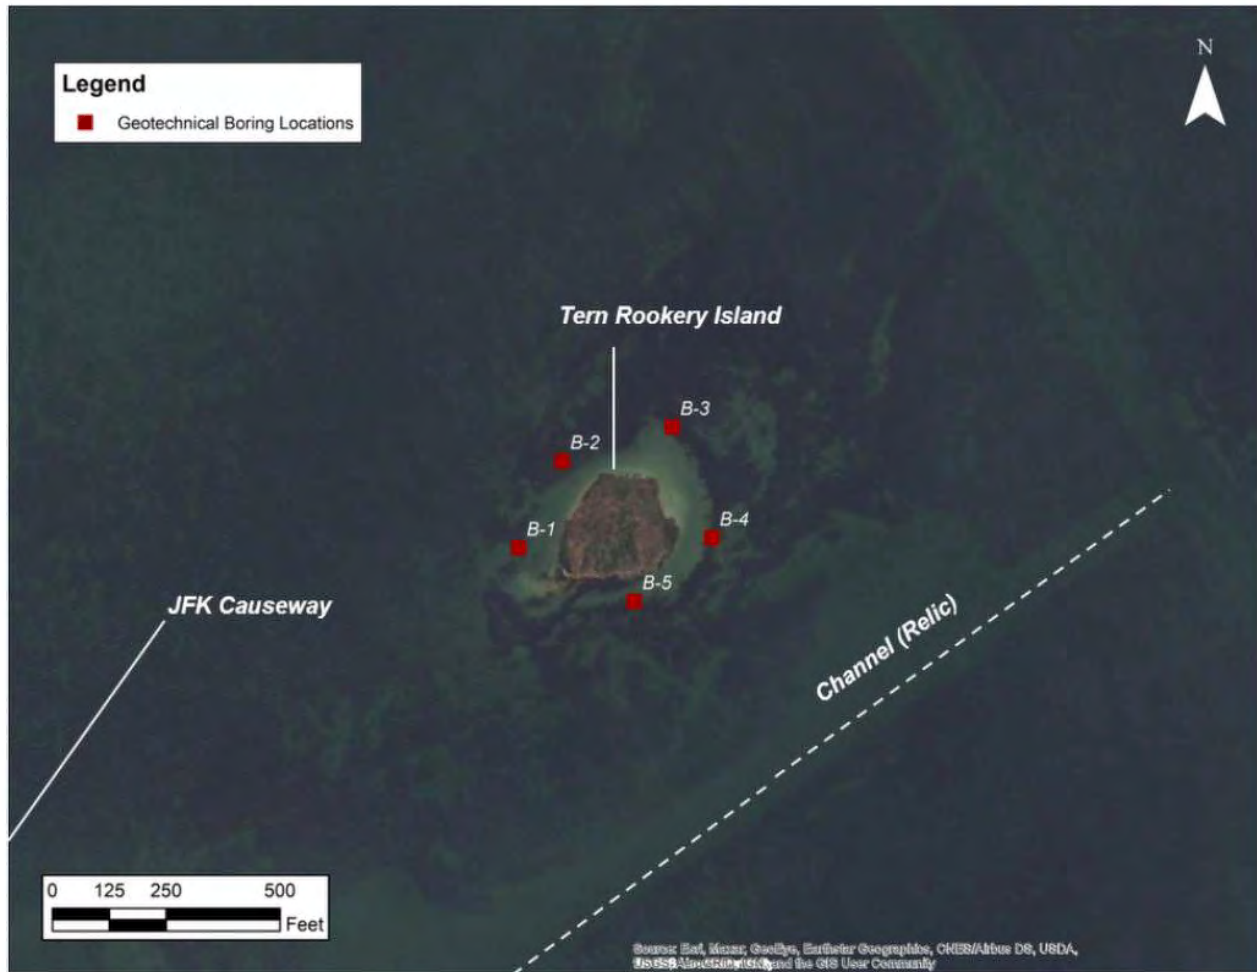
Figure 8. Geotechnical boring locations

A preliminary geotechnical investigation was performed by Rock Engineering & Testing Laboratory, Inc. (RETL) and documented in their report dated January 18, 2021. Five borings were performed in the project area to identify soil types and to provide engineering recommendations for shoreline protection foundation design. The investigation showed a top layer of silty and/or silty clayey sand underlaid by a layer of clayey sand. The analysis predicted approximately 8 inches to 10 inches of initial settlement after construction of a low-crested rock breakwater (refer to Section 3 for a discussion on the shoreline protection concepts being considered for this project). Long term consolidation is expected to be approximately 5 inches. RETL determined that the soils will likely provide a suitable foundation for a low-crested rock breakwater of the type described in this alternatives analysis. Figure 8 provides the locations of the borings.

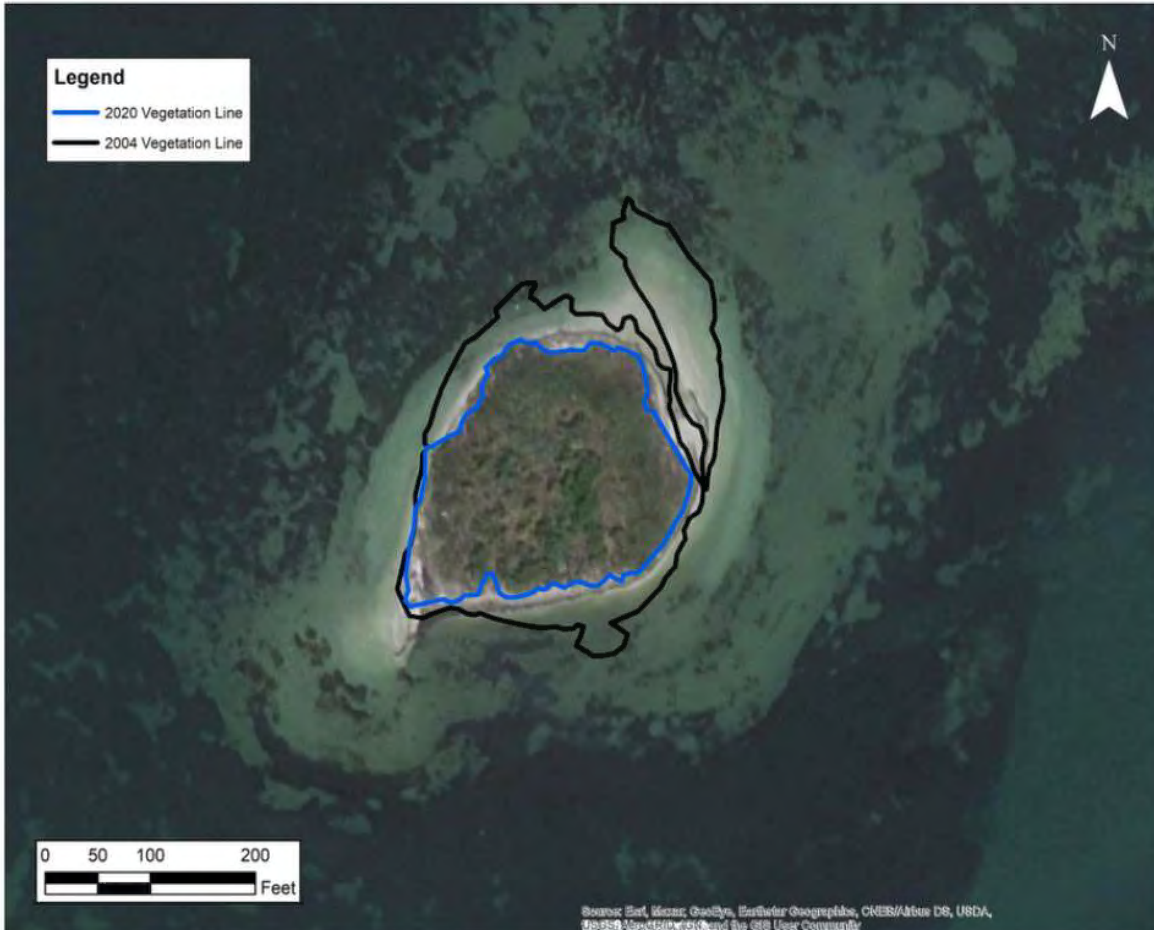
Figure 10. Comparison of vegetation lines in 2004 and 2020

A review of historical aerial photography from 2004 and 2020 indicates that the northern shoreline retreated approximately 45 ft (Figure 10), which equates to a rate of approximately 3 ft/yr.

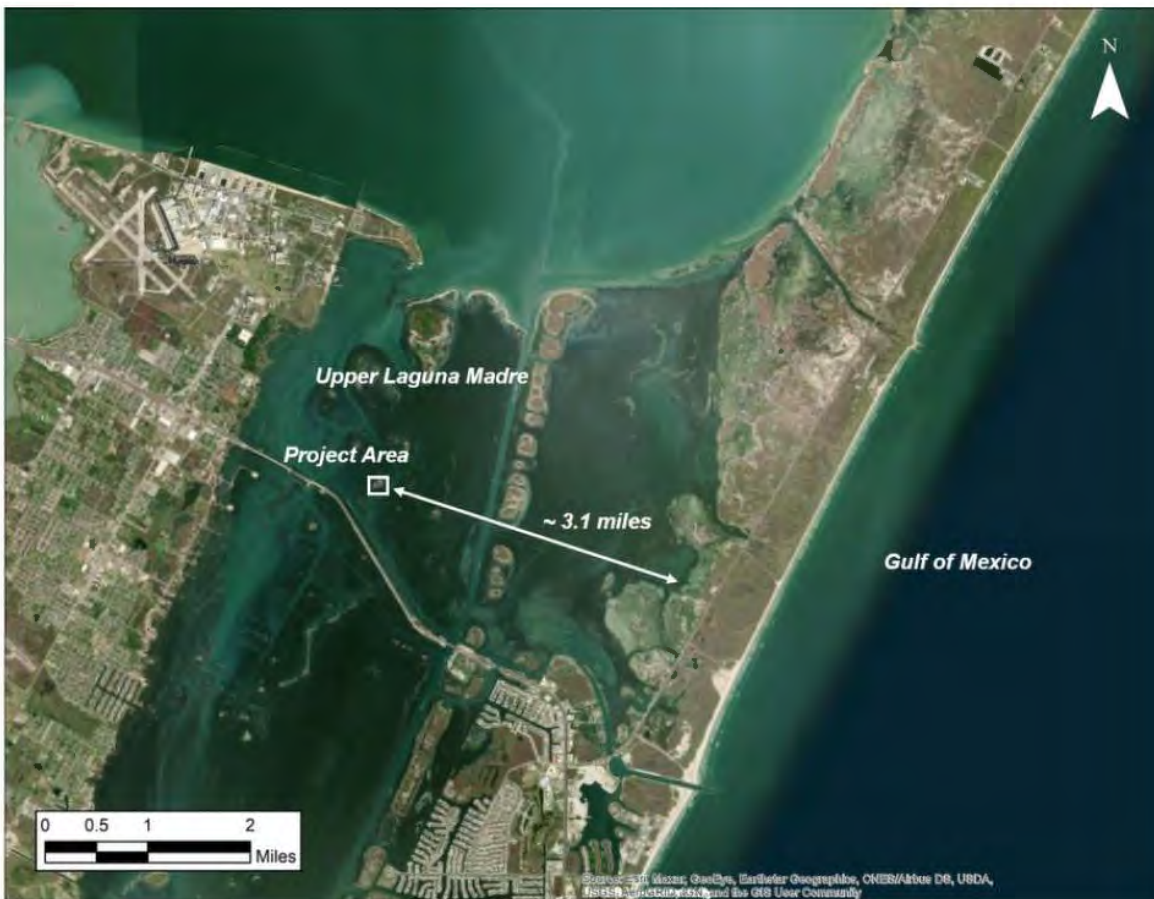
Figure 11. Fetch applied for wave analysis

The project site is exposed to waves generated by wind blowing across open fetches of the upper Laguna Madre (Figure 11), but measured wave data are not readily available in the project area. To develop wave conditions at the project site, one-dimensional wave modeling was performed using the Automated Coastal Engineering System (ACES) module of the Coastal Engineering & Design Analysis System (CEDAS) developed by the United States Army Corps of Engineers (USACE). Modeled waves represent conditions that occur during strong seasonal storms.

southeast; however, most winds over 30 mph were from the north. During the site visit in January 2021, scarping and wrack lines on the eastern and western shorelines of the island were observed, suggesting wave forcing and erosion taking place. Additionally, a review of historical aerial imagery indicates both the northern and southern shorelines have retreated over the past decades. Taking this into consideration, several wind directions were used in the wave height analysis. Although seasonal storms arriving from the north and northwest typically produce the strongest winds, the project area has more protection from the north due to neighboring islands. Thus, the longest fetches are from the southeast, which coincides with the predominant wind direction. The depths of the Upper Laguna Madre were determined to be similar between fetches, and therefore the longest fetch was conservatively used as the wave height design parameter for the project in its entirety (see Figure 11).

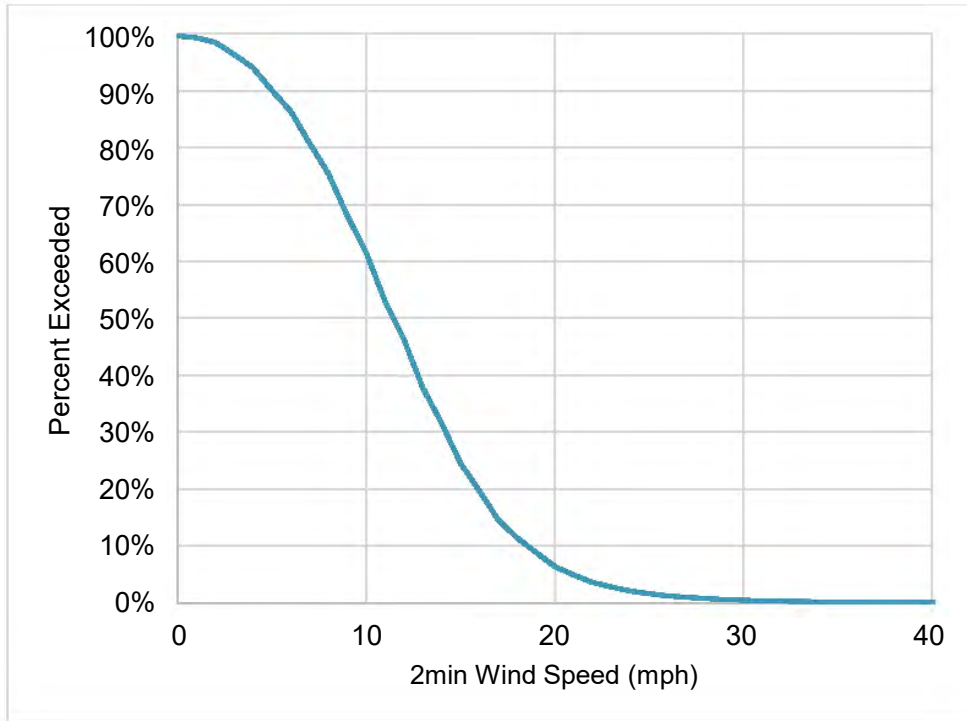
Figure 12. Wind speed exceedance plot for Packery Channel NOAA Station for 2008-2020

To consider wind speeds for application in the one-dimensional model, hourly wind data were obtained from the Packery Channel NOAA Station for 2008 to 2020. These data are summarized in an exceedance plot in Figure 12 and a wind rose in Figure 13. Winds were primarily from the

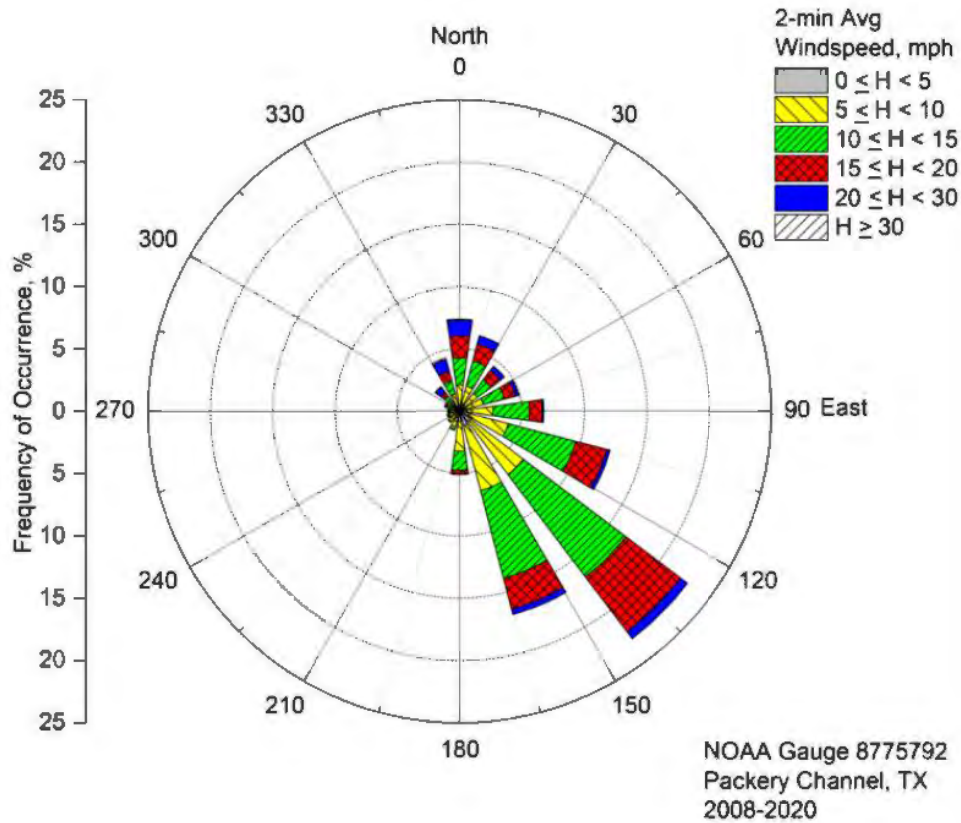
Figure 13. Wind rose for Packery Channel NOAA Station for 2008-2020

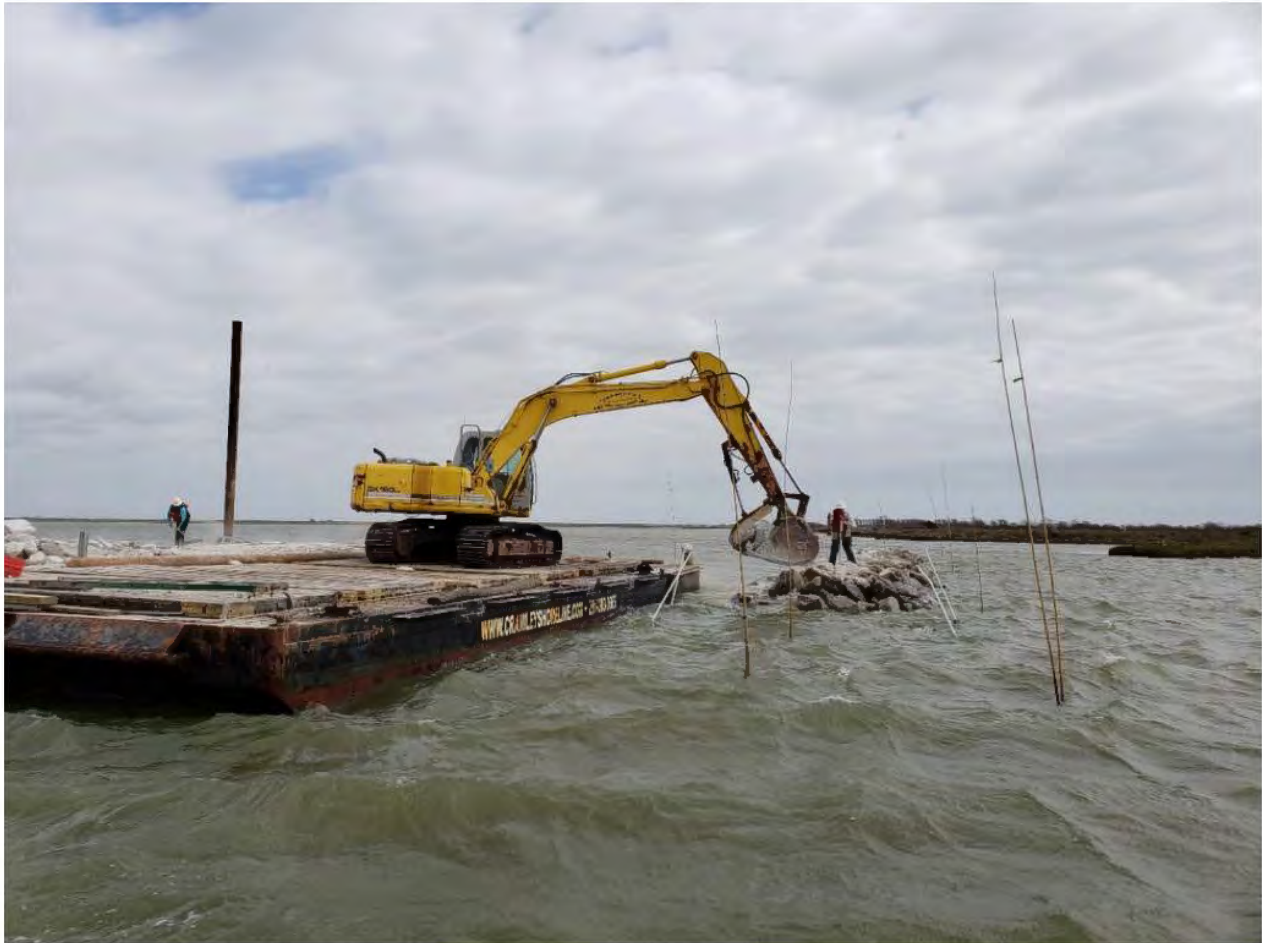
**Figure 14. Breakwater construction by light loaded barges**

The alignment and typical cross-section of a riprap breakwater depend on the accessibility of the project area. The two construction methods applicable for this project are 1) construction by excavator on a barge (Figure 14), or 2) end-on construction where the breakwater is wide enough to serve as an access road and work platform during construction (Figure 15). Based on the breakwater dimensions discussed above and a typical cross section for an end-on construction method, a wave transmission analysis indicated a transmitted wave height of 0.7 ft for the given design wind and wave conditions (see section 2.6). Transmitted wave heights less than 1.0 ft is a general threshold for estimating stability of vegetated shorelines (Shafer *et al.*, 2003). The conceptual design characteristics for both construction methods are listed in Table 7.

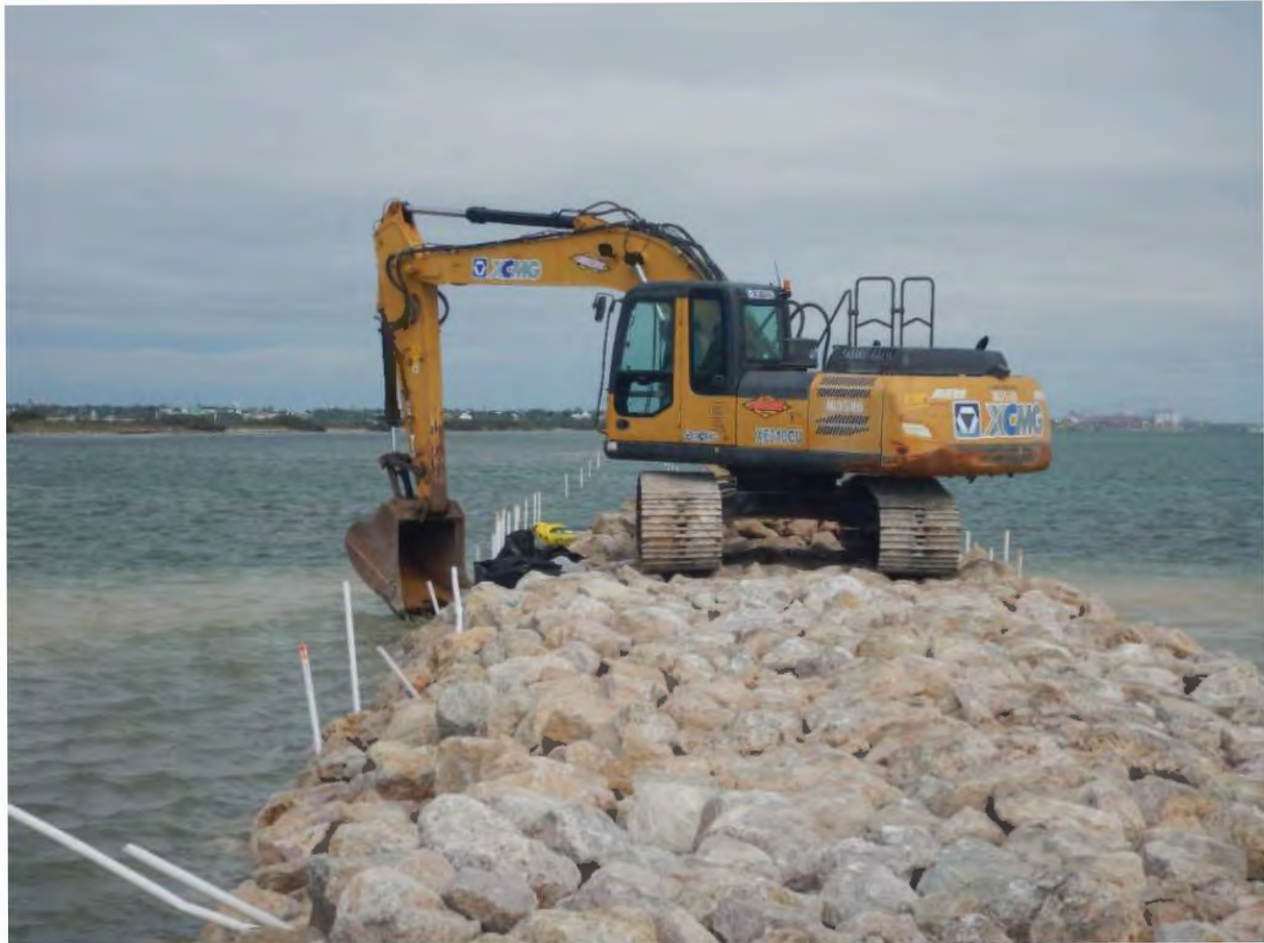
Figure 15. End-on breakwater construction

Method	Crest Width (ft)	Approx. Bottom Width (ft)	Breakwater Length (ft)	Seagrass Impacts (ac)
Excavator on Barge	5	19	1,300 ft	0.06
End-on Construction	10	24		0.11
Notes:				
1. A 2H:1V slope and trapezoidal cross section was used in both scenarios.				
2. Ground elevation was assumed to be 0.0 ft; bottom widths can vary depending on ground elevation.				
3. The same alignment was used for both construction methods.
