**Tern Rookery Island Protection and Restoration, Phase I: Feasibility Study & Alternatives Analysis**

**GLO Contract No. 21-060-008-C668**

**Final Report**

# Feasibility Study & Alternatives Analysis Report

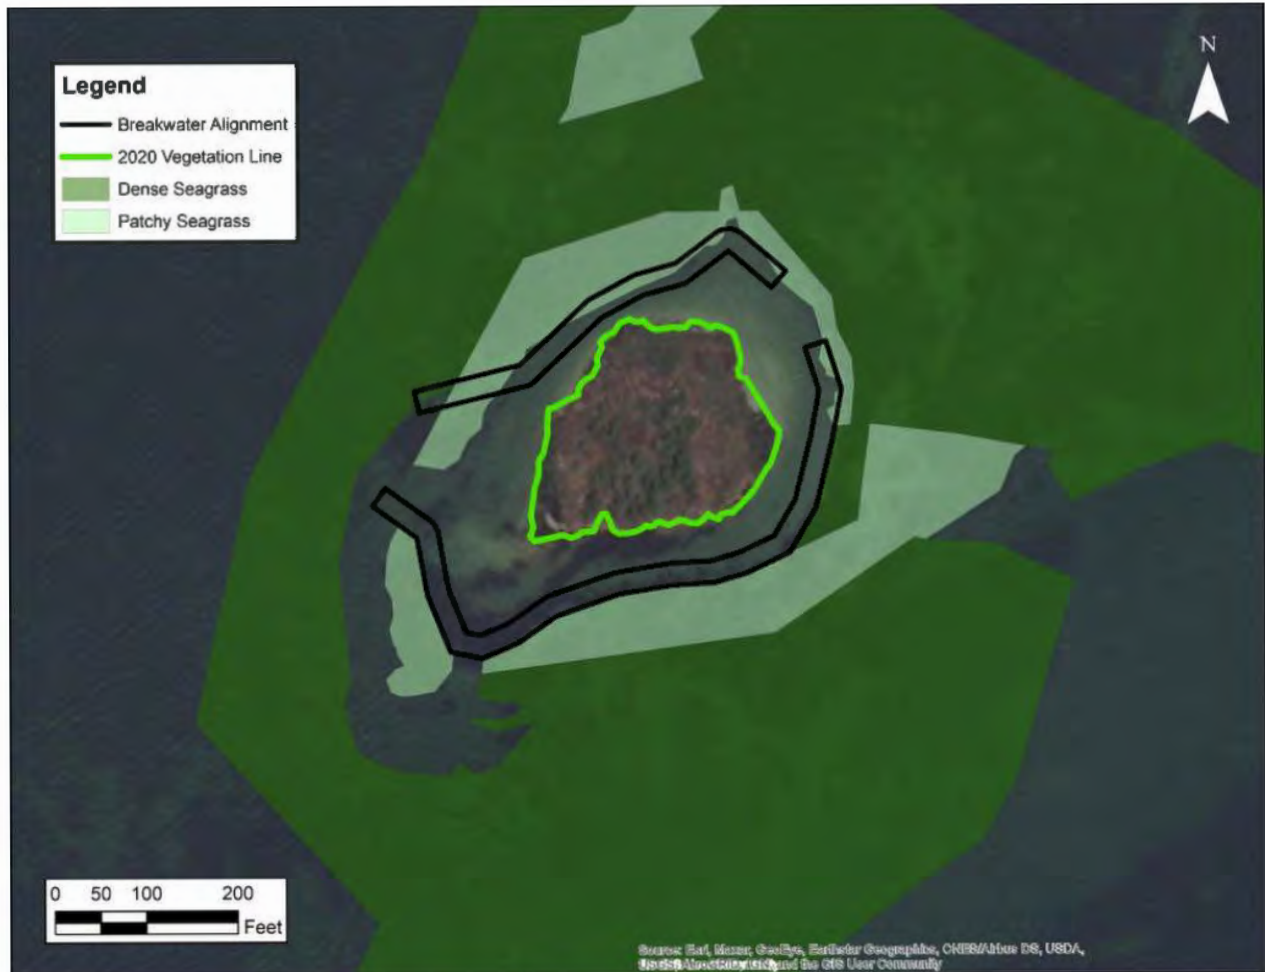
Figure 16. Plan view of Alternative 1: riprap breakwater

Plan and profile views of the riprap breakwater alternative (Figure 16 and Figure 17 respectively) were developed based on the following considerations:

- The proposed breakwater alignment generally remains between the 0.0 ft and +1.0 ft depth contours to help reduce impacts to seagrass.
- Use of the “end-on” construction method.

- Ensure the northern and southern sides of the island are protected while allowing for two gaps in the overall breakwater alignment.
- Western ends of breakwaters extend into deeper water to facilitate access for end-on construction.

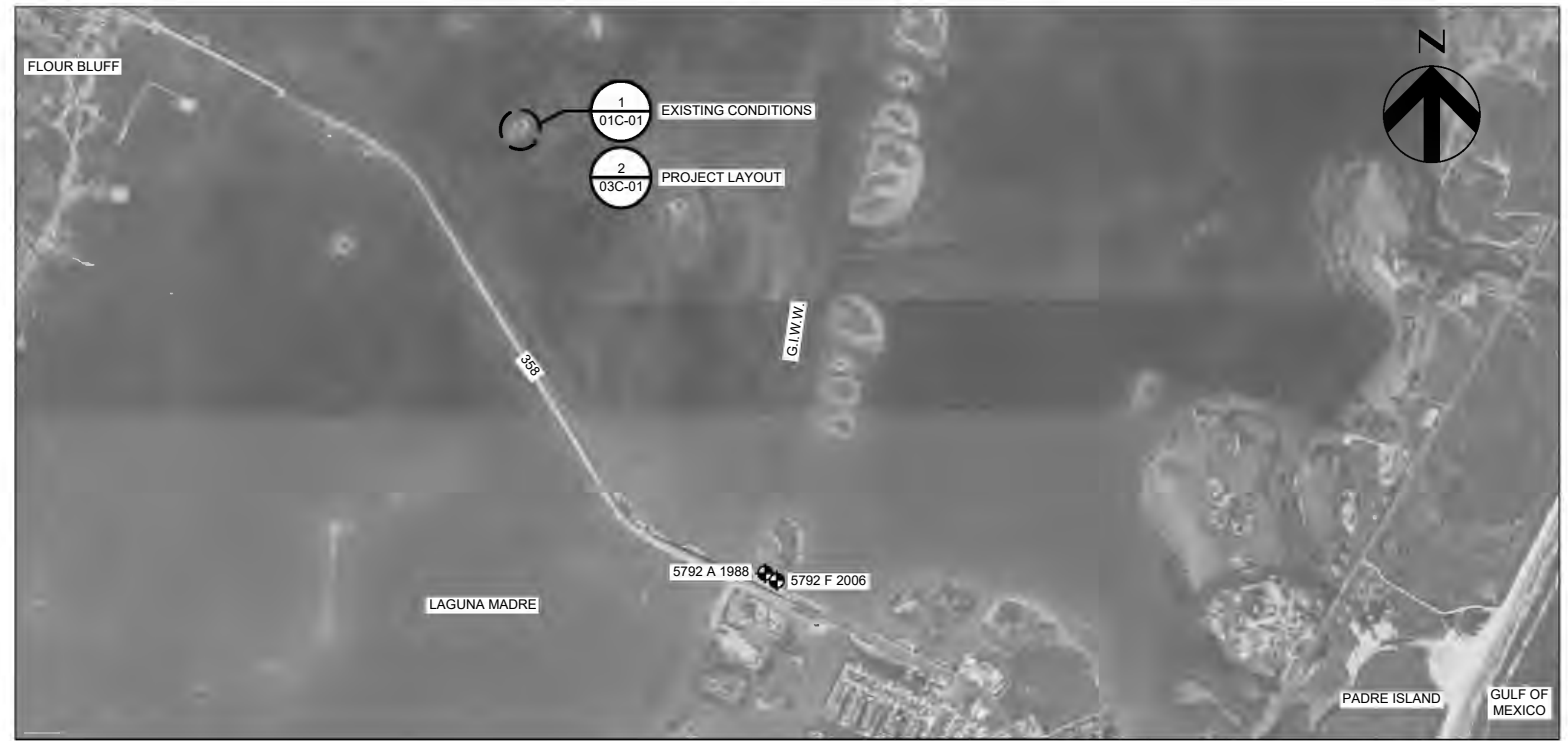
**1 SURVEY MAP AND KEY MAP**  
N.T.S.

- SURVEY NOTES:**
- COORDINATES SHOWN ARE IN U.S. FEET AND ARE REFERENCED TO STATE PLANE, TEXAS SOUTH ZONE, NAD '83.
  - ELEVATIONS SHOWN ARE IN FEET AND REFERENCED TO NAVD '88, GEOID 18.
  - EXCEPT AS NOTED OTHERWISE, HYDROGRAPHIC AND TOPOGRAPHIC SURVEYS WERE CONDUCTED BY T. BAKER SMITH ON MARCH 29, 2023 AND REPRESENT THE CONDITIONS THAT EXISTED AT THE TIME OF THE SURVEYS.
  - MAGNETOMETER SURVEY WAS PERFORMED BY T. BAKER SMITH ON MARCH 29, 2023. SEE RESULTS IN APPENDIX D. THIS MAGNETOMETER SURVEY IS PROVIDED FOR INFORMATIONAL PURPOSES ONLY. CONTRACTOR SHALL BE RESPONSIBLE FOR DETERMINING LOCATIONS OF POTENTIAL HAZARDS, OBSTRUCTIONS, AND UTILITIES WITHIN WORK AND NAVIGATION AREAS. SEE SPECIFICATION 35 00 01, "CONSTRUCTION SURVEYING."
  - MONUMENTS FOR SURVEY CONTROL PROVIDED IN TABLE BELOW.

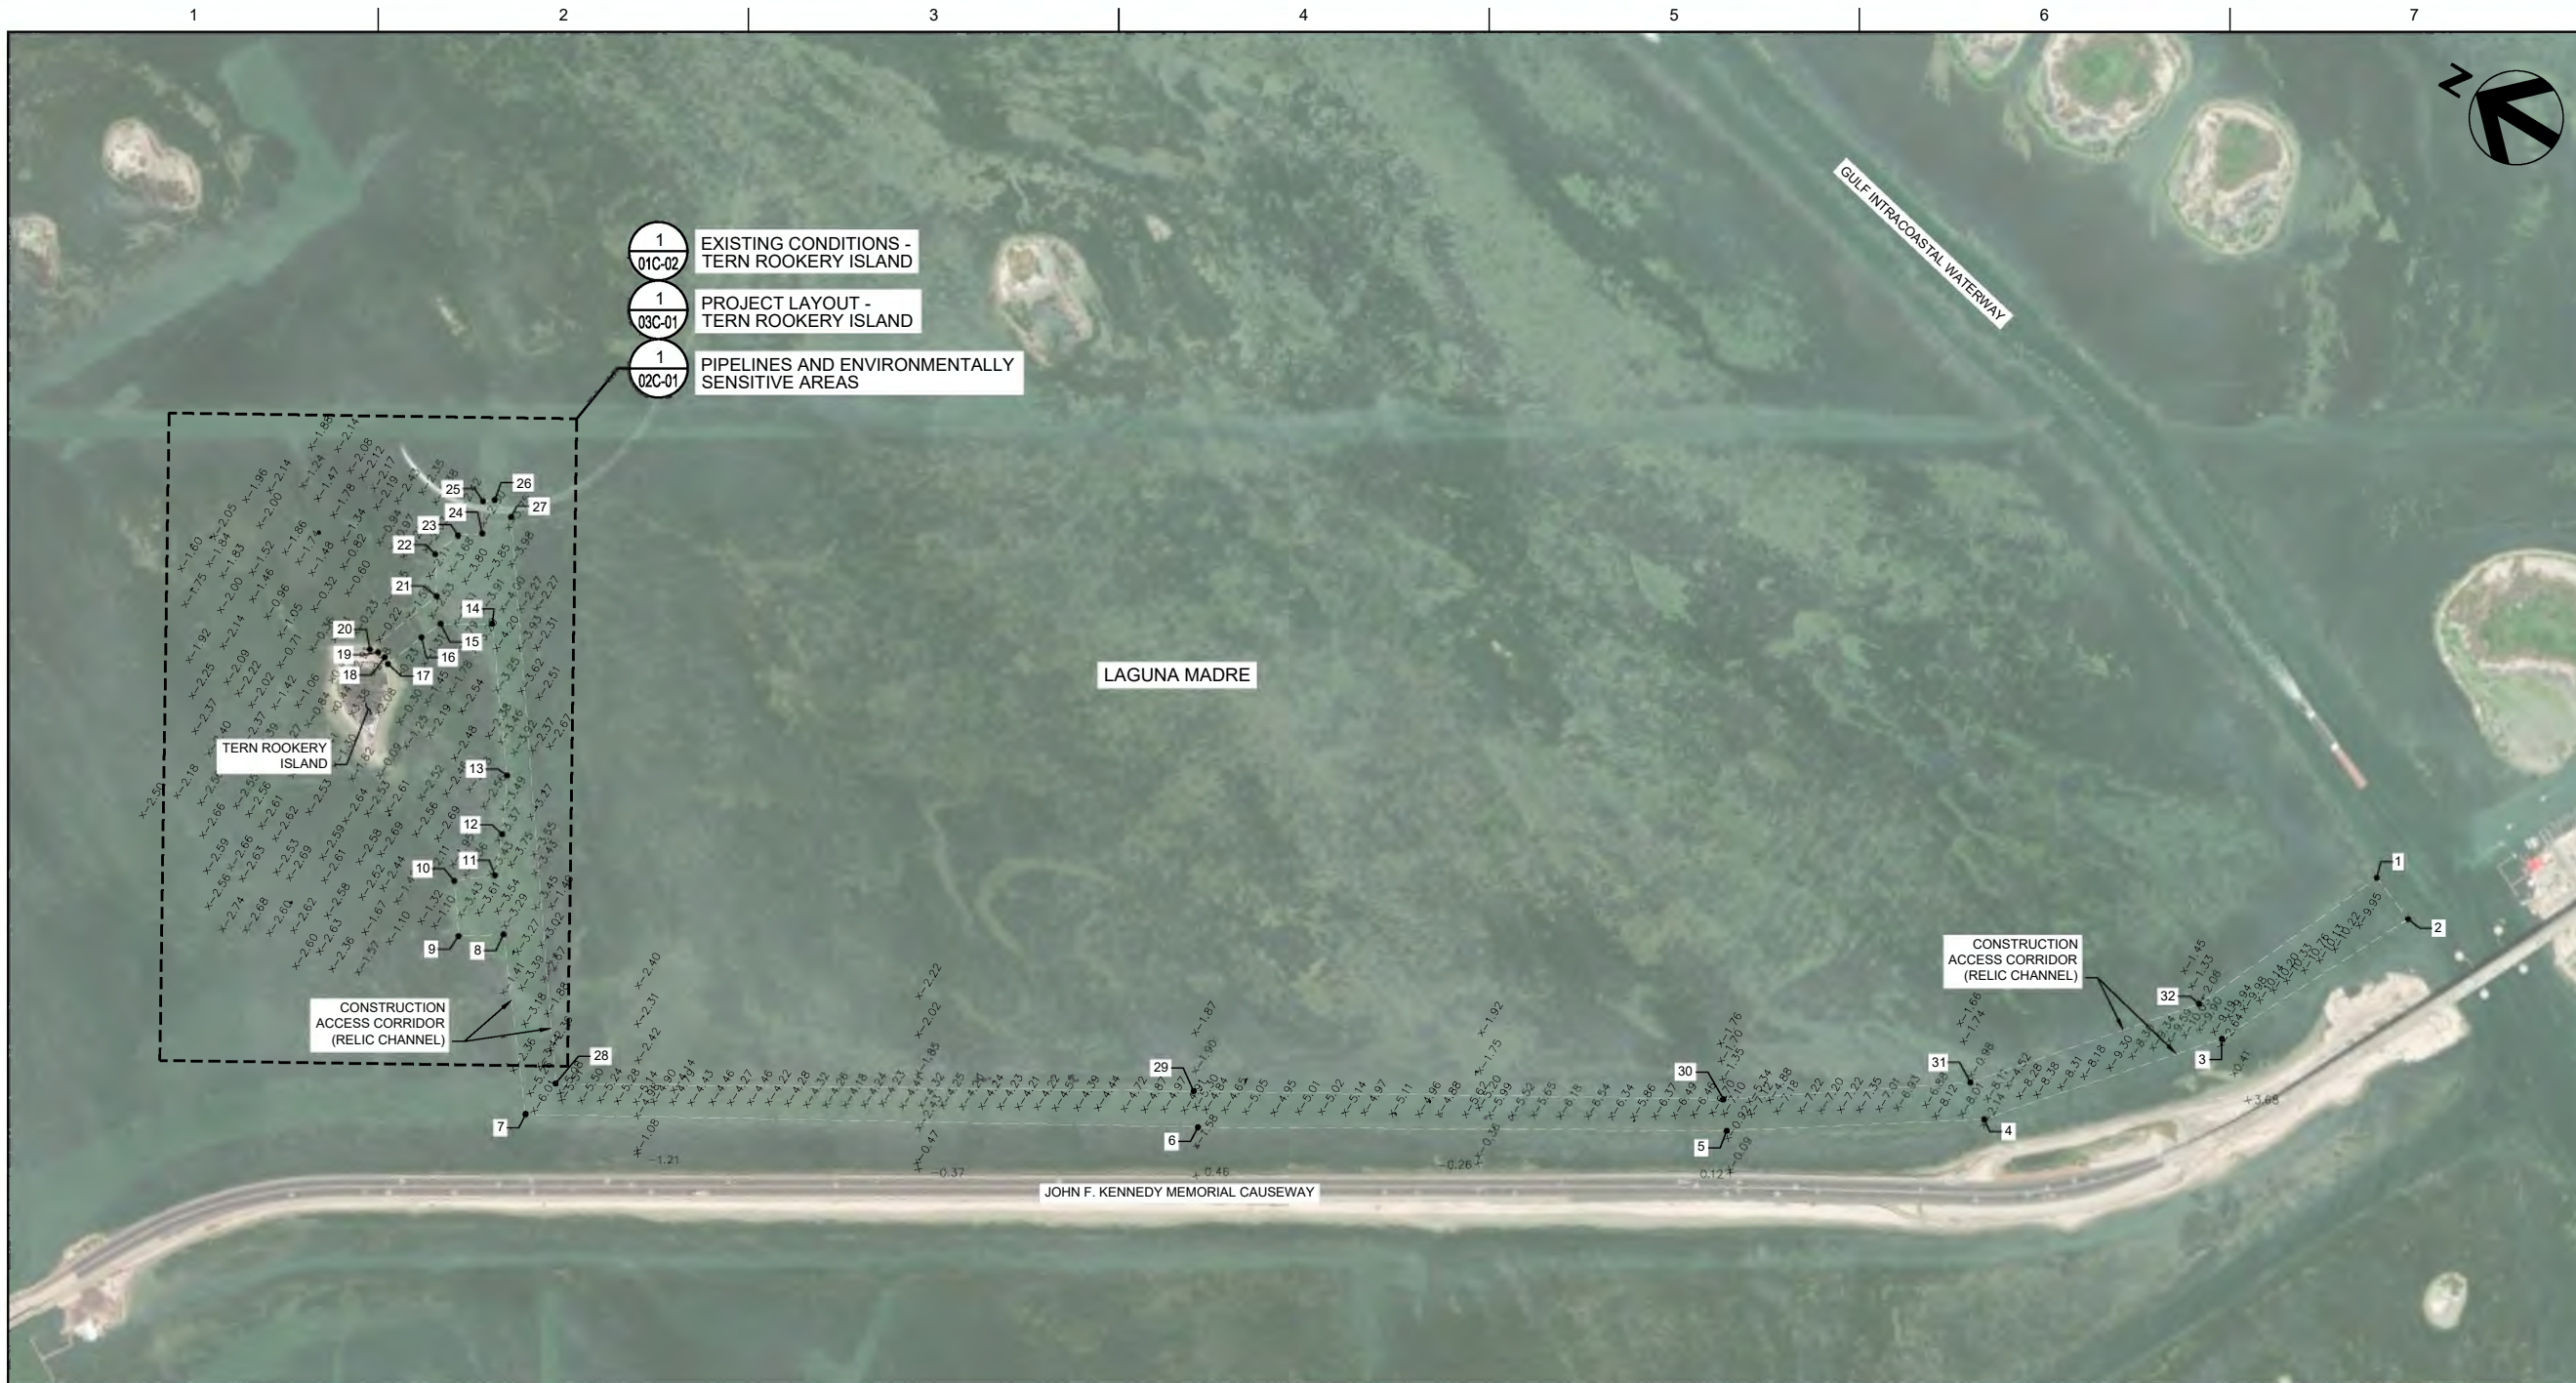
**EXISTING CONDITIONS - SITE PLAN**

- NOTES:**
- REFER TO NOTES ON SHEET 00G-01.
  - SITE INGRESS AND EGRESS FROM GIWW SHALL BE LIMITED TO THE CONSTRUCTION ACCESS CORRIDOR. THESE LIMITS SHALL BE CLEARLY MARKED THROUGH THE DURATION OF CONSTRUCTION. CONSTRUCTION EQUIPMENT SHALL REMAIN WITHIN THESE BOUNDARIES AT ALL TIMES.
  - CONTRACTOR SHALL BE RESPONSIBLE FOR DETERMINING LOCATIONS OF ANY OBSTRUCTIONS AND UTILITIES WITHIN CONSTRUCTION ACCESS CORRIDOR OR WORK BOUNDARY.
  - PIPELINE AND WELLHEAD INFORMATION WERE OBTAINED FROM THE RAILROAD COMMISSION OF TEXAS.

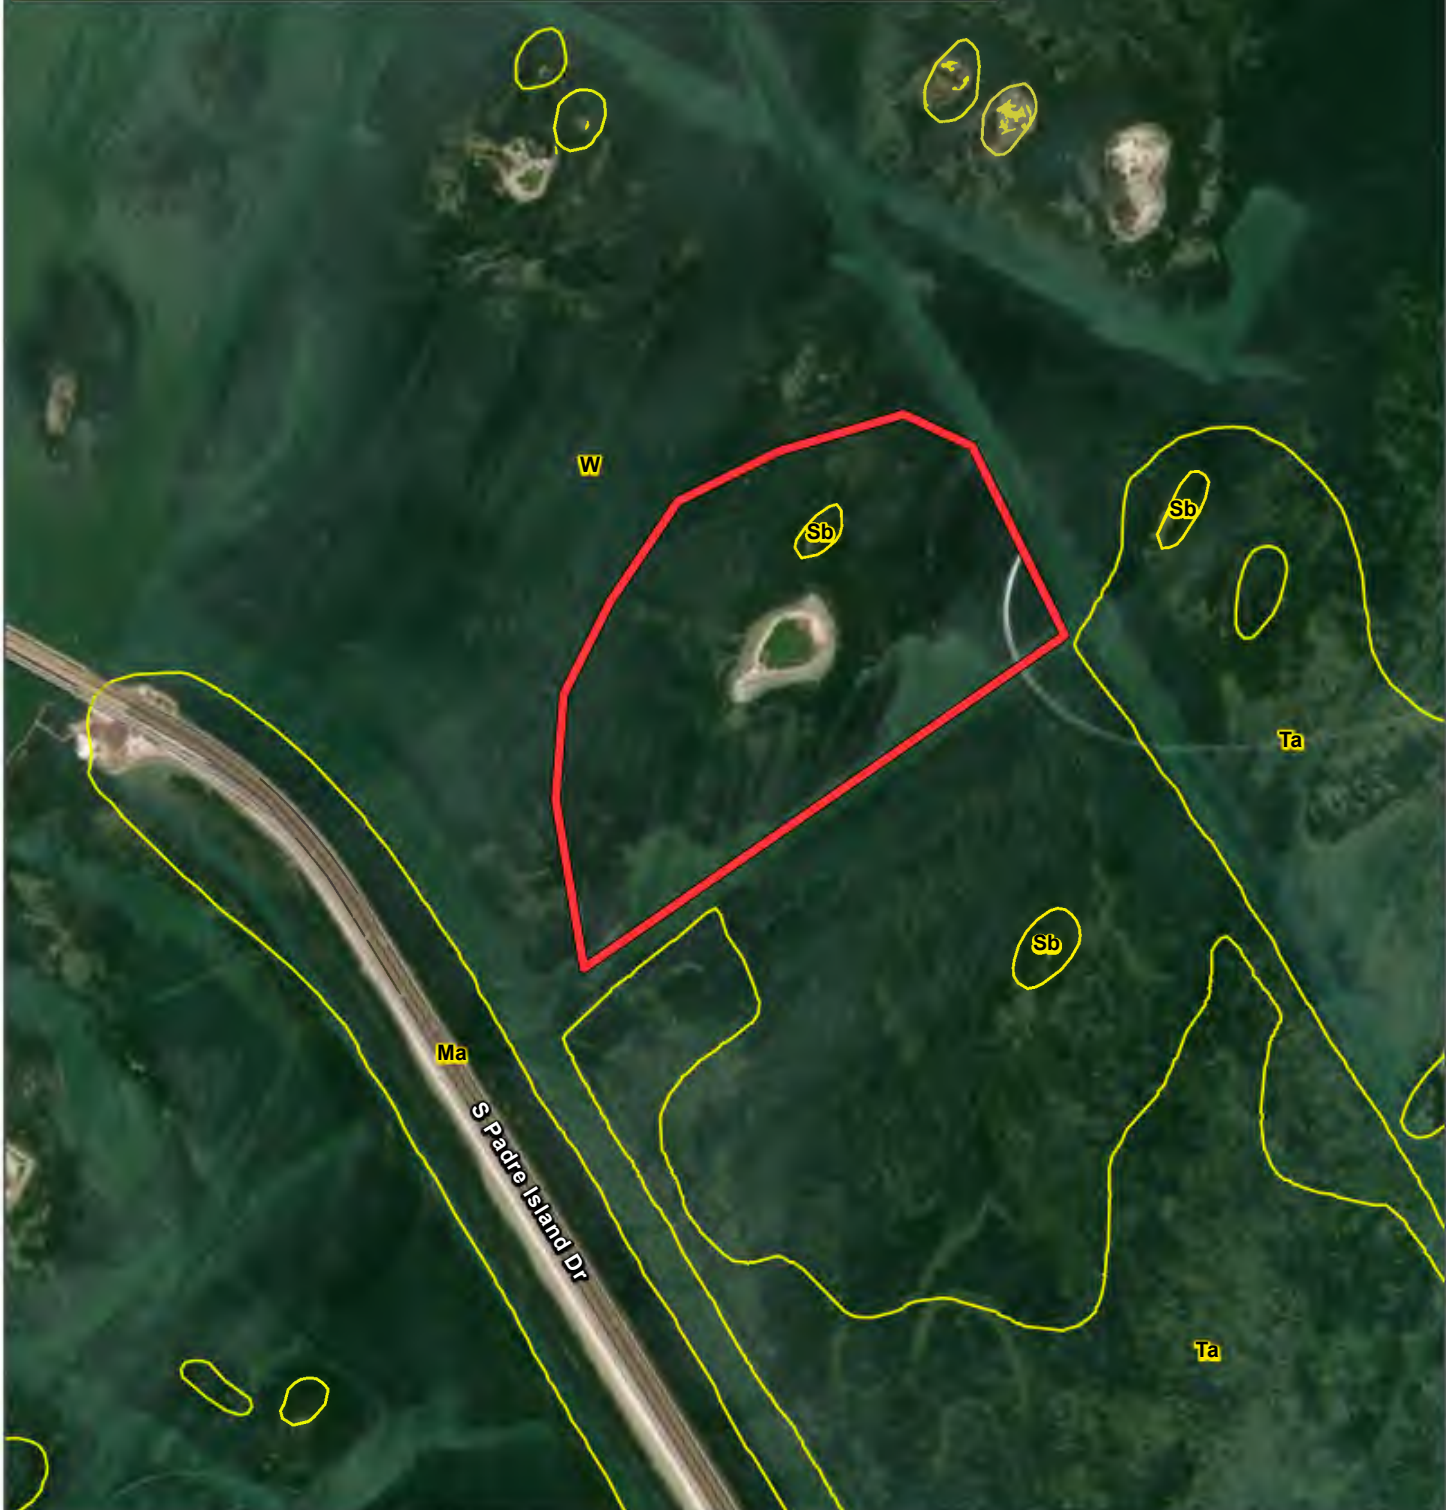
FIGURE 4

Map Unit	Soil Description	Percent of Study Area
Sb	Twinpalms occasionally flooded-Yarborough frequently flooded complex, 0 to 3 percent slopes	1
W	Water	99

**NRCS SOILS MAP**  
 TERN ROOKERY ISLAND  
 RESTORATION PROJECT

According to the Soil Survey for Nueces County, Texas (U.S. Department of Agriculture Soil Conservation Service [USDA SCS], 1982), one soil type (not including water) is found within the Project Area: Twinpalms occasionally flooded-Yarborough frequently flooded complex, 0 to 3 percent slopes (Sb). Sb soils are listed on the National Hydric Soil List for Texas (Natural Resources Conservation Service [NRCS], 2023a). This hydric soil type covers approximately 1 percent of the total Project Area. The remaining 99 percent is water (**Appendix A - Figure 4, Soils Map**).

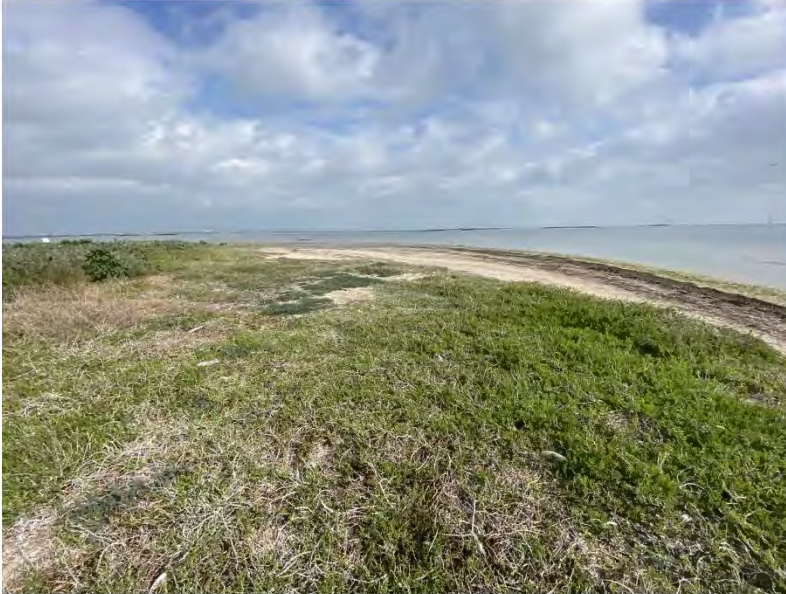
#### Photo 1

Estuarine emergent wetland (W-1) above the annual high tide line (AHTL) and located within the northeastern portion of Tern Rookery Island (island). Note the AHTL was indicated by physical markings on the soil along the shore, continuous deposit of fine shell, debris along the foreshore and berm, and a vegetation line at the general height reached by a rising tide (background). Photo taken to the east.

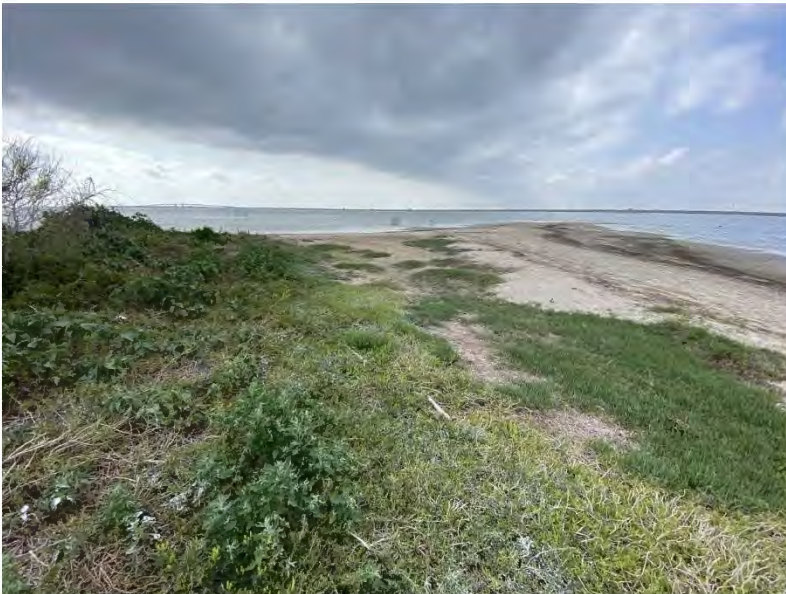
#### Photo 2

Estuarine emergent wetland (W-2) surrounded by open water bare bottom (OW-1) and located within the southwestern portion of the island. Photo taken to the south.

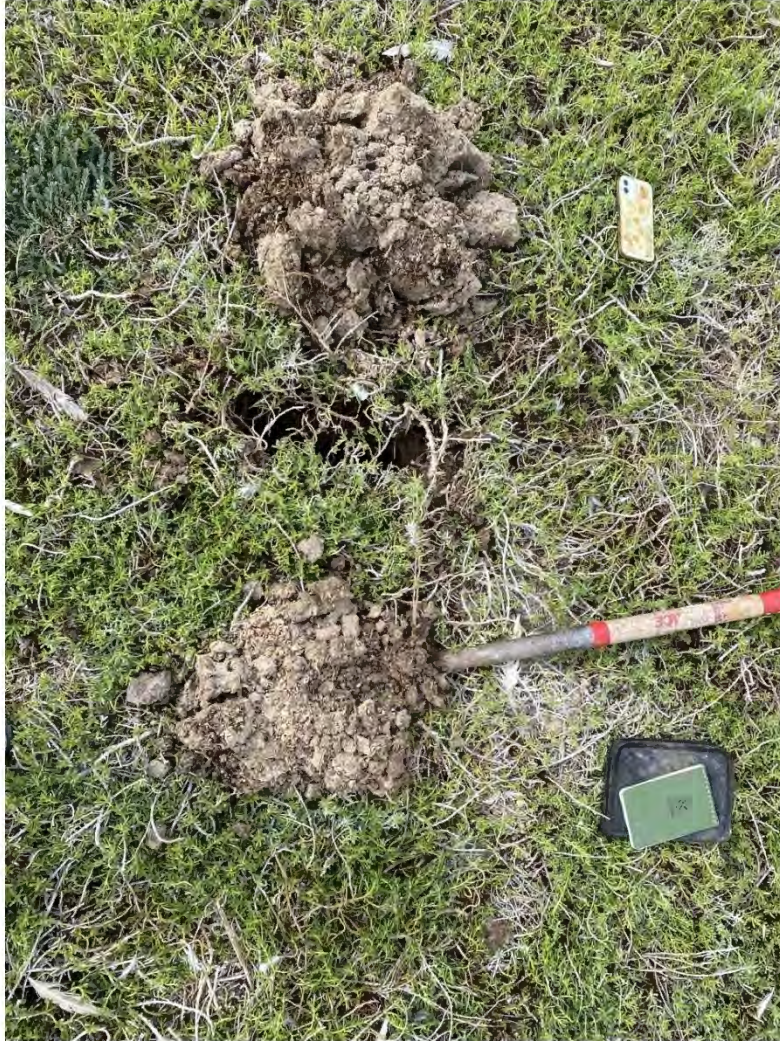
**Photo 3**

Photo of DP-1 located within estuarine emergent wetland (W-1) and southeast of the island. DP-1 is also representative of estuarine emergent wetland (W-2). Photo taken to the south.

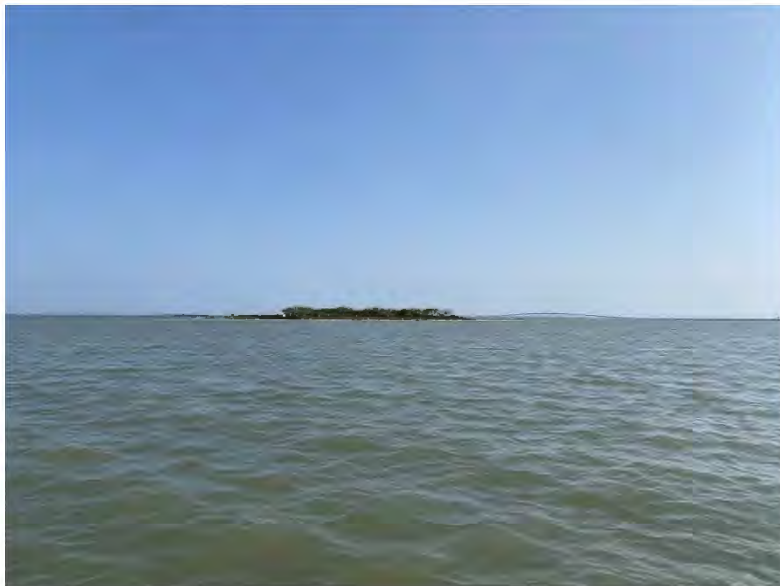
**Photo 4**

Photo of Tern Rookery Island (background) and dense seagrass (SAV-1) (foreground). Dense seagrass was observed at different water depths ranging from 1 to 5 feet. Dense seagrass consisted of shoal grass (*Halodule wrightii*). Photo taken to the southeast.

A total of 47.74 acres of seagrass beds (SAV-1 to SAV-5) were identified within open water surveyed within the Project Area (**Appendix A - Figure 7, Potential WOTUS**). The dominant seagrass species was shoal grass, with less dense species including manatee grass, and star grass (**Appendix D – Photos 4, 5, 6, and 7**). Seagrass bed SAV-1 was surrounding the island within the Project Area. The majority of SAV-1 was dense in cover and observed at depths ranging between 1 to 5 ft. Seagrass beds SAV-2 to SAV-5 were located adjacent to OW-1, were patchy in cover, and observed at depths ranging between 0 to 4 ft. Seagrass beds would be considered jurisdictional due to habitat presence within Corpus Christi Bay, a TNW.

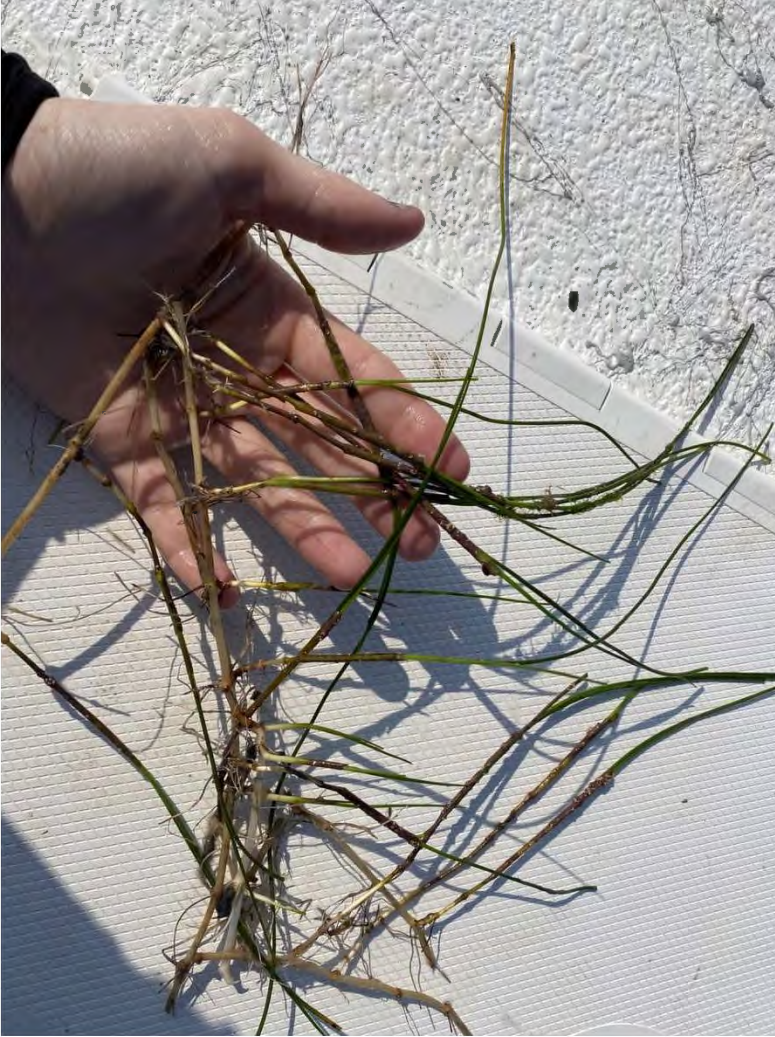
**Photo 5**

Photo of observed shoal grass located within dense seagrass SAV-1. Photo taken to the south.

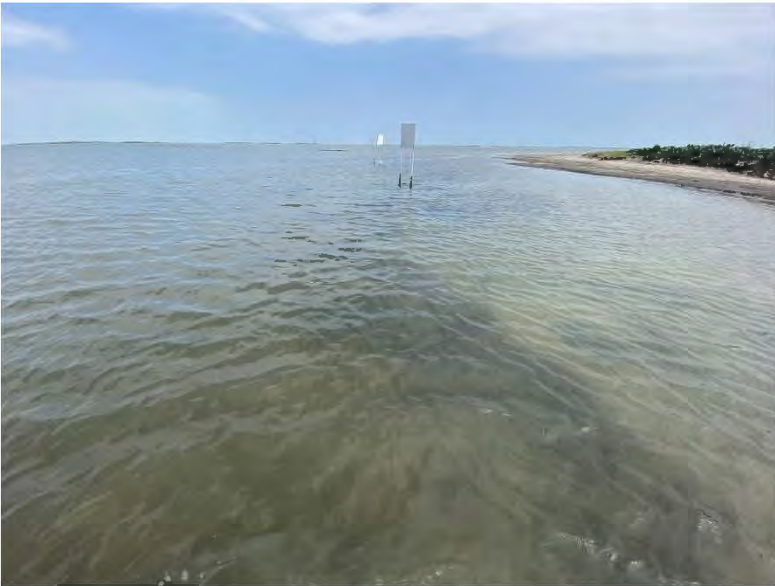
**Photo 6**

Photo of patchy seagrass within SAV-4 and located northwest of the island. Patchy seagrass was observed at different depths ranging from 0 to 4 feet. This photo is representative of SAV-2 and SAV-3. Photo taken to the north.

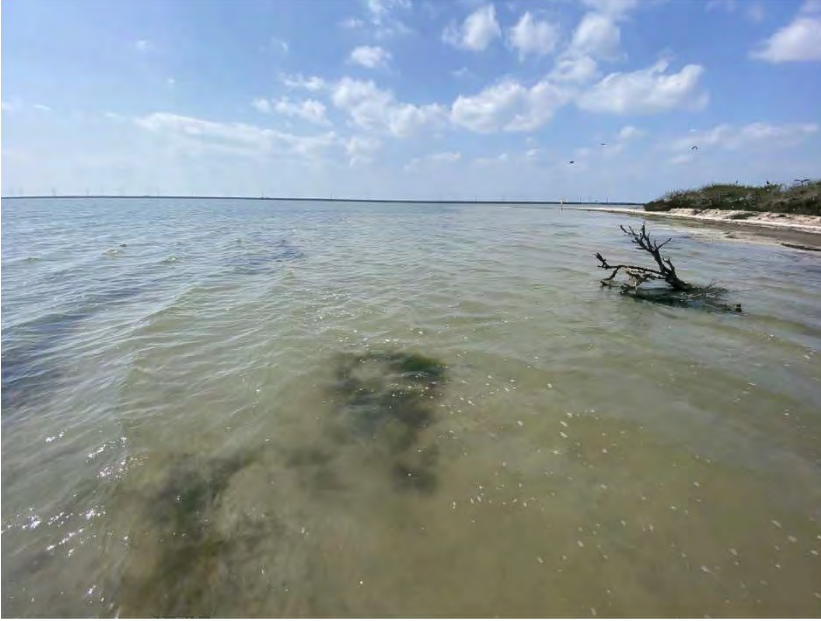
**Photo 7**

Photo of patchy seagrass within SAV-5 located east of the island. Photo taken to the northeast.

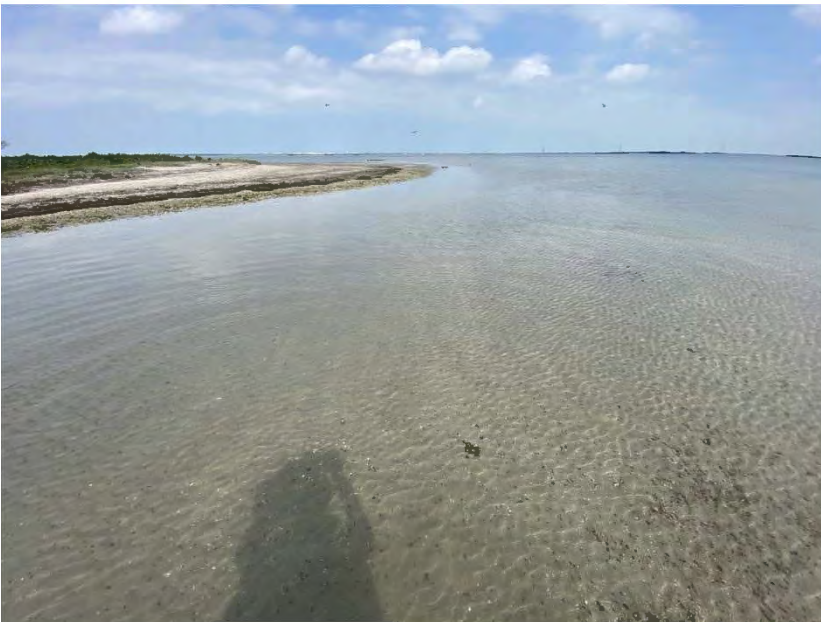
**Photo 8**

Photo of open water bare bottom (OW-1) located around the island. Photo of OW-1 is representative of OW-2, OW-3, OW-4, OW-5, OW-6, and OW-7. Photo taken to the west.

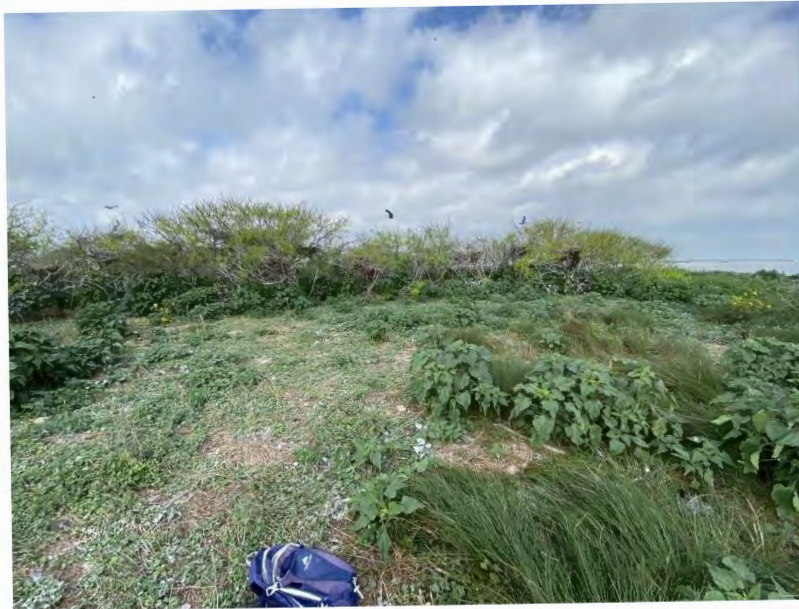
**Photo 9**

Photo of upland tree/shrub habitat (background) located on the island and near DP-2. Photo taken to the northwest.

The delineation of the Project Area did not result in the identification of non-jurisdictional aquatic features. The remaining 0.99 acres of the Project Area was determined to be upland. This area did not exhibit all three wetland indicators (**Appendix B – Data Form DP-2, and DP-3**). The upland area of the Project Area was situated at higher elevations compared to surrounding wetland and water features and consisted of primarily upland vegetation such as honey mesquite, common sunflower, cheeseweed, and erect prickly-pear (*Opuntia stricta*) covering the herbaceous layer (**Appendix D – Photo 9, 10, and 13**).

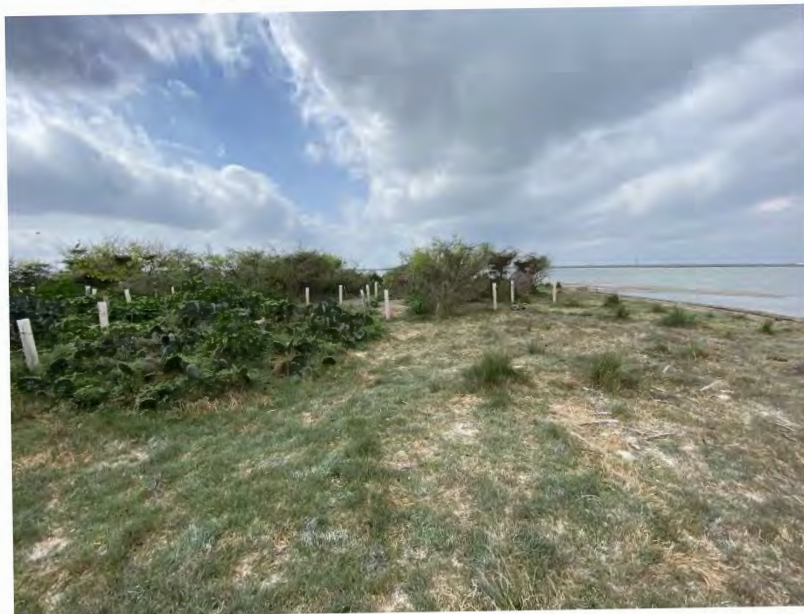
**Photo 10**

Photo of upland tree/shrub habitat (background) located on the island and near DP-3. Photo taken to the south.

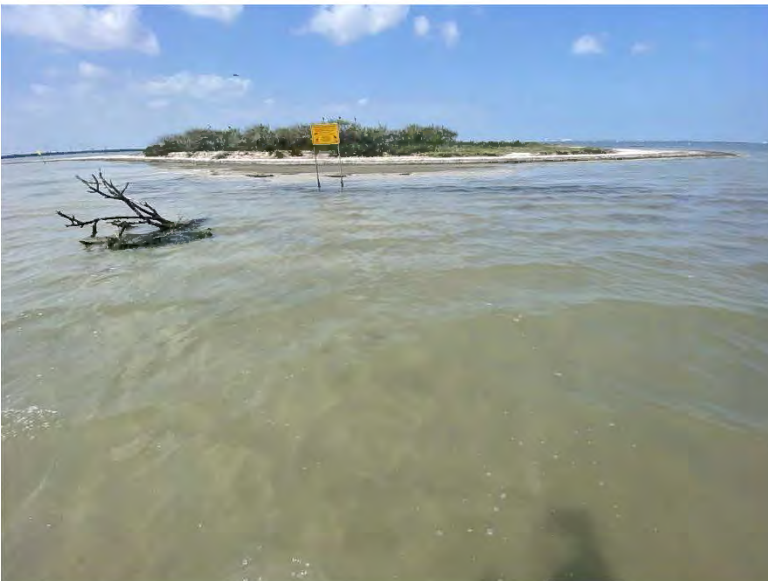
**Photo 12**

Photo of Tern Rookery Island with tidal flats (background) and patchy seagrass SAV-5 (foreground). Photo taken to the west.

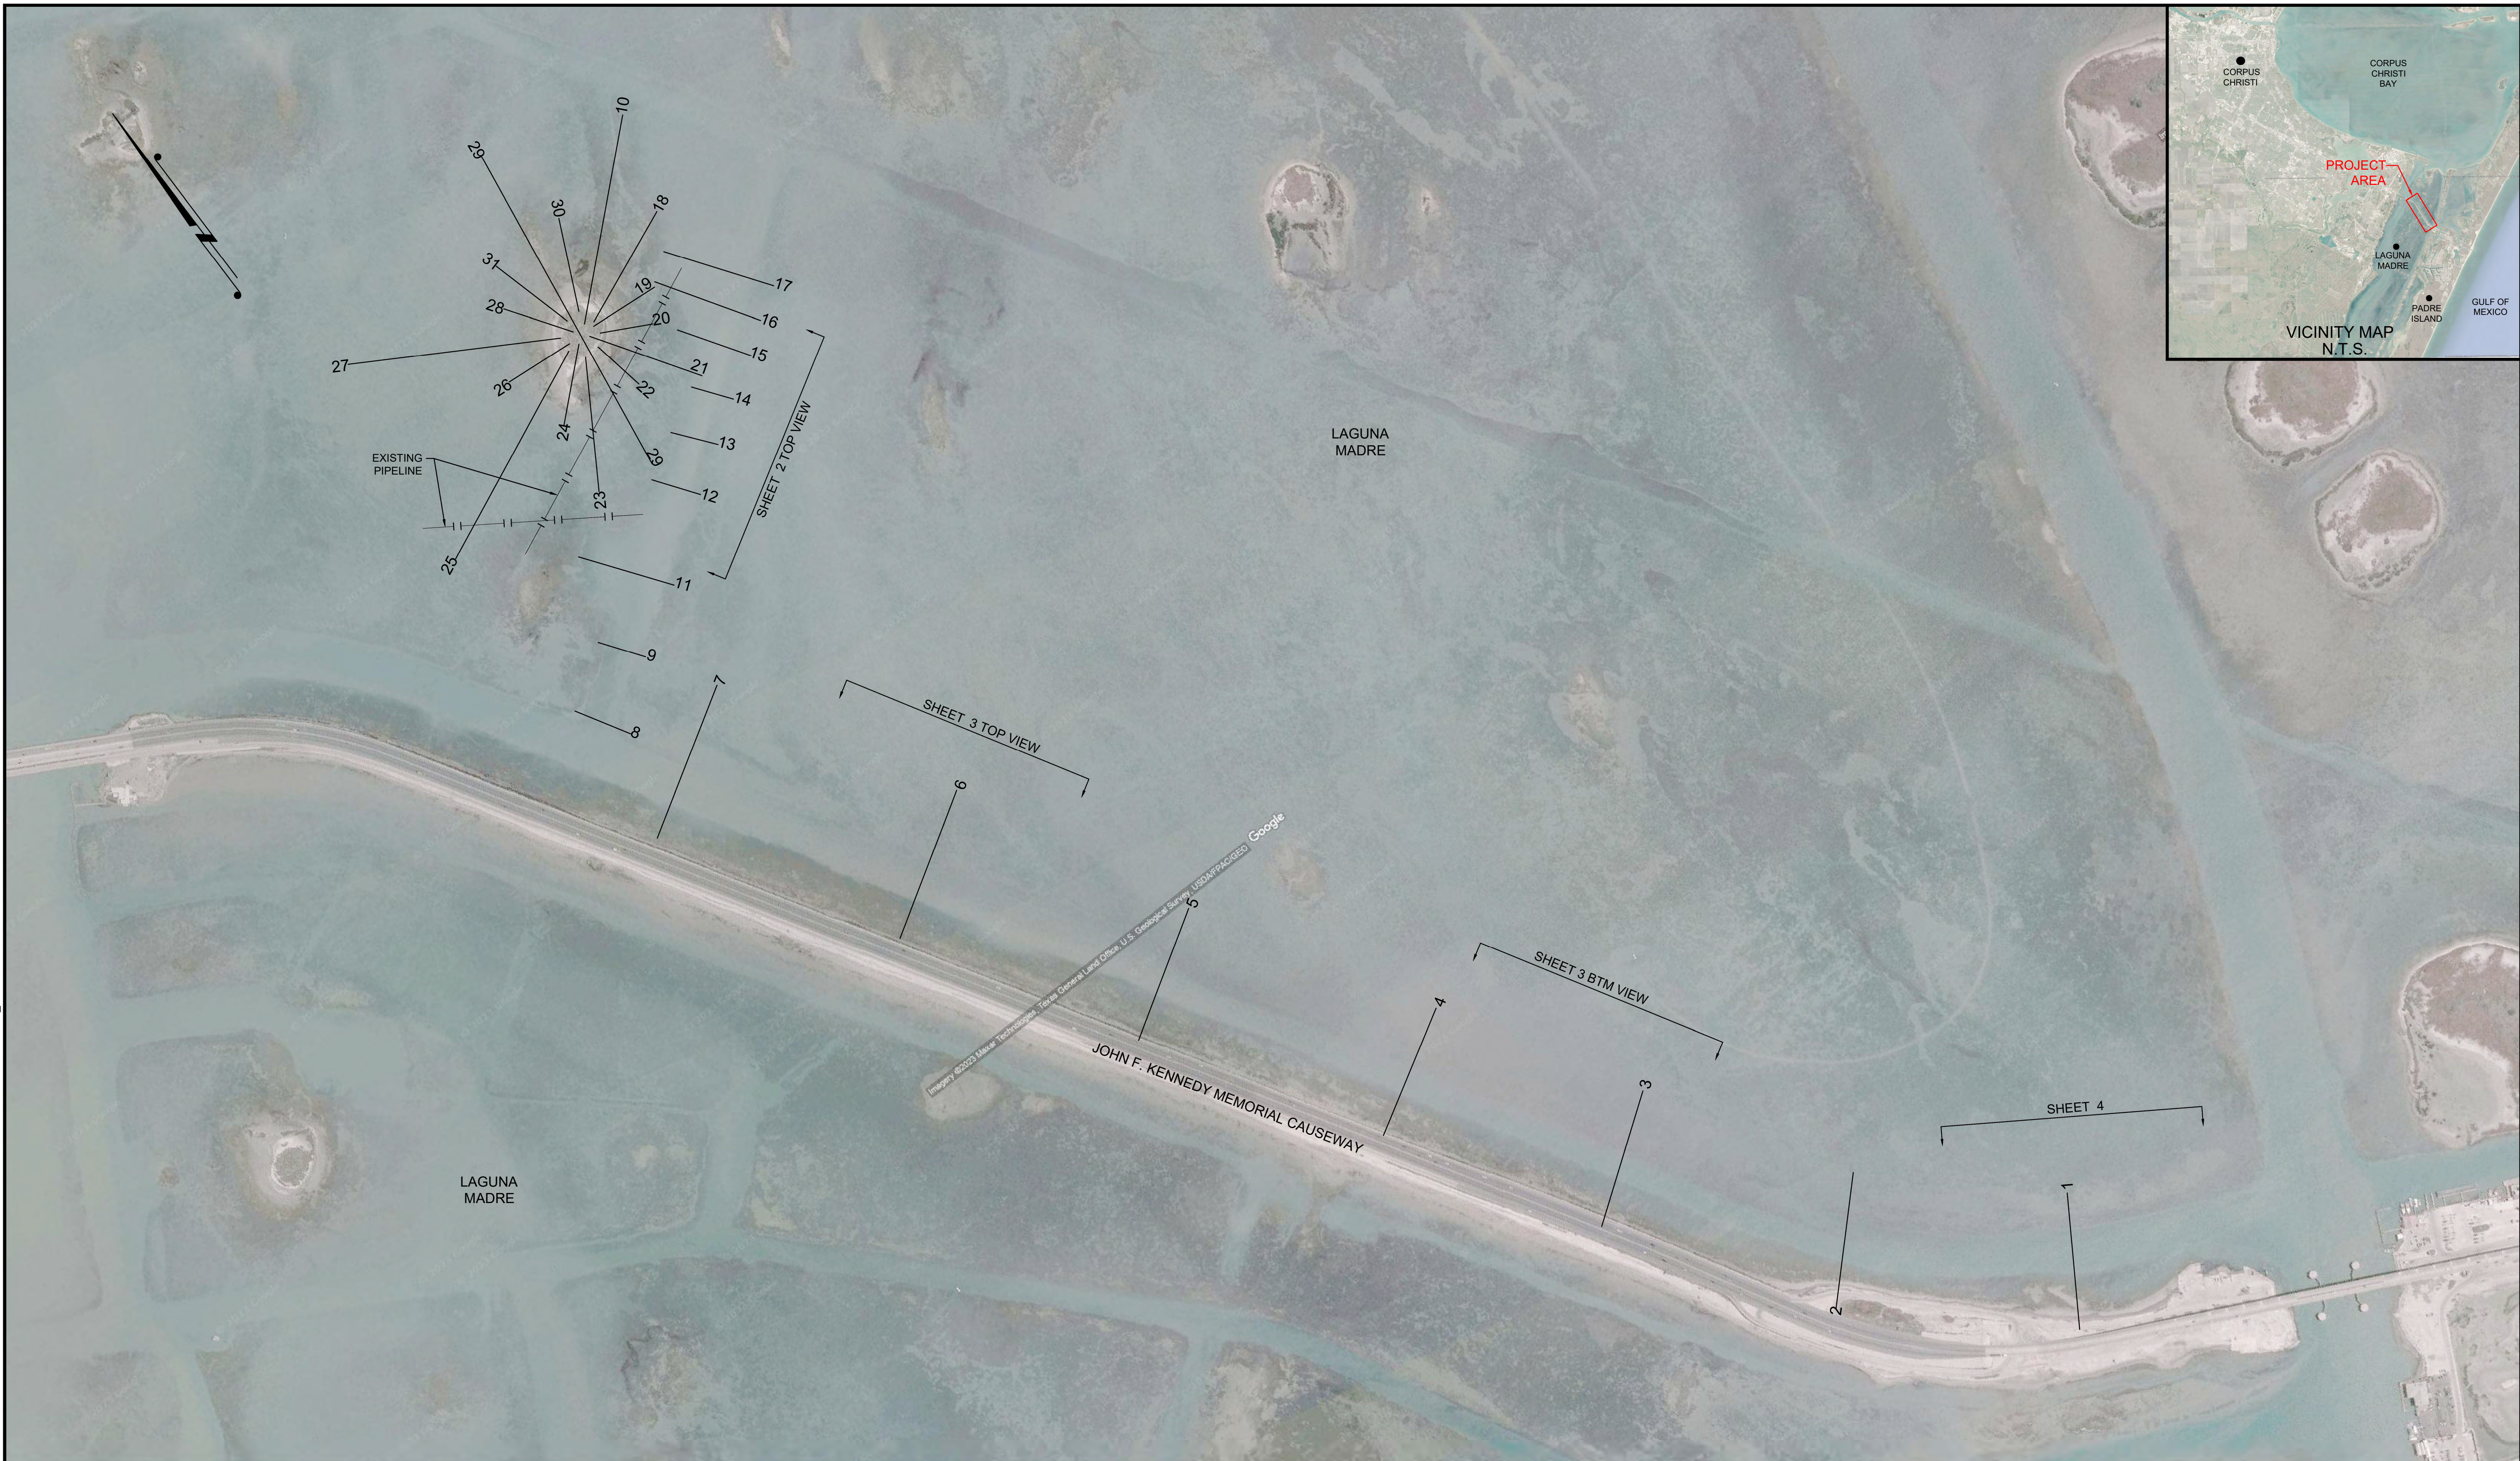
**BATHYMETRIC & TOPOGRAPHIC SURVEY**  
 HDR ENGINEERING, INC.  
 AN EXHIBIT OF A  
 BATHYMETRIC & TOPOGRAPHIC SURVEY  
 LOCATED IN  
 LAGUNA MADRE, TEXAS

**NOTES:**  
 1. SOUNDINGS AND TOPOGRAPHIC DATA WAS RECORDED BY T. BAKER SMITH ON 29 MARCH AND 26 MAY, 2023. SEA FLOOR CONDITIONS ARE SUBJECT TO CHANGE.  
 2. HORIZONTAL DATUM: NAD83 (2011), TEXAS SOUTH ZONE. ALL DISTANCES ARE U.S. SURVEY FEET (GRID).  
 3. VERTICAL: NAVD88 (GEOID 18)

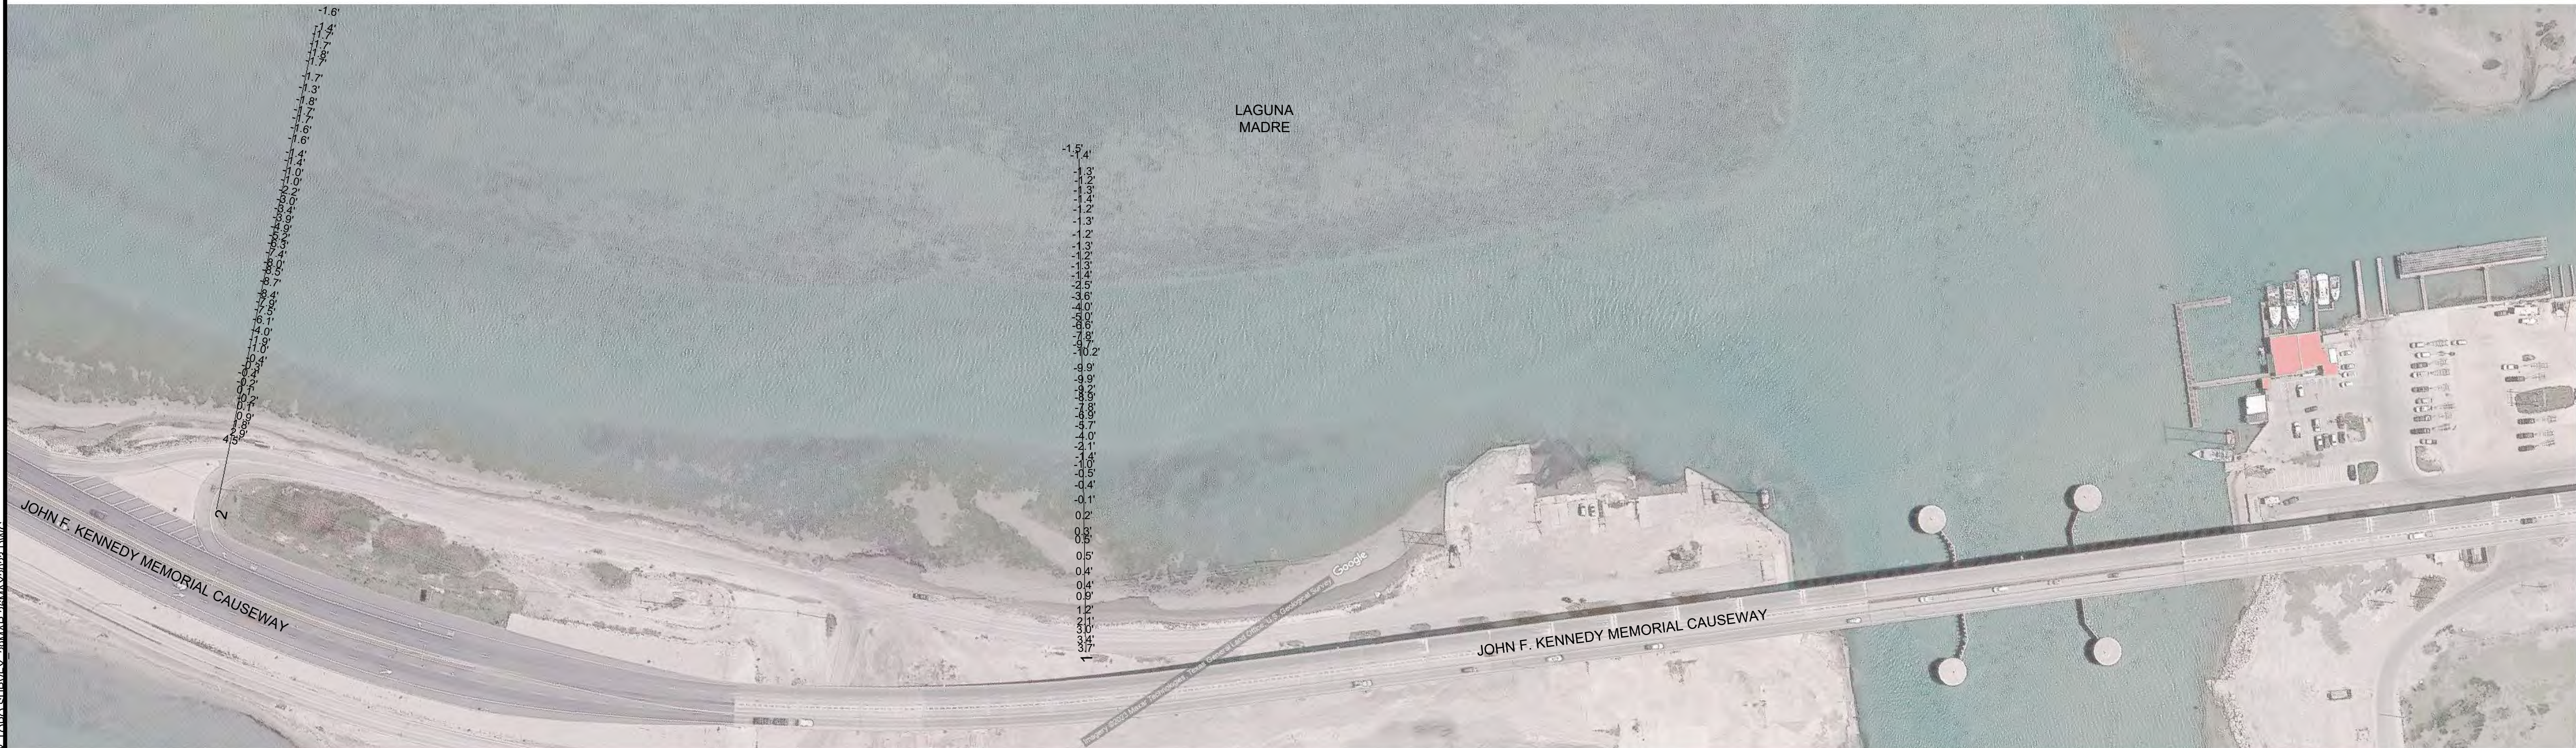
NOTES:  
 1. SOUNDINGS AND TOPOGRAPHIC DATA WAS RECORDED BY T. BAKER SMITH ON 29 MARCH AND 26 MAY, 2023. SEA FLOOR CONDITIONS ARE SUBJECT TO CHANGE.  
 2. HORIZONTAL DATUM: NAD83 (2011), TEXAS SOUTH ZONE. ALL DISTANCES ARE U.S. SURVEY FEET (GRID).  
 3. VERTICAL: NAVD88 (GEOID 18)
