**Tern Rookery Island Protection and Restoration, Phase I: Feasibility Study & Alternatives Analysis**

**GLO Contract No. 21-060-008-C668**

**Final Report**

# Feasibility Study & Alternatives Analysis Report

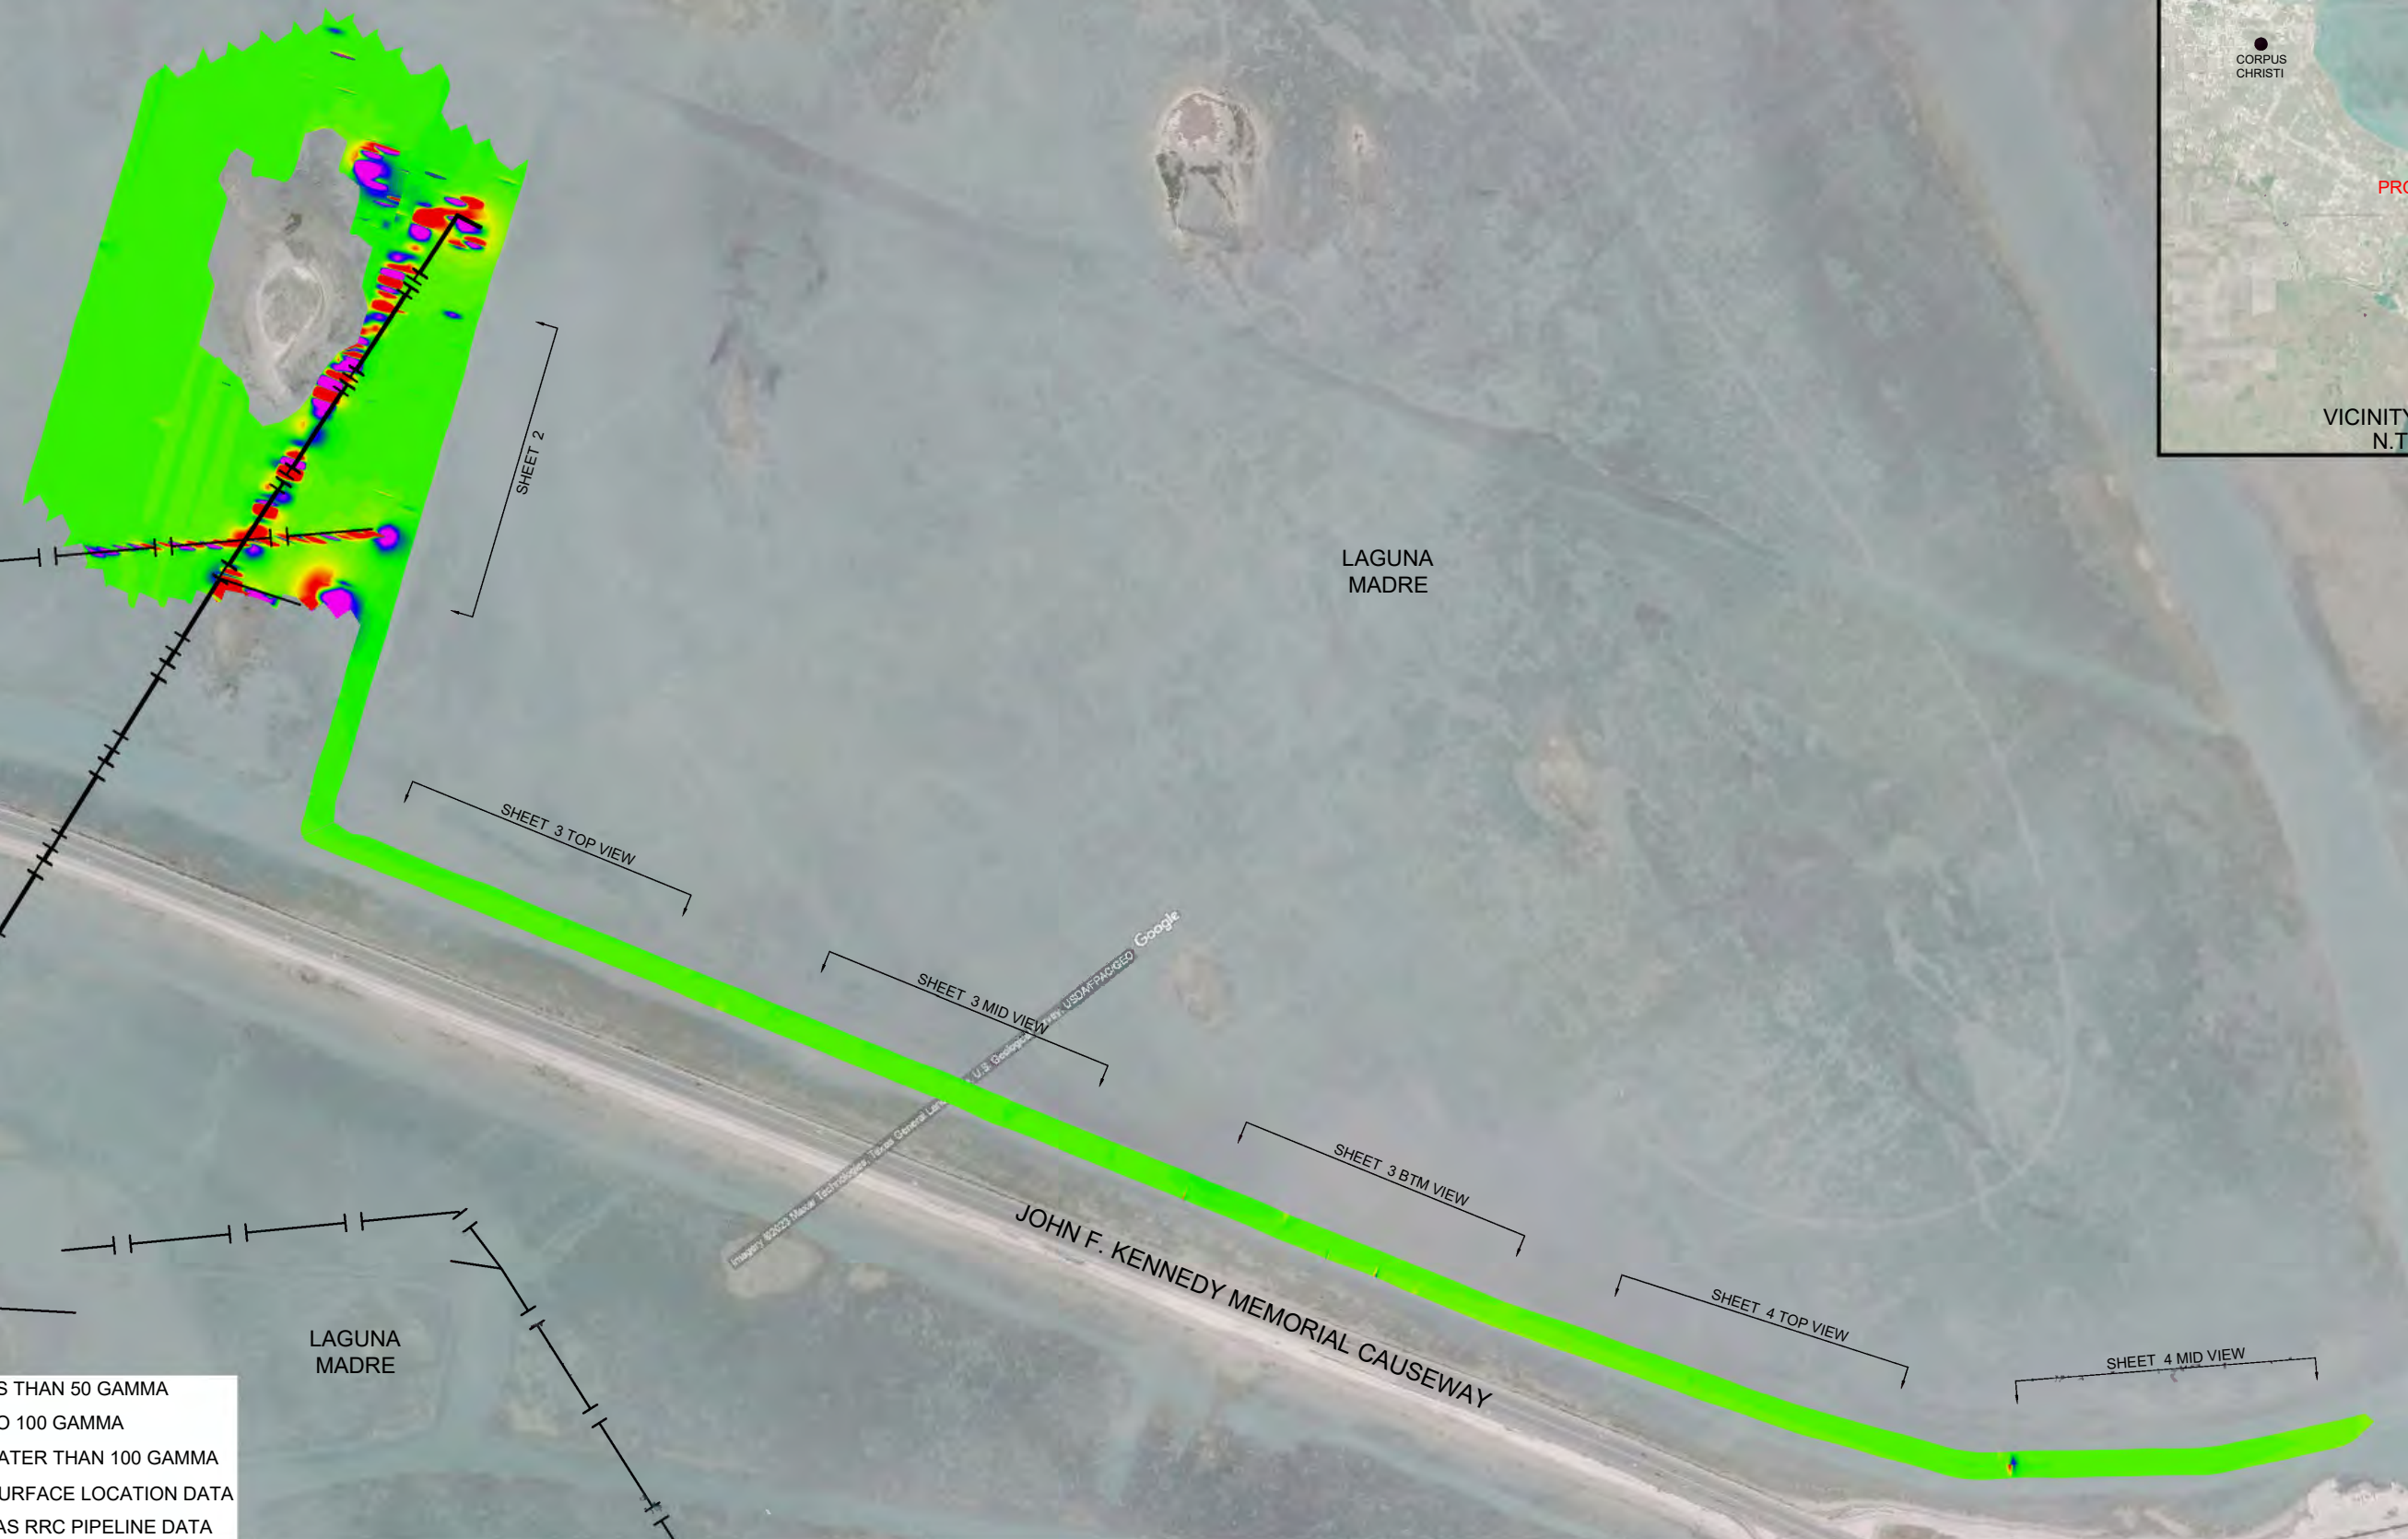
**MAGNETOMETER SURVEY**  
 HDR ENGINEERING, INC.  
 TERN ISLAND  
 AN EXHIBIT OF A  
 MAGNETOMETER SURVEY  
 LOCATED IN  
 LAGUNA MADRE, TEXAS

1. MAGNETOMETER DATA WAS RECORDED BY T. BAKER SMITH ON 29 MARCH, 2023. SEA FLOOR CONDITIONS ARE SUBJECT TO CHANGE.
2. HORIZONTAL DATUM: NAD83 (2011), TEXAS SOUTH ZONE. ALL DISTANCES ARE U.S. SURVEY FEET (GRID).
3. VERTICAL: NAVD88 (GEOID 18)
