BRAZORIA COUNTY EROSION RESPONSE PLAN

An Amendment to the Dune Protection and Beach Access Plans for:

April 16, 2012

COAST & HARBOR ENGINEERING, INC.
3410 Far West Blvd., Austin, TX 78731
TEL: 512.342.9516 FAX: 512.342.9708
www.coastharboreng.com

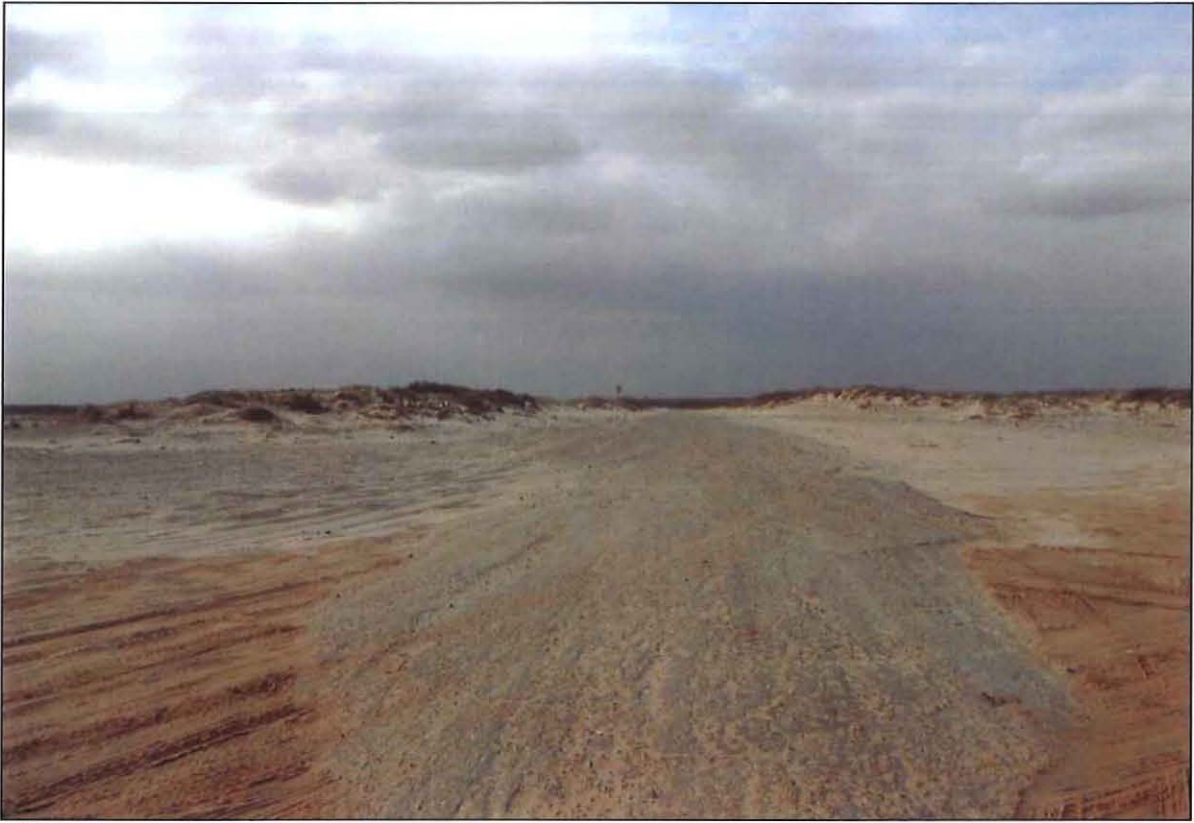
(A.) City of Freeport: Vehicle Beach Access Point at CR 241. (DSCF0101.JPG)

There are two vehicular access points within the City of Freeport jurisdiction. Beach Access #2 at CR 241 is in good working condition and vehicular access onto the beach was easy. Beach Access #2 is angled to the beach and to the prevailing wind direction which may help reduce storm surge propagation inland during a storm. Beach Access #1 at CR 750 needs some improvement and will benefit from additional crushed limestone road base at the entrance to the beach. Additionally, this entrance is not perpendicular to the beach which helps reduce storm surge propagation. However,

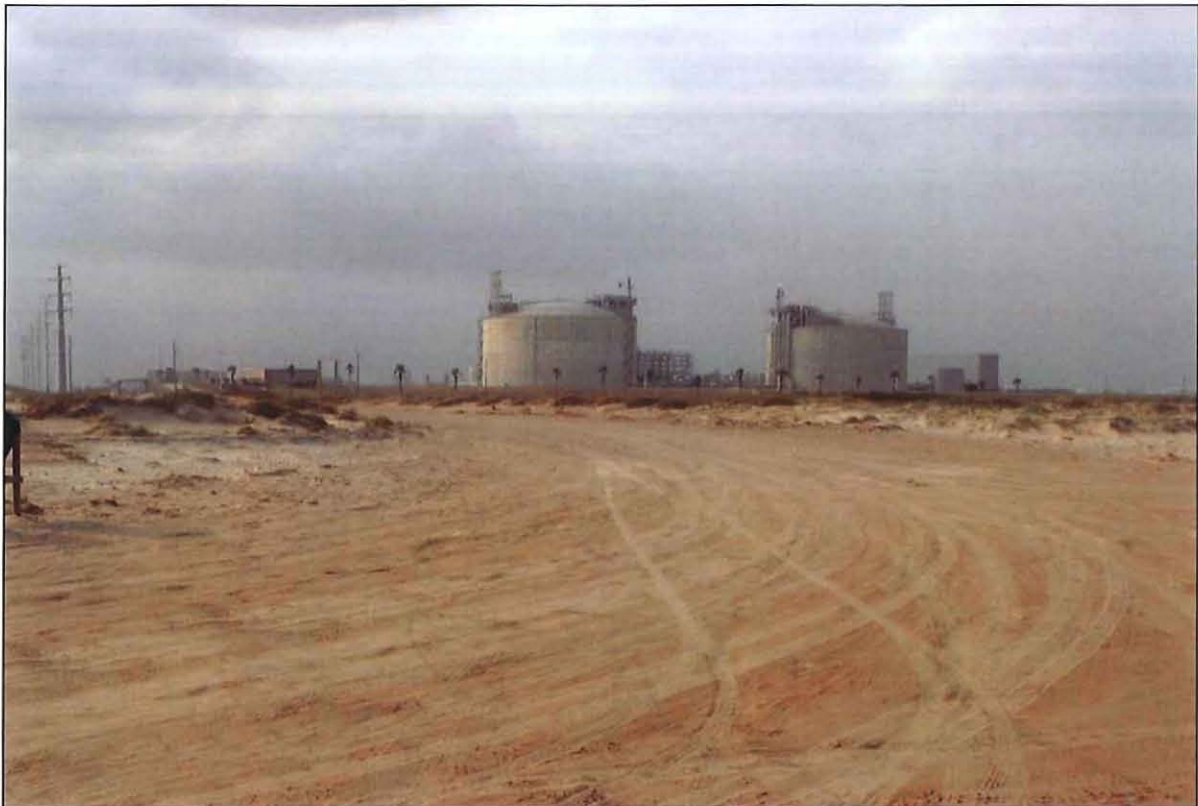
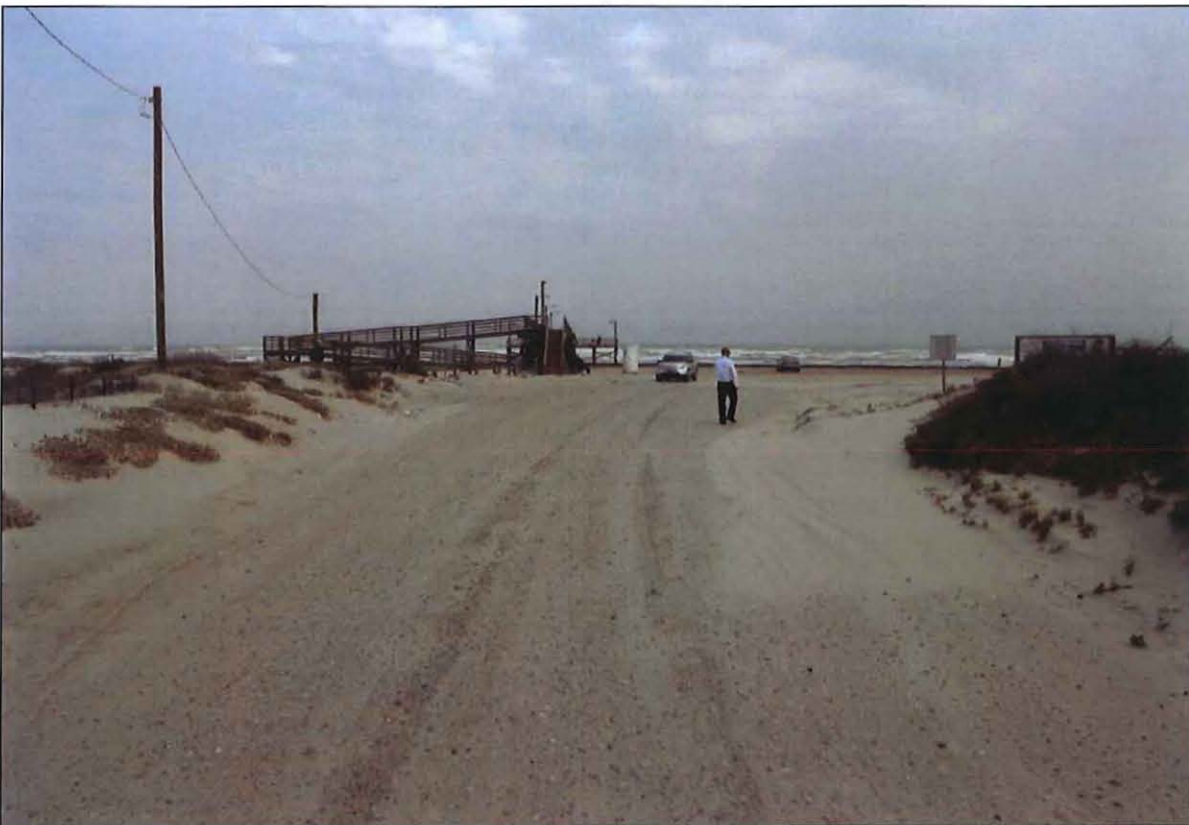
(C) Town of Quintana: Vehicle Beach Access Point at 16th Street. (DSCF0110.JPG)

(D) Town of Quintana: Vehicle Beach Access Point at 8th Street. (DSCF0087.JPG)

There are two vehicular access points within the Town of Quintana. These access points are in good condition, allow easy driving onto the beach, and do not need any improvements at the present time. However, these roads are aligned to the prevailing wind direction and beach and could be avenues for storm surge propagation during a storm. These vehicular access points can be improved by increasing the elevation of the road by 4 feet at the dune location. Any improved protection project would be subject to available funding.

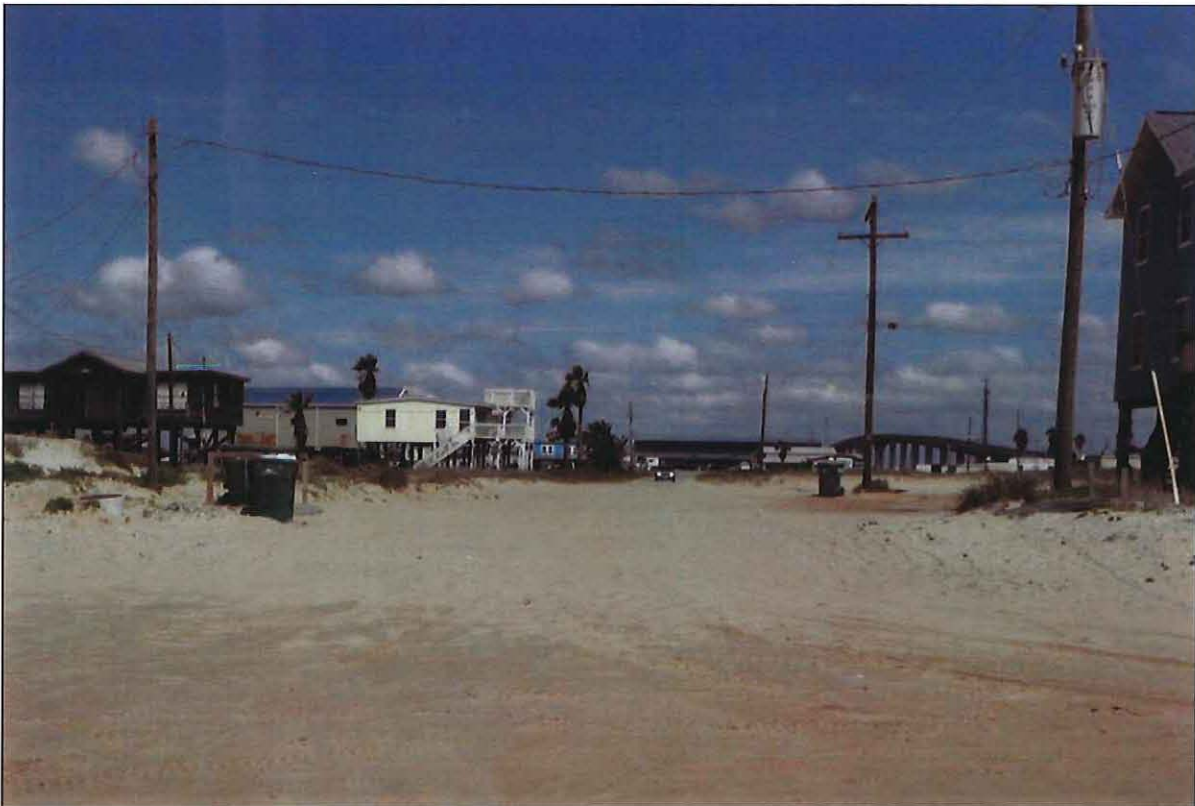
J. Village of Surfside Beach: Vehicle Beach Access Point at Hwy 332. (DSCF0141.JPG)

PRIORITY	LOCATION	REPAIR
1	<i>Surfside:</i> Access at Hwy 332	Additional crushed limestone road base at the entrance to the beach and raising elevation by 4 ft.
2	<i>Brazoria County/Surfside:</i> Beach Access #1 at Seagull Ave	Additional crushed limestone road base at the entrance to the beach and raising elevation by 4 ft.
3	<i>Freeport:</i> Beach Access #1 at CR 750	Additional crushed limestone road base at the entrance to the beach and raising elevation by 4 ft.
4	<i>Brazoria County:</i> Beach Access #3 at CR257E	Additional crushed limestone road base at the entrance to the beach and raising elevation by 4 ft.
5	<i>Brazoria County:</i> Beach Access #4 at Nacal Drive	Scour holes need to be filled and stabilized with vegetation

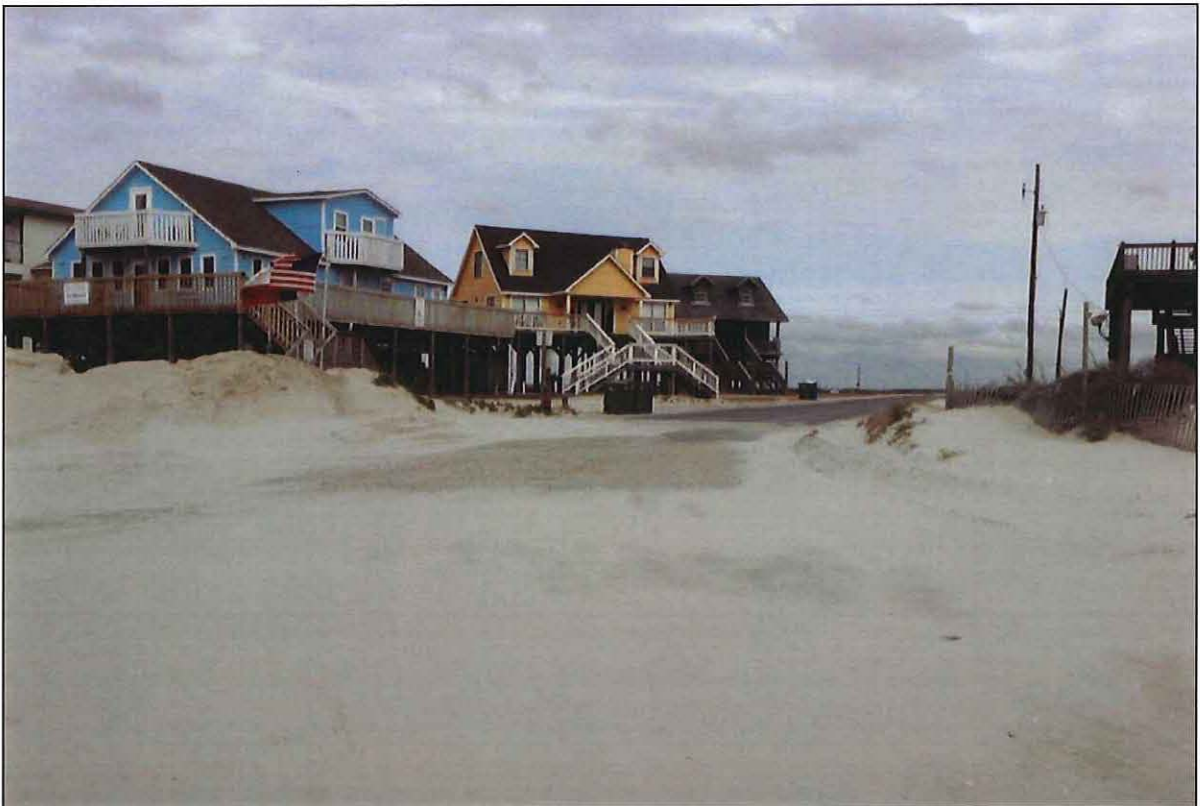
(X.) Brazoria County: Vehicle Beach Access – BA Point #1 at Seagull Drive. (DSCF0134.JPG)

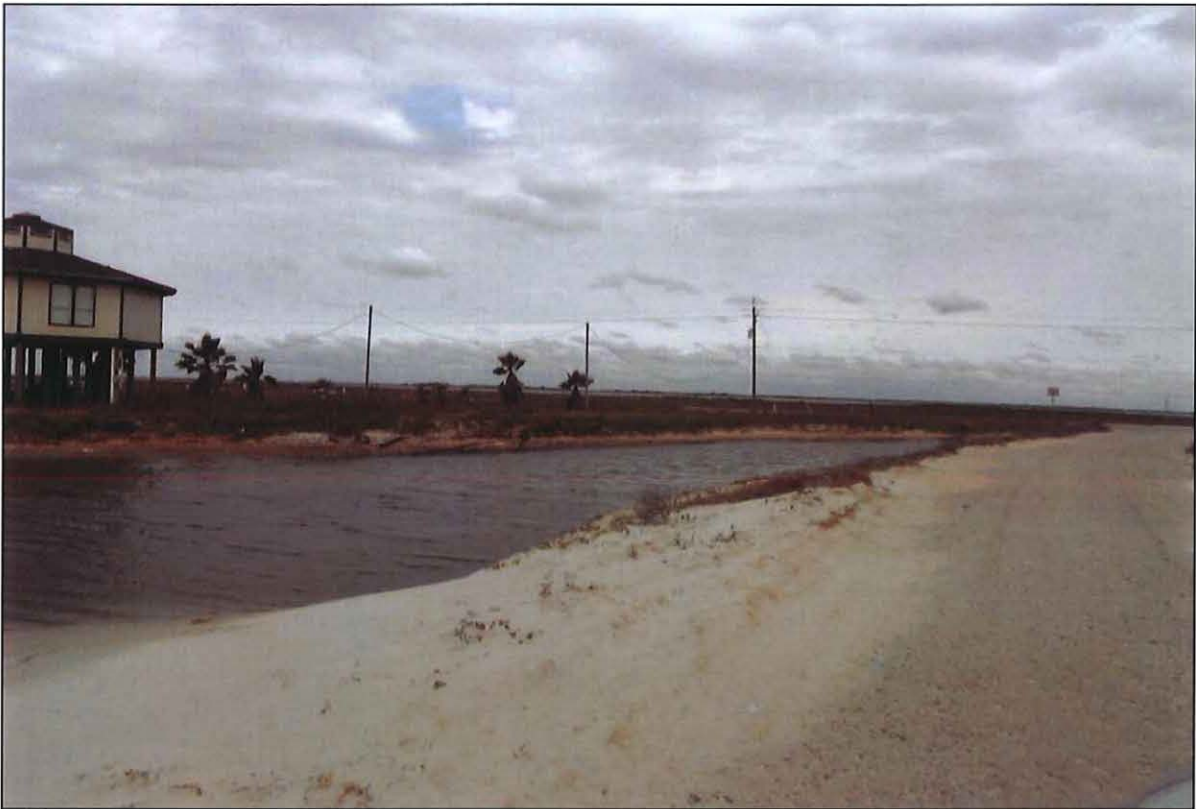
AA. Brazoria County: Vehicle Beach Access – BA Point #4 at Nacal Drive/257K. (DSCF0131.JPG)

There are seven vehicular beach access points and three pedestrian access points within the Brazoria County jurisdiction. Each of these access points were evaluated and is functioning properly. Based on the limitations of space and few alternatives available for protection, these access points are optimally placed to minimize their damage from erosion and storm surge; however, Beach Access #1 and #3 will benefit from additional crushed limestone road base at the entrance to the beach and raising their elevation by 4 feet at the dune location will mitigate storm surge propagation. Beach Access #4 has deep scour holes on each side of the road caused by Hurricane Ike. These scour holes

should be filled and stabilized with vegetation to improve safety to vehicles entering the beach through this road. Vehicular Beach Access points 1-6 are perpendicular to the beach and could be realigned to reduce storm damage. However, changing the angle of the roads to the beach would require the purchase of private property and may impact the secondary dune at some of the locations. Therefore, raising the elevation of the roads at the dune location as stated is the best solution to reduce storm surge propagation.
