# TEXAS COASTWIDE EROSION RESPONSE PLAN

2013 Update

**Final Report to the Texas General Land Office**

**GLO Contract No. 14-148-000**

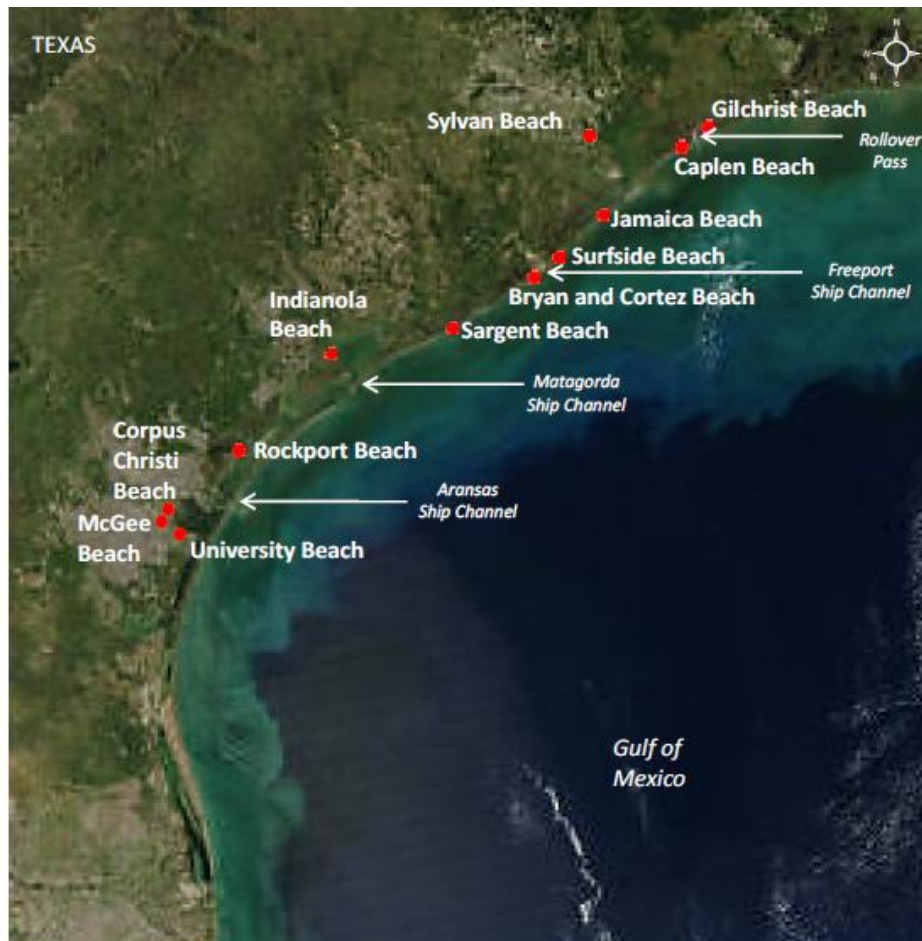
Figure 4. Shoreline monitoring locations at some CEPRAs beach nourishment projects (Williams, 2013).

The GLO established a *Beach Monitoring and Maintenance Plan* (BMMP) protocol for monitoring CEPRAs beach nourishment projects for FEMA reimbursement eligibility should the project be damaged by a federally-declared natural disaster. Twelve CEPRAs-funded projects are monitored by the Conrad Blucher Institute for Surveying and Science (CBI) under contract to the GLO (Williams, 2013). Figure 4 shows the specific locations along the Gulf and bay shorelines where baseline shoreline position and beach/nearshore profile surveys have been conducted since 2007 and will continue annually in an effort to monitor dry beach width and volumetric changes to determine beach nourishment longevity. The combination of aerial photography and datum-based beach profiling can be effective for small, easily accessible project areas. This process is time consuming but provides good datasets for determining the changes in beach nourishment volumes and also provides the necessary information for determining maintenance renourishment schedules. Recommendations for future nourishment cycles are based upon the performance of an individual project: the amount of sand within the project limits (less than 50% of the recommended width or targeted sand volume) and whether there is “wide-spread,” “accelerated,” or “hot spot” erosion that threatens dunes or backshore infrastructure in the project area. The recommended actions can include additional sand placement, relocation of existing sand accumulations, or planting vegetation. Monitoring results are reported by CBI annually to the GLO.

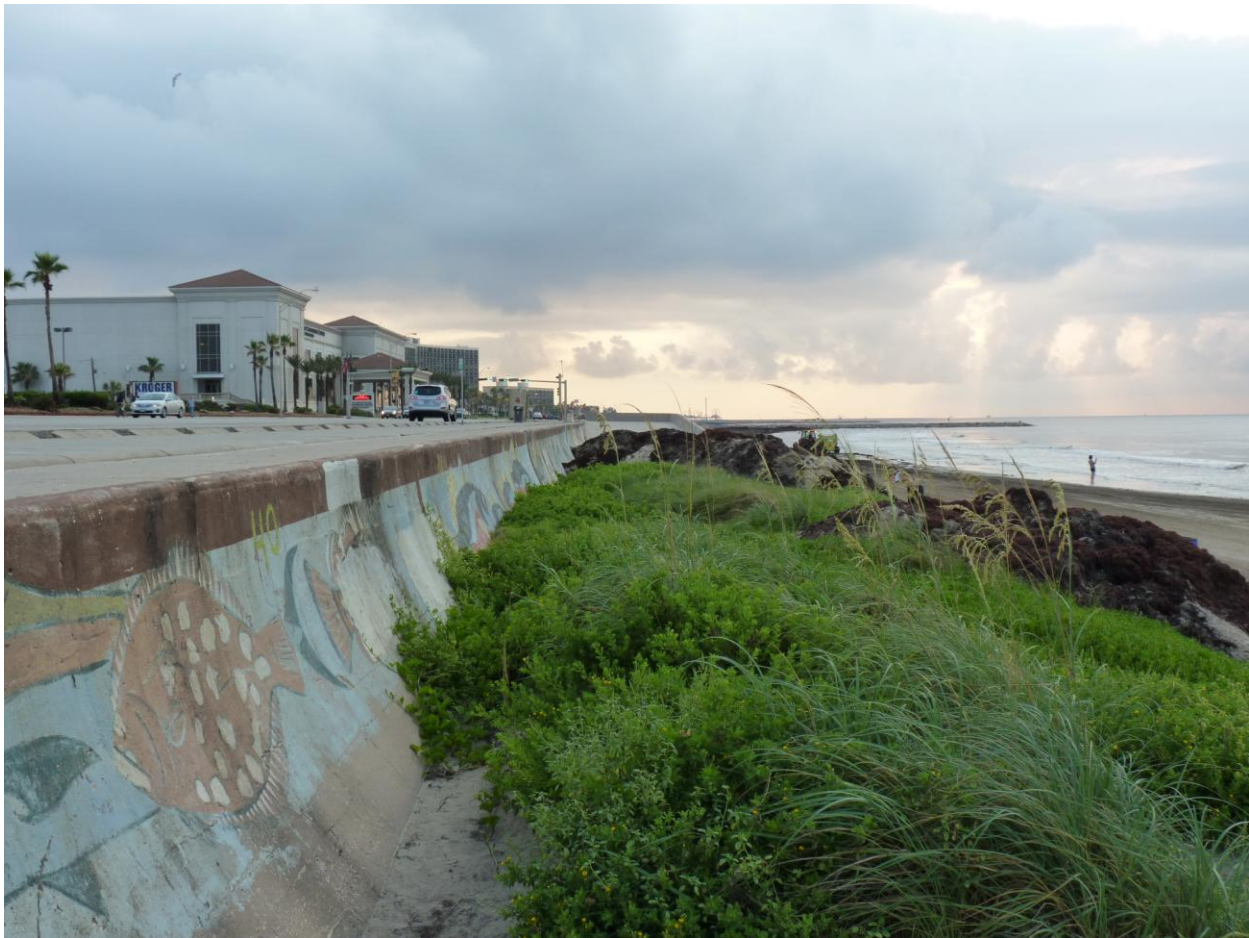
Figure 15. The beach, dunes and *Sargassam* mounds in front of the Galveston Seawall. (July 2014, view to the east)

Shoreline management has become more of a Park Board initiative on Galveston Island (Figure 15). The impact of the *Sargassam* deposits has been substantial to the Park Board at the beaches along the seawall. Stormwater drains at the base of the seawall have been clogged by overnight accumulations. Vehicular access for removing the large quantities of *Sargassam* can be difficult as the beach becomes too soft to support heavy equipment. In some instances, a person can sink several inches into the mix of soft sands and *Sargassam* (Galveston City Park Board of Trustees field supervisor, personal communication, 2014). On the beaches along the west end of the island, local citizen groups and homeowners' associations are taking on dune construction without the assistance of the City. The City Planning Commission has adopted best practices to authorize maintenance permits (e.g., removal of *Sargassam*) but does not monitor the efforts by local citizens or community groups.

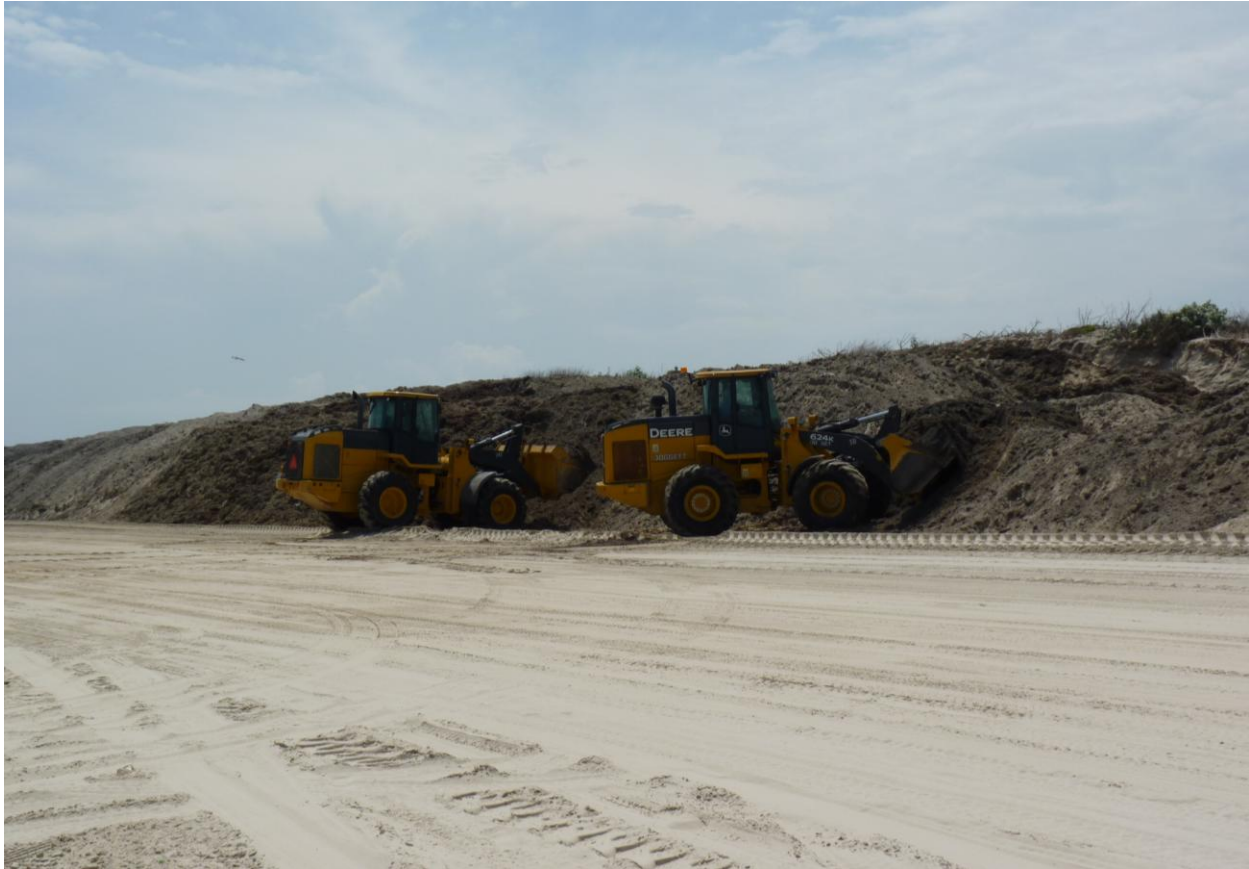
Figure 16. Beach maintenance crews “front-notching” dunes that were created from scraped *Sargassam* and sand and placed along the beach roadway. After the *Sargassam* disintegrates, the sand is placed back onto the beach. (July 2014, view to the west)

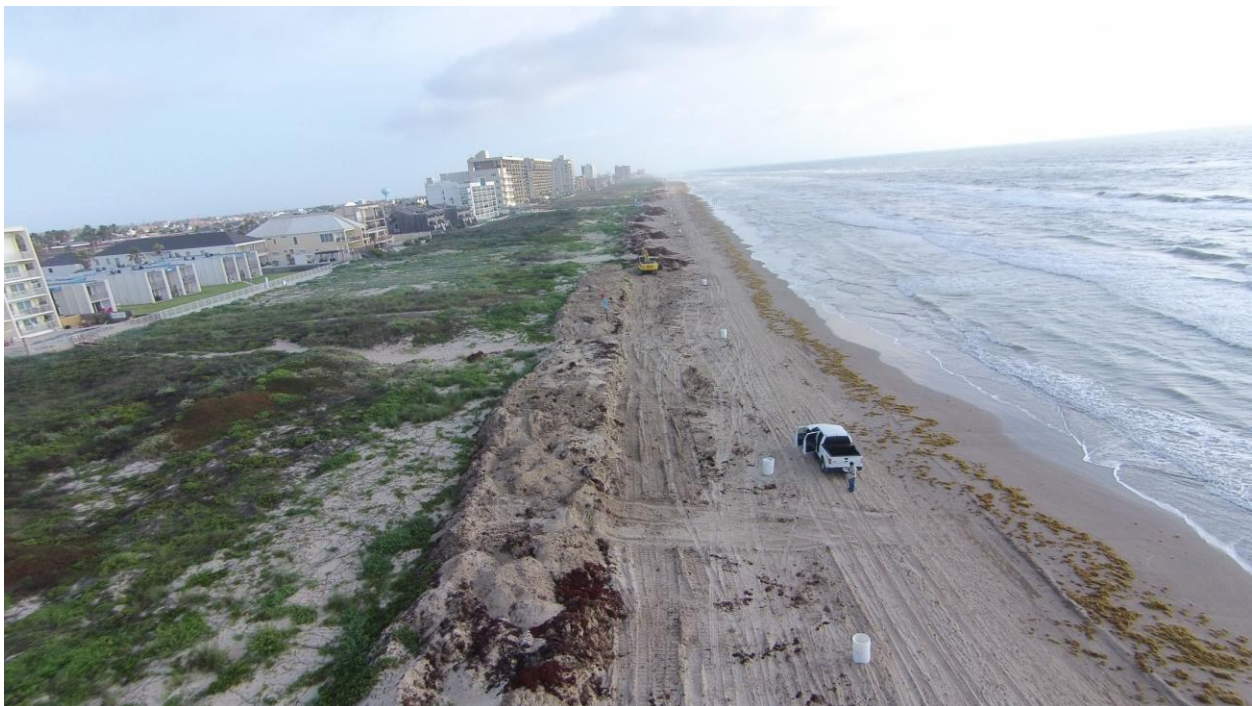
Figure 17. Beach, dune, and *Sargassam* management practices in South Padre Island. (photo courtesy R. Trevino, May 2014, view to north)

The City's beaches, dunes and washover areas are considered coastal natural resource areas that are threatened by erosion. Due to management and sand conservation efforts at the north end of town, some former washover areas now support dunes. The management of the *Sargassam* deposits has been an issue for the City and they have had to use excavators to remove the heavier amounts. The relocated *Sargassam* is placed in the dunes along the vegetation line and planted with sea oats by volunteers (Figure 17).
