FINAL REPORT

Texas High School Coastal Monitoring Program: 2018–2019

Tiffany L. Caudle

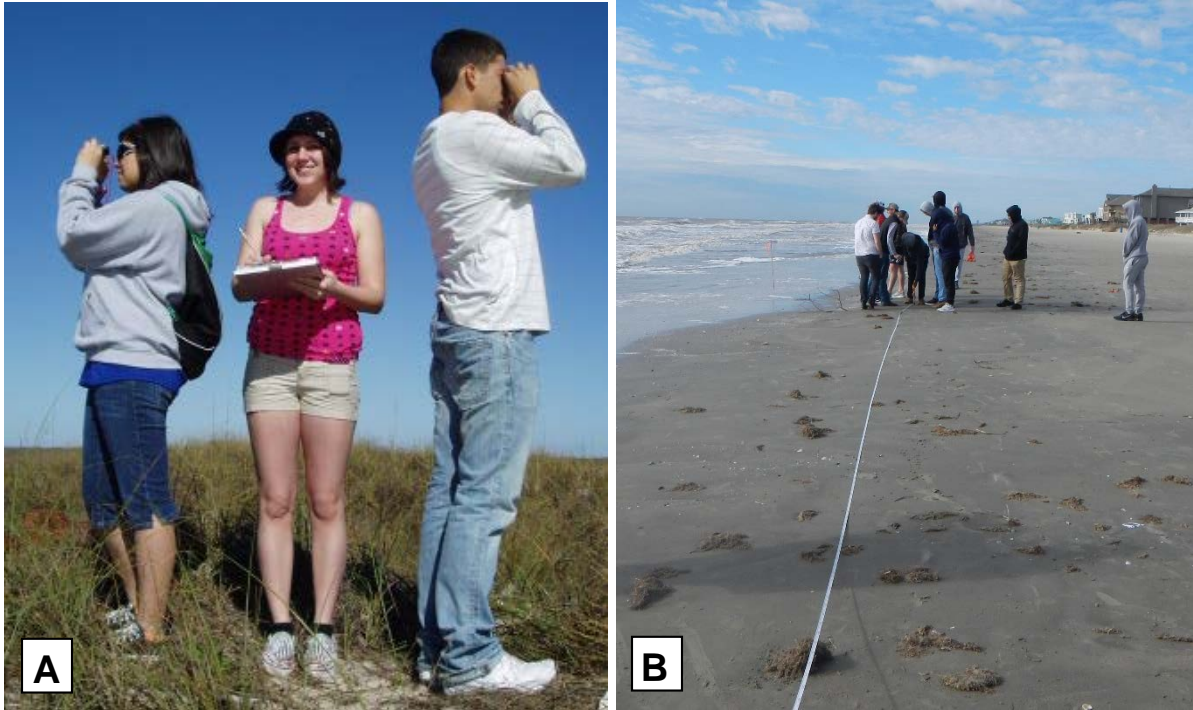
Figure 4. Students (A) using a sighting compass to measure dune orientation, and (B) measuring how far along the shoreline the float (an orange) drifted to determine longshore current.

(3) *Beach processes (fig. 4).* Students measure wind speed and direction, estimate the width of the surf zone, and observe breaker type. They note wave direction, height, and period and estimate longshore current speed and direction using a float, stopwatch, and tape measure. Students also take readings of shoreline and foredune orientation. From these measurements, they can infer relationships between physical processes and beach changes in time and space. Students also learn to obtain weather and oceanographic data from resources on the Internet.

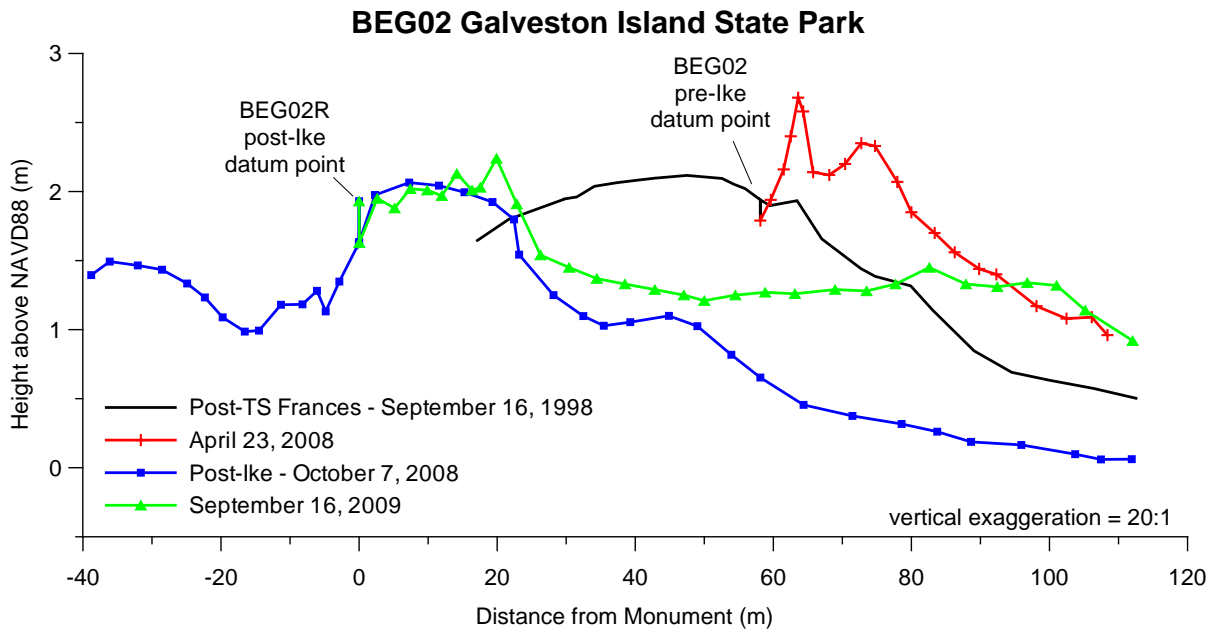
Figure 18. Beach-profile plots from BEG02 in Galveston Island State Park comparing the post-Hurricane Ike profile with a pre-storm profile from early 2008 and the post-Tropical Storm Frances profile from September 1998. Data from September 2009 (one-year post-storm) is also included.

Ball High School students from the 2007–2008 academic year provided extremely valuable pre-storm profile data on February 8, 2008, and April 23, 2008. These data have been used to determine how much the beach and dunes changed after Hurricane Ike. **Figure 18** is a profile plot at BEG02 comparing the Ball High School pre-storm profile (April 2008) with the post–Hurricane Ike profile measured on October 7, 2008. The post–Tropical Storm Frances profile from September 16, 1998, is also plotted for comparison. At Galveston Island State Park the dune system was completely destroyed; the shoreline (wet beach/dry beach boundary) moved 53 m landward between April 23, 2008, and October 7, 2008; the vegetation line moved 56 m landward; and the old datum point was 1.14 m above the post-storm surface of the beach (**fig. 18**, Caudle and Paine, 2017). Data from one-year post-storm is also included. This profile shows that the elevation of the beach had been restored, the beach width (dunes to waterline) has increased, and incipient dunes are beginning to form (**fig. 18**).

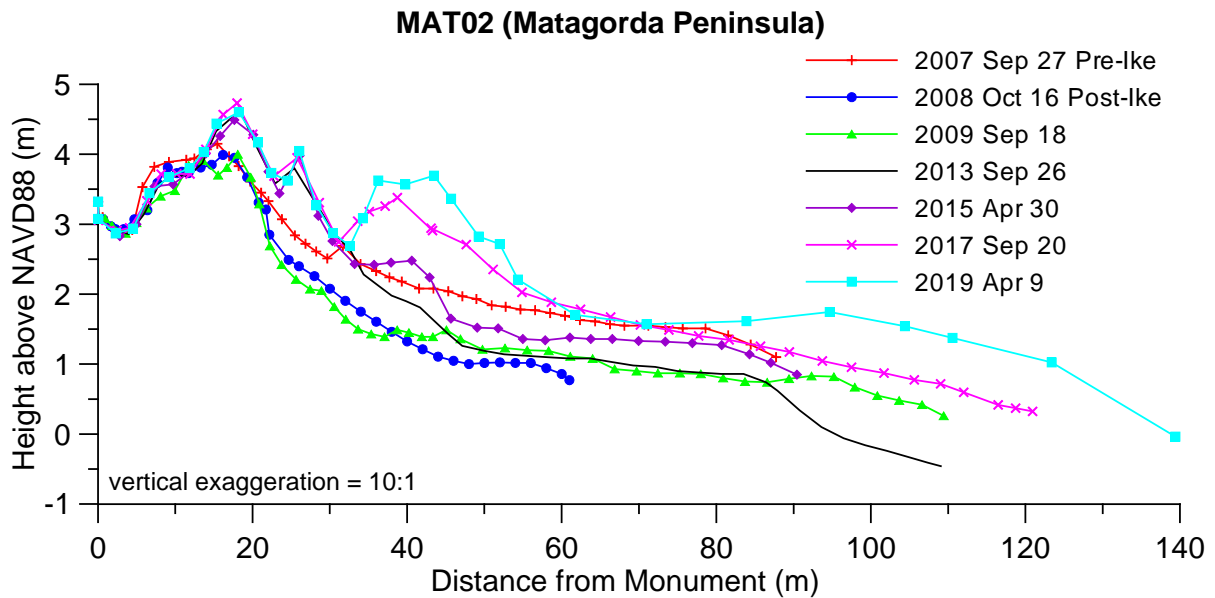
Figure 20. MAT02 pre- and post-Hurricane Ike profile data collected by Palacios High School students. Students are monitoring recovery of the foredune at this site.

Despite Ike being only a category 2 storm on the Saffir/Simpson scale (Simpson and Riehl, 1981) at the time of landfall, the sheer size of the hurricane caused impacts along the entire Texas coast. Dune erosion due to Hurricane Ike was documented on the middle Texas coast at Matagorda Peninsula and to a lesser extent on Mustang Island (see Appendix C). Van Vleck and Palacios High Schools students have been monitoring the recovery and growth of the dunes (**fig. 20**) and the

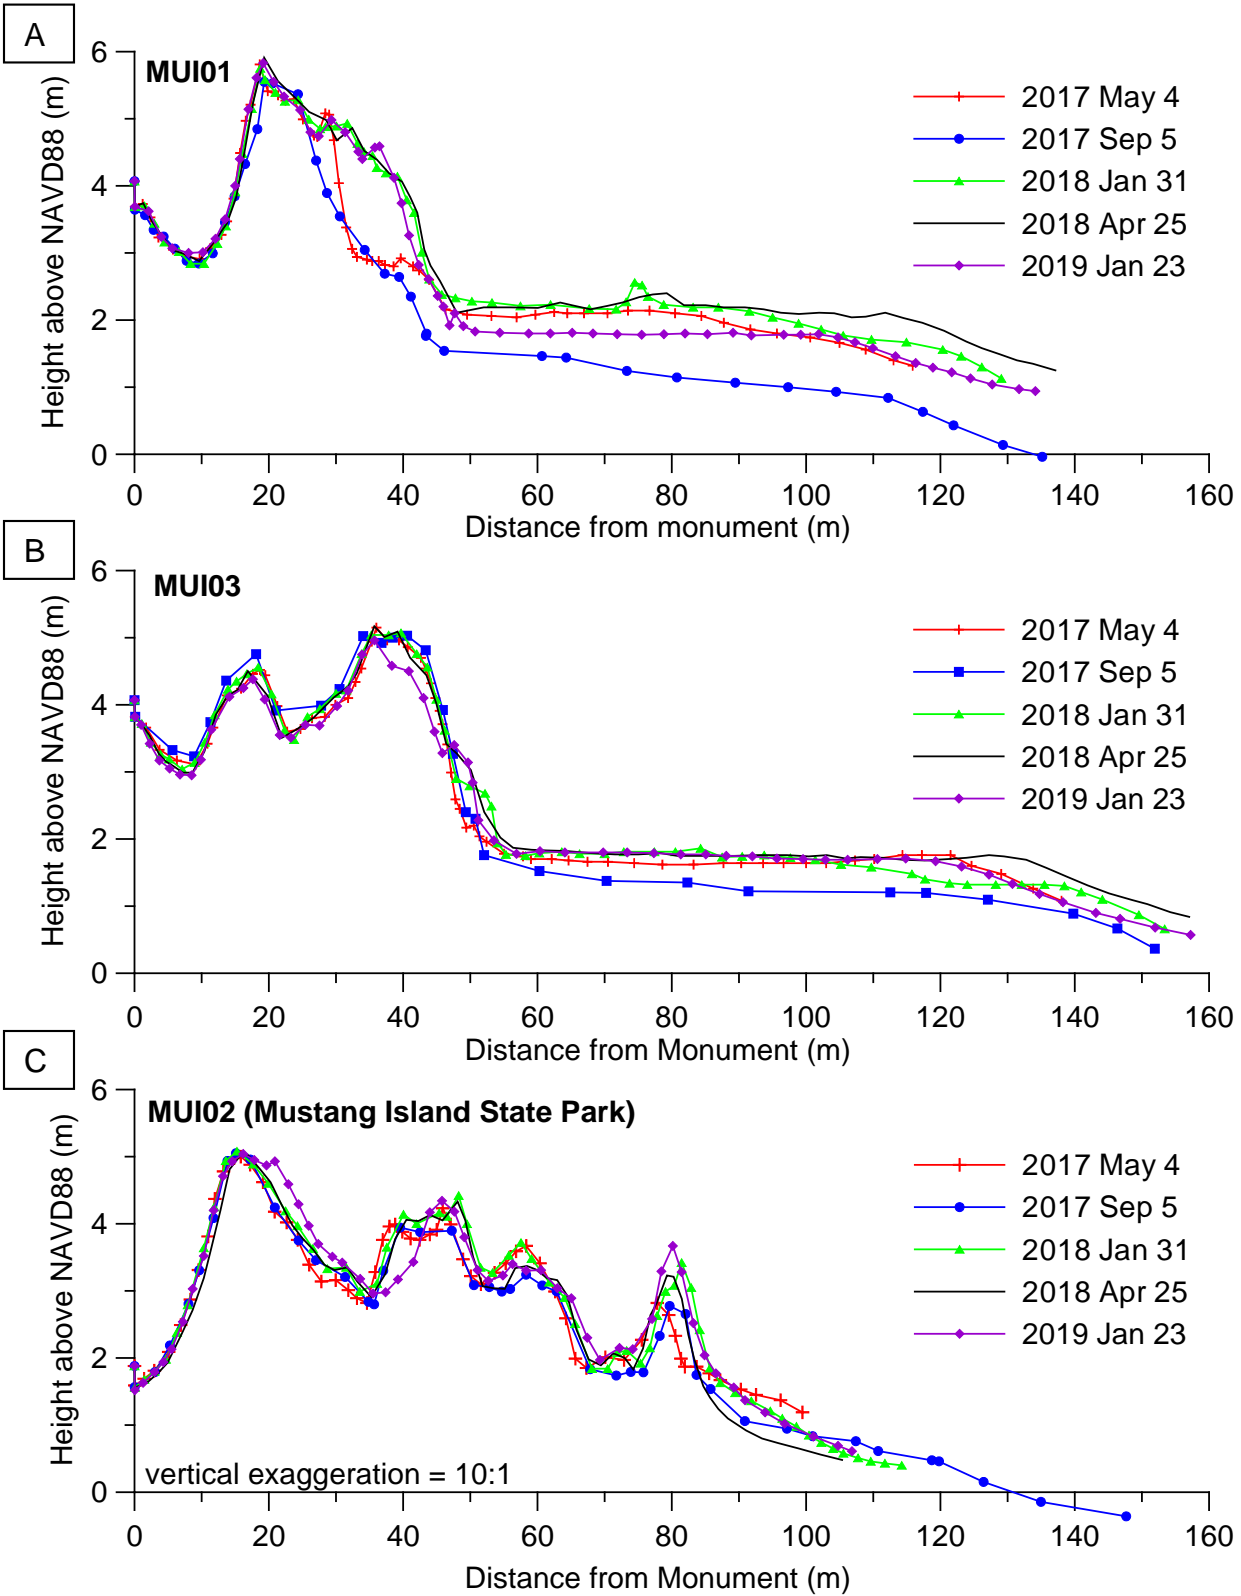
Figure 26. Mustang Island pre- and post-Hurricane Harvey profile data collected by Port Aransas High School and Texas A&M University Corpus Christi at (A) MUI01, (B) MUI03, and (C) MUI02.

Hurricane Harvey made landfall on San Jose Island (northeast of Mustang Island) on August 25, 2017 as a category 4 storm. The City of Port Aransas was devastated by impacts from a storm surge from the bay and Aransas Pass and wind and rain damage. The school remained closed for several weeks. Students and staff from the Harte Research Institute at Texas A&M University Corpus Christi collected post-storm profiles on September 5, 2017 which were compared to pre-storm profiles collected by Port Aransas High School students on May 4, 2017. Despite the proximity to the landfall of a major hurricane, the beach and dune system monitored by THSCMP suffered minor impacts. The Mustang Island beaches were planed (lowered) but there is no evidence of scarping on the dunes (**fig. 26**). The greatest impact to the Mustang Island beach was documented at MUJ01, the profile closest to the south jetty at Aransas Pass and center of the hurricane (**fig. 26A**). The beach recovered to pre-storm conditions at all three profile locations by January 2018 and the profile remained stable throughout the 2018–2019 academic year. Beach erosion and dune breeches are present on San Jose Island where Harvey made landfall but this area is not monitored by THSCMP students.

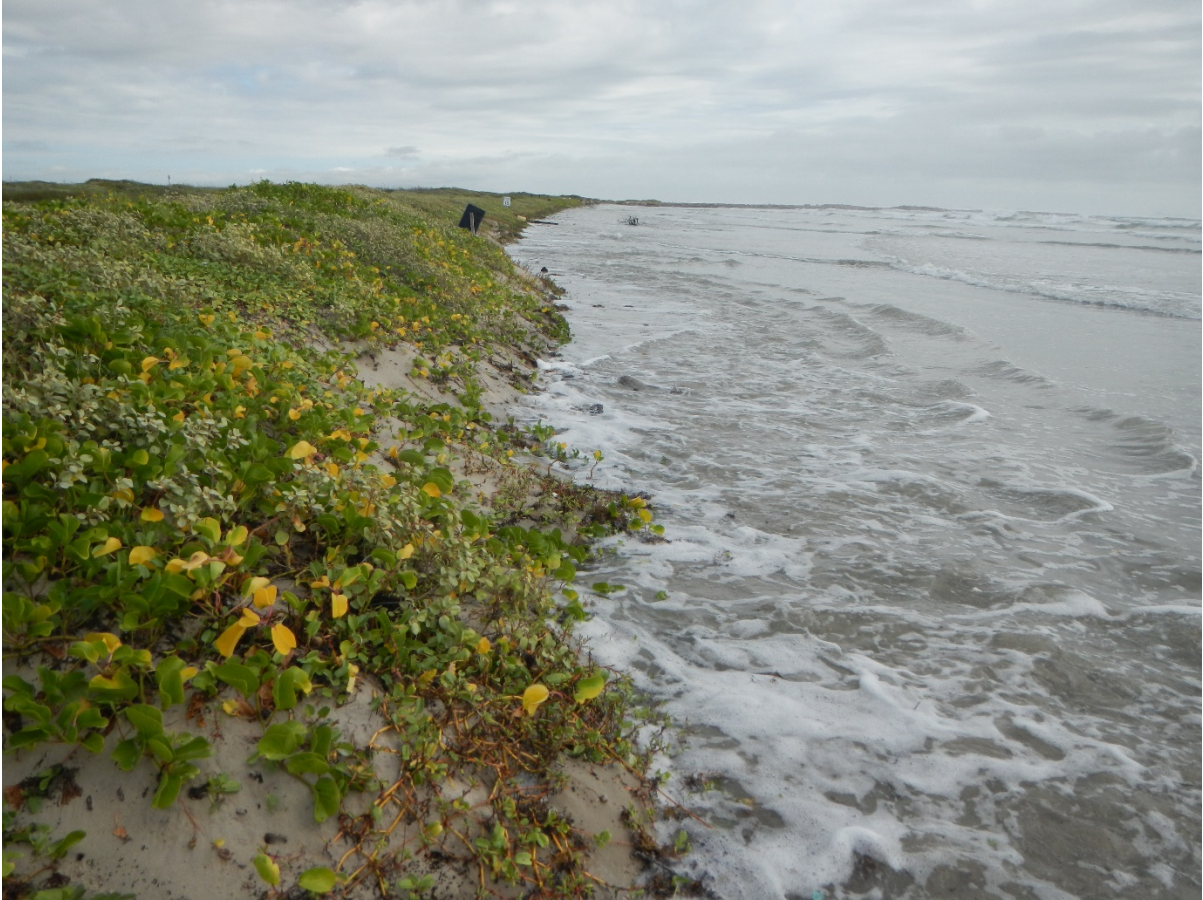
Figure 29. Elevated water levels at MUJ02 (Mustang Island State Park) due to Hurricane Michael in the eastern Gulf of Mexico, October 10, 2019.

Weather, high water levels, and construction activities created issues during field trips during the 2018–2019 academic year. Hurricane Michael in the eastern Gulf of Mexico created large waves and elevated water levels on the Texas coast in early October 2018 and impeded access to the beach and dunes on Mustang Island (**fig. 29**). Port Aransas students were unable to collect data during their October 10th field trip. Instead the students helped to collect kinematic GPS data for use to ground-truth airborne lidar data. Higher than normal water levels were observed during the spring 2019 field trips. This created shortened beach profiles and wet beach/dry beach boundaries at higher elevations. Road construction at the intersection of Highways 124 and 87 impeded access to the High Island High School monitoring site HIB01. We were unable to safely transport the students or park the bus at the High Island Beach access point. Isla Blanca Park, a Cameron County beach park on the southern tip of Padre Island, was undergoing renovation construction during the 2018–2019 academic year which impacted the SPI01 profile location monitored by Port Isabel High School students. The profile datum for SPI01 was located on the retaining wall adjacent to Sandpiper Pavilion in the park. The retaining wall was inaccessible due to the demolition of the old pavilion and construction of a new pavilion, restroom facility and beachside boardwalk (**fig. 30**). A new profile datum will be established along the SPI01 azimuth when field trips resume in the fall of 2019.

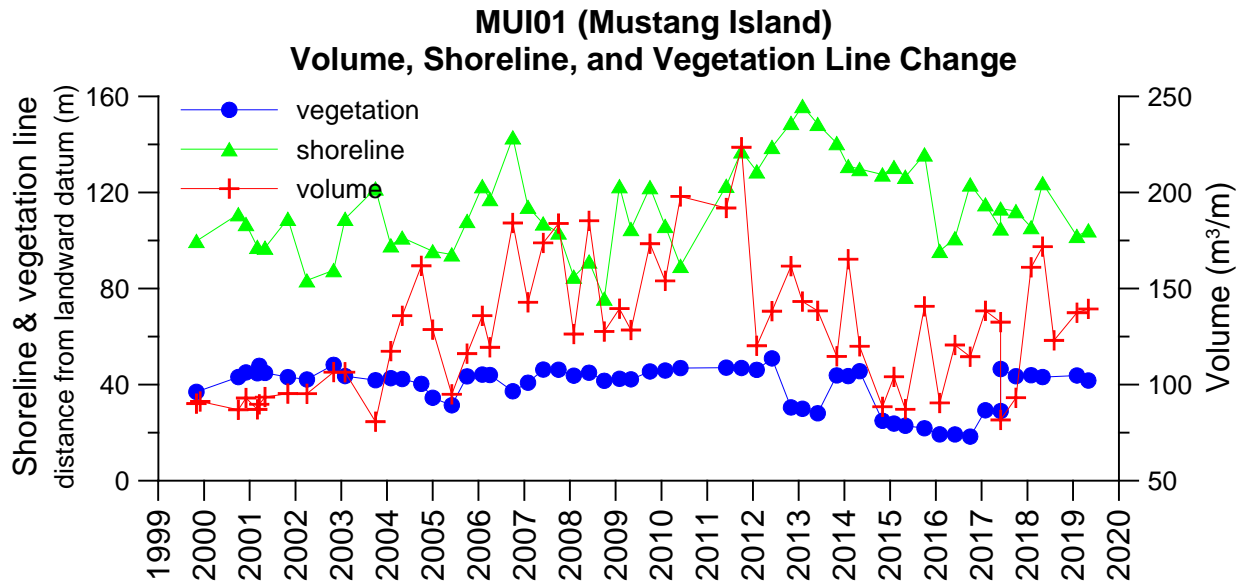
MUI01 volumes were calculated above 1.5 meters NAVD88. Profiles that did not extend below the 1.5 meter NAVD88 elevation were extrapolated.
