FINAL REPORT

Texas High School Coastal Monitoring Program: 2020–2021

September 2021

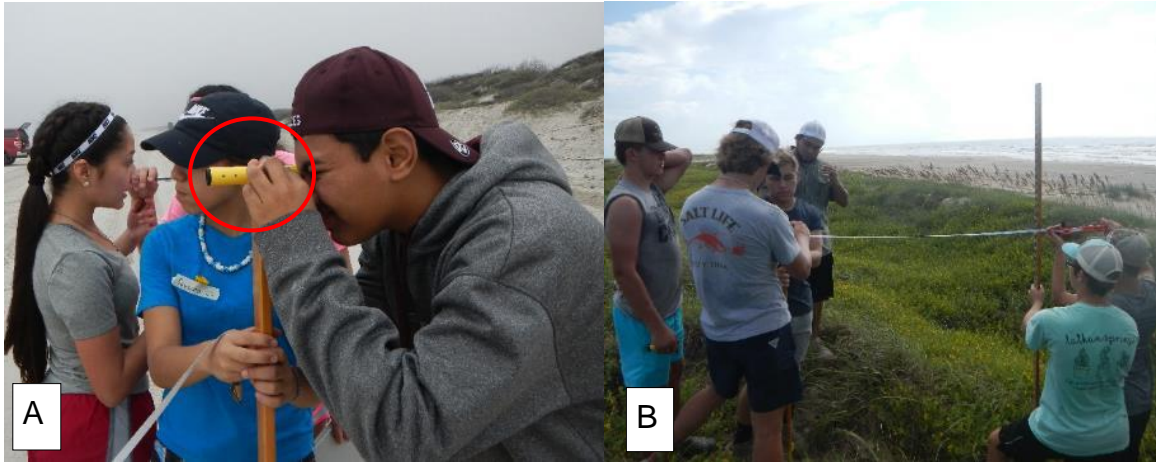
Figure 2. Students using (A) a sighting level to determine vertical offset between Emery rods and (B) a metric tape to measure horizontal distance.

Beach profile: Students use a pair of Emery rods, a metric tape, and a hand level to accurately survey a shore-normal beach profile from behind the foredunes to the waterline (**Fig. 2**; Emery, 1961; Krause, 2004; O'Connell, 2001). The students begin the profile at a pre-surveyed datum stake so that they can compare each new profile with earlier profiles. Consistently oriented photographs are taken with a digital

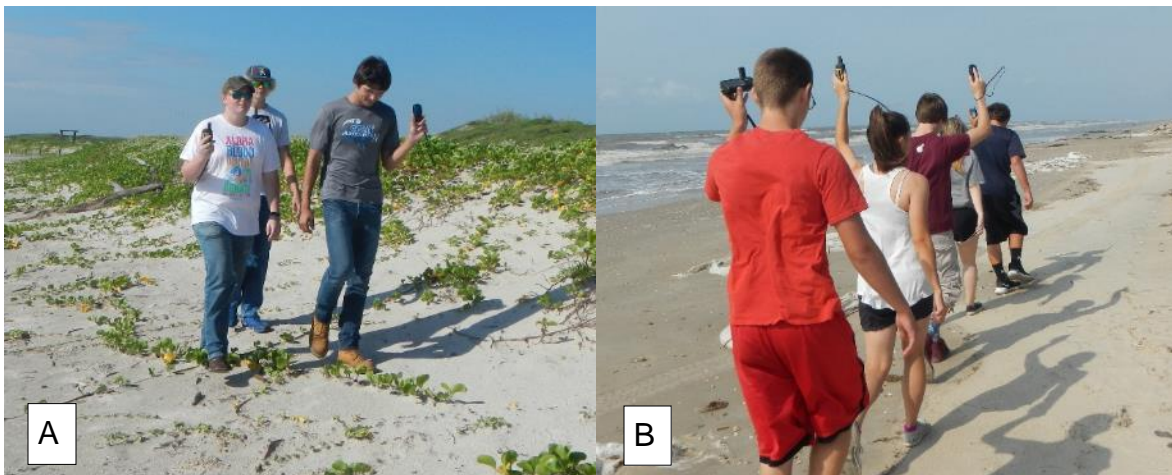
Figure 3. Students mapping (A) the vegetation line and (B) the shoreline (wet/dry line) using handheld GPS units.

Shoreline and vegetation-line mapping: Using handheld Global Positioning System (GPS) units, students walk along the shoreline and vegetation line, mapping these features for display on Geographic Information System (GIS) software (**Fig. 3**). GPS mapping can be used to measure the rates of change to these features. By comparing positions determined through GPS mapping over time, students are able to visualize shoreline and vegetation-line changes.

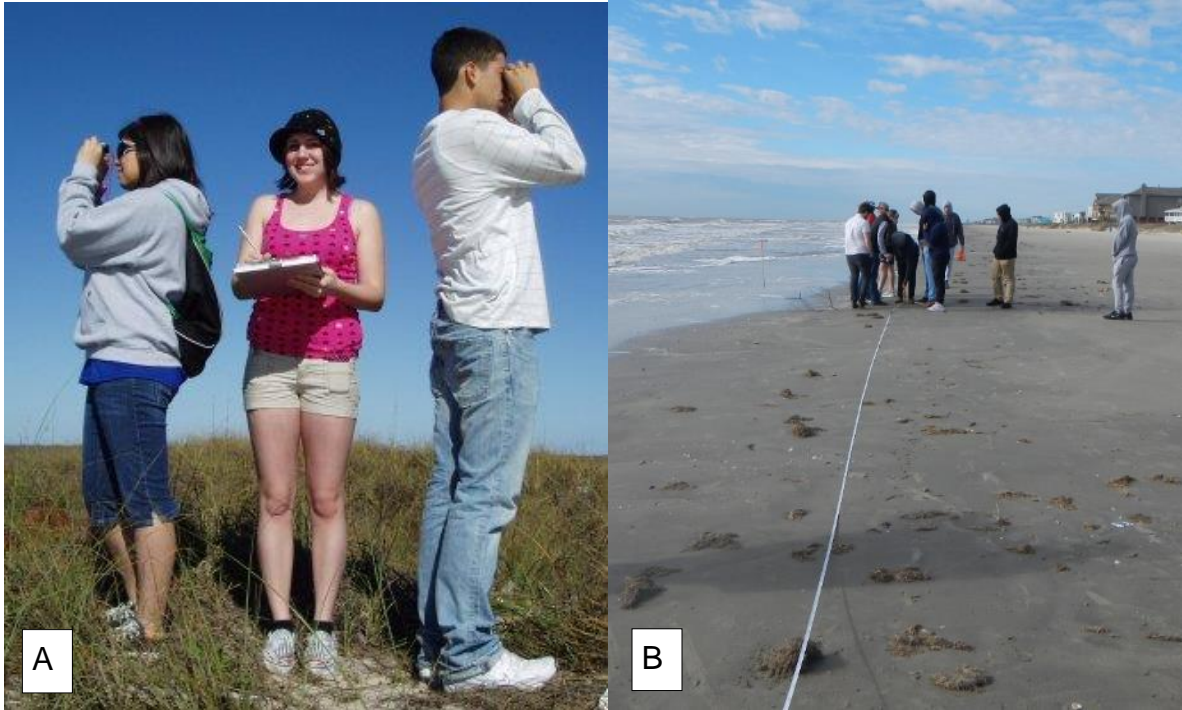
Figure 4. Students (A) using a sighting compass to measure dune orientation and (B) measuring how far along the shoreline the float (an orange) drifted to determine longshore current.

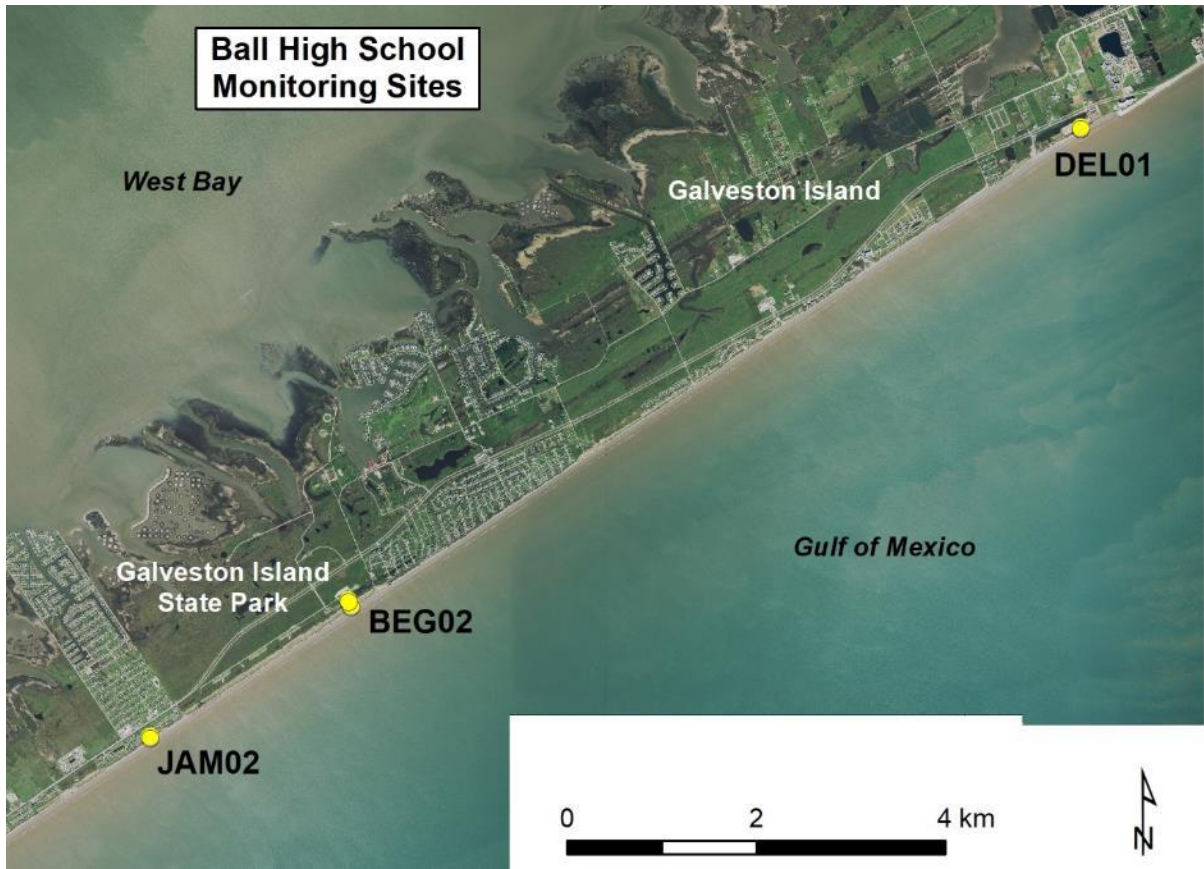
Figure 6. Location map of Ball High School monitoring sites.

Dr. Daniel Hochman’s Advanced Placement (AP) Environmental Science classes at Ball High School conduct surveys at site BEG02 in Galveston Island State Park (**Fig. 6**), a profile that the Bureau has been measuring since the 1980’s. Ball High School students also collect data at JAM02 in Jamaica Beach and DEL01 in the Dellanera RV Park (**Fig. 6**). Both of these sites monitor beach nourishment and Coastal Erosion Planning and Response Act (CEPRA) beach and dune restoration activities. GPS mapped shoreline positions are collected along the Babe’s Beach section of Galveston Island (west of 61st Street) as well. Bureau scientists collected data from the Ball High School sites on May 19, 2021.

THSCMP-collected data has played a large role in important Bureau studies. In one study, site BEG02 has been used by Bureau scientists to investigate the effects of geotextile tubes installed along the upper Texas coast. BEG02, located in Galveston Island State Park (**Fig. 6**), is adjacent to a subdivision where these erosion-control devices have been installed. The study compared beach width (distance from the vegetation line or dune base to the waterline) in front of the geotextile tubes versus at a natural beach area in the adjacent state park. Beach width in the natural beach area was observed to be wider than in the subdivision—45.7 m on average compared to 20.4 m in the subdivision (Gibeaut and others, 2003; **Fig. 12**). The natural area allowed for the landward migration of the dunes as the shoreline retreated, whereas the geotextile tube created a fixed dune line (Caudle and Paine, 2017).

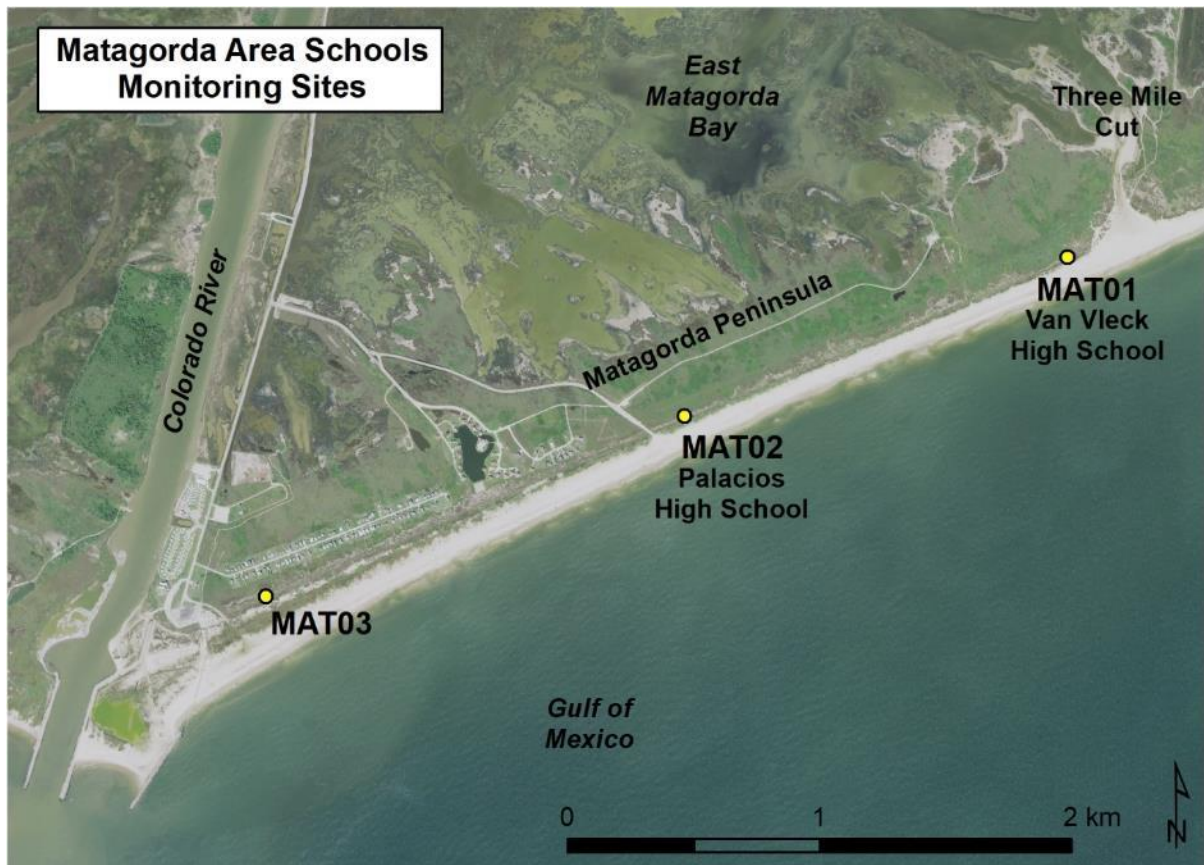
Figure 8. Location map of sites monitored by Matagorda-area schools.

Van Vleck High School from Sherry Martinez’s environmental science class collect data at MAT01 (**Fig. 8**). Science students from Palacios High School collect data at MAT02 (**Fig. 8**). A new teacher will be joining the program for the 2021–2022 academic year. The MAT03 profile location (**Fig. 8**) has seen a significant increase in beach width, including a coppice mound field with intermittent swales that usually contain water, marsh plants, and venomous snakes. It has become dangerous for students, teachers, and staff to collect profile data at this location without the proper protective gear. Though beach profile data is no longer collected at MAT03, Van Vleck and Palacios High Schools continue mapping via GPS of the shoreline and

Van Vleck High School students collect data at MAT01, which is adjacent to a washover channel—Three Mile Cut—that will occasionally open with the passage or landfall of a tropical storm or hurricane (**Fig. 8**). Students from Palacios High School collect data at MAT02, which is northeast of the vehicular beach access point on Matagorda Peninsula (**Fig. 8**). Hurricane Ike made landfall on Galveston Island on September 13, 2008, as a Category 2 hurricane. Owing to the size of the storm, impacts from this hurricane were seen along the entire Texas coast, including on Matagorda Peninsula. The storm surge from Hurricane Ike briefly opened Three Mile Cut and caused vegetation line retreat and dune erosion at MAT01 and MAT02. Over the decade since Ike's landfall, students from Van Vleck and Palacios High Schools have been monitoring the recovery and growth of the dunes (**Fig. 22**) and the seaward movement of the vegetation line (Appendix B) post-Hurricane Ike on Matagorda Peninsula.

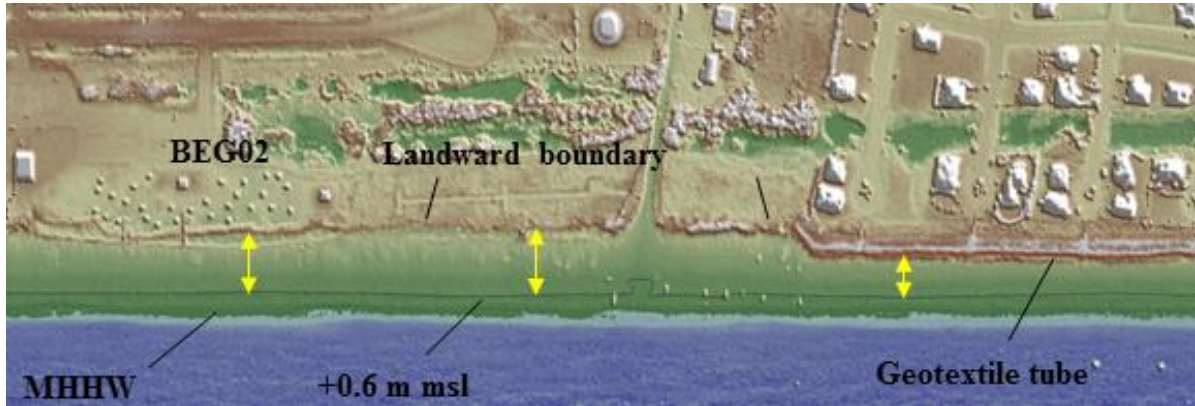
Figure 12. Lidar topographic-relief image of Galveston Island State Park and Pirates Beach subdivision. Note the difference in beach width between the natural beach and the area in front of the subdivision. From Gibeaut and others (2003).

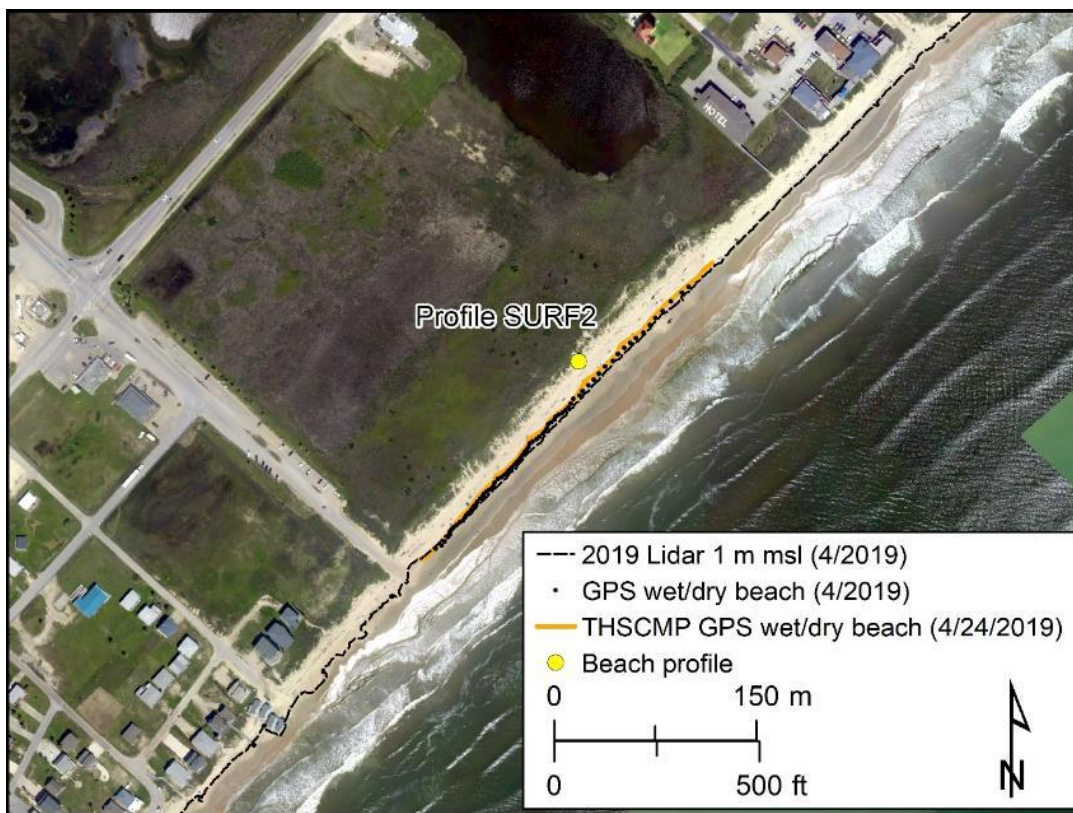
Figure 14. Shoreline position comparison at Surfside Beach site SURF2. Shorelines include the wet-beach/dry-beach boundary mapped on April 24, 2019, by THSCMP students and Bureau staff using ground GPS and the 1 m (3.3 ft) above mean sea level shoreline proxy extracted from airborne lidar data acquired in spring 2019, superimposed on 2019 Bureau imagery. From Paine and others (2021).

The long-term rates of Gulf shoreline movement along the Texas coast have been updated through 2019. The shoreline position extracted from 2019 lidar data was verified by visually comparing the shoreline proxy contour elevation with the wet-beach/dry-beach boundary as shown on georeferenced 2016 and 2018 NAIP aerial photographs and imagery acquired during the airborne survey. We used beach profiles and GPS-mapped shorelines acquired by the THSCMP near the dates of the lidar survey to compare the observed wet- and dry-beach positions. The Surfside Beach profile site SURF2 on Follets Island (**Fig. 14**; Paine and others, 2021) is representative of data comparison all along the Texas coast. At this site, there is excellent positional agreement between the 2019 lidar-derived shoreline proxy; the wet-beach/dry-beach boundary mapped on April 24, 2019, by THSCMP participants and Bureau staff; 2018 NAIP imagery, and 2019 aerial imagery.

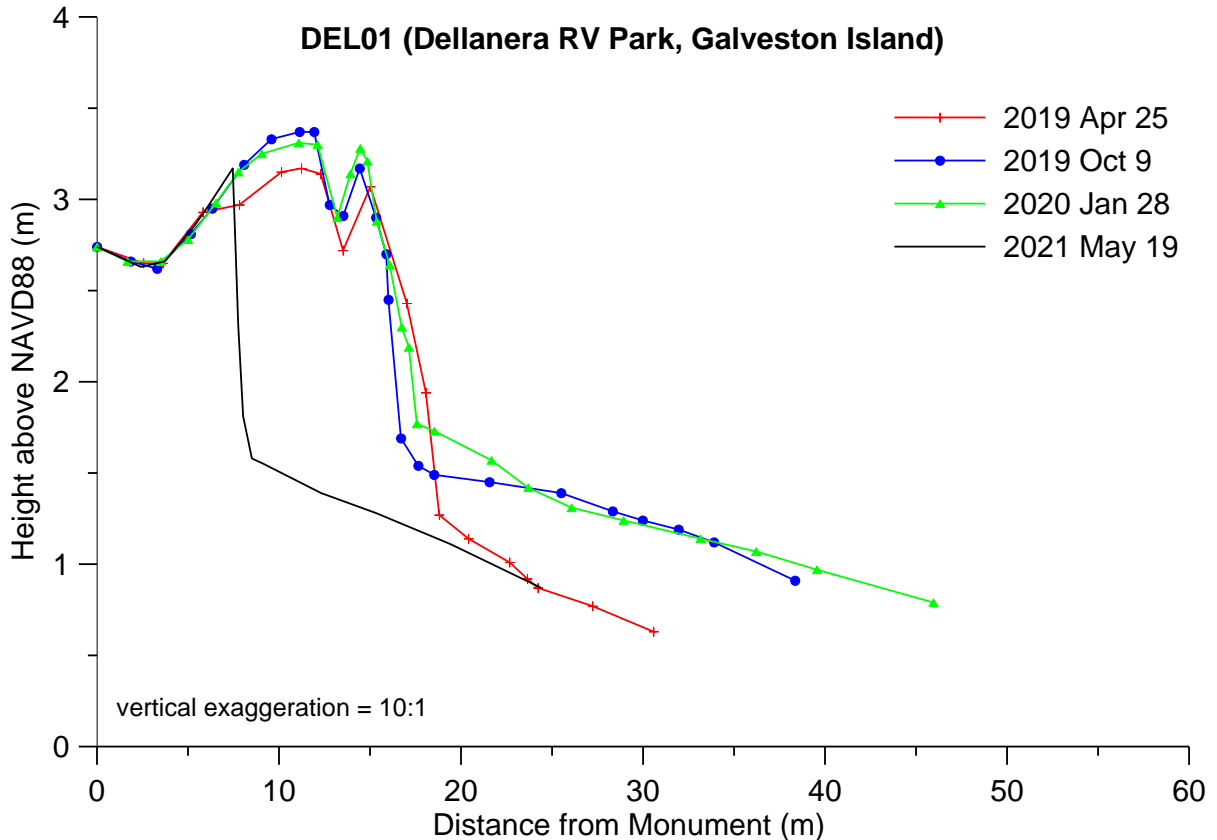
Figure 20. Erosion of the dune at DEL01 in the Dellanera RV Park due to the 2020 hurricane season.

Hurricane Harvey in 2017 had minimal impacts to the beach and dune system on Galveston Island but the 2020 hurricane season did cause beach and dune erosion. At Galveston Island State Park, the beach was eroded landward and overwash was deposited in the coppice dune area (**Fig. 19**). Site DEL01 at the Dellanera RV Park (**Fig. 5**), experienced significant changes to the reconstructed dune (**Fig. 20**).

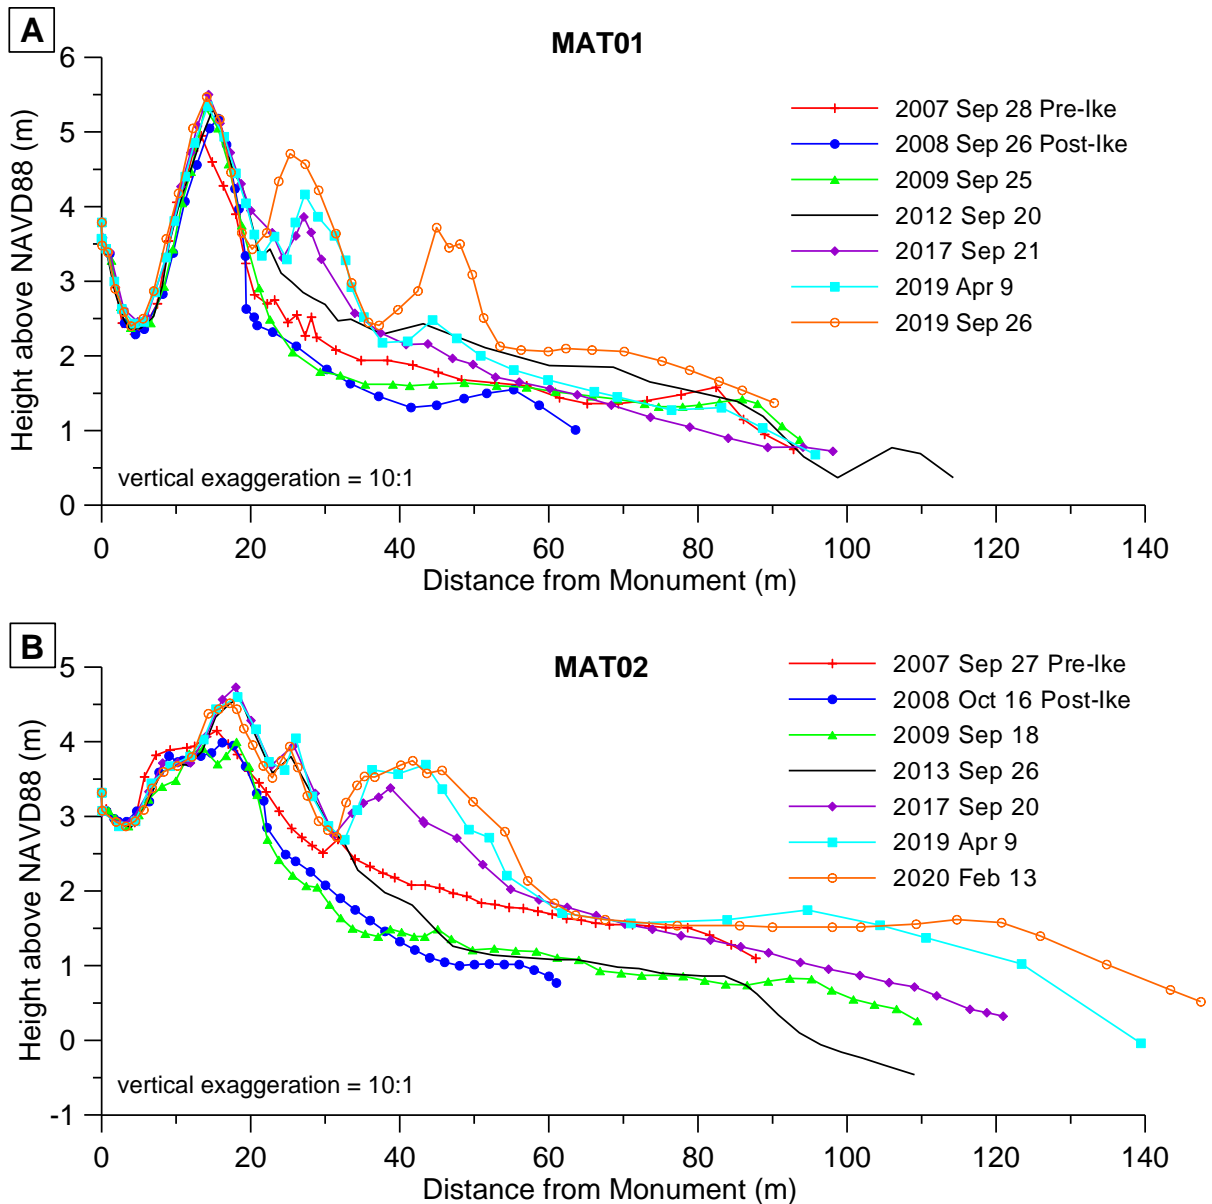
Figure 22. Pre- and post-Hurricane Ike profile data collected by Van Vleck High School students at (A) MAT01 and Palacios High School students at (B) MAT02. Students are monitoring recovery and growth of the foredune at these sites.

Palacios and Van Vleck students measure beaches adjacent to Matagorda Bay Nature Park, which have two special circumstances that make this monitoring especially informative and important: (1) the sites are on the updrift side of the jetty at the mouth of the Colorado River and (2) these sites allow students to compare a beach/dune system where vehicular traffic on the beach is limited (MAT03) with an adjacent area where vehicular traffic is unrestricted (MAT01 and MAT02). Information on impacts of coastal structures (jetties) is critical to coastal management, and impacts of vehicles on Texas' beaches are not well documented. Vehicular traffic was permitted on the beach adjacent to the Nature Park until 2007. Vehicular traffic was restricted in the section closest to the park for several years. Currently, vehicles are able to access this section of beach, but traffic is very limited because of difficult driving conditions.

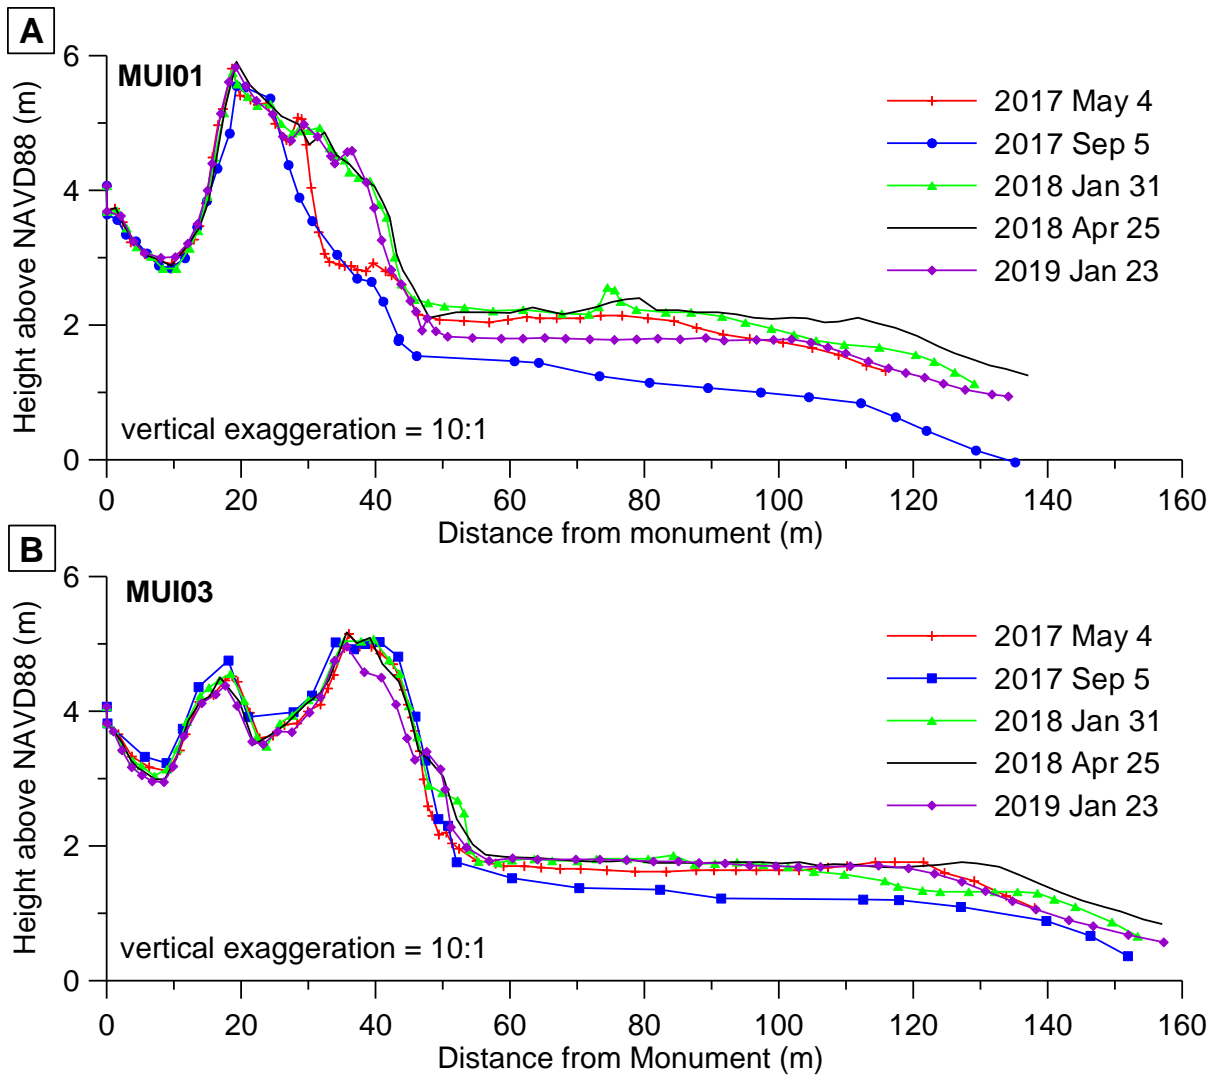
Figure 28. Mustang Island pre- and post-Hurricane Harvey profile data collected by Port Aransas High School and Texas A&M University-Corpus Christi at (A) MUI01 and (B) MUI03.

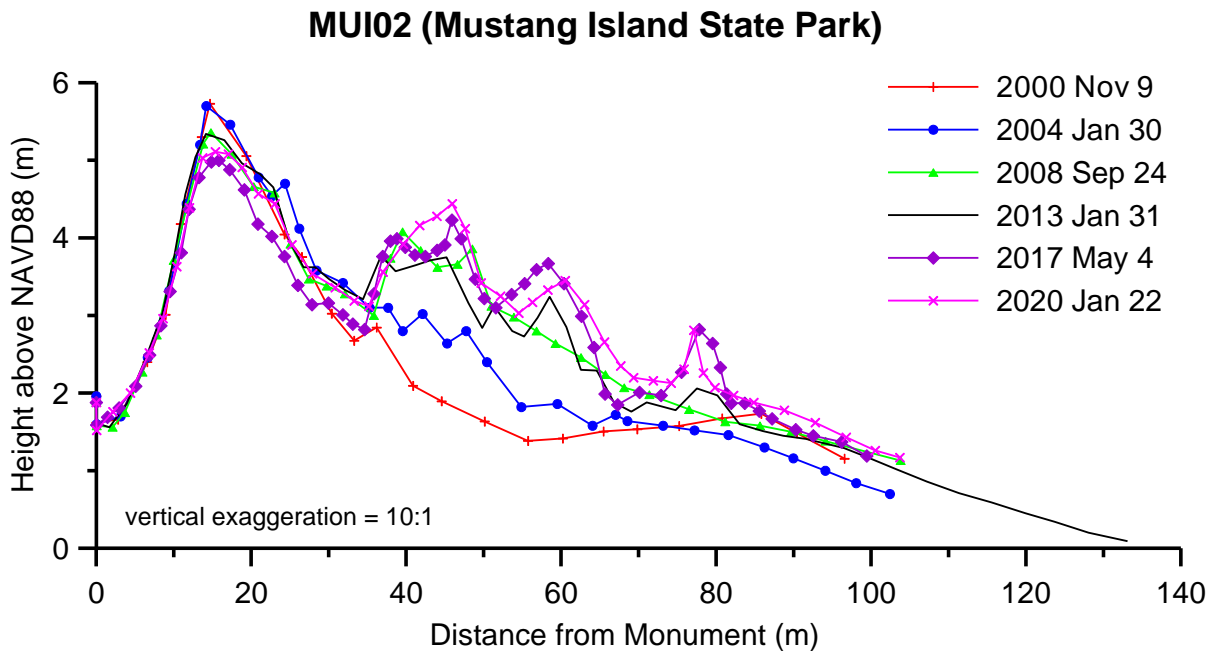
Figure 29. Student monitoring at MUI02 documents an increase in volume of the dune system and seaward migration of the vegetation line.

The MUI02 monitoring site is located within Mustang Island State Park, just to the south of Fish Pass. This site has seen significant changes since student monitoring began in 2000. Port Aransas students have documented several lines of coppice dunes forming and coalescing into continuous dune ridges (**Fig. 29**). The dune system and vegetation-line position have expanded seaward, and total profile volume has increased at this location (Appendix B). The shoreline position has remained stable throughout the monitoring program. The increased dune width and stable shoreline position have caused the beach width (distance between vegetation line and shoreline) to decrease. Minimal beach maintenance is performed within the state park boundaries, mainly to keep the beach access points open.

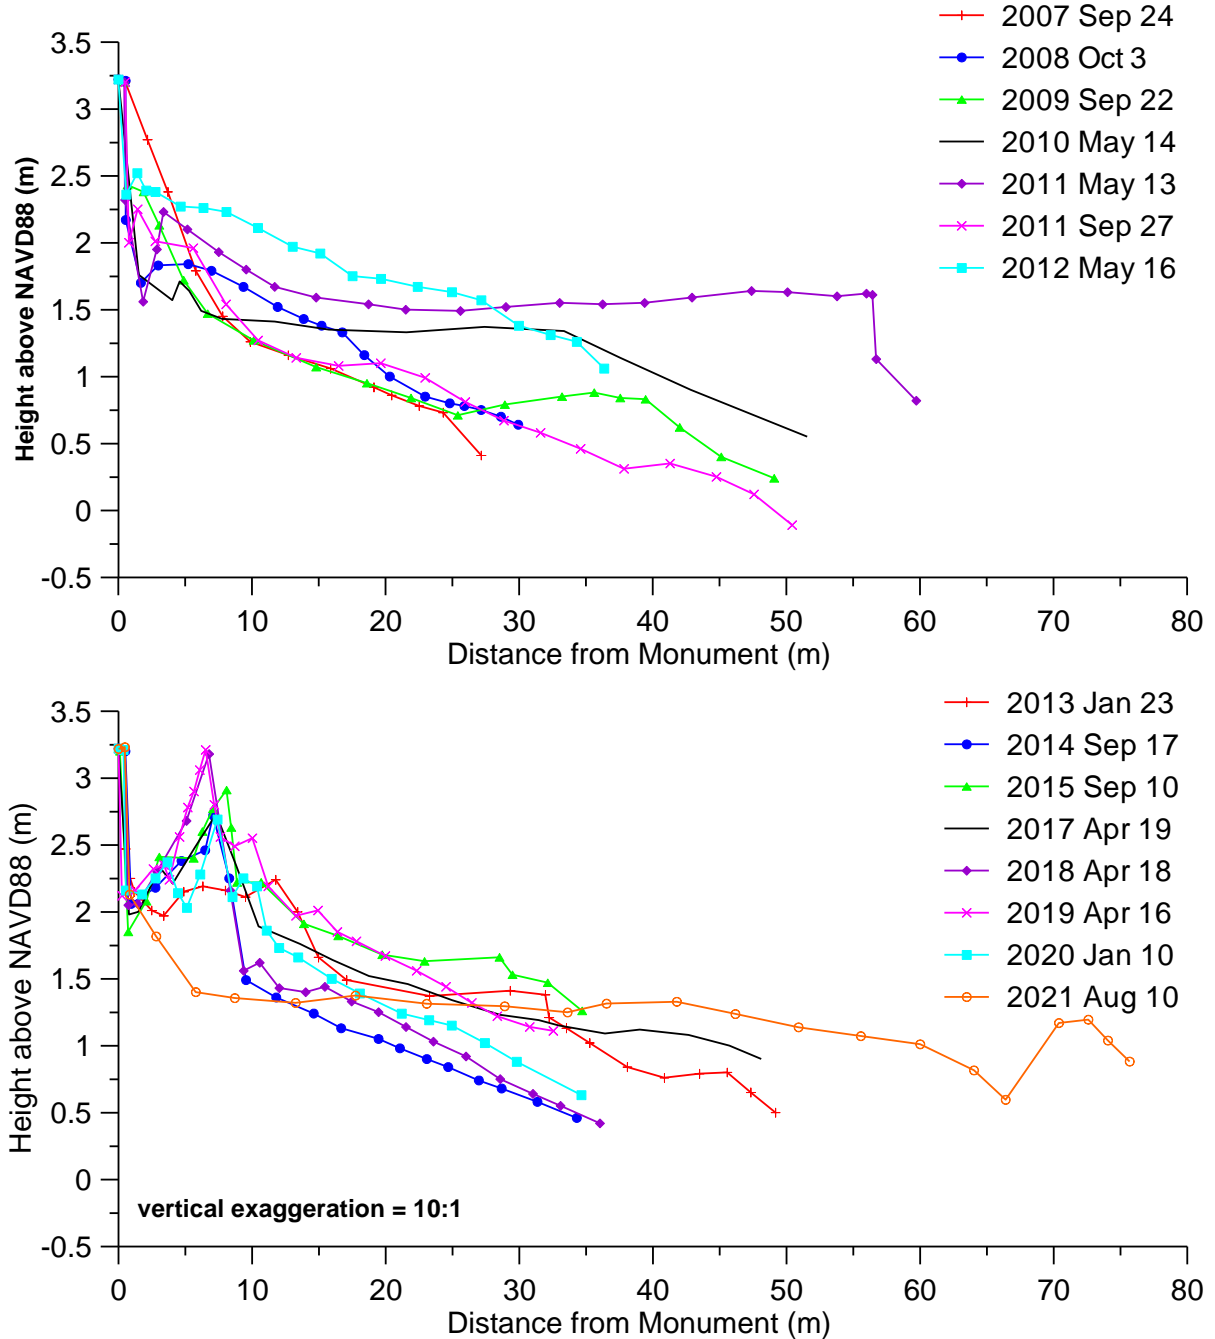
SPI08 (South Padre Island)

Figure 32. Sand volume and shoreline position changes at SPI08 on South Padre Island due to beach nourishment projects and the installation of sand fences.
