FINAL REPORT

Texas High School Coastal Monitoring Program: 2021-2022

Bureau of Economic Geology

August 2022

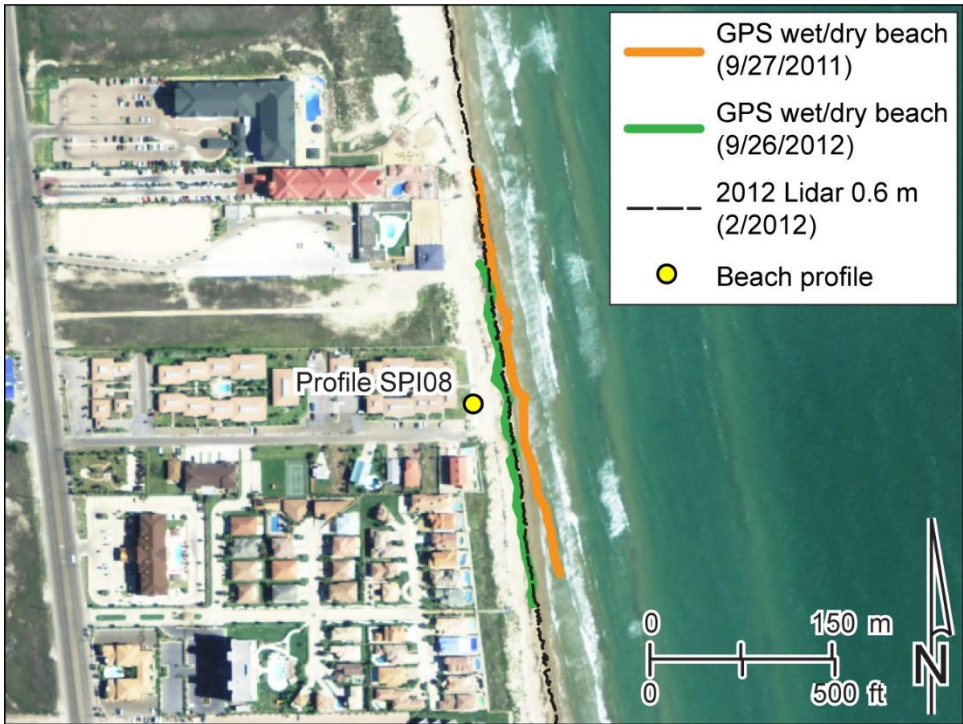
Figure 13. Shoreline position comparison at South Padre Island site SPI08. Shorelines include the wet-beach/dry-beach boundary mapped on September 27, 2011, and September 26, 2012, by THSCMP students using GPS and the shoreline proxy extracted from airborne lidar data acquired in February 2012. Shorelines are superimposed on NAIP imagery acquired on April 23, 2012. From Paine and other (2014).

The long-term rates of Gulf shoreline movement along the Texas coast have been updated through 2019. The shoreline position extracted from 2019 lidar data was verified by visually comparing the shoreline proxy contour elevation with the wet-beach/dry-beach boundary as shown on georeferenced 2016 and 2018 NAIP aerial photographs and imagery acquired during the airborne survey. We used beach profiles and GPS-mapped shorelines acquired by the THSCMP near the dates of the lidar survey to compare the observed wet- and dry-beach positions. The Surfside Beach profile site SURF2 on Follets Island (**Fig. 14**; Paine and others, 2021) is representative of data comparison all along the Texas coast. At this site, there is excellent positional agreement between the 2019 lidar-derived shoreline proxy; the wet-beach/dry-beach boundary mapped on April 24, 2019, by THSCMP participants and Bureau staff; 2018 NAIP imagery, and 2019 aerial imagery.

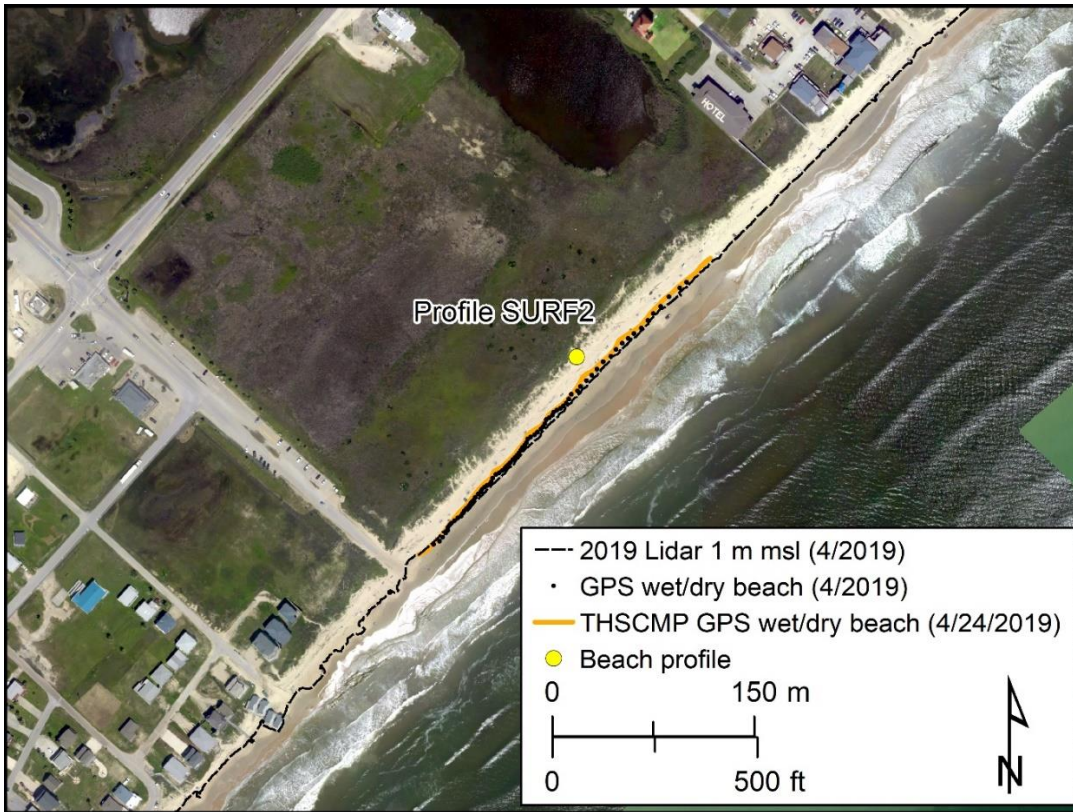
Figure 14. Shoreline position comparison at Surfside Beach site SURF2. Shorelines include the wet-beach/dry-beach boundary mapped on April 24, 2019, by THSCMP students and Bureau staff using ground GPS and the 1 m (3.3 ft) above mean sea level shoreline proxy extracted from airborne lidar data acquired in spring 2019, superimposed on 2019 Bureau imagery. From Paine and others (2021).
