Nueces Bay Portland Causeway Marsh Restoration CMP Cycle 15 Final Report

August 29, 2012

COASTAL BEND BAYS & ESTUARIES PROGRAM**PORTLAND CAUSEWAY MARSH RESTORATION (DREDGING)****SITE VISIT / CONSTRUCTION STATUS REPORT**

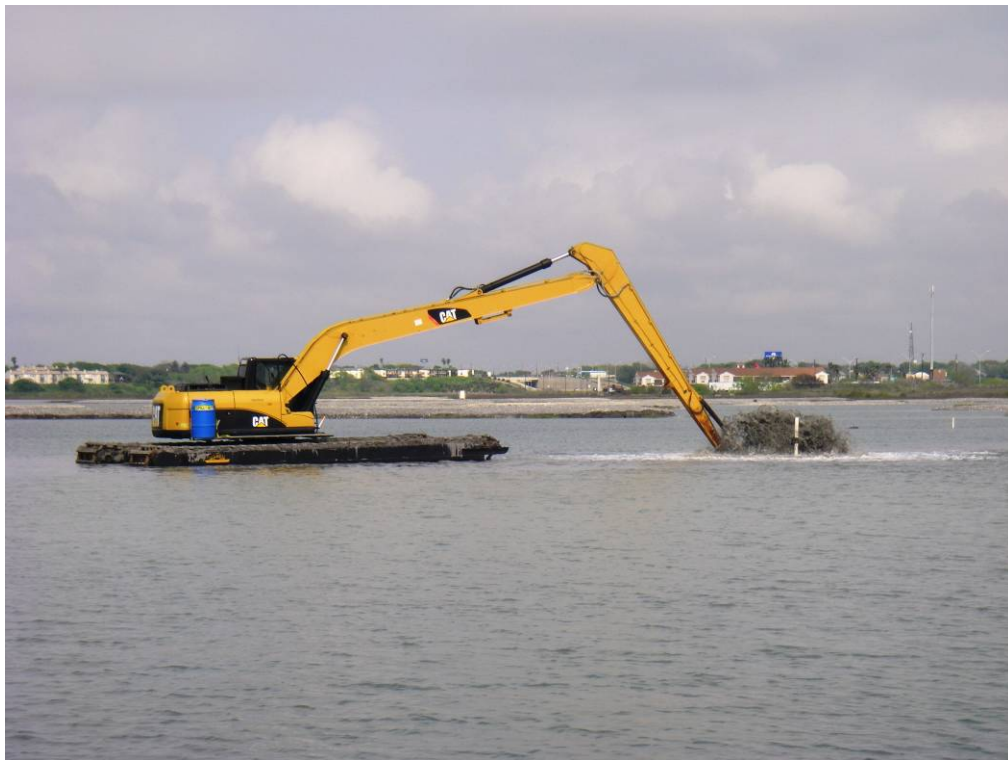
Pumping mound M11.

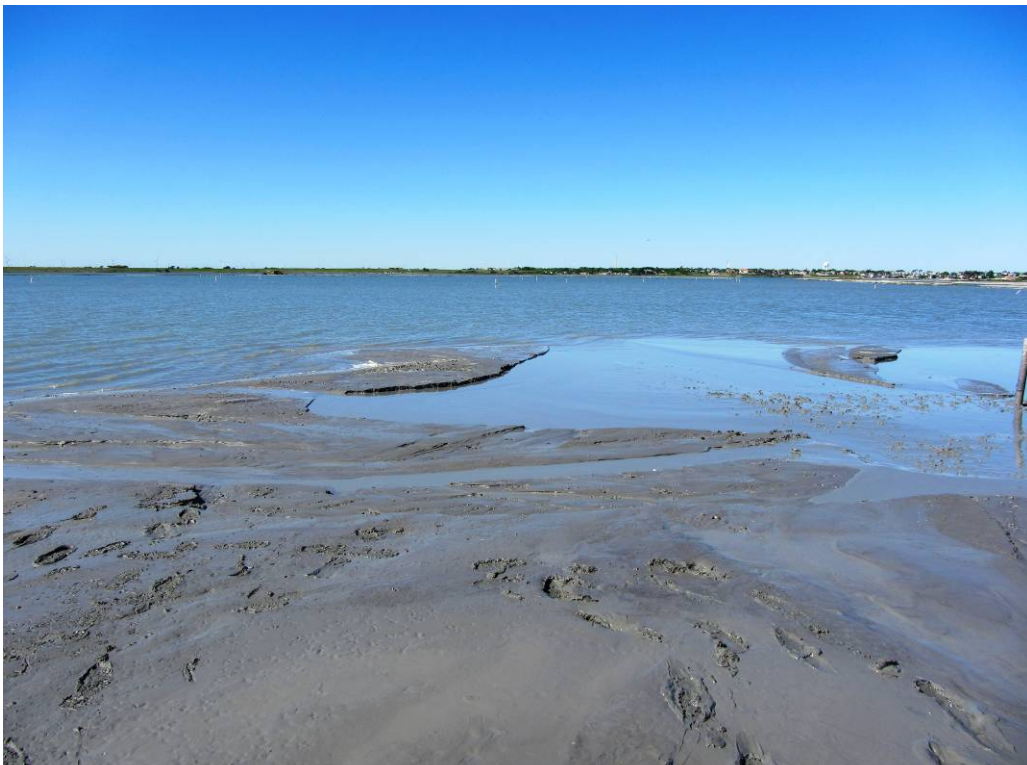
Mound M11 side slopes.

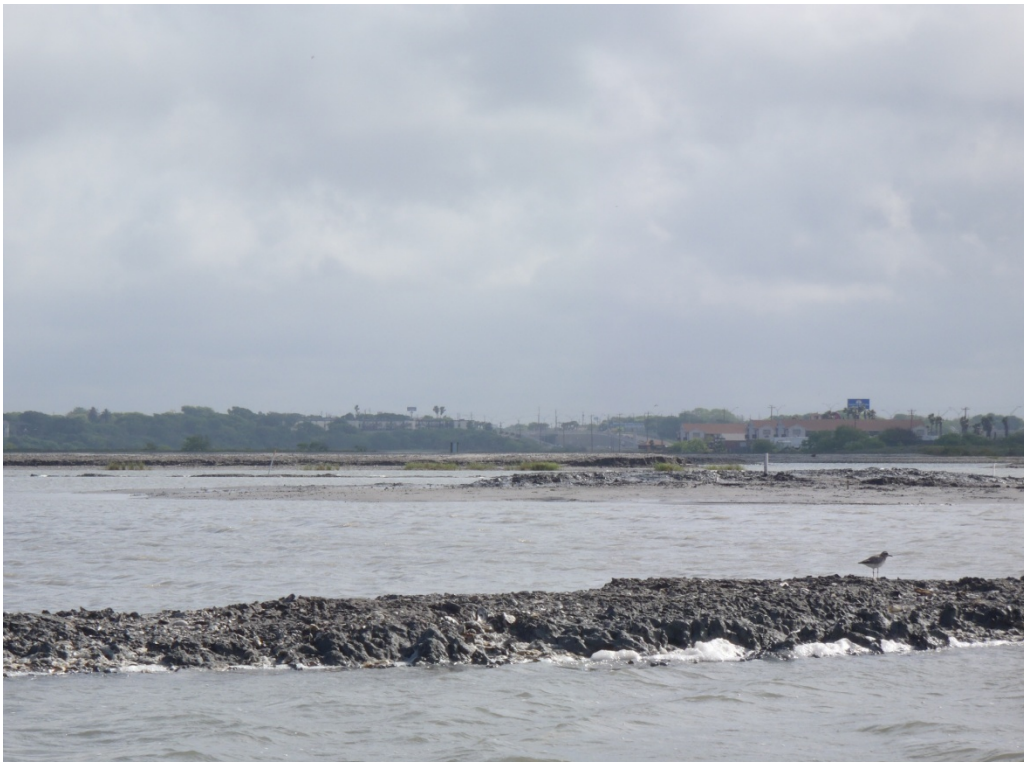
Marsh mound M11 and Cell 3 toe berm.

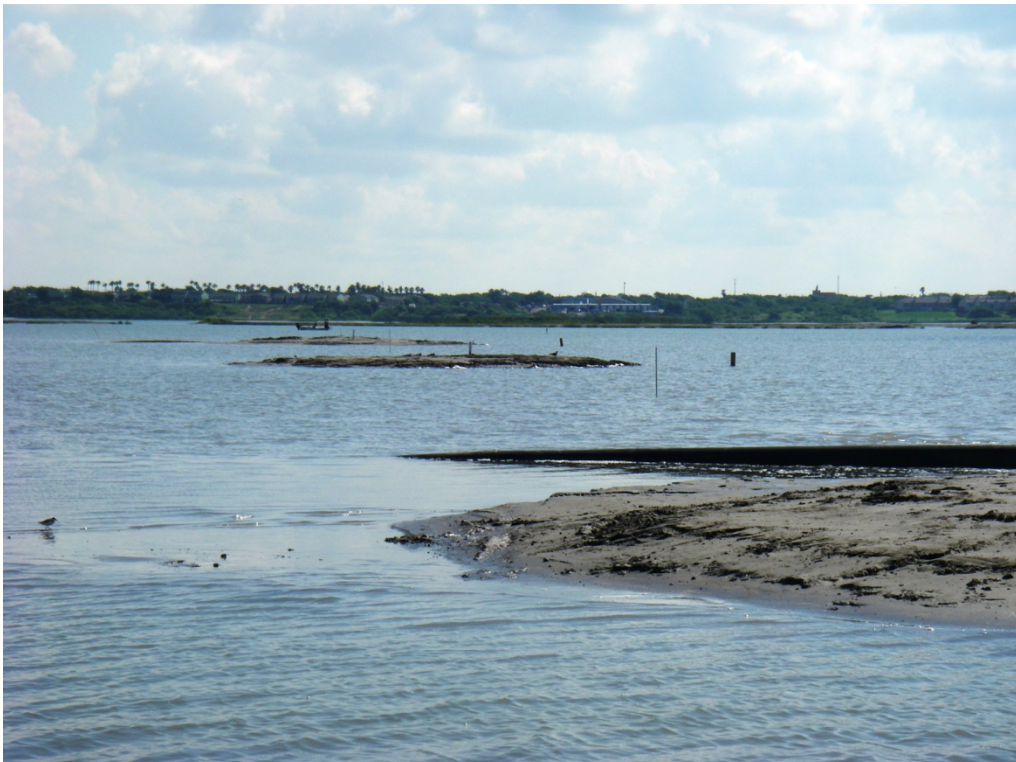
Marsh mounds M1, M2 and M3 (front to back).
